Alpha Home & Commercial Building Inspections

Property Inspection Report

Sample 37 Year old residential beach front, Rye, NH 03870
Inspection prepared for: Sample Client
Real Estate Agent: Lorrie Gould - Lorrie Gould Real Estate Broker

Date of Inspection: 10/15/2015 Time: 1:15 PM
Age of Home: 37 years Size: 1438 sf
Order ID: 2989

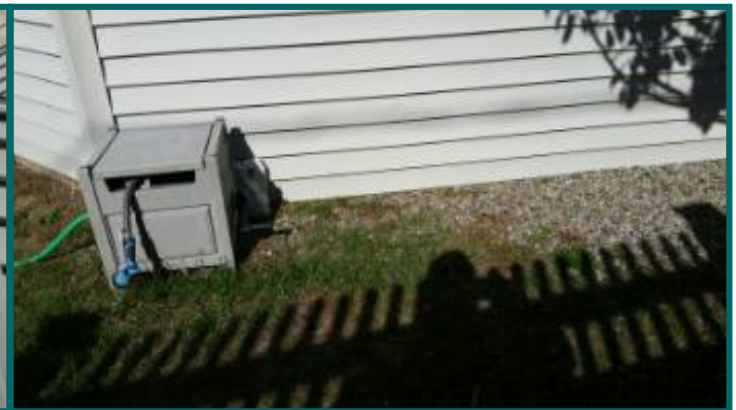
2.1. Siding is in contact with finish grade at one or more area of building, this is conducive to moisture and insect intrusion, recommend monitor area and have repaired as needed by a qualified contractor.

Siding in contact with finish grade.

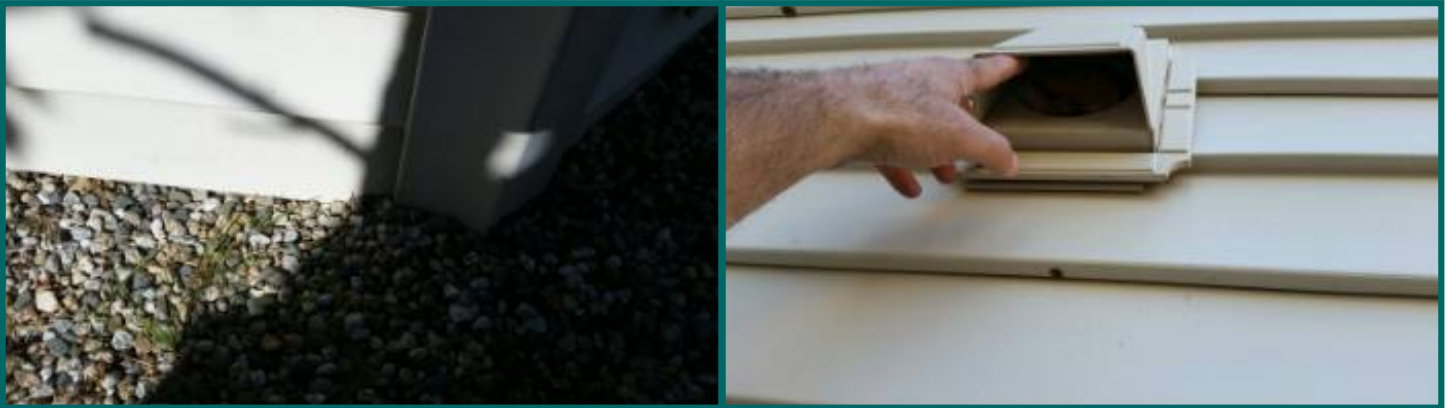
vent on left side of house is blocked with insulation

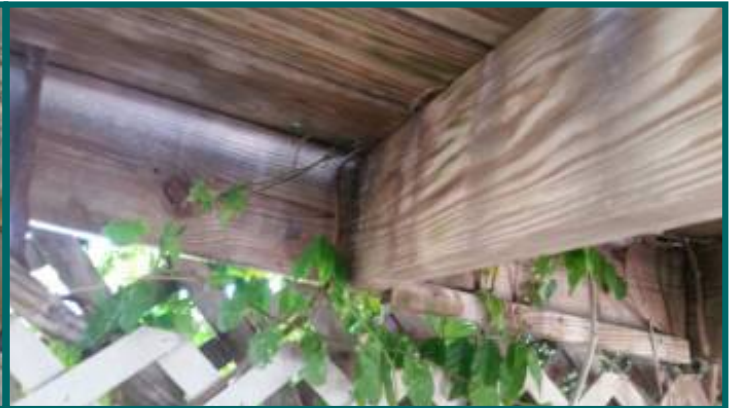
6.3. One or more support joists are missing properly installed mechanical hangers, recommend installation and proper nailing of joist hangers by a qualified contractor.

missing joist hangers at outside rim frame

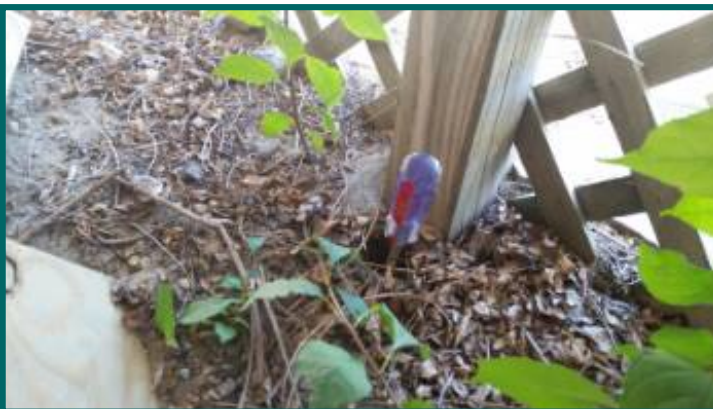
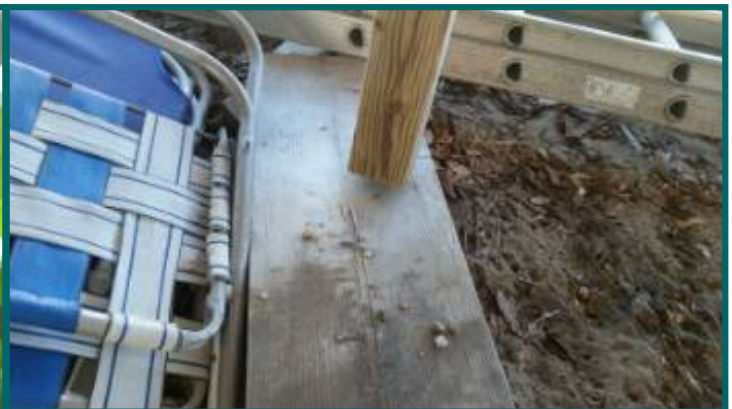
6.4. One deck support post is not in contact with footing, is loose, recommend assessment by a qualified contractor.

center post has no contact with ground or footing

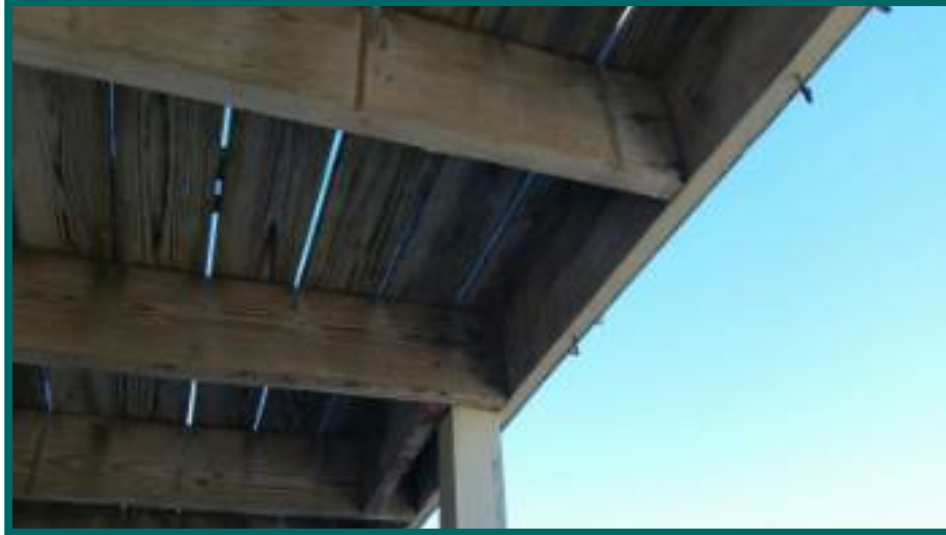
Missing Joist hangers.

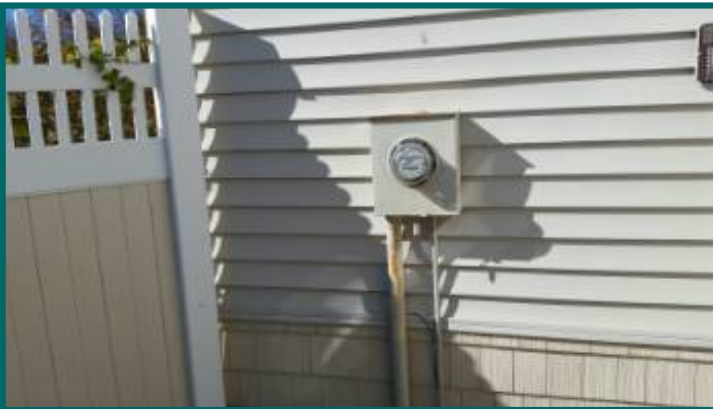
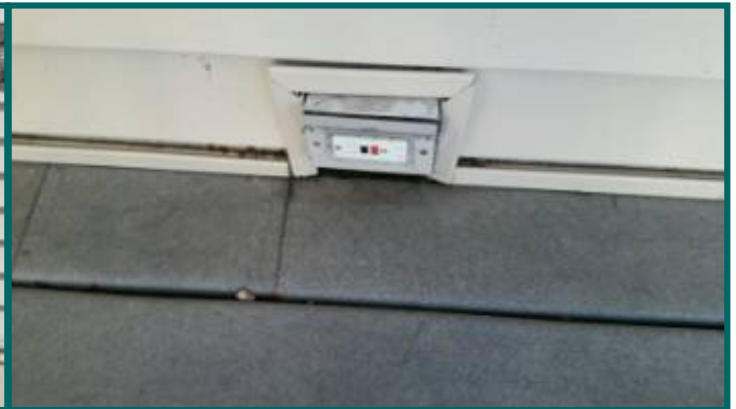
7.3. One or more exterior wall outlets have no power, recommend repairs by a qualified electrician.

7.4. One or more exterior outlet has damaged or missing weatherproof cover, recommend repairs by a licensed electrician.

no power missing weatherproof cover at lower sliding door area

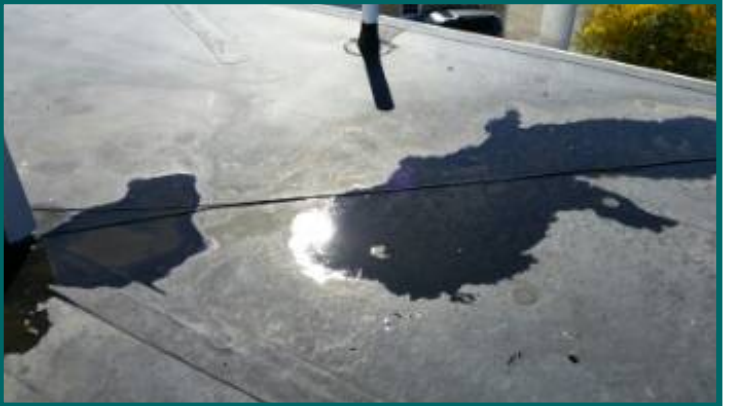
1.3. Water ponding in areas, roof is draining improperly, this can contribute to roof leaks and damage, recommend assessment by a qualified roofing contractor.

ponding on second upper room

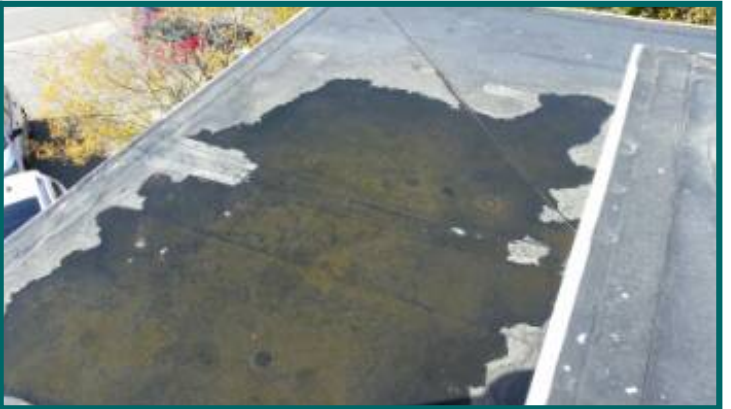
ponding at lower roof

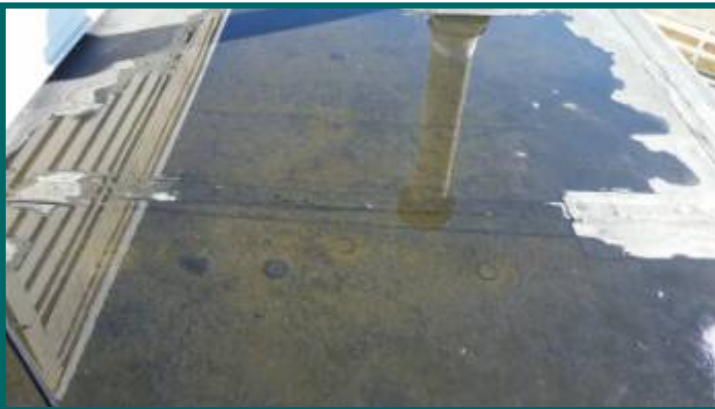
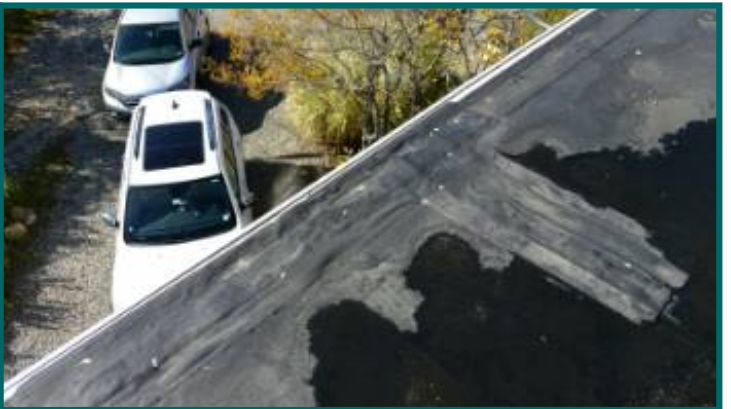
A few areas of patches on roof surfaces should be inspected and resealed from time to time

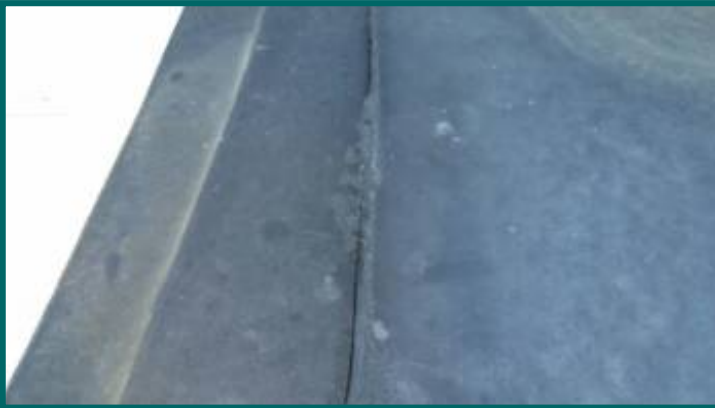
lifting seam

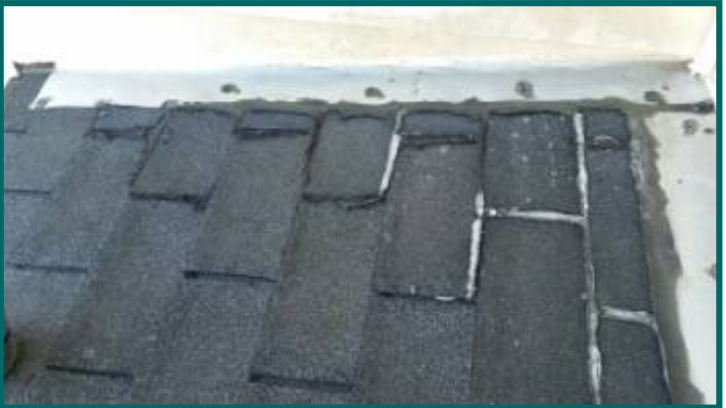
1.2. One or more areas of shingles lifting or loose, shingles should lay flat to help prevent water intrusion, recommend assessment and repairs by a qualified roofing contractor.

damage and prior repair to shingles over rear shed

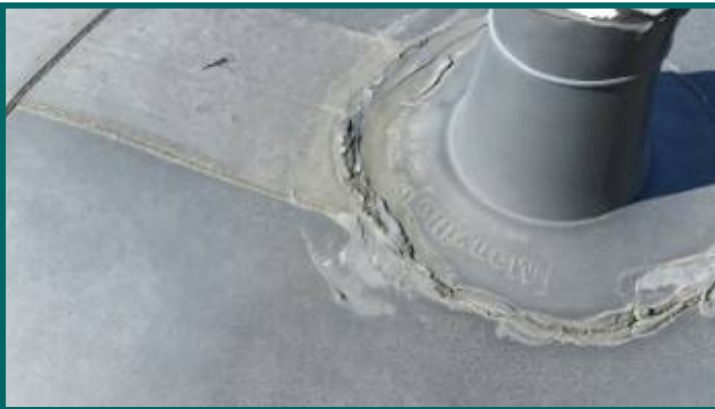
2.2. Sealant around chimney and **vent stack** penetration is dried and cracking. Recommend inspection and proper repair by a qualified roofing contractor.

crack sealant on second roof vent stack

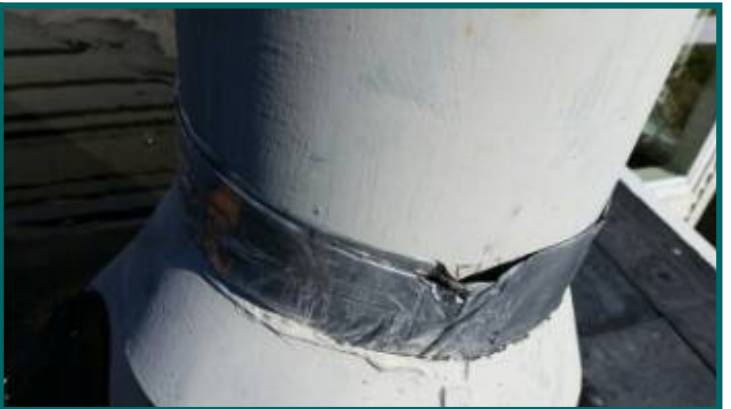
flashing tape is lifting on fireplace vent stack

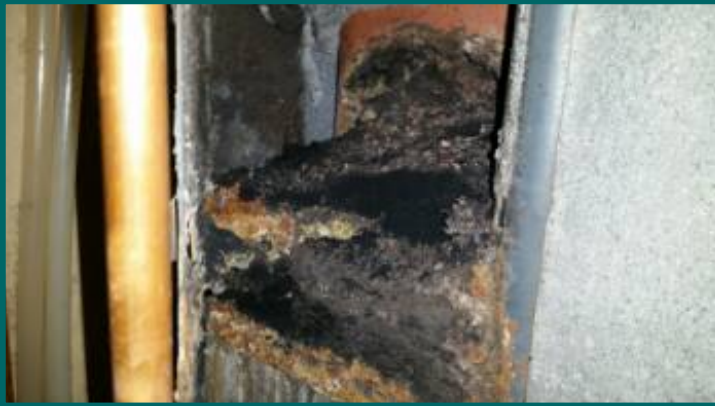
4.3. Chimney clean out is full recommend cleaning.

Chimney clean out

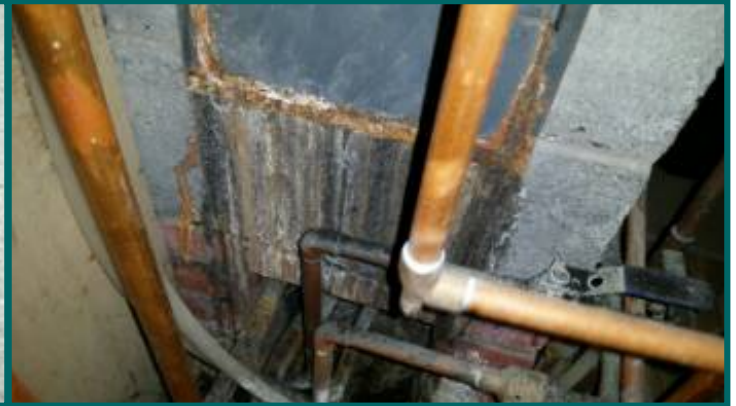
Stains at clean out

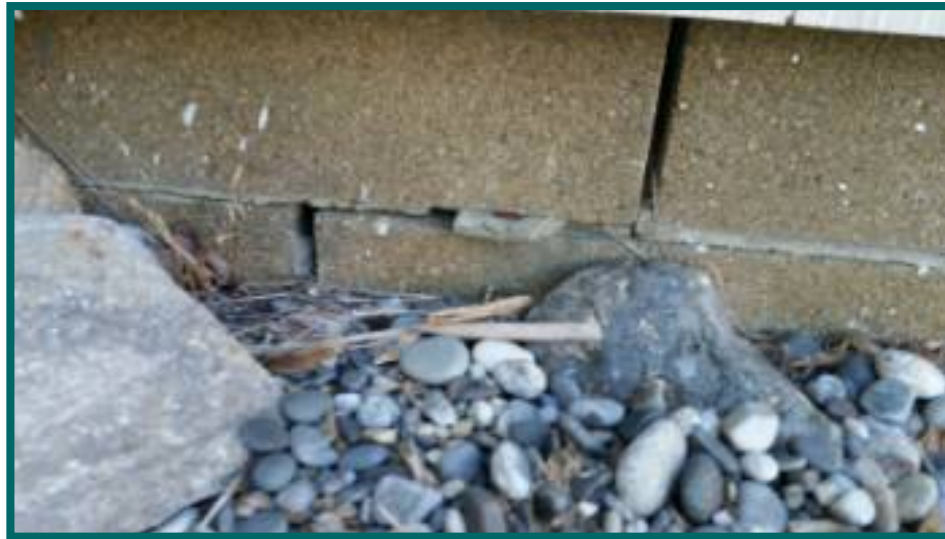
1.4. There is step cracking to foundation walls, this can be typical for age of home. These areas should be monitored closely for further movement and any signs of water intrusion and repaired as needed by a qualified masonry contractor.

damage grout lines on left side of house

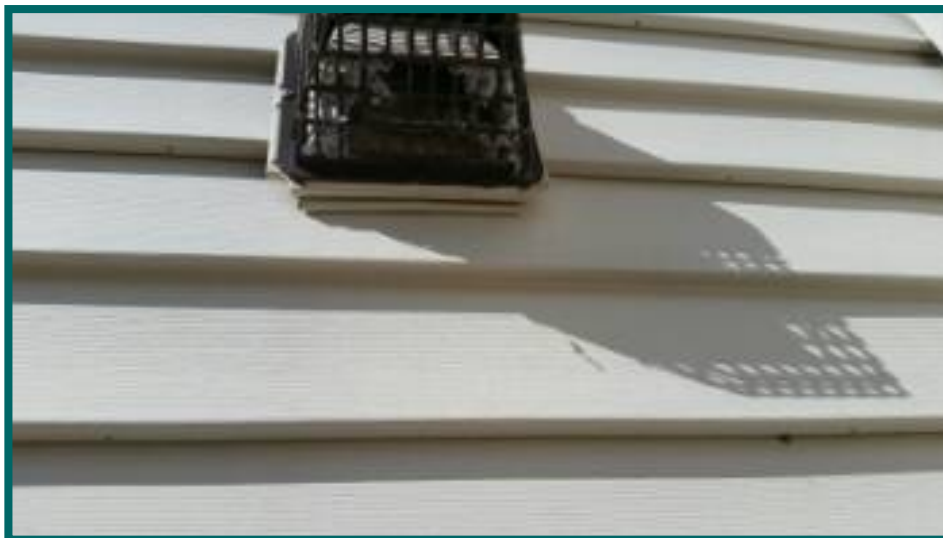
- 4.1. Recommend regular inspection and cleaning of dryer vent to help prevent fire hazard.
- 4.2. There is excessive lint at dryer vent termination, recommend inspection and cleaning as needed.

Dryer vent termination

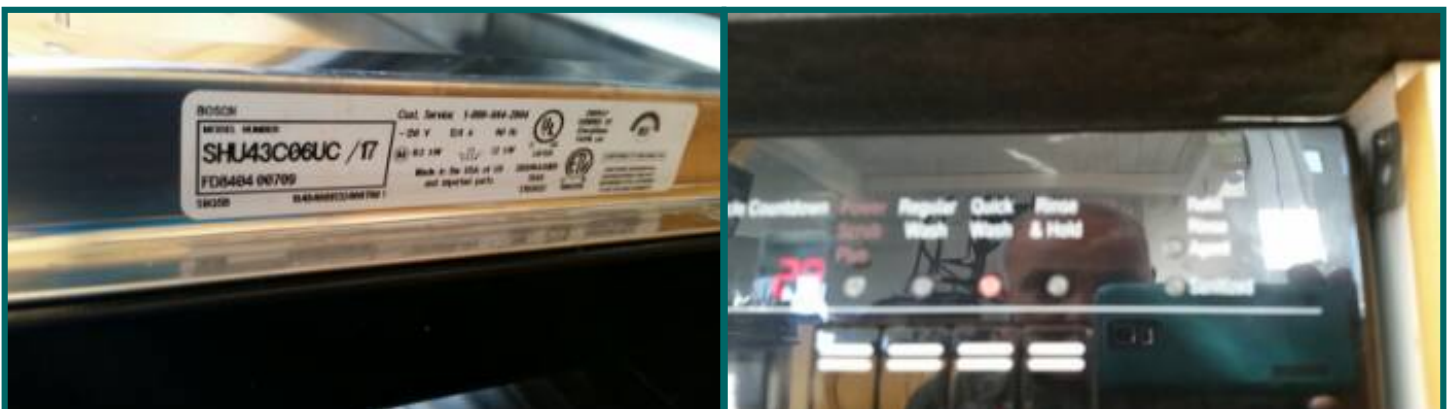
2.4. Unit is not properly fastened, recommend securing to countertop using the appropriate length screw to prevent tip from exiting top of counter causing damage.

Not properly secured

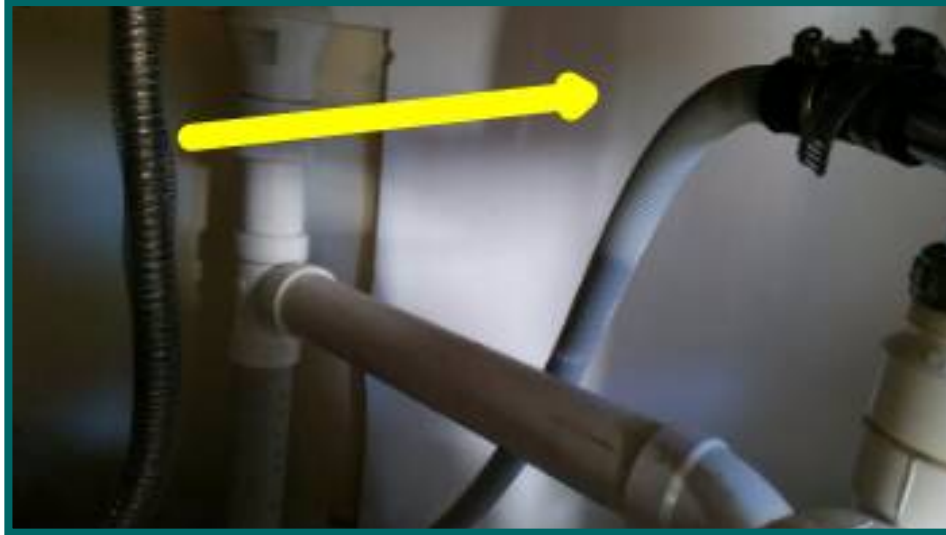
2.3. Dishwasher is missing high loop on drain, this is needed to prevent back flow from sink to dishwasher, recommend repair by a qualified tradesman.

No high loop in drain line.

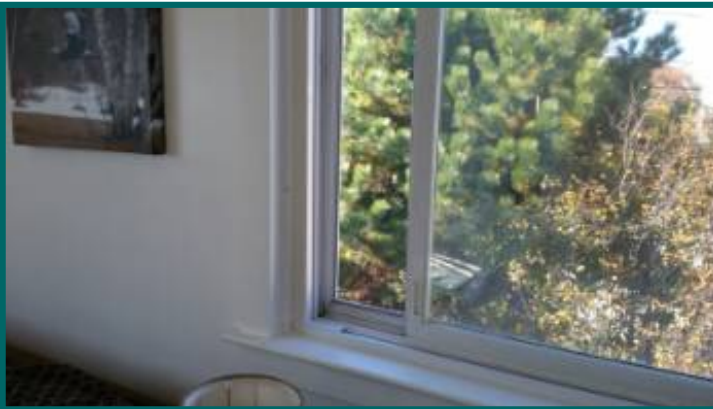
2.3. One or more windows have tight sash, window is difficult to open. Recommend repair by a qualified window contractor.

windows are difficult to slide

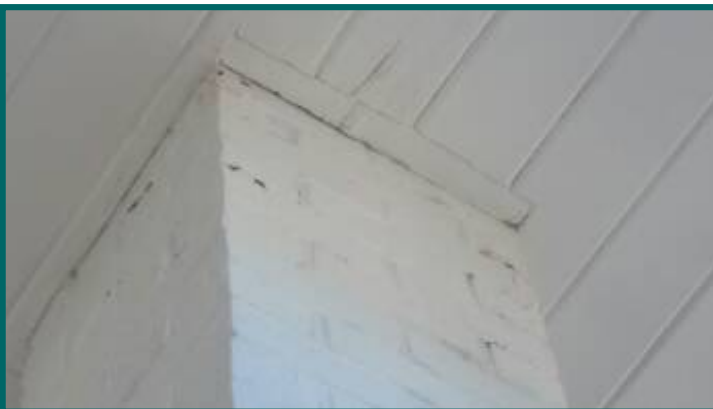
4.2. Stains noted on ceilings in one or more area of home. This is evidence of past or present leaks. They tested dry at the time of the inspection. Recommend repairs of any affected areas and monitor for further water staining.

Ceiling stains at chimney roof penetration.

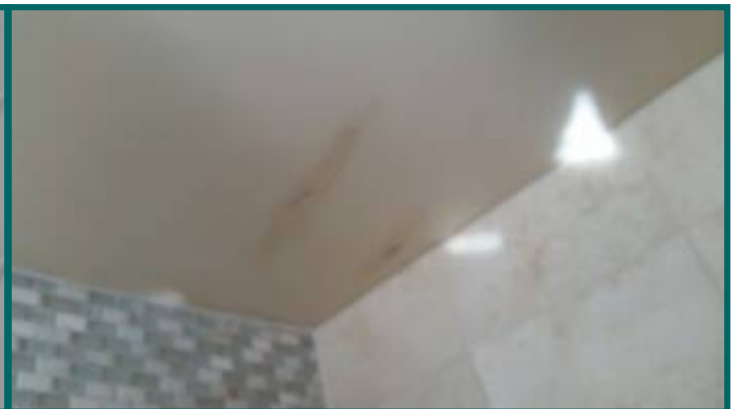
staining above shower

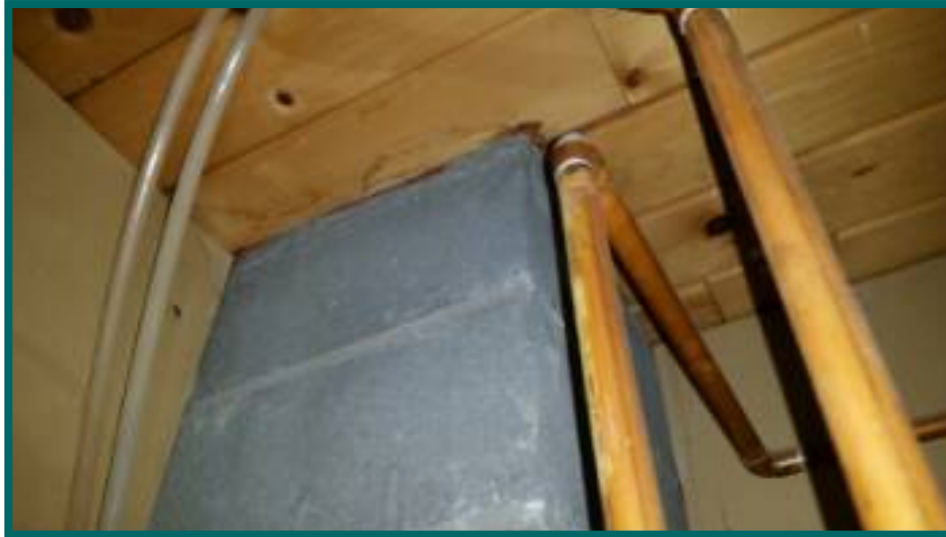
Basement ceiling around chimney

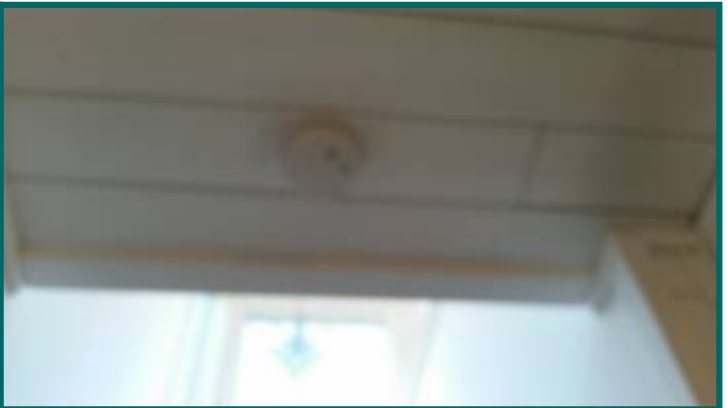
7.2. Smoke and or CO detectors are missing at one or more bedrooms, recommend assessment and installation of smoke / CO detectors at the correct locations by a licensed electrician.

There is one smoke detector in bedroom hallway area, no smoke or CO detectors in bedrooms.

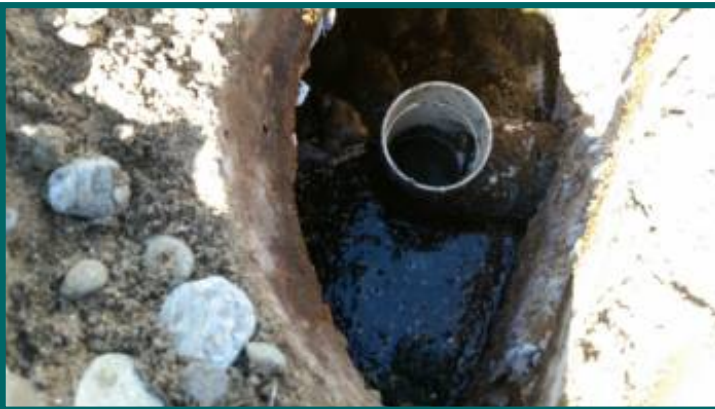
1.2. Tank needs to be pumped.

Septic tank outlet baffle.

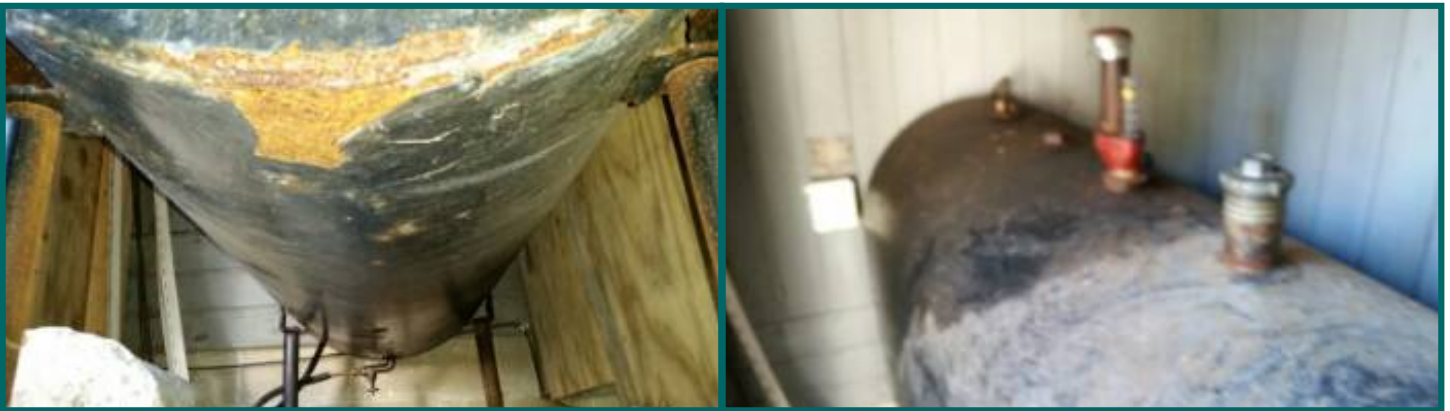
3.3. Corrosion or staining on oil tank, recommend have inspected by a qualified oil burner company. A leaking oil tank can create environmental hazardous conditions. Oil tank should be inspected for evidence of leaking by a qualified oil burner company and replaced as needed.

Underside of oil tank

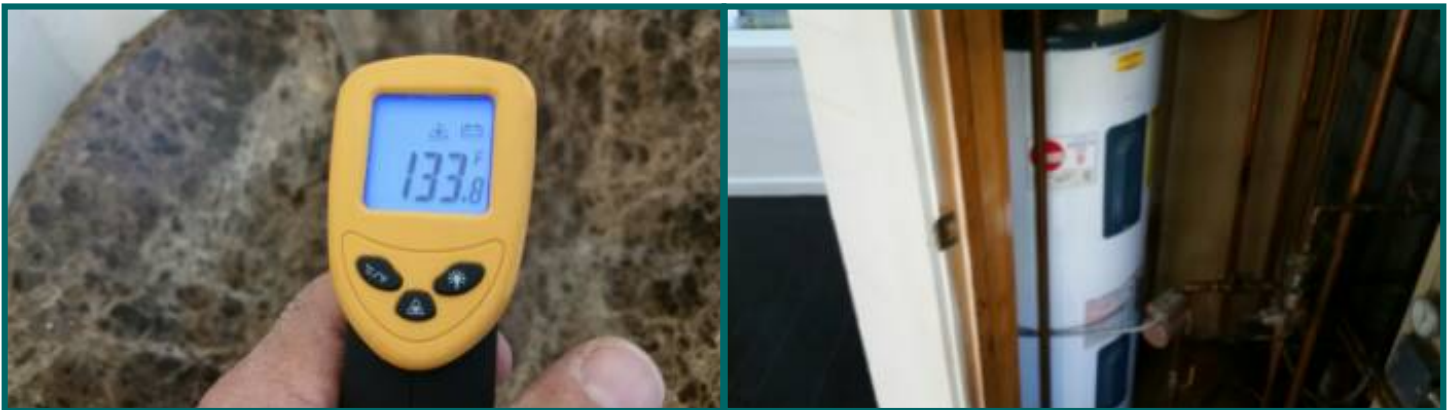
1.3. Water temperature is above 120 degrees, should be set minimum 110 degrees for comfort and maximum 120 degrees to prevent scalding particularly for very young and very old persons.

Water Temperature
