Property Inspection Report

85 Year Old Single Family Victorian, NH
Inspection prepared for: Sample Client
Real Estate Agent: -

Date of Inspection: 10/9/2015 Time: 1:00 PM
Age of Home: 115 years Size: 2738 sf
Order ID: 2977

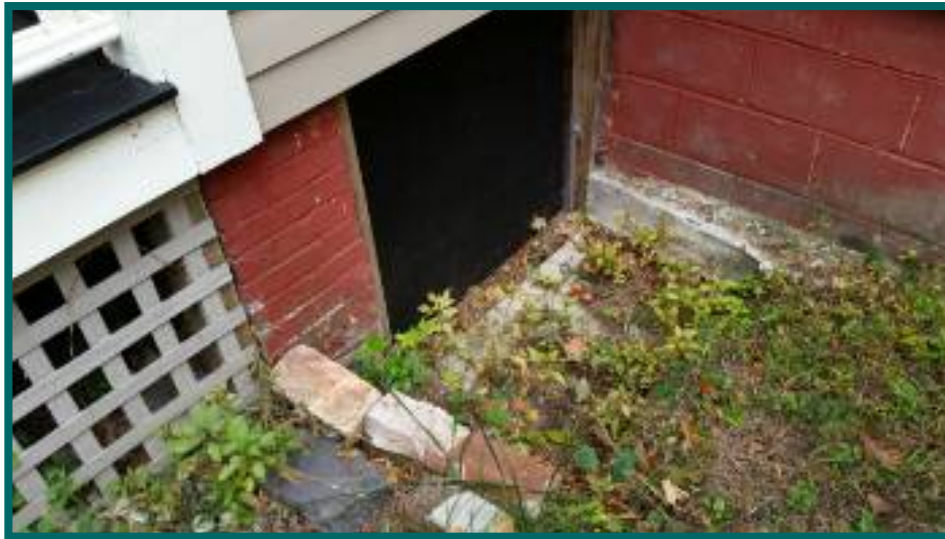
2.3. There is a depression in grading at one or more exterior area of foundation wall. This is conducive to ponding and possible water intrusion into house, recommend filling or re grading any depressions and taking measures to divert water away from this area and monitor for proper drainage.

old bulkhead door well may be conducive to ponding and water intrusion

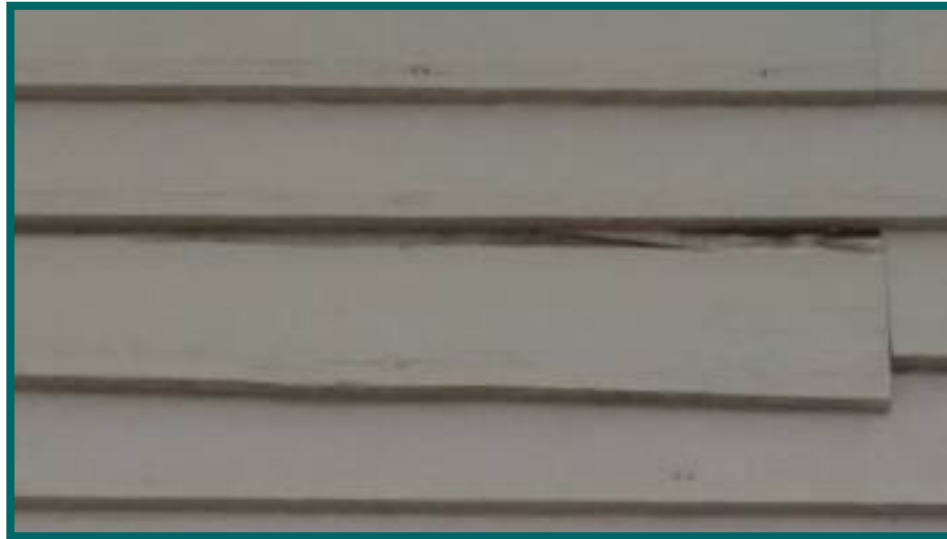
2.1. One or more areas of lifting or deterioration to siding. Recommend assessment and repair by a qualified tradesman.

loose siding on rear barn wall

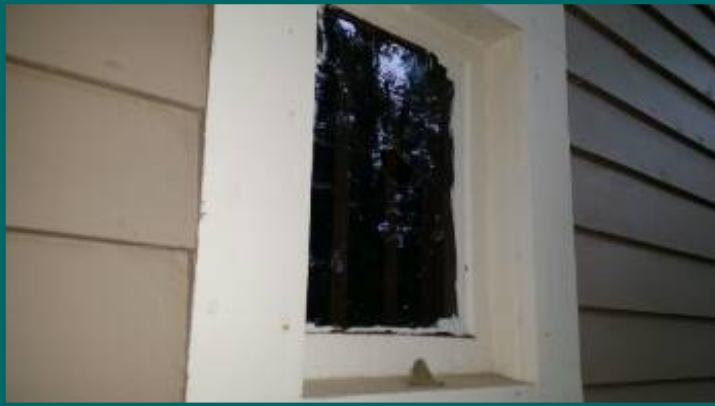
3.1. Window glass cracked at one or more area window, recommend repair by a qualified tradesman.

broken glass on barn window

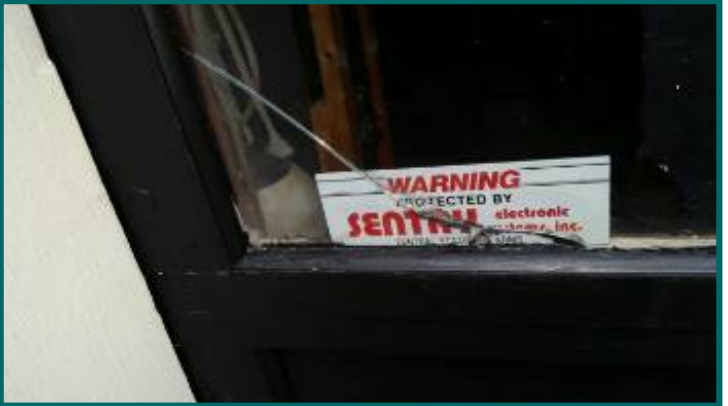
broken glass in overhead garage door

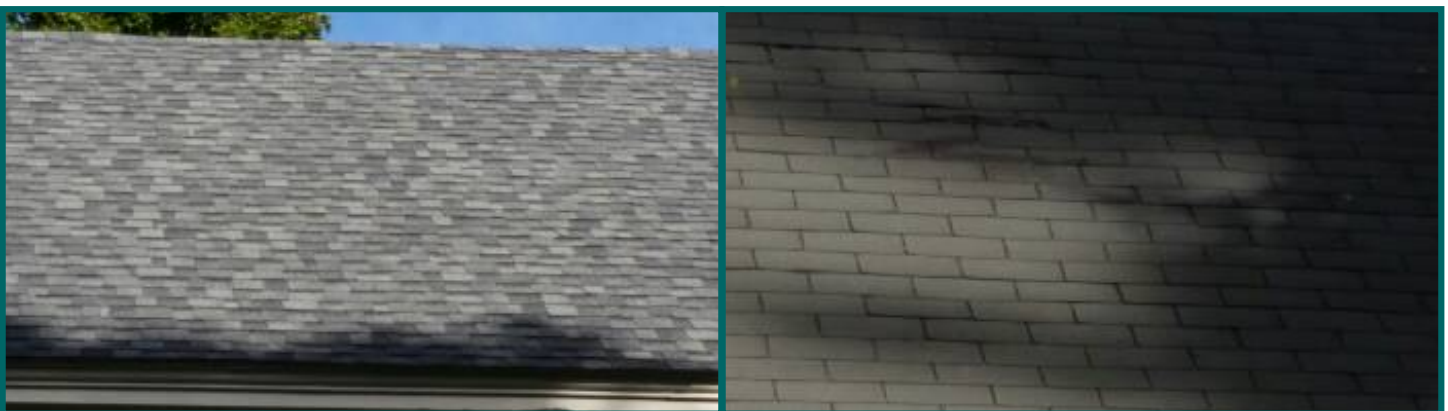
1.3. There are areas of damage and broken or missing shingles, recommend assessment and repairs by a qualified roofing contractor.

Garage roof is older, a few areas of damaged shingles over garage

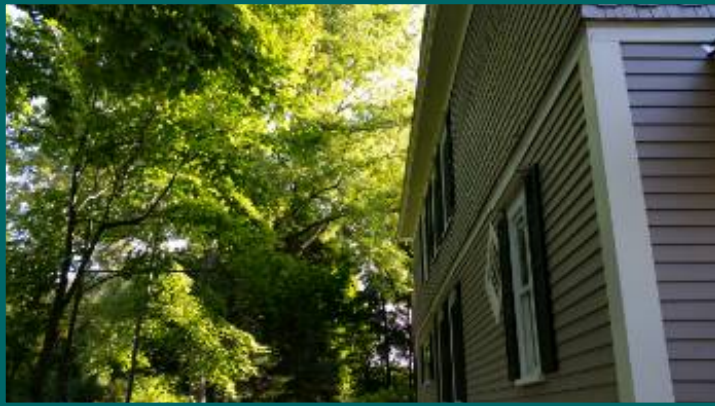
There are trees and branches over hanging or in contact with roof, this condition is detrimental to life of roof and can cause damage, fungal growth, water, insect and animal intrusion. Keep trees and branches trimmed to help prolong life of roof covering.

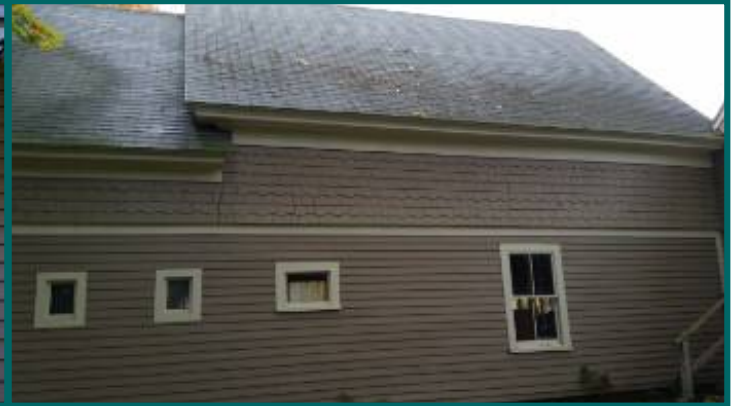
1.2. Staining and fungal growth on surface of roof, recommend cleaning of shingles by a qualified roofing contractor to help prolong life of roof.

fungal growth on barn roof

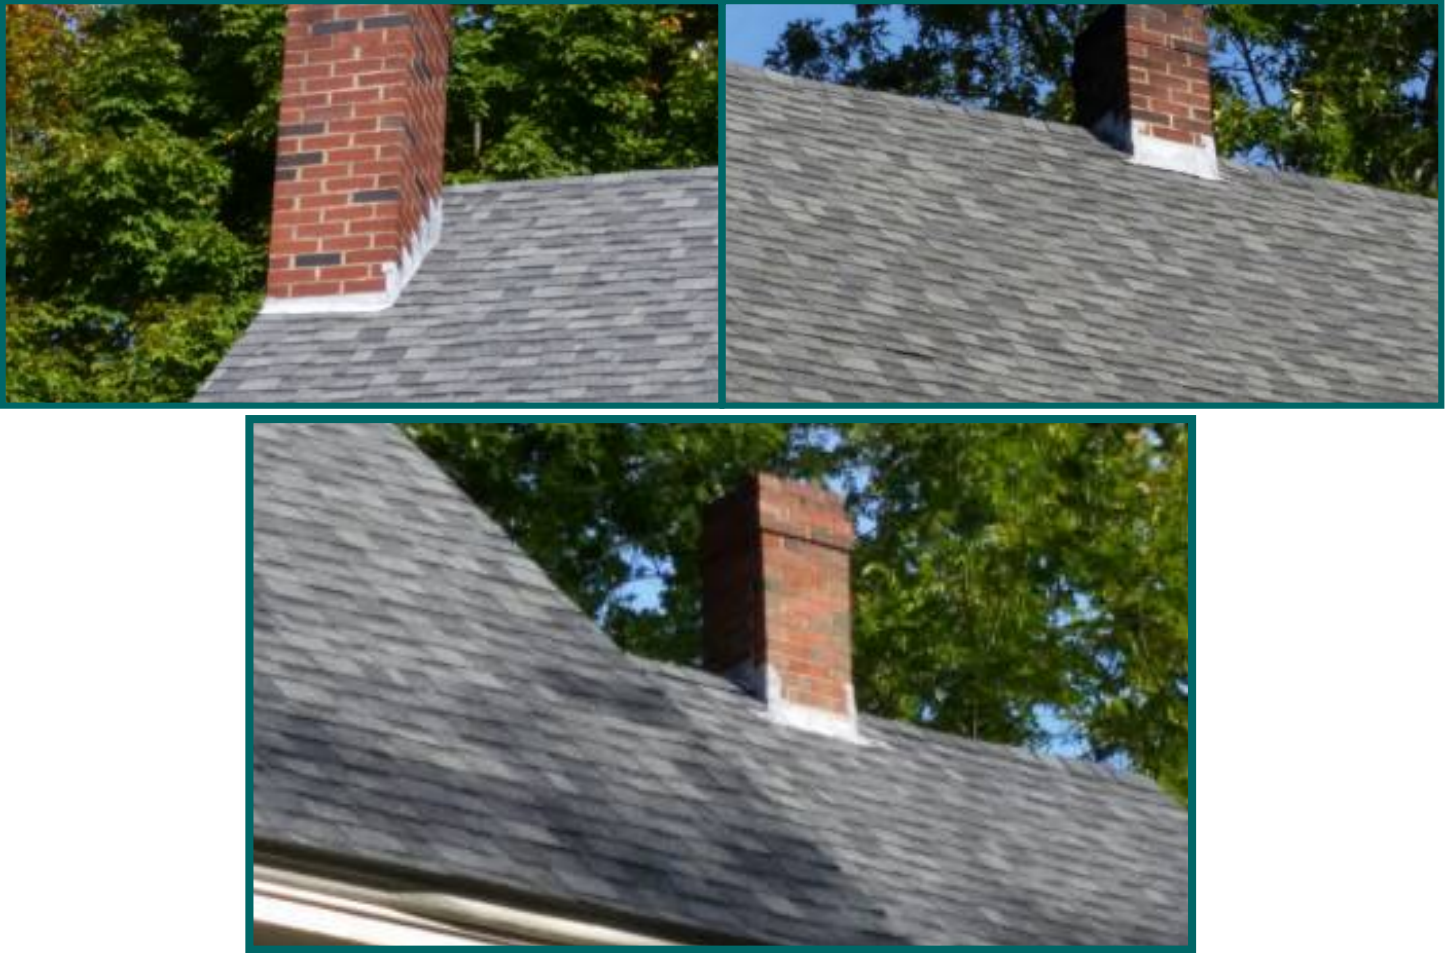
2.1. Metal flashing around chimney is lifting, should lay flat against brick to prevent water intrusion, Recommend monitor condition and repair by a qualified roofing contractor as needed.

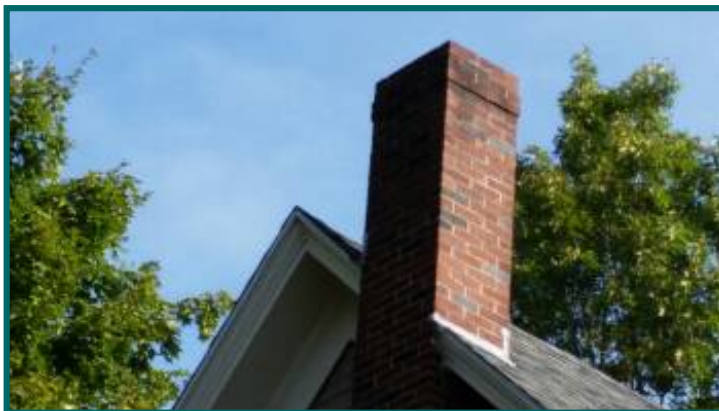
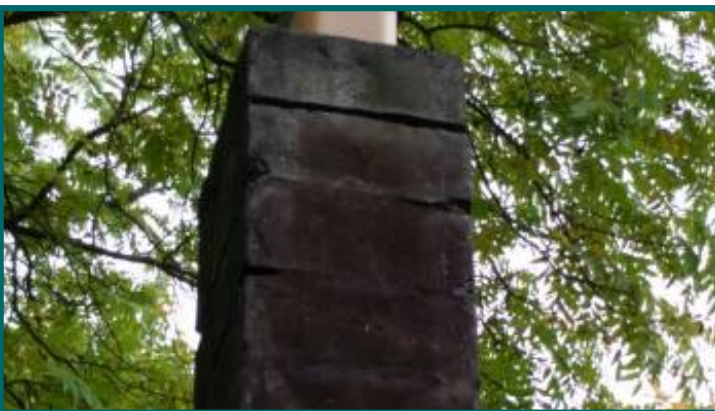
3.4. Chimney Mortar and brick has areas of deterioration or cracking. Recommend having assessed and repaired as necessary by a qualified masonry contractor.

deterioration to mortar on rear chimney

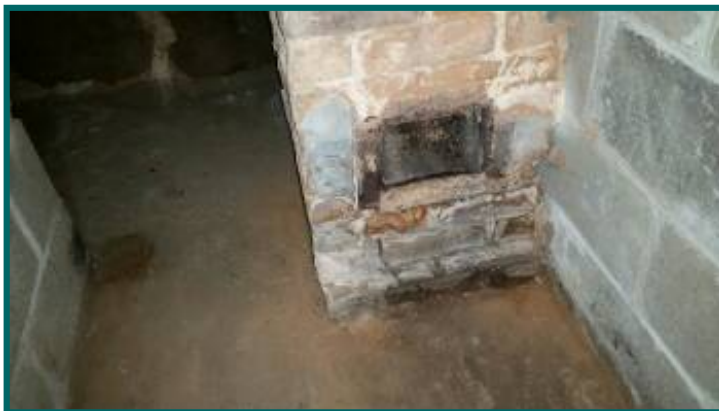
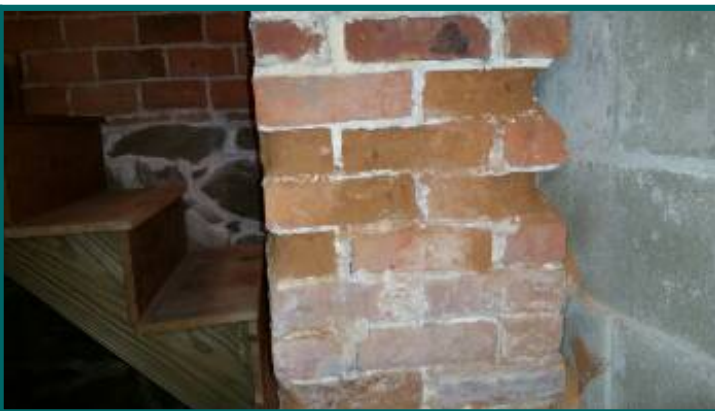
deterioration basement chimney surfaces.

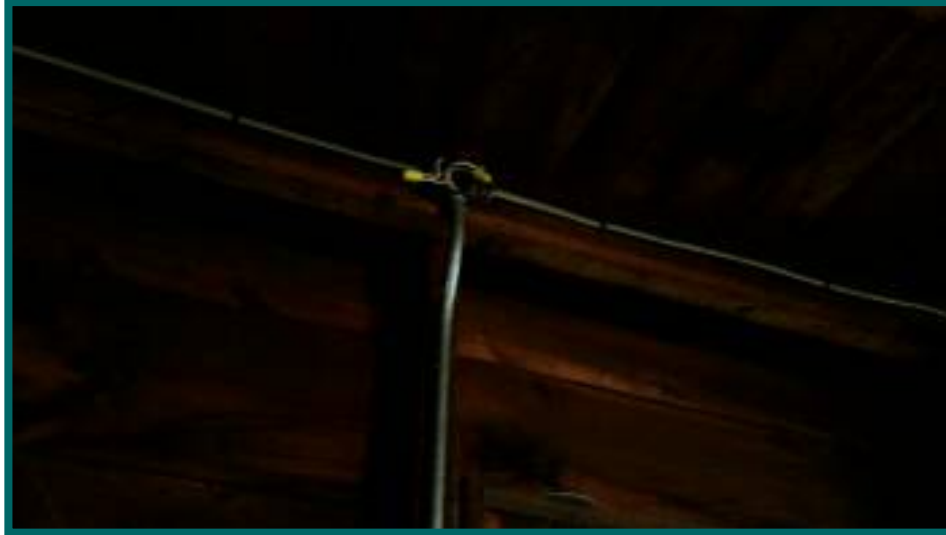
- 2.1. Open junction boxes were observed, which is a safety concern. Recommend installing proper covers, as needed, for safety.

numerous open junction boxes in garage

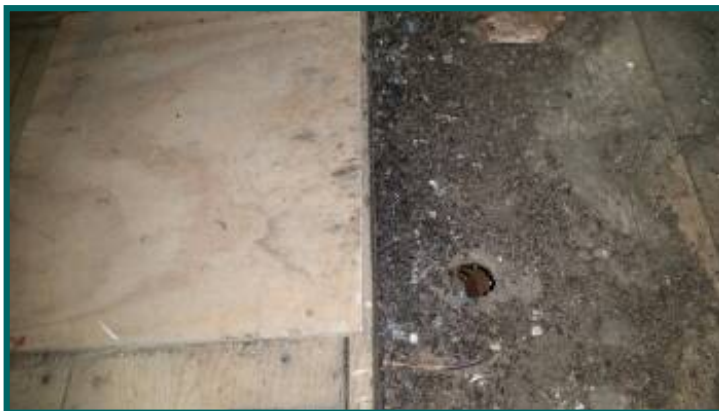
6.1. Rodent activity observed in the garage. Vermin can damage insulation & electrical wiring. Recommend a professional pest contractor evaluate for treatment.

rodent droppings in 2nd floor

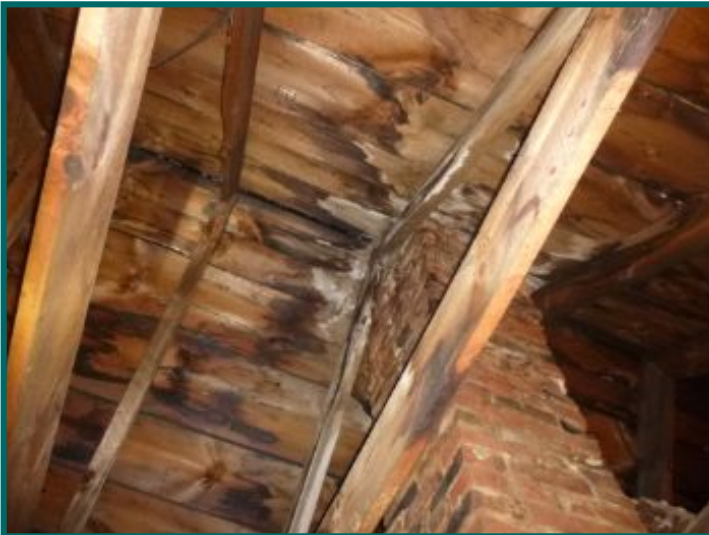
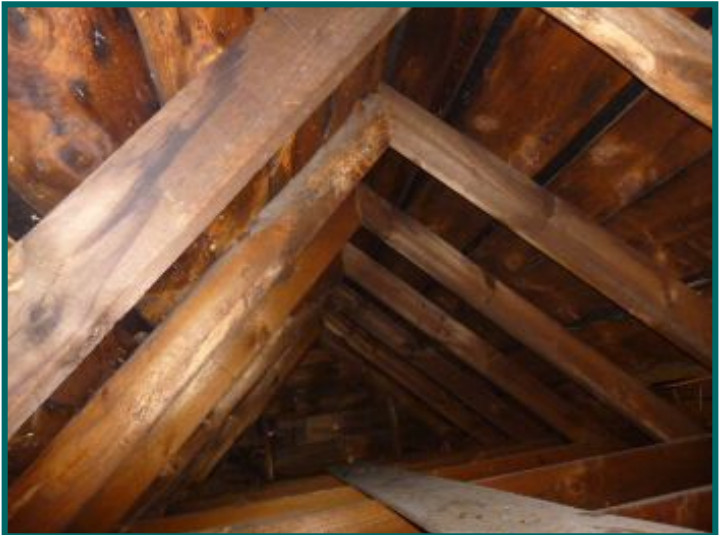
2.5. Staining on attic framing, evidence of past or present leaks, mainly around chimney area, dry at time of the inspection. Recommend monitor for leaks &/or have roofing contractor evaluate.

Stains around chimneys.

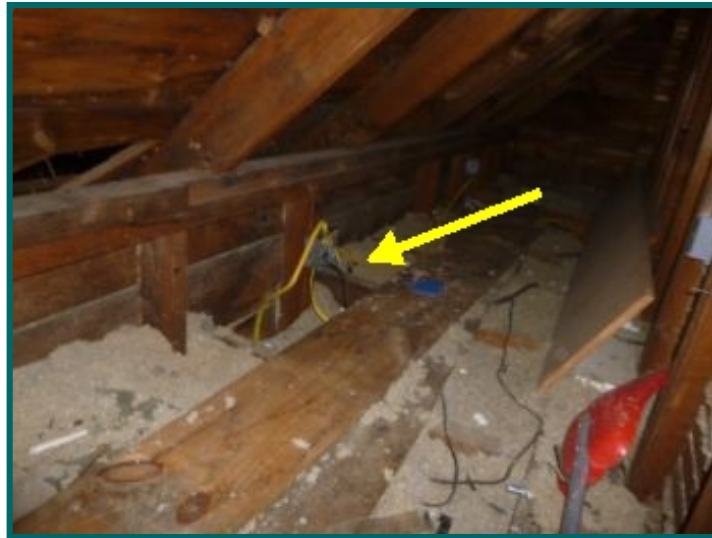
5.1. Open junction boxes were observed, which is a safety concern. Recommend installing proper covers, as needed, for safety.

Open junction box.

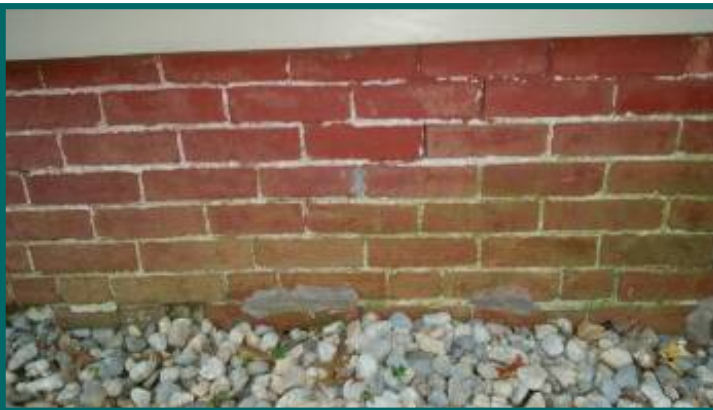
1.5. There is step cracking to foundation walls, this can be typical for age of home. These areas should be monitored closely for further movement and any signs of water intrusion and repaired as needed by a qualified masonry contractor.

step cracking and repairs to brick on left side of house

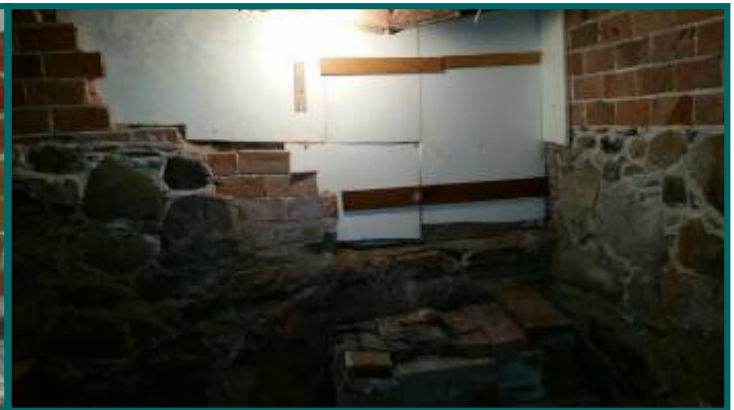
1.6. A few areas of damage to the foundation walls, due to the age it is recommend to have stone and grout lines on wall inspected and repaired as needed on a regular basis.

area near old bulkhead access door

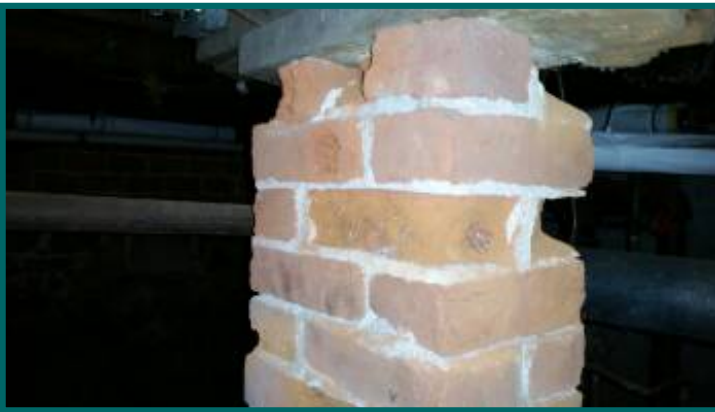
2.6. Foundation framing is very old , there are areas where framing components have been repaired or replaced, there is deterioration to one or more support posts, there is settlement on floors in finished space noted, condition should be monitored closely and repaired as needed. Damage to brick support posts should be assessed and repaired by a qualified masonry contractor.

deterioration to brick support posts

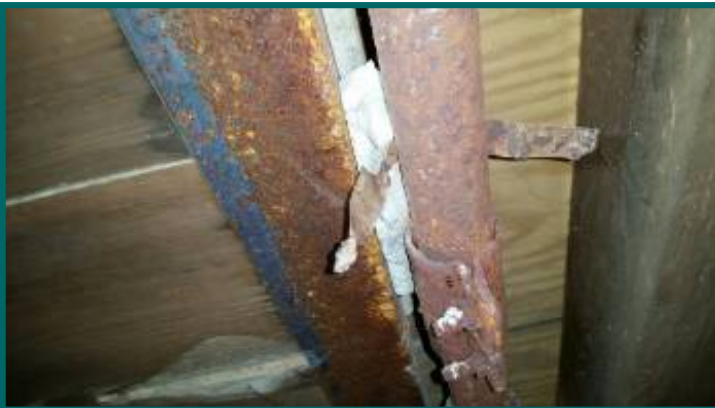
4.1. Insulation on heat pipes in basement may contain asbestos. Recommend further investigation and encapsulation or proper removal if needed by a qualified asbestos remediation company.

some remnants of old style suspected asbestos insulation on wrapped steam pipes

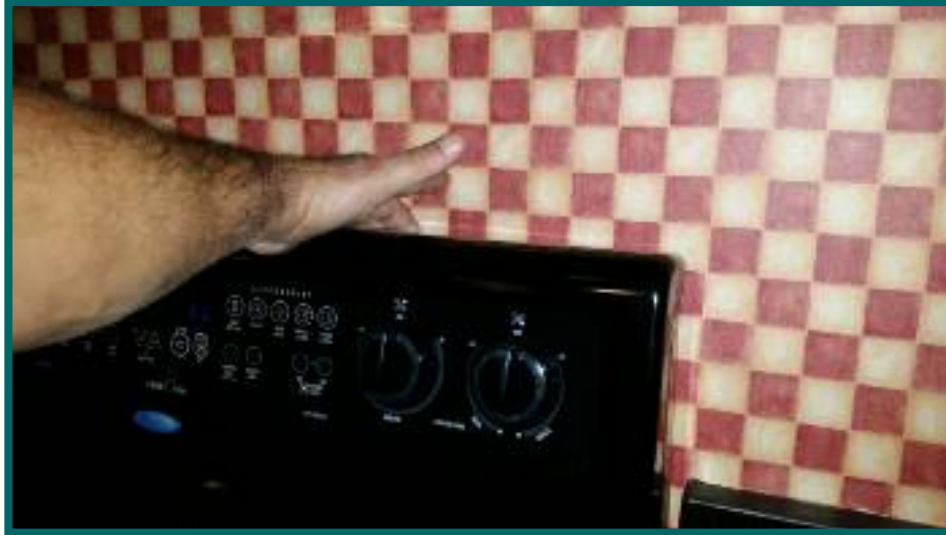
3.3. Oven is missing anti tip bracket, recommend installation of anti tip devise to prevent stove from tipping over and causing injury

Missing anti tip device.

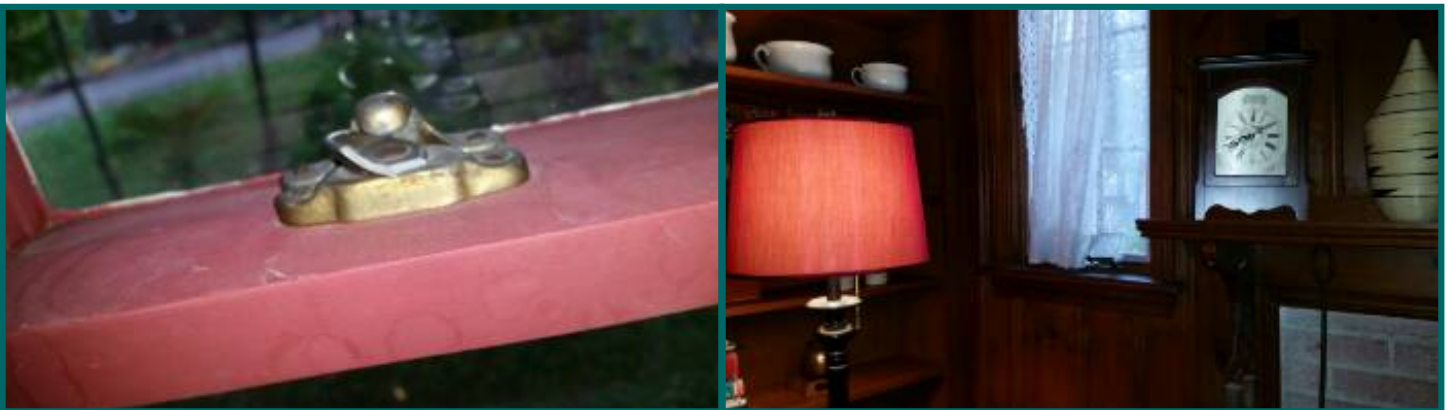
2.2. Window is sealed closed at one or more areas of home. Recommend assessment of windows and repairs by a qualified tradesman.

2.3. Windows at one or more area did not lock/latch properly, recommend repairs for enhanced security/safety to occupants.

1 kitchen sink lock is broken window was not opened

front living room window is stuck shut

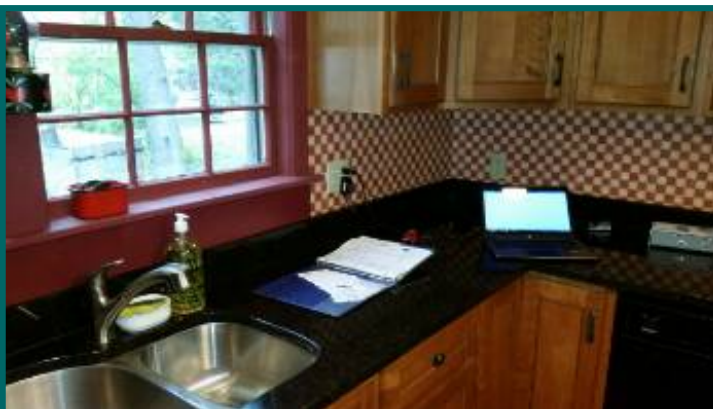
No GFI protection at kitchen outlets.

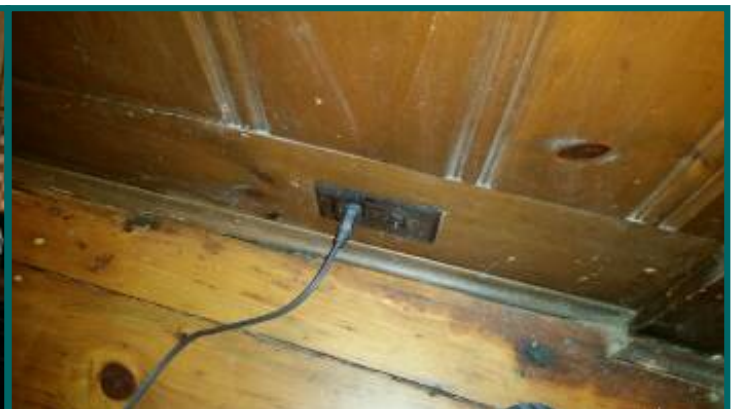
numerous ungrounded outlets on first floor

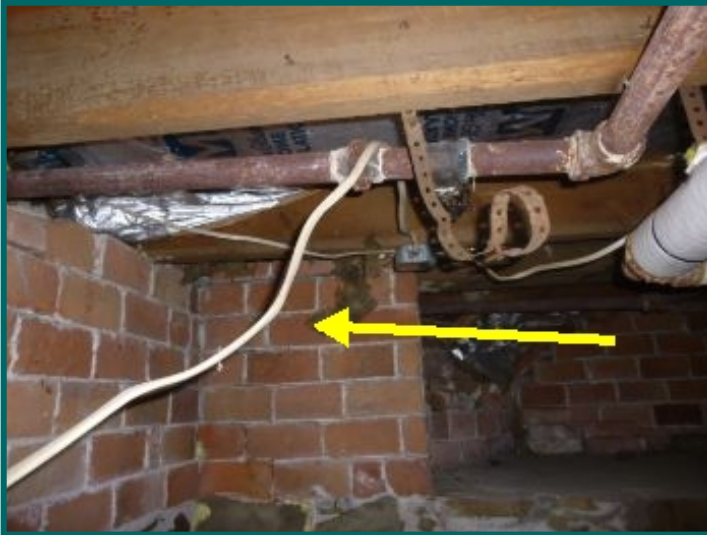
6.5. Improperly secured wires present, all wiring should be properly secured to the framing. recommend assessment by a licensed electrician.

improperly secured wires in basement.

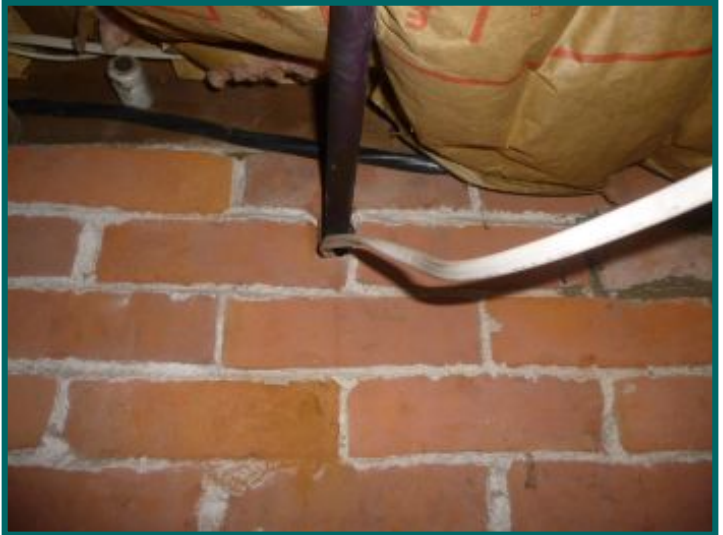
6.6. Electric wires in contact with plumbing or heating lines, this is a potential safety hazard, causing damage to wires and potential energizing of pipes / duct. Recommend repairs by a licensed electrician.

Wires in contact with plumbing lines

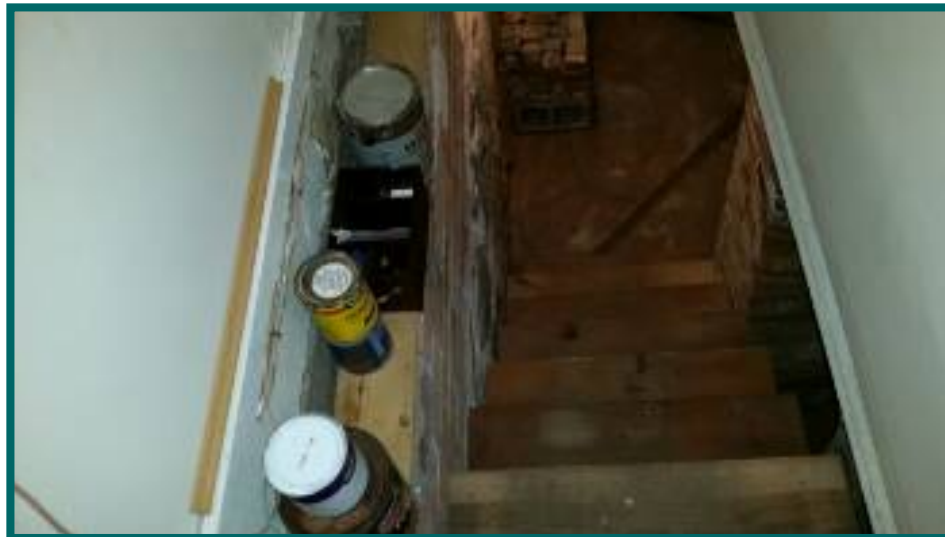
9.2. Stairs have one or more area of handrail missing. Recommend installing proper hand rail and **balusters** by a qualified contractor for safety.

missing hand rail at basement stairs.

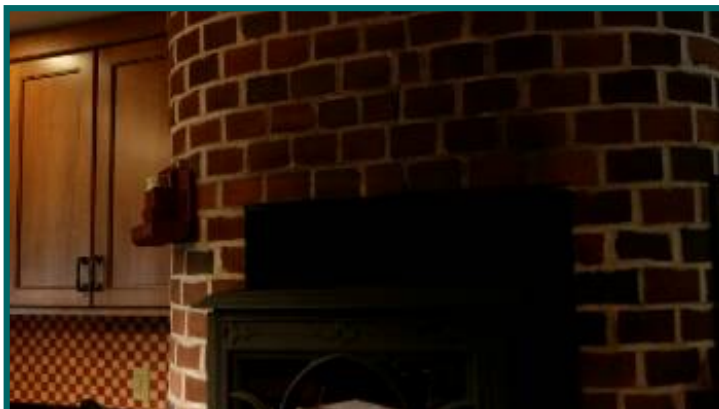
10.1. Cracks in brick on face of chimney, recommend monitor for further movement and have further investigation and repairs by a qualified masonry contractor if needed.

vertical crack on brick facing above kitchen stove

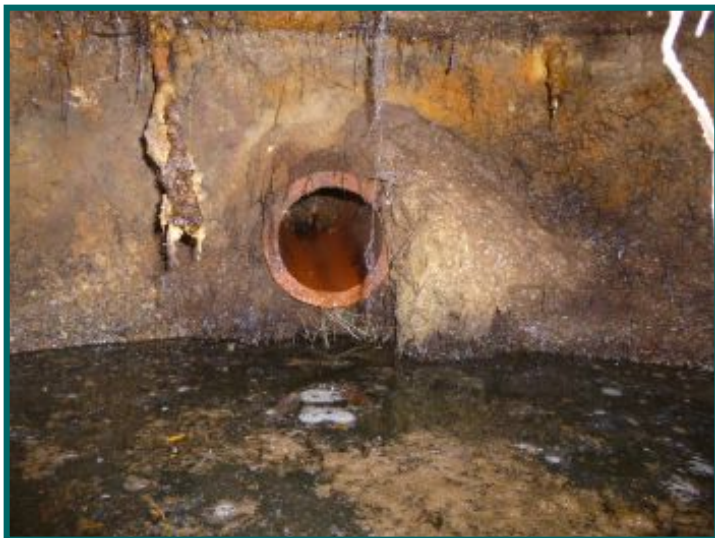
Inlet baffle missing

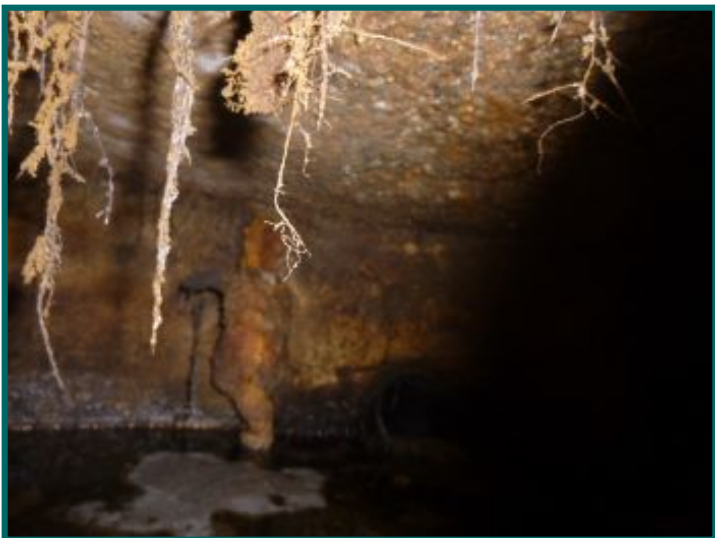
1.2. Outlet baffle is a concrete wall style with areas of deterioration, recommend installation of a PVC "T" baffle to help prevent solids from entering the leach field.

Outlet baffle missing

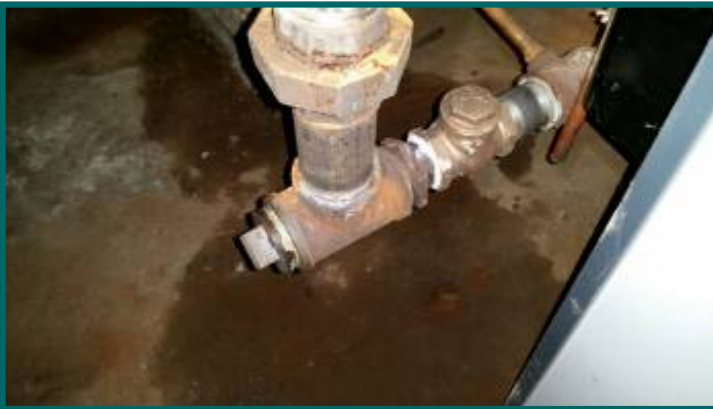
leak on fitting near boiler

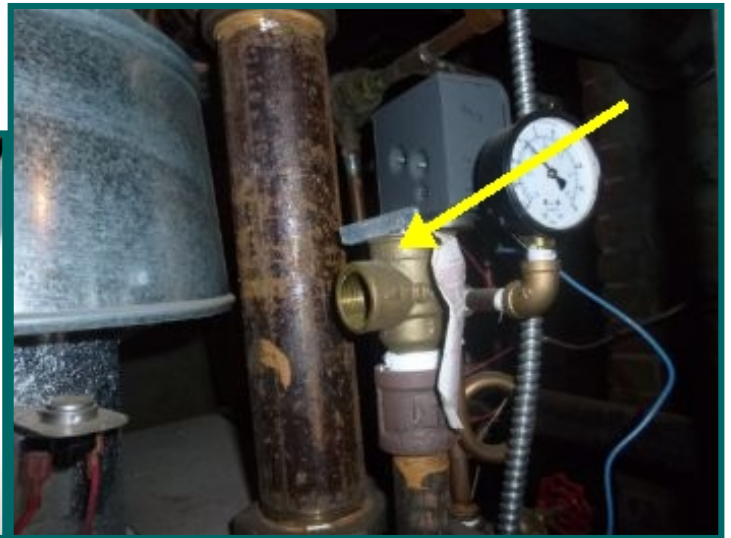
1.4. T/P relief valve extension is missing. Recommend installing of extension pipe that exits within 6" of floor. This is a safety item to prevent scalding in the event the temperature pressure relief valve releases hot water and or steam.

Missing down pipe for pressure relief valve

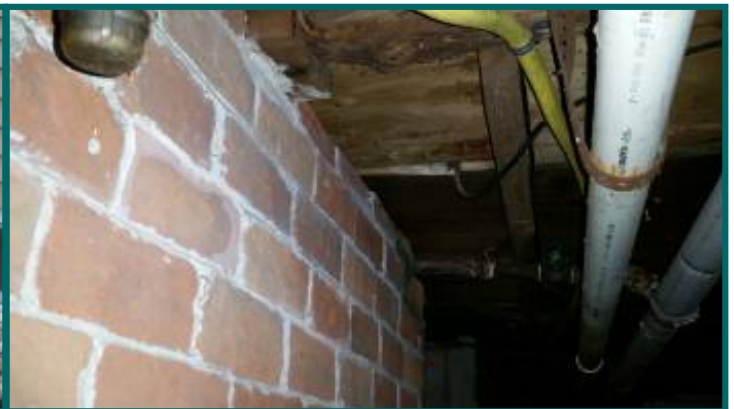
3.6. This house has corrugated stainless steel tubing (CSST) gas supply piping. The CSST gas piping system needs to be properly bonded to the electric grounding system. CSST gas pipe has been associated with lightning related fires, product defect allegations and litigation. Recommend an electrician and or plumber trained in CSST installation, local regulations and defect recognition inspect the CSST system and install or confirm proper grounding.

CSST gas lines
