# Alpha Home & Commercial Building Inspections

## Property Inspection Report

Sample 85 year old 2 Family, NH 03064  
Inspection prepared for: Sample Client  
Real Estate Agent: -

Date of Inspection: 9/30/2015 Time: 1:00 PM  
Age of Home: 85 years Size: 2090 sf  
Order ID: 2941

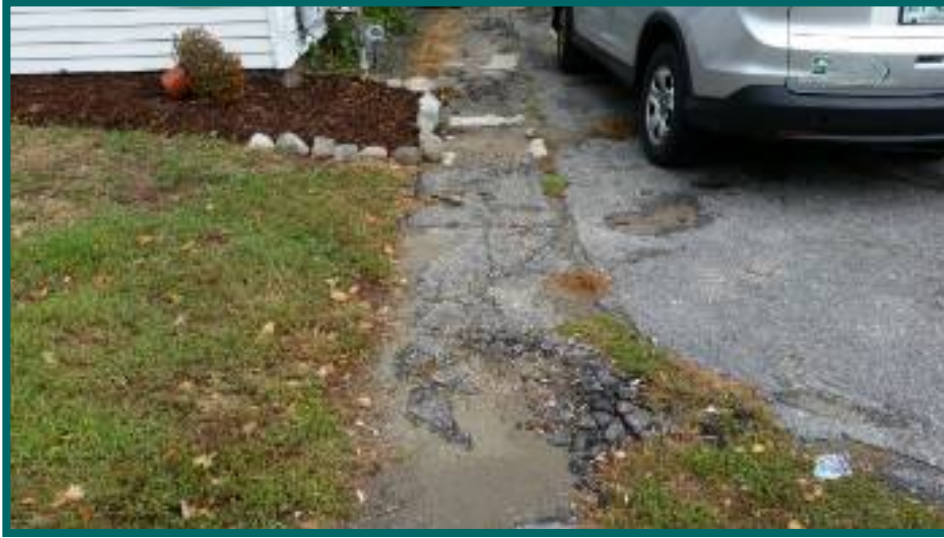
1.1. Excessive deterioration and cracking was observed at the asphalt surfaces. Recommend assessment and repairs by a qualified asphalt contractor.

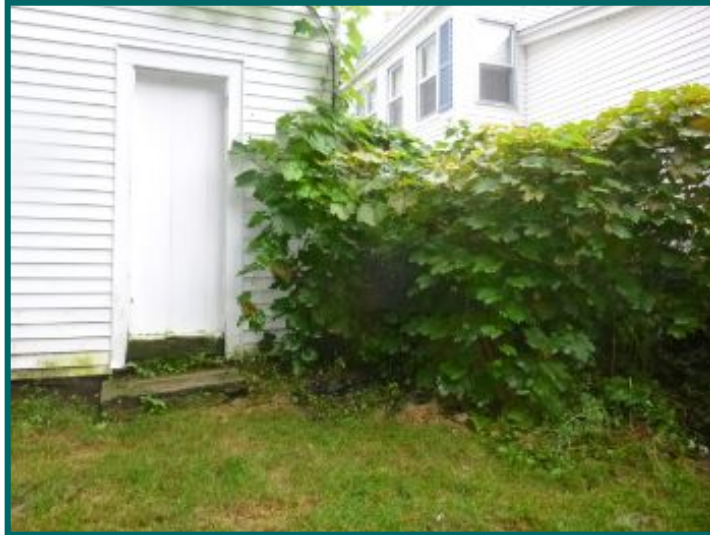
3.1. Vegetation such as trees, shrubs and/or vines are in contact with or less than one foot from the structures exterior. Vegetation can serve as a **conduit** for wood destroying insects and fungal growth and may retain moisture against the exterior after it rains. Vegetation should be pruned and/or removed as necessary to maintain a one foot clearance between it and the structures exterior.

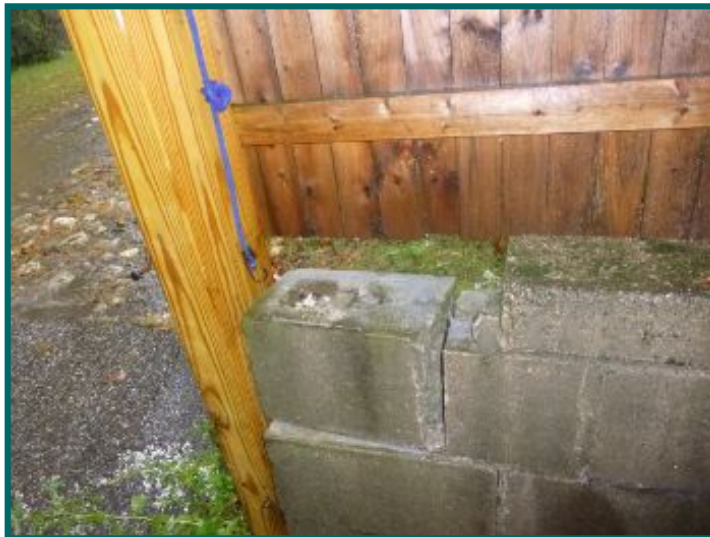
4.1. There are cracks, damage or evidence of movement in retaining walls. Recommend further investigation and repair as needed by a qualified masonry contractor.

Damage to side block wall.

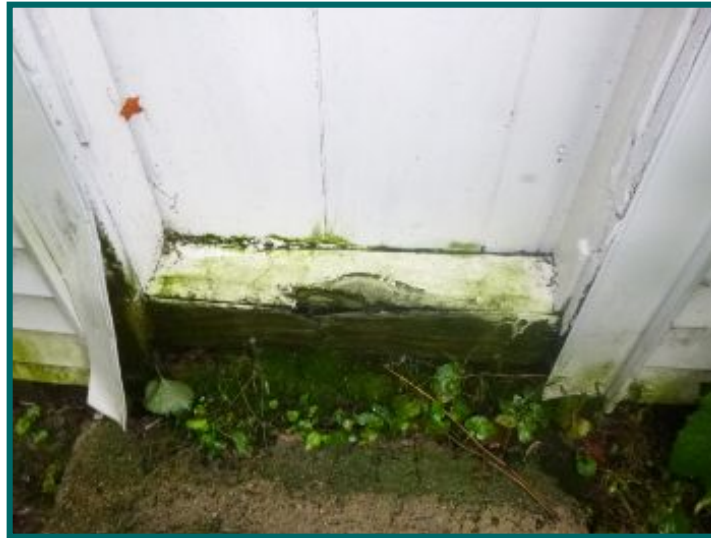
1.2. One or more exterior door has damage of door, frame, or trim, recommend further investigation of all doors and repairs by a qualified tradesman as needed.

Damage to rear door frame

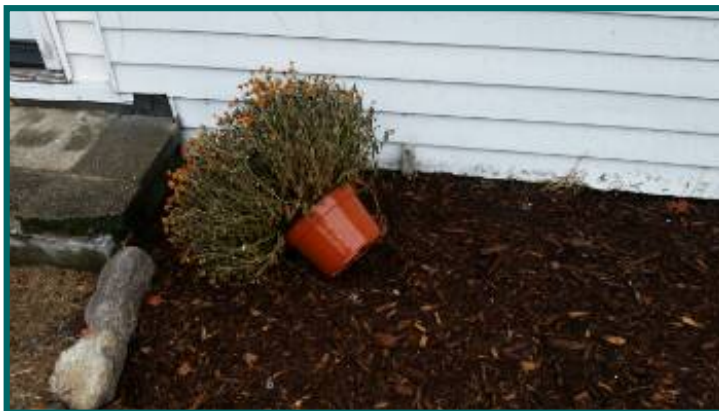
2.2. Siding is in contact with finish grade at one or more area of building, this is conducive to moisture and insect intrusion, recommend monitor area and have repaired as needed by a qualified contractor.

contact with finish grade front of house

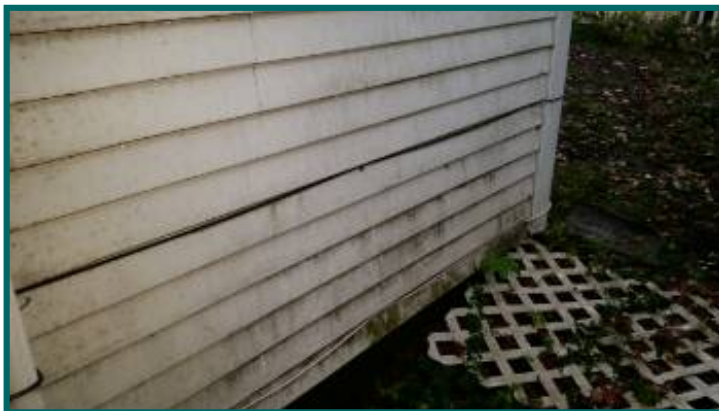
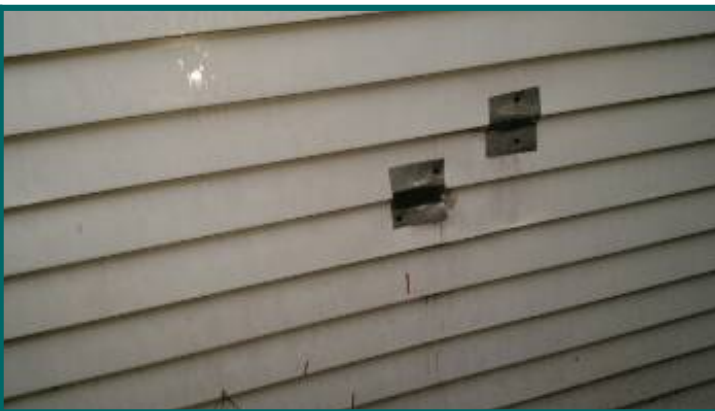
contact with finish grade side of house

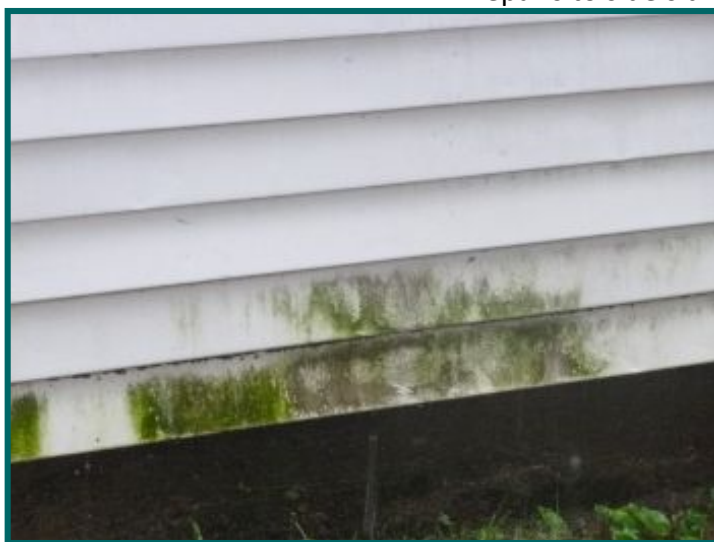
repairs to side siding left side of house

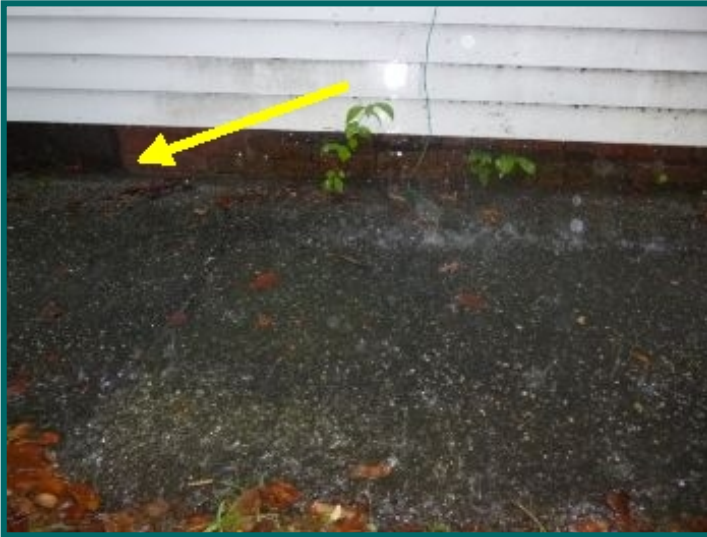
Basement window

3.2. Peeling paint observed at one or more window and or window frame, suggest scraping and painting as necessary.

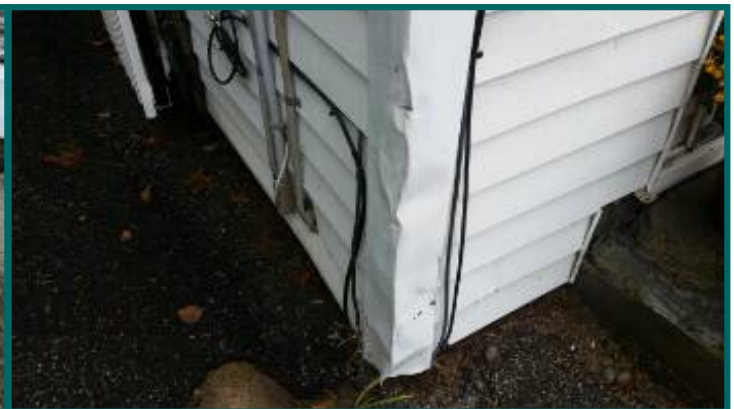
4.2. Trim boards have areas of damage and or deterioration, recommend assessment and repair by a qualified contractor.

deterioration to trim below front door

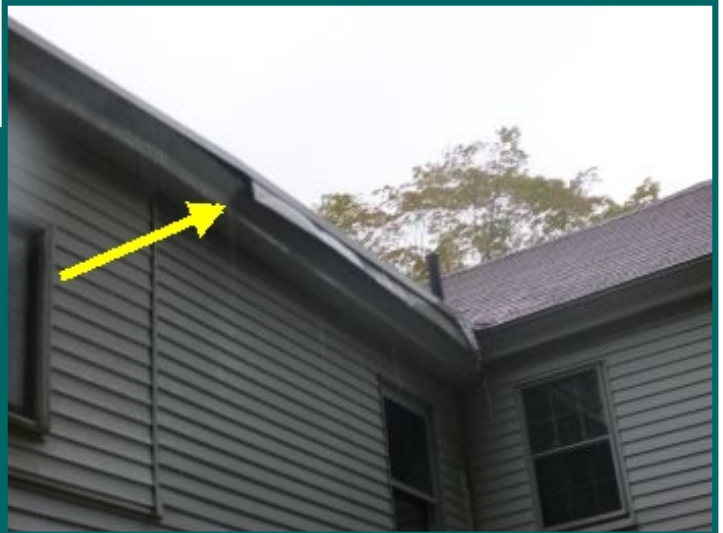
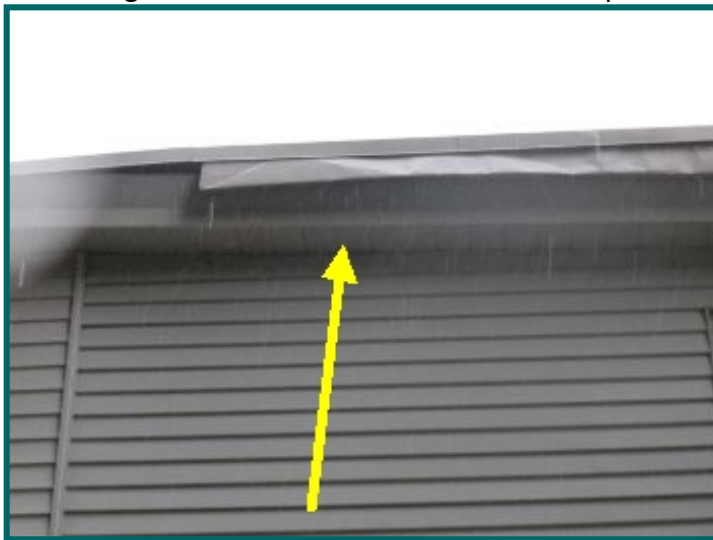
damage fascia board and trim above front porch

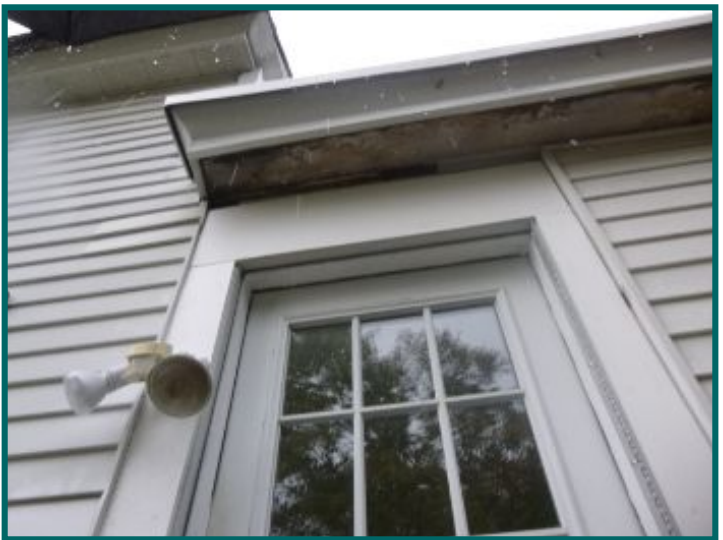
Damaged trim at rear of house.

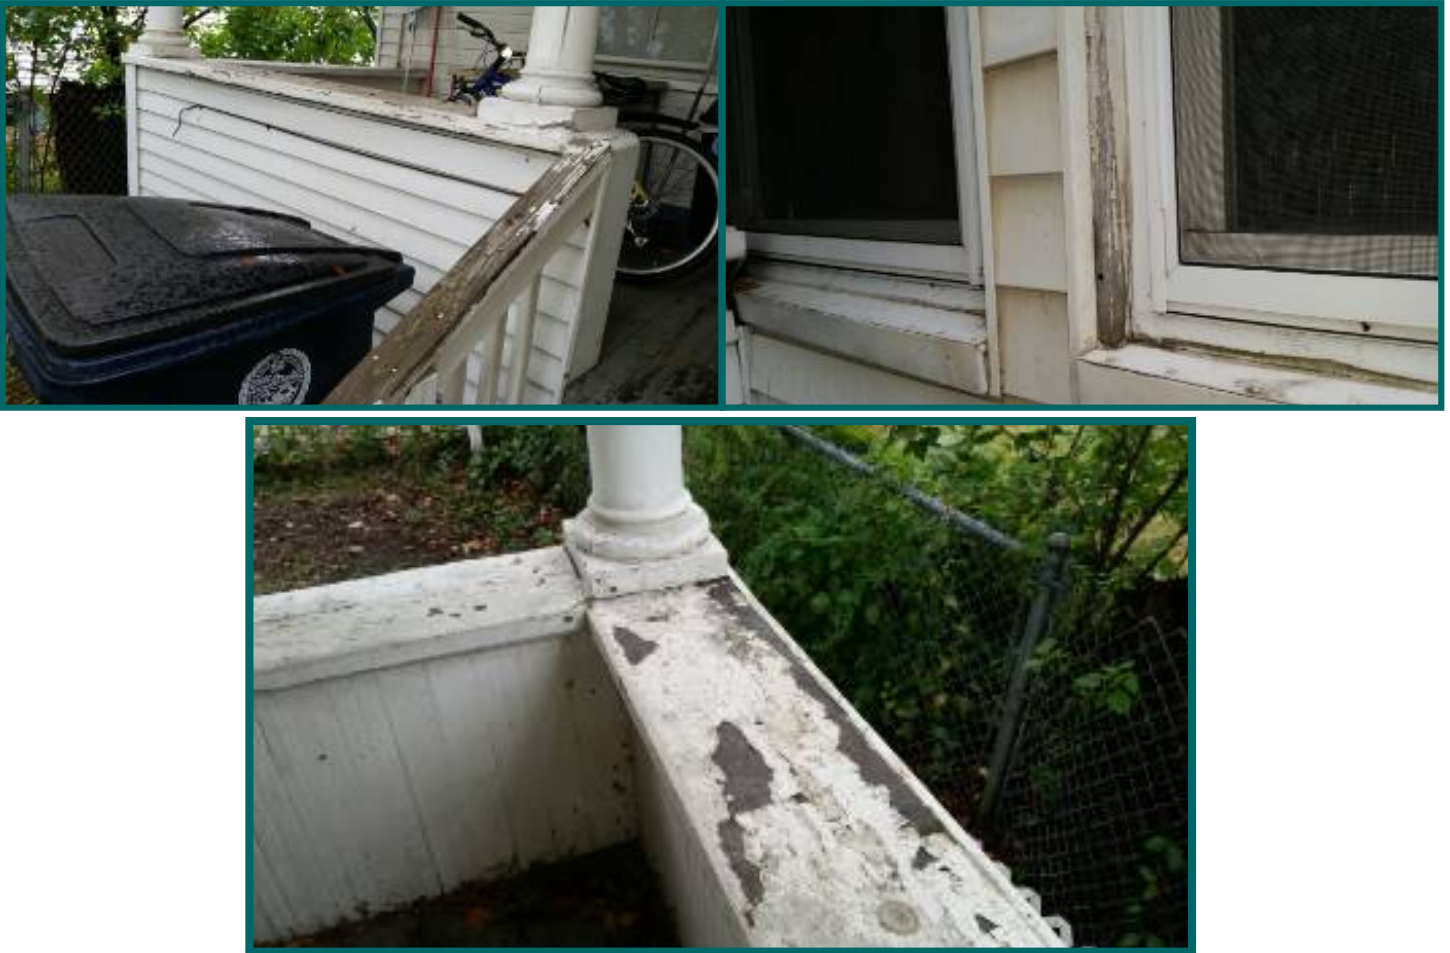
5.1. Peeling paint observed on fascia and trim boards in one or more area, suggest assessment by a qualified painting contractor and scraping and painting as necessary.

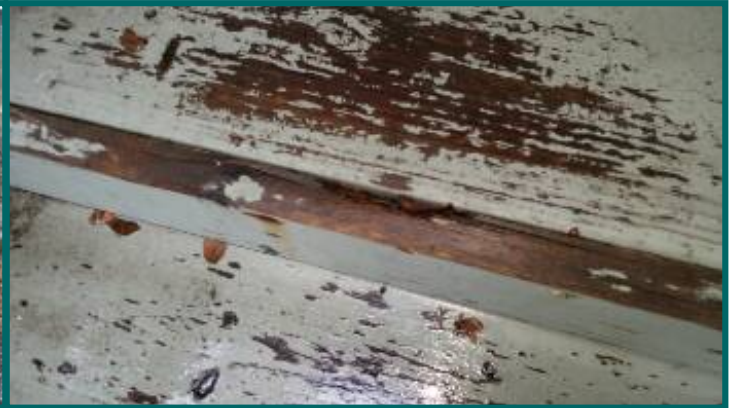
6.2. Front steps have damage to brick or mortar. Recommend further investigation and repair by a qualified masonry contractor.

Damaged tread at front porch

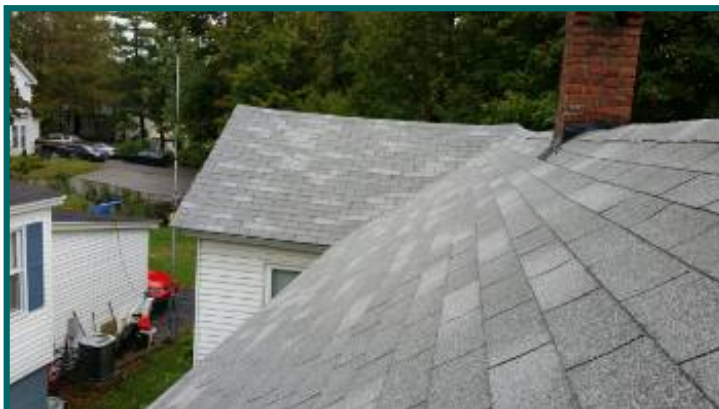
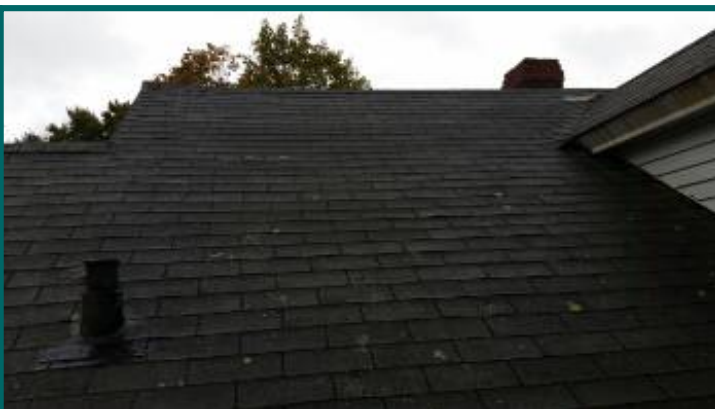
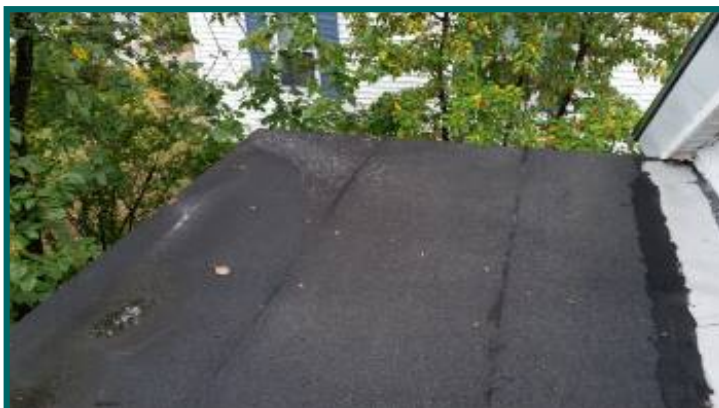
1.3. Shingles show granular loss, are cracked in several areas and showing age. Recommend further investigation and repair by a qualified roofing contractor.

1.4. There are areas of damage and broken or missing shingles, recommend assessment and repairs by a qualified roofing contractor.

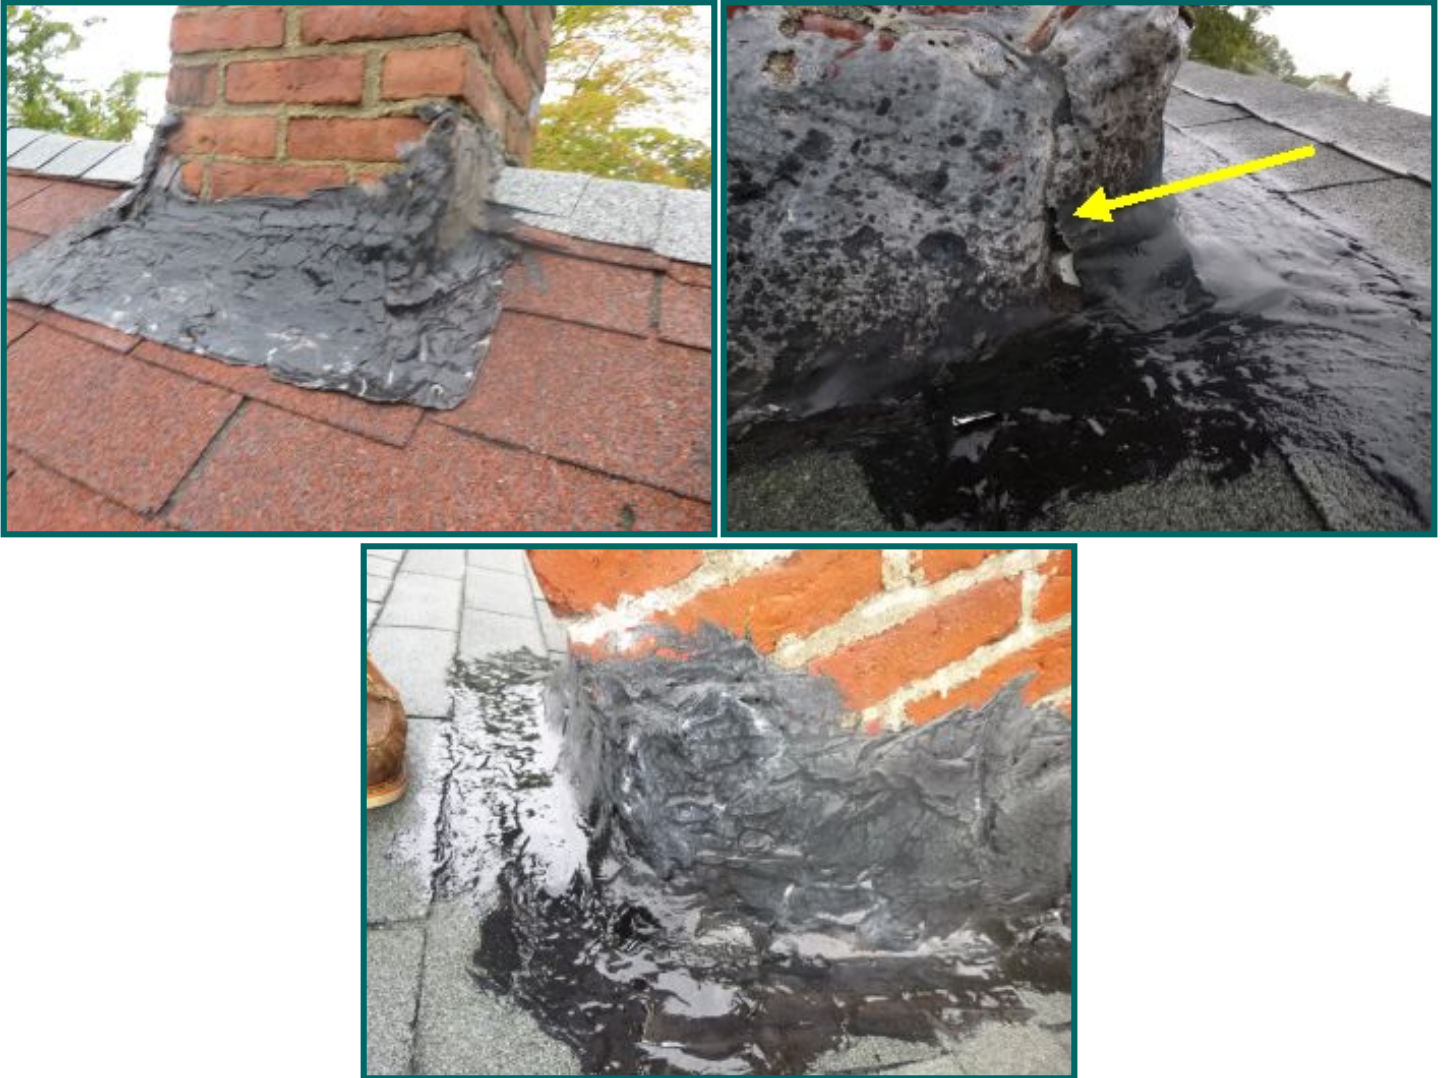
2.1. Flashing around chimney and or **vent stack** penetrations is sealed with roofing tar, this is considered a temporary repair and will have to be monitored for leaking and repaired or sealed from time to time. Recommend inspection and proper repair by a qualified roofing contractor.

2.2. Water staining and active moisture noted in attic at chimney penetration. Recommend assessment by a qualified roofing contractor.

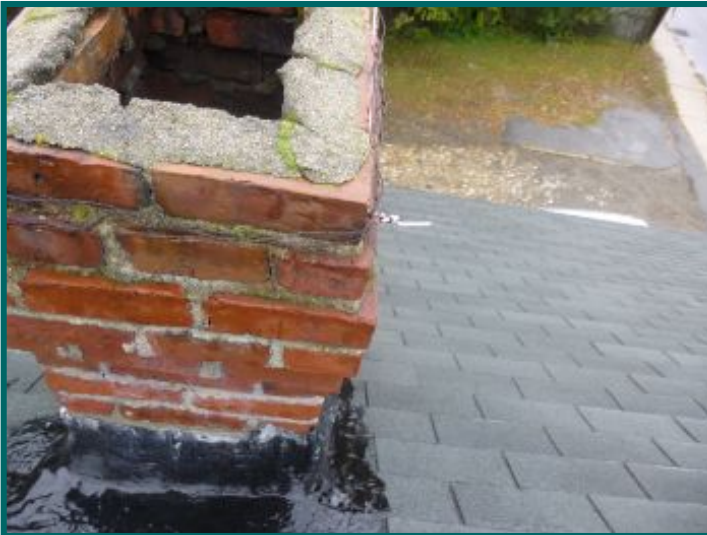
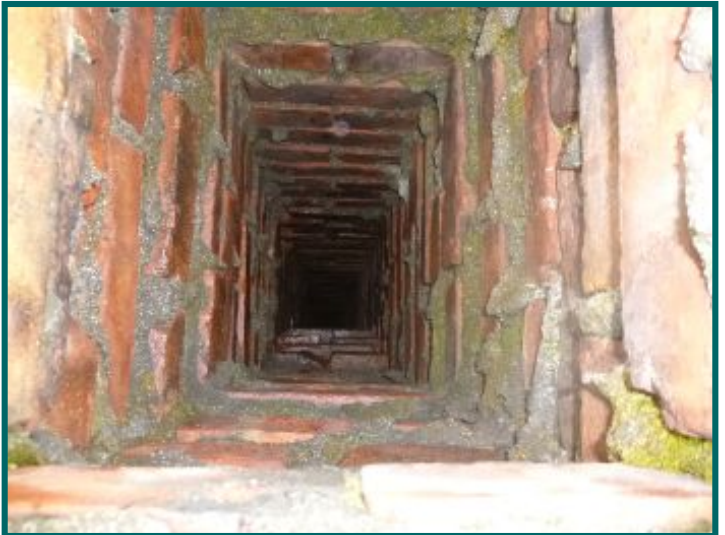
4.2. Chimney(s) are over 50 years old and will require inspection and maintenance from time to time.

4.3. The chimney stack appears to have an unlined flue. While this may have been acceptable at the time of construction, flue liners are a fire safety feature which the client should consider installing to enhance safety. Regular cleaning of the chimney is recommended to ensure safe and efficient operation.

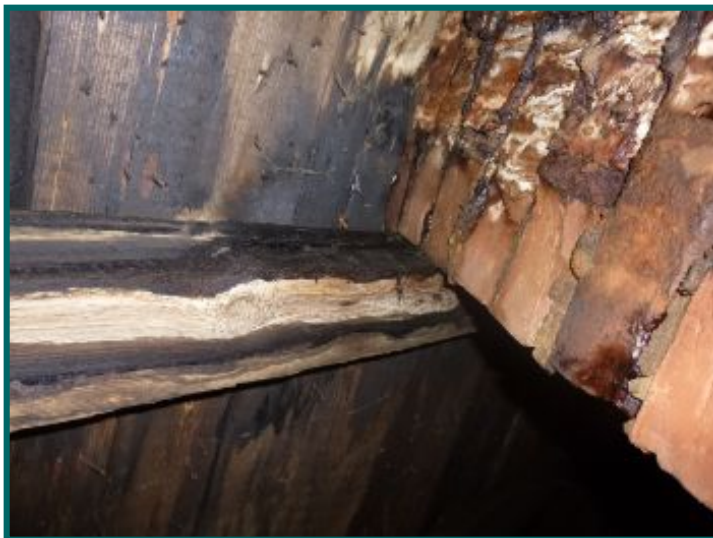
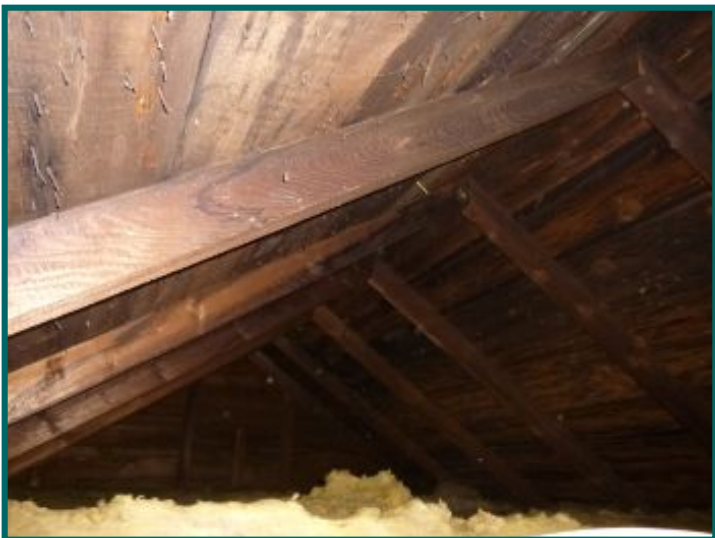
- 2.1. Attic Framing Materials:
- 2.2. Rafters
- 2.3. Panel Boards
- 2.4. Water intrusion mainly around chimney penetration. Recommend further investigation and repairs to chimney flashing by a qualified roofing contractor.
- 2.5. Stains were found in one or more surfaces. The stain(s) may be due to past or present roof and/or plumbing leaks. Recommend asking the property owner(s) about this, and monitoring the stained area(s) in the future, especially after heavy or prolonged rain. If elevated moisture is found in the future, a qualified contractor should evaluate and repair areas as necessary.

Leak around chimney.

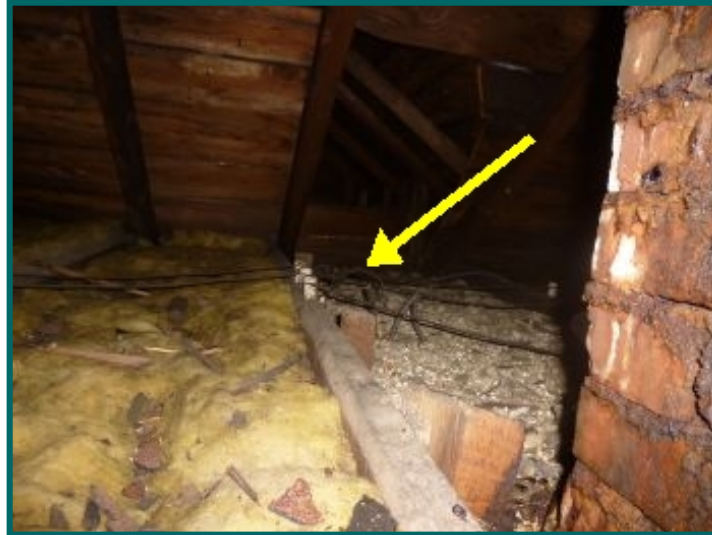
5.1. Knob and tube wiring in attic in contact with insulation, was not tested to determine if it is still active, this type of wiring is at least 70 years old and is no longer considered safe, recommend further investigation and repairs as needed by a qualified electrician.

Knob and tube

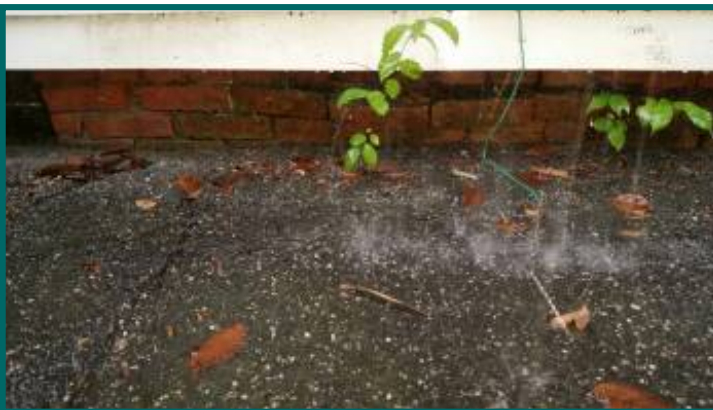
1.6. A few areas of damage to the foundation walls, due to the age it is recommend to have stone and grout lines on wall inspected and repaired as needed on a regular basis.

loose bricks left side of house

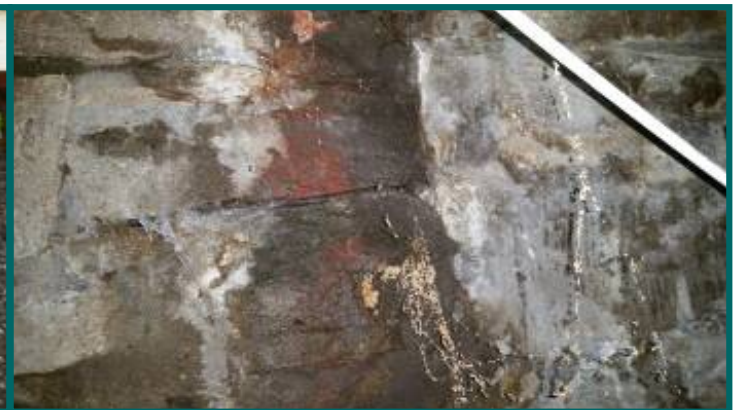
1.7. Moisture intrusion was observed one or more areas of the foundation. Moisture can create high humidity, mold & can damage stored items & finishing materials. Recommend a basement specialist review the foundation for correcting any water intrusion issues.

leak below side window

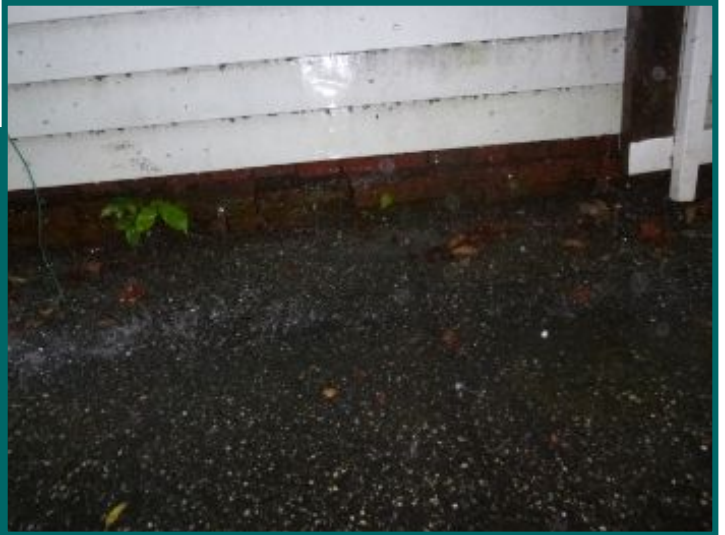
Wet wall right side window

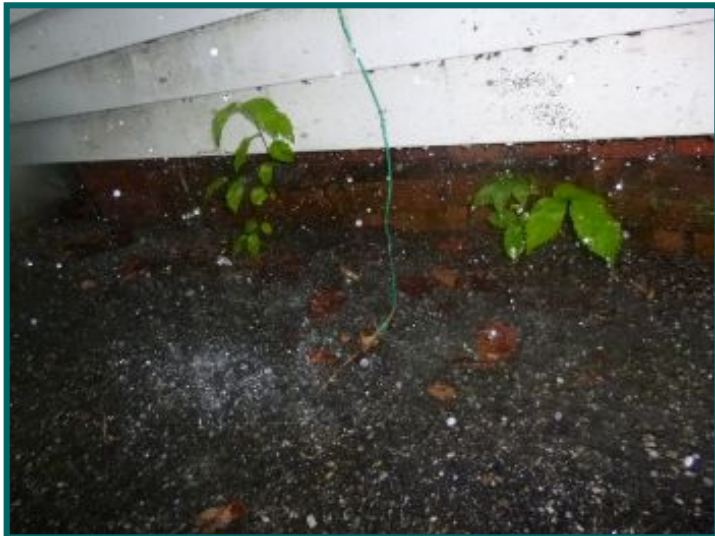
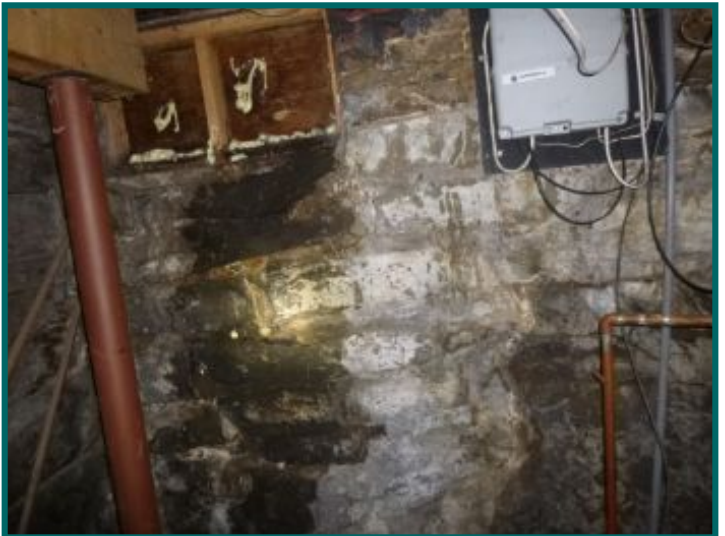
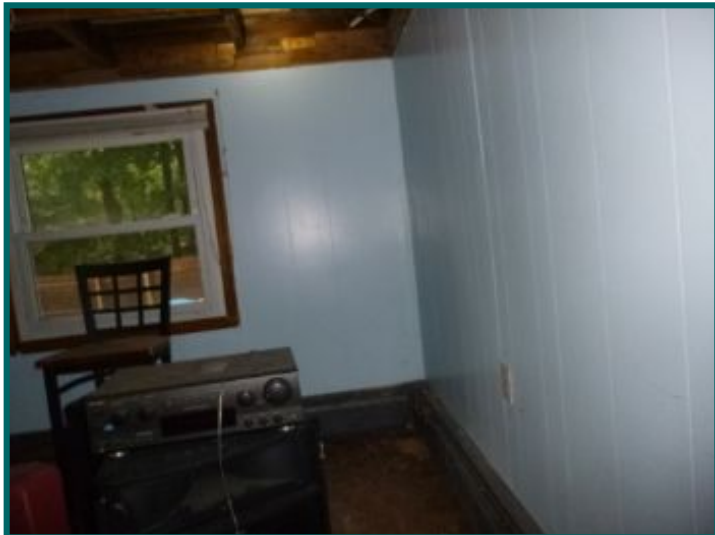
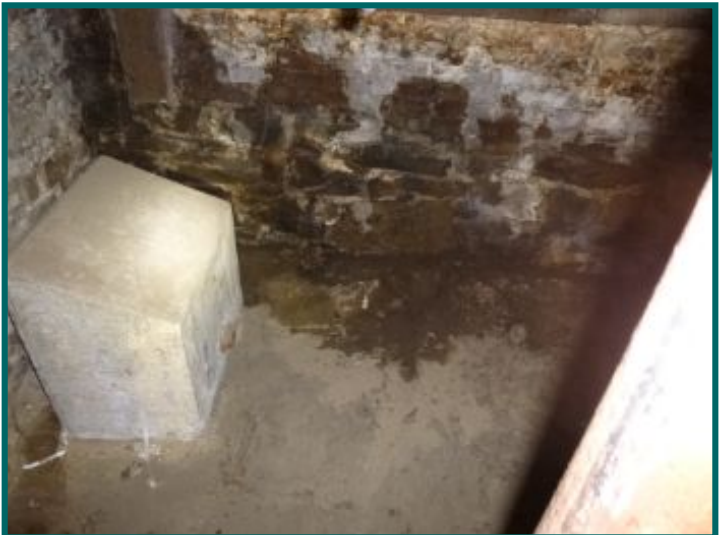
Water leak at wall.

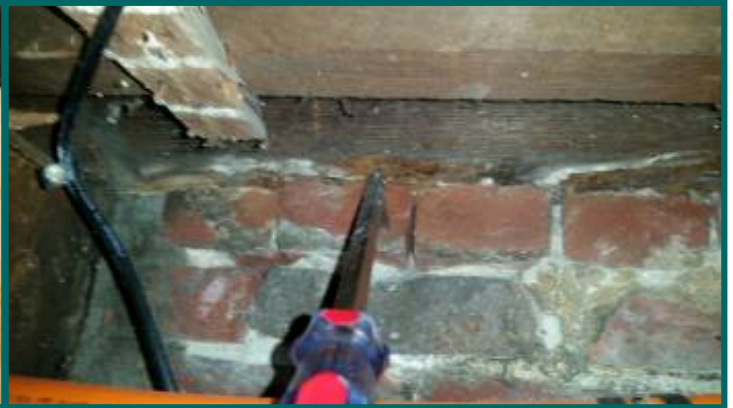
Damaged wood next to left side window

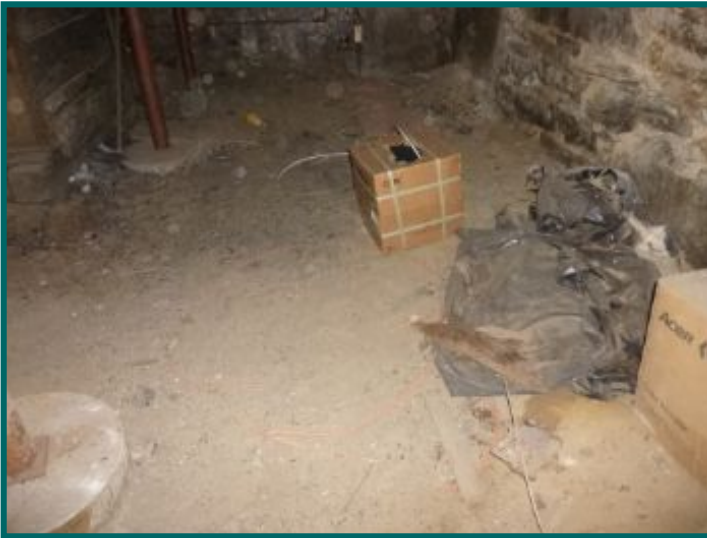
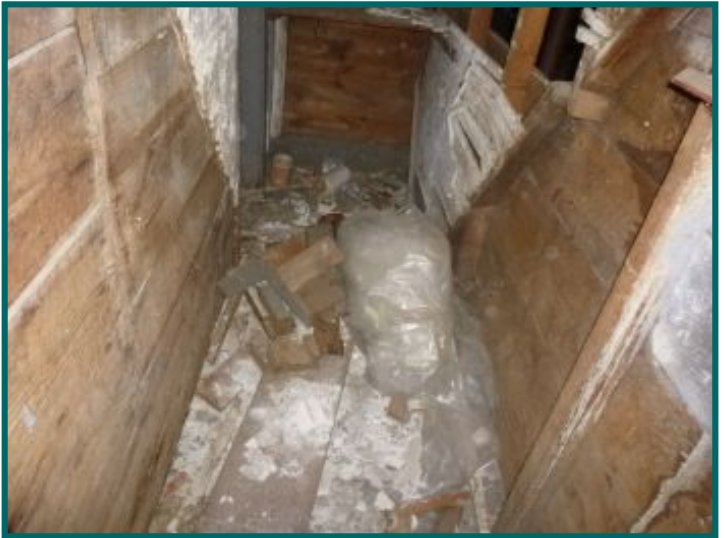
3.5. Dirt floor with no **vapor barrier**, this is conducive to moisture and insect intrusion. recommend installation of vapor barrier and ballast, (plastic sheeting and crushed stone) by a qualified tradesman.

3.6. There is wood flooring in contact with dirt in basement, areas of damaged flooring and construction debris in basement, this can be conducive to insect intrusion. Recommend removal of any area of wood to earth contact in basement.

Dirt floor

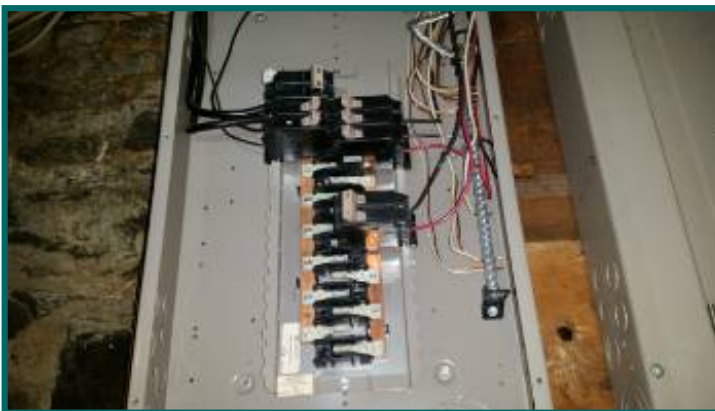
left side apartment main panel

2.6. Undersized wires noted at breakers in service panel. Recommend further evaluation and repair by a licensed electrician.

2.7. Rodent activity inside electric panel, recommend assessment by a licensed electrician.

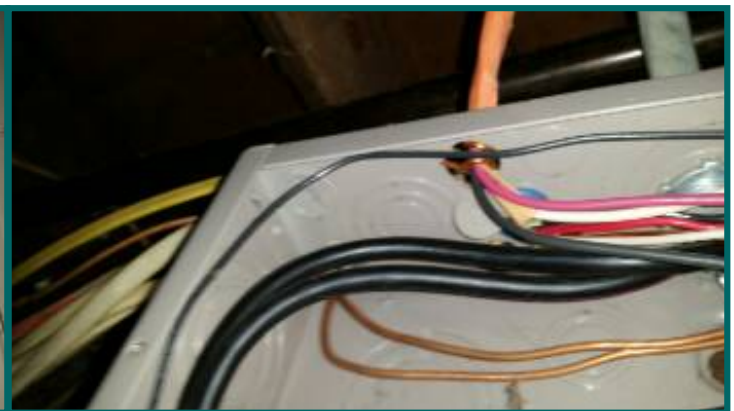
open knock outs, missing bushings

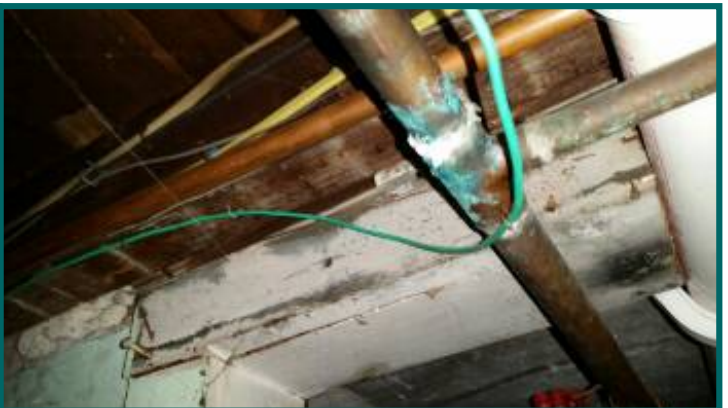
Leak on plumbing line in basement.

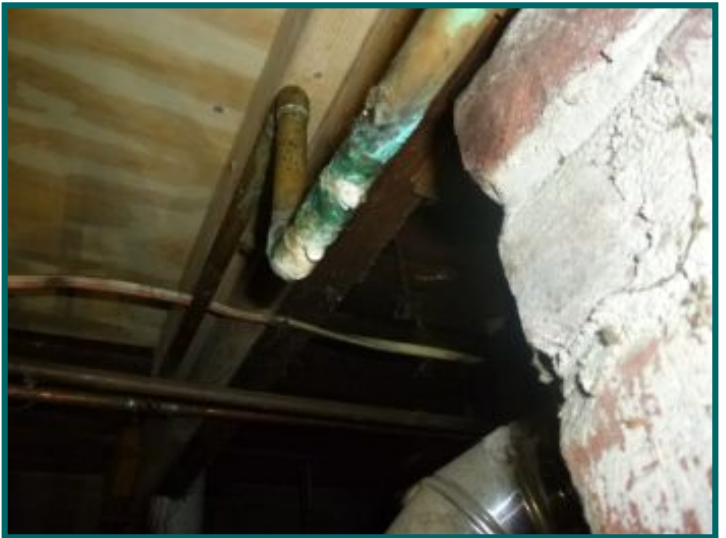
Leak on plumbing line in basement.

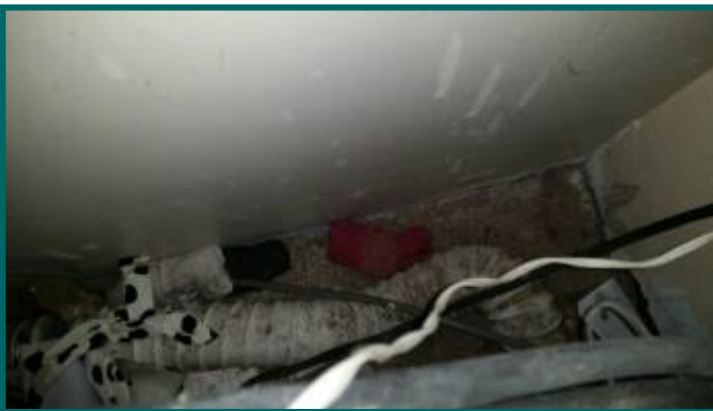
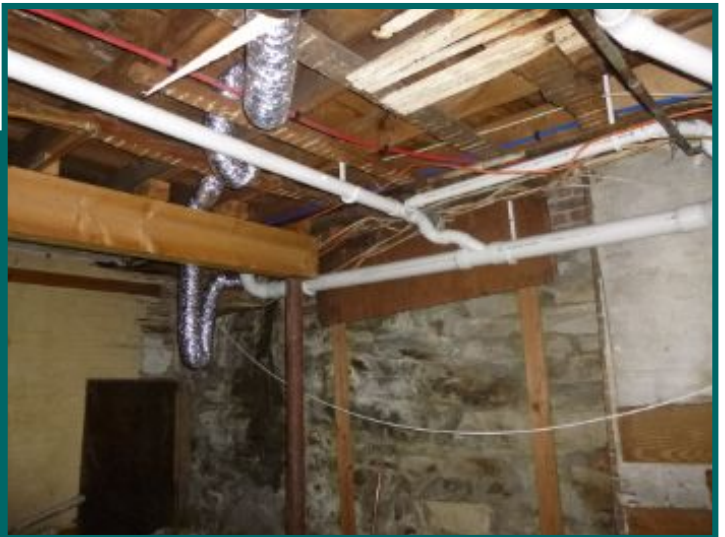
4.2. The clothes dryer is equipped with a plastic or foil, accordion-type, flexible exhaust duct. The U.S. Consumer Product Safety Commission considers these types of ducts to be unsafe for gas fired dryers, and a fire hazard. These types of ducts can trap lint and are susceptible to kinks or crushing, which can greatly reduce the air flow. This duct should be replaced with a rigid or corrugated semi-rigid metal duct, and by a qualified contractor if necessary. Most clothes dryer manufacturers specify the use of a rigid or corrugated semi-rigid metal duct. For more information on dryer safety issues, see <http://www.cpsc.gov/PageFiles/98570/clothesdryer.pdf>

4.3. The dryer vent has a very long run, this can make it more prone to clogging, difficult to vent properly and become a fire hazard. It appeared to be operating properly at the time of inspection but should be monitored closely. Recommend regular cleaning and inspection for safe operation.

Accordion type dryer hose right side.

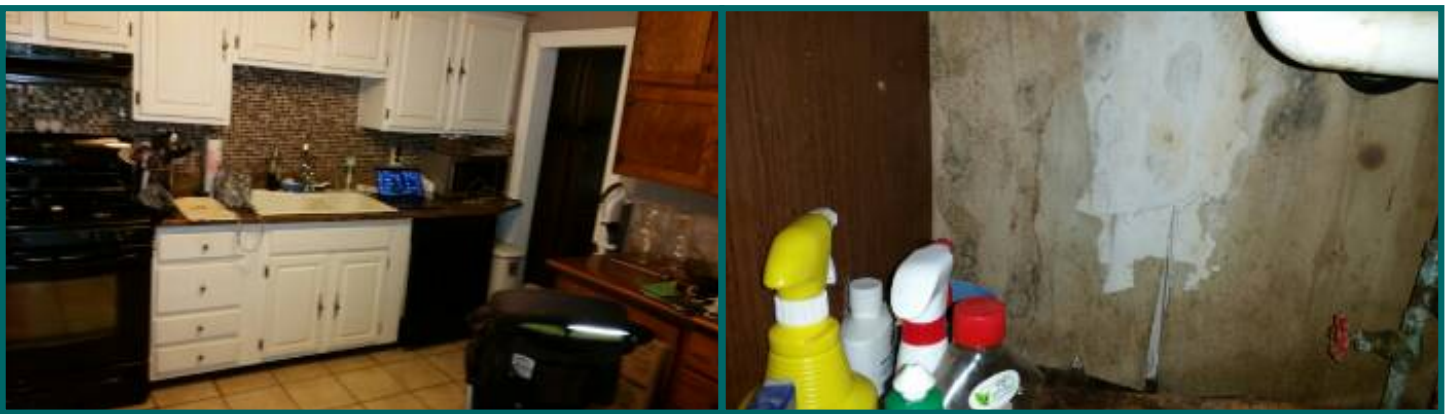
1.2. There is dark staining that appears to be mold on cabinet surfaces below sink. Recommend cleaning or removing all affected areas and monitor for further staining, further investigation and treatment by a qualified professional if needed.

Staining below sink right side kitchen

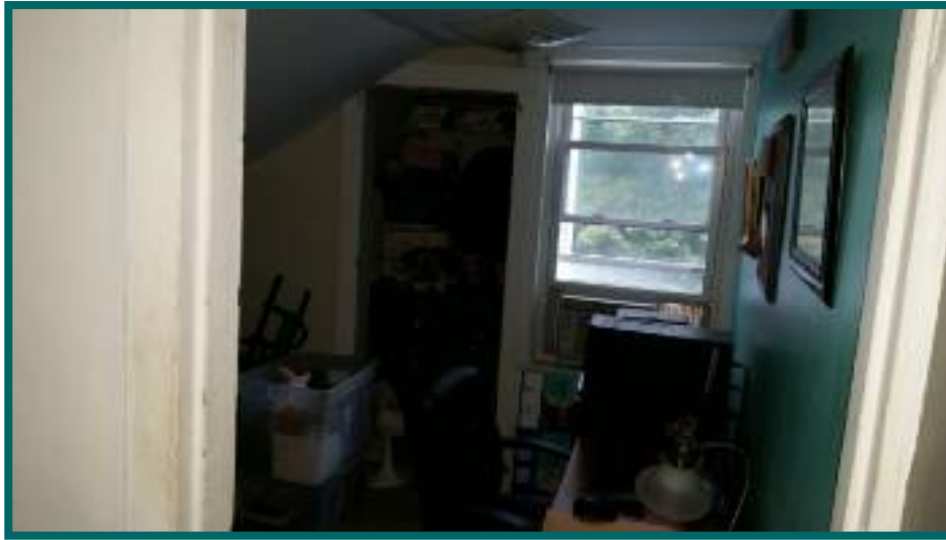
1.2. Doors are not installed at one or more area of house.

doors are missing at 2nd floor rear bedroom

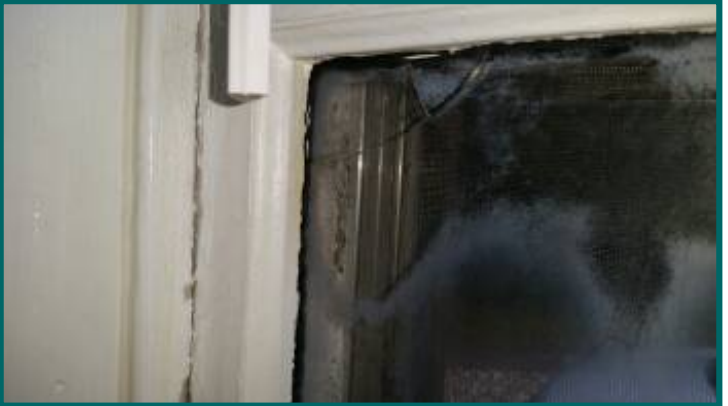
broken glass first floor side wall

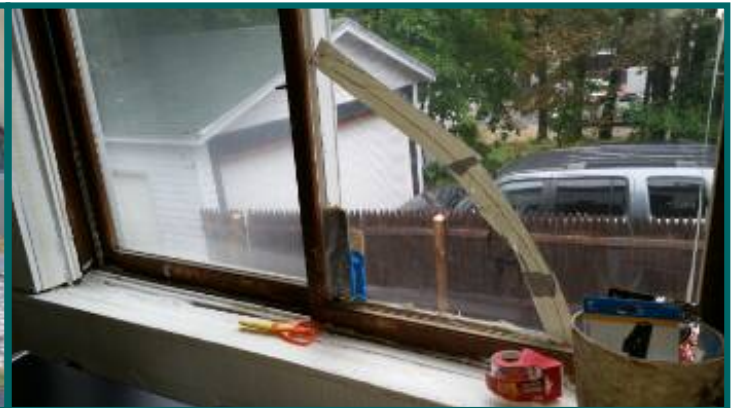
right side apartment family room window has broken  
glass will not open

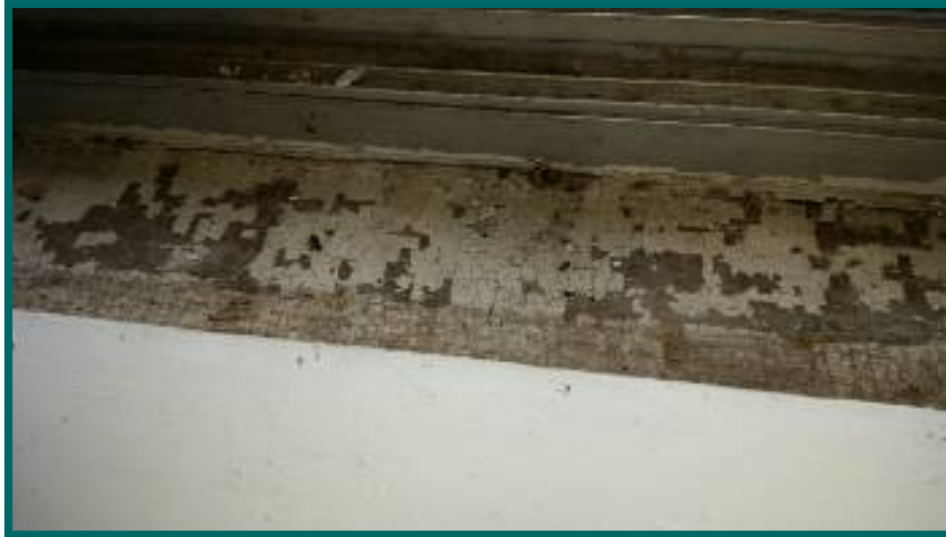
First floor peeling paint

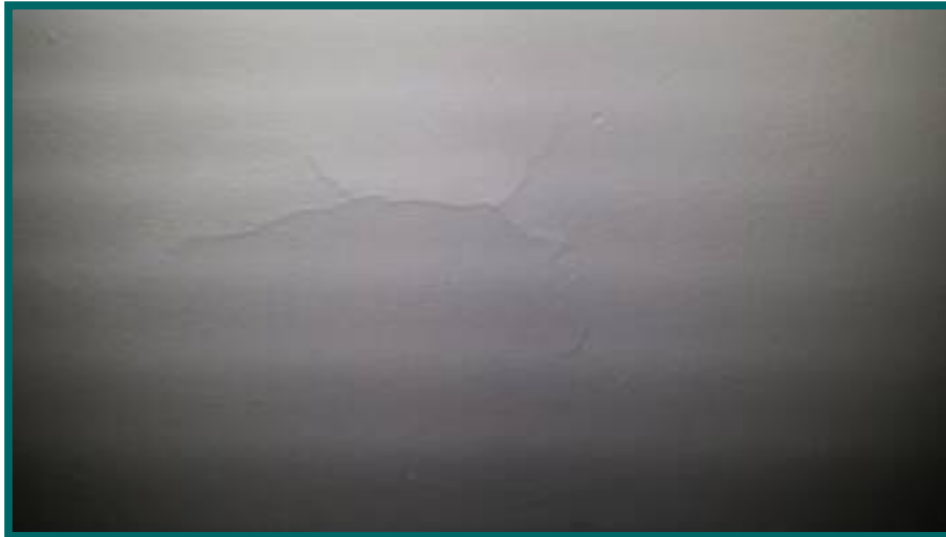
2nd floor rear bedroom

4.3. There are damaged areas mainly in the basement. Recommend having repaired as needed.

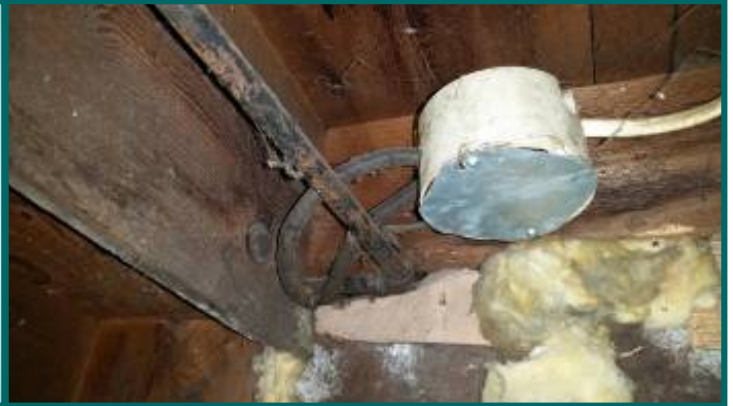
improperly secured junction box, wires in contact with pipes

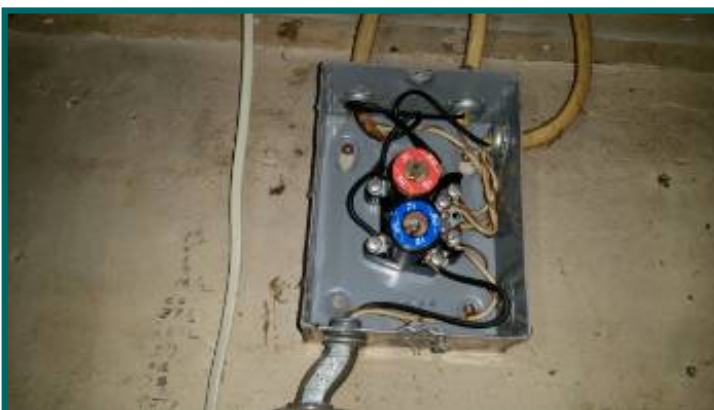
improperly secured junction box, wires in contact with pipes

Open junction box, screw fuse sub panel in basement

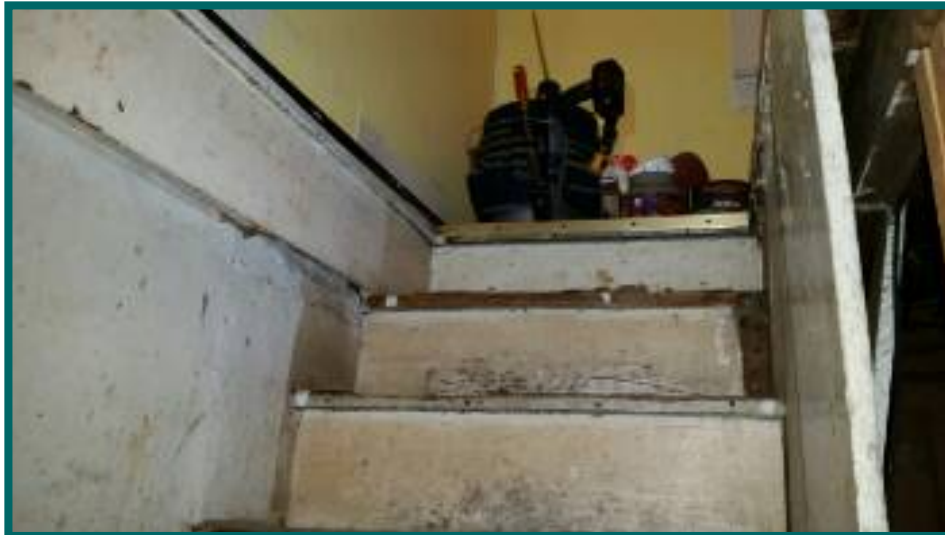
9.2. Stairs have one or more area of handrail missing. Recommend installing proper hand rail and **balusters** by a qualified contractor for safety.

missing hand rail at basement stairs.

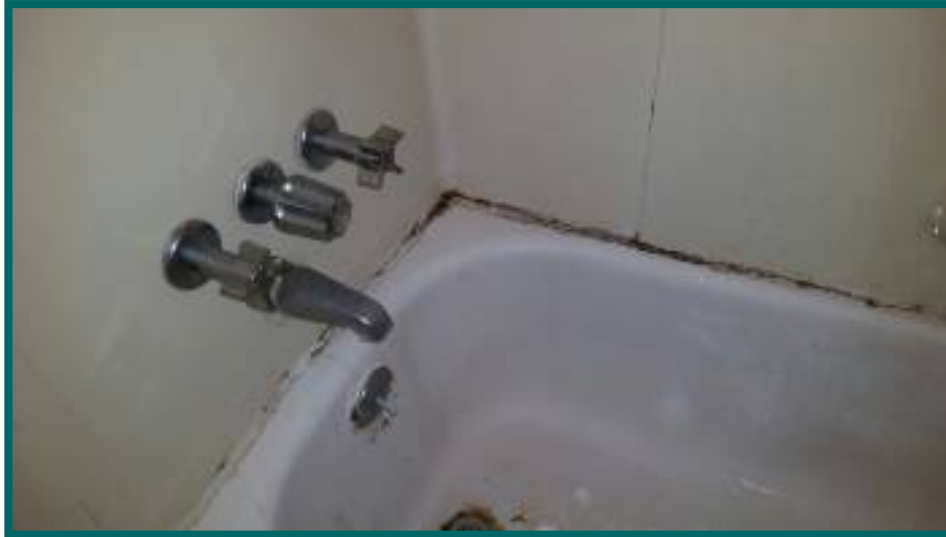
left side

3.2. Caulking is damaged or missing near base of tub/ shower enclosure at second floor hall bathroom. Recommend further evaluation by a qualified plumber. Caulking around tub to prevent water from leaking behind wall tile may prohibit further damage that may be present.
