# Alpha Home & Commercial Building Inspections

## Property Inspection Report

Sample 85 year old 2 Family, NH 03064  
Inspection prepared for: Sample Client  
Real Estate Agent: -

Date of Inspection: 9/30/2015 Time: 1:00 PM  
Age of Home: 85 years Size: 2090 sf  
Order ID: 2941

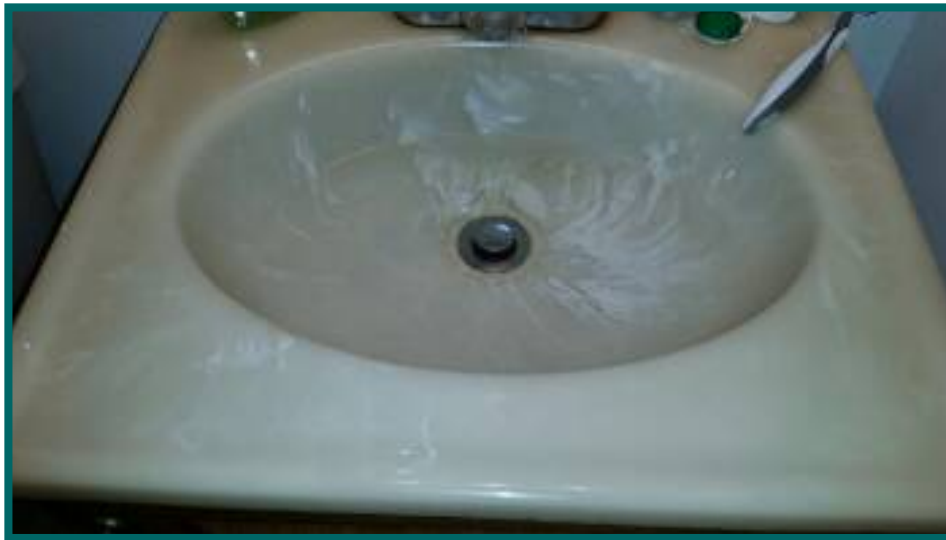
4.2. Sink drains slow at one or more bathroom. Recommend servicing by a qualified plumber.

slow drain at left side apartment sink

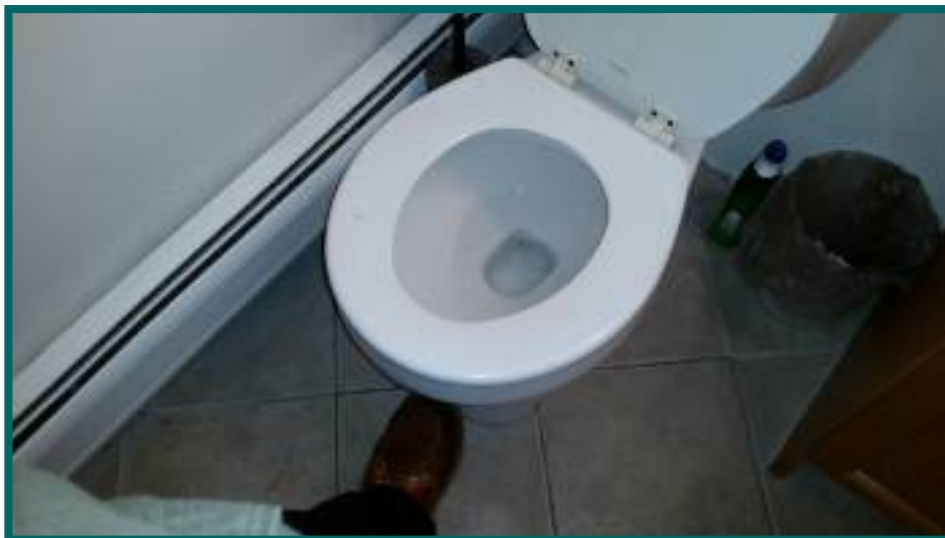
5.2. The toilet bowl at the one or more bathroom is loose at floor anchor bolts. The wax ring inside the unit must have a snug, secure fit in order to keep from leaking. Properly resealing and re-securing this unit is suggested to prevent water leakage and damage to the sub-floor area. This type of damage is not always visible or accessible to the inspector at time of inspection.

left side apartment toilet is loose

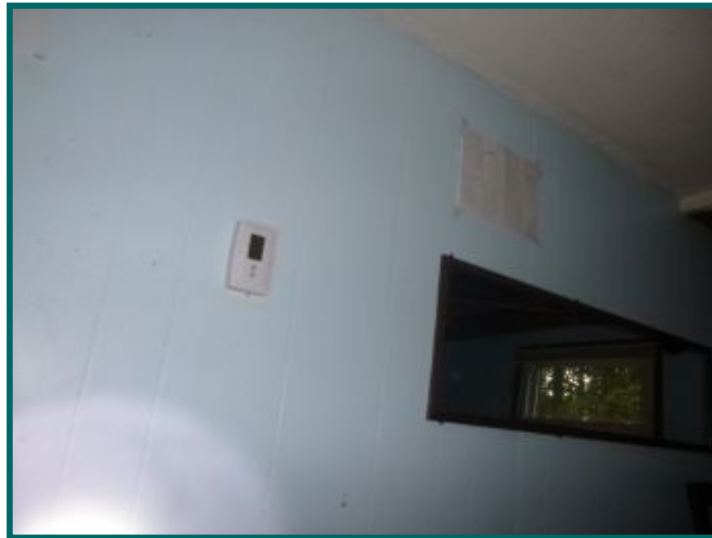
3.1. Thermostat in basement does not start furnace / boiler, basement zone was not tested, recommend to have system assessed by a qualified heating contractor.

Basement thermostat low battery was not tested.
