# *Alpha Home & Commercial Building Inspections*

## Property Inspection Report

Date of Inspection: 8/13/2015 Time: 9:00 AM  
Order ID: 2748

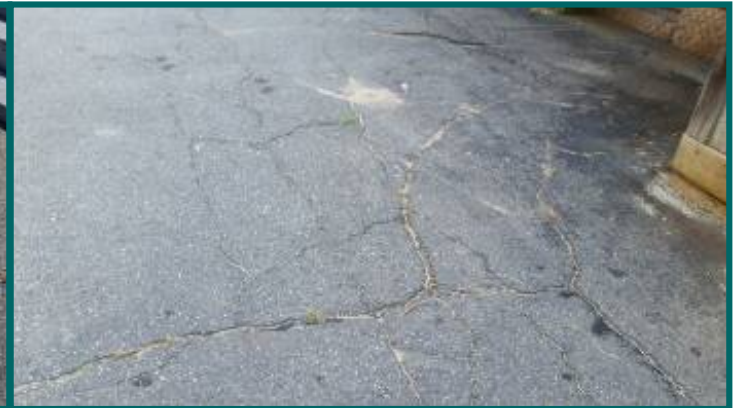
1.3. One or more area of damaged concrete surfaces, may be causing water intrusion into building. Recommend assessment by a qualified concrete flat work contractor and repairs as needed.

cracks and settlement in concrete surfaces front of building

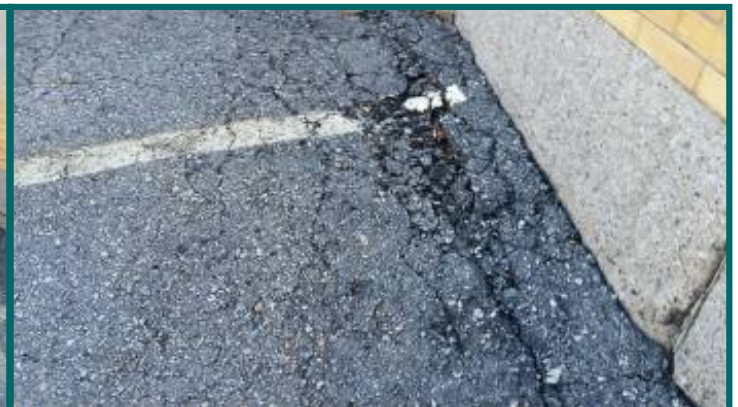
1.2. Typical deterioration was observed at the lot surfaces. Further deterioration will occur as water expands and contracts from freeze and thaw cycles. Recommend assessment by a qualified asphalt surfacing contractor.

deterioration to surfaces rear of building

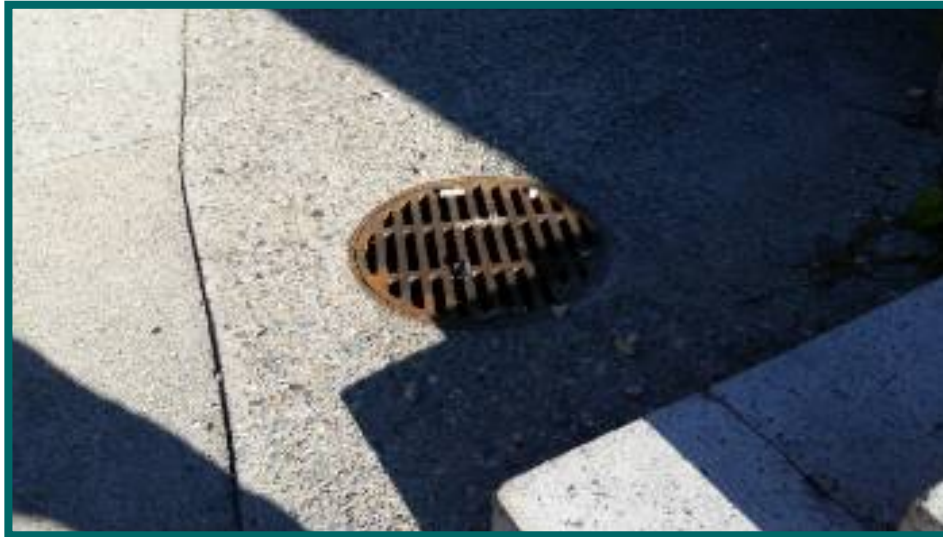
2.3. Rain run off drains via sheeting action to multiple drain culverts throughout parking lot area. It is important that culverts are serviced on a regular basis to assure proper drainage.

drain cover at front walkway entrance area

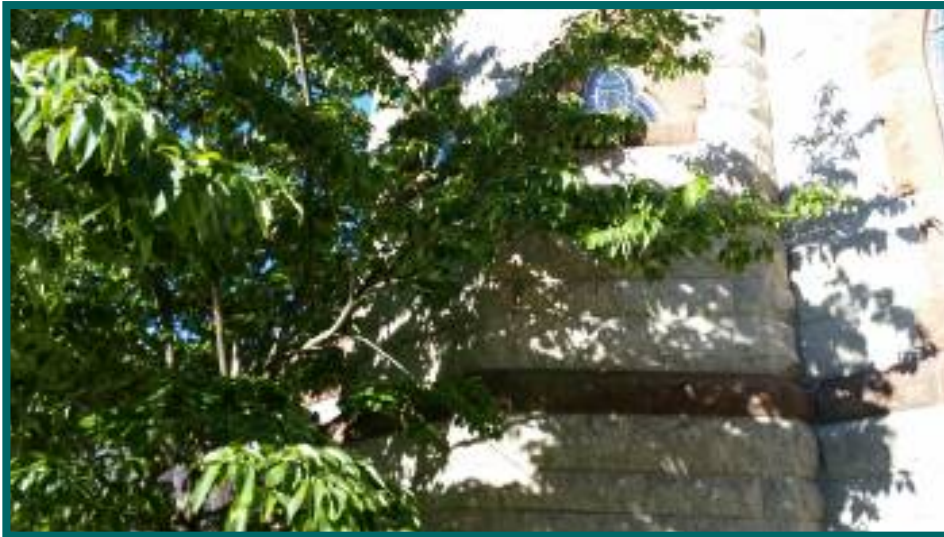
3.1. Vegetation such as trees, shrubs and/or vines are in contact with or less than one foot from the structures exterior. Vegetation can serve as a **conduit** for wood destroying insects and fungal growth and may retain moisture against the exterior after it rains. Vegetation should be pruned and/or removed as necessary to maintain a one foot clearance between it and the structures exterior.

Trees overhanging or in contact with building should be cut back or removed.

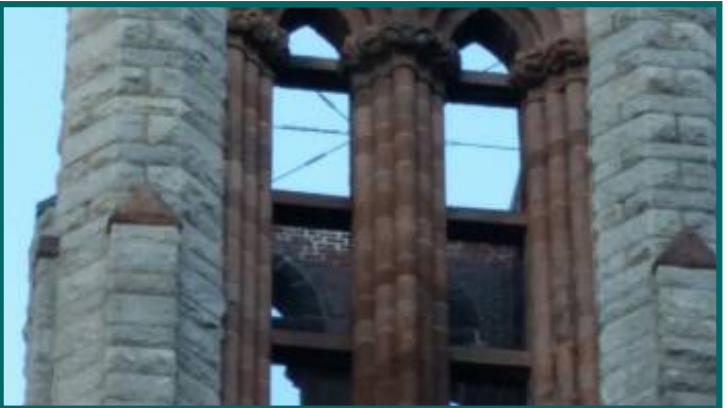
- 2.1. The exterior brick and stone masonry walls are in fair condition. There are many areas of loose and receding grout, there are several vertical and step cracks walls, some loose bricks at upper corners, some areas of prior repair. Front surface basement wall has elevated levels of moisture, outside surface should be assessed immediately in this area. Recommend full inspection and repairs by a qualified masonry contractor.

damage grout line right side tower arch

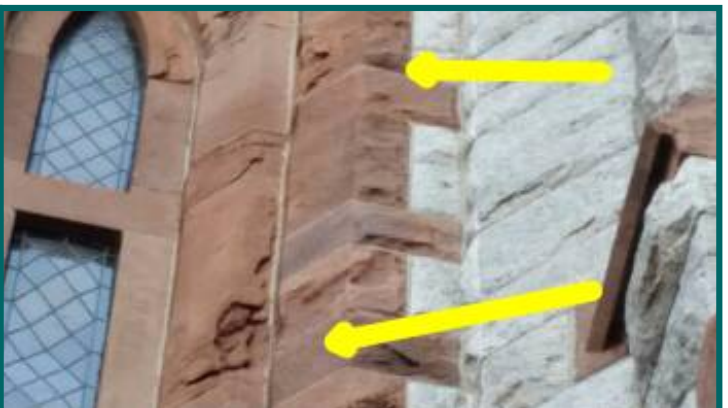
missing grout front left tower window

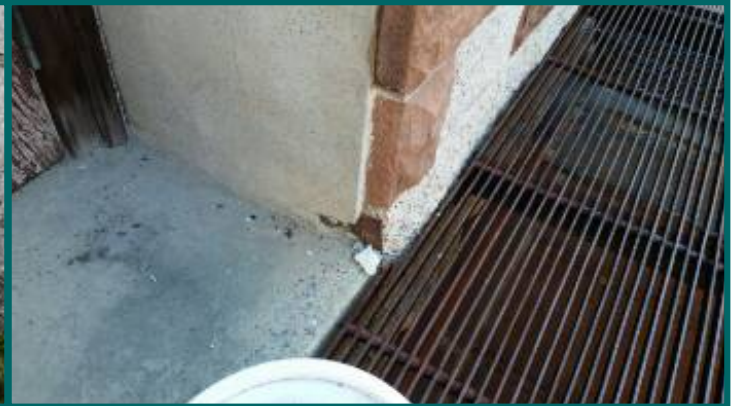
damage surface front of building this area appears to be letting rain run off into the building .

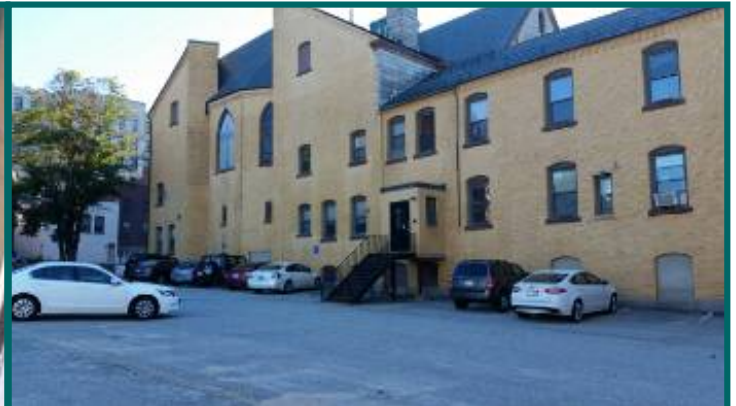
damaged wall surfaces under left side stairway

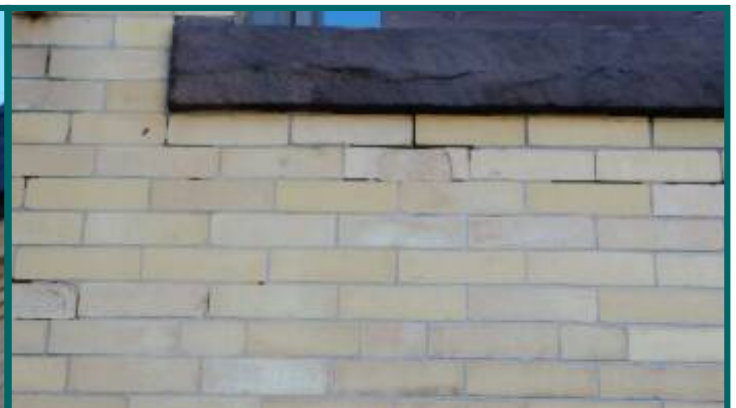
deteriorated grout rear brick surface

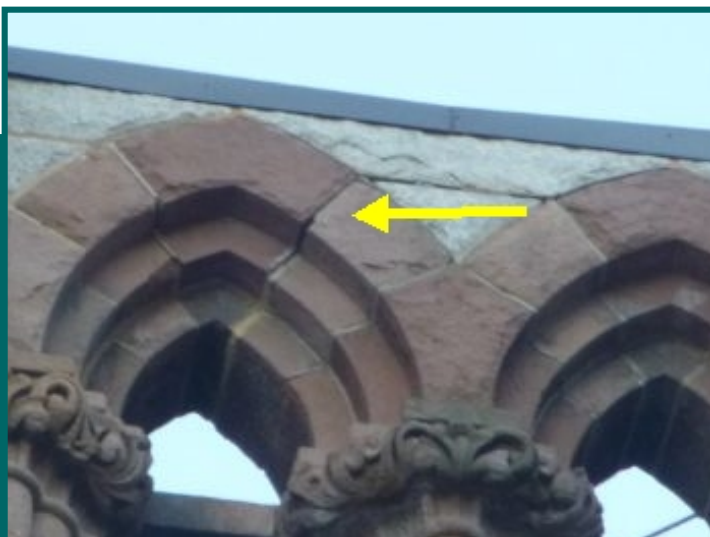
damage brick rear surface

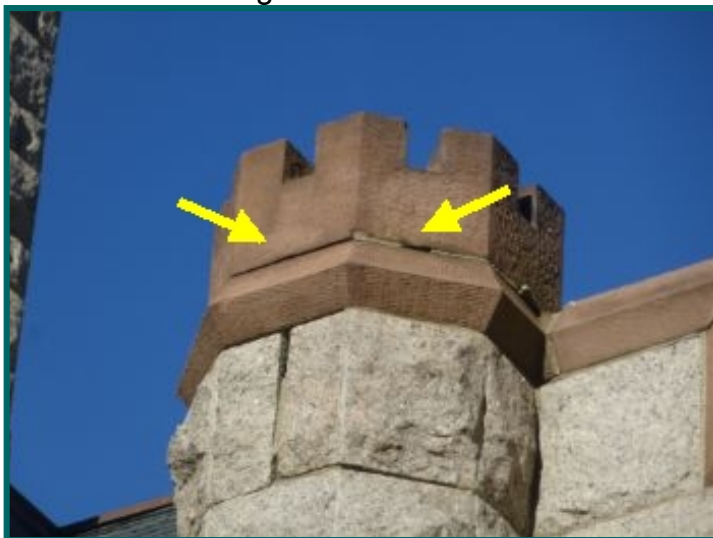
Gap in grout line front tower.

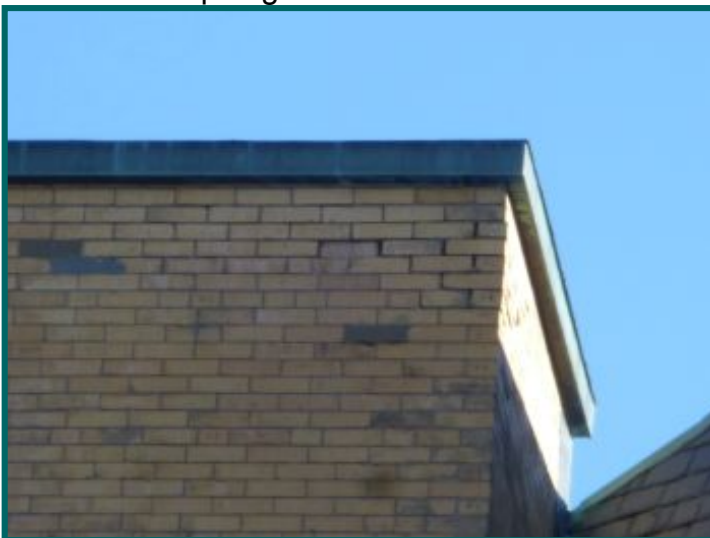
Damaged grout lines at rear wall surface.

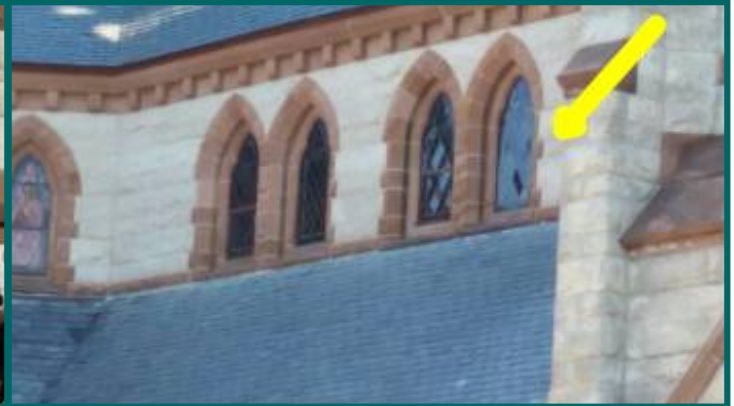
4.1. There are damaged window panes or broken glass at one or more area of building, recommend repair by a qualified tradesman.

missing glass front left tower

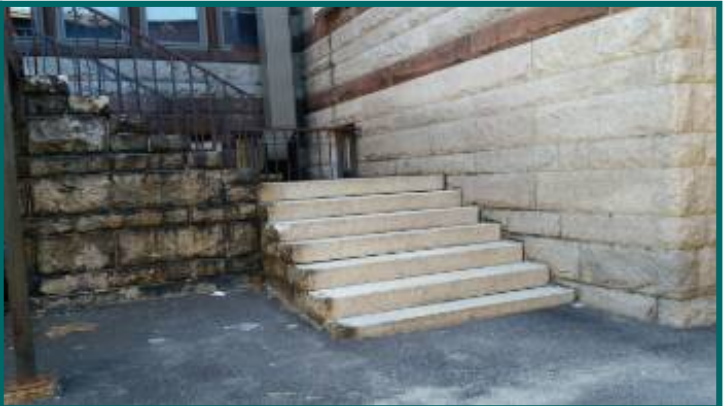
- No handrail present at at one or more stair way. Where four or more stairs are present it is recommended to have installation of hand rail by a qualified tradesman for safety.

missing handrails front of building

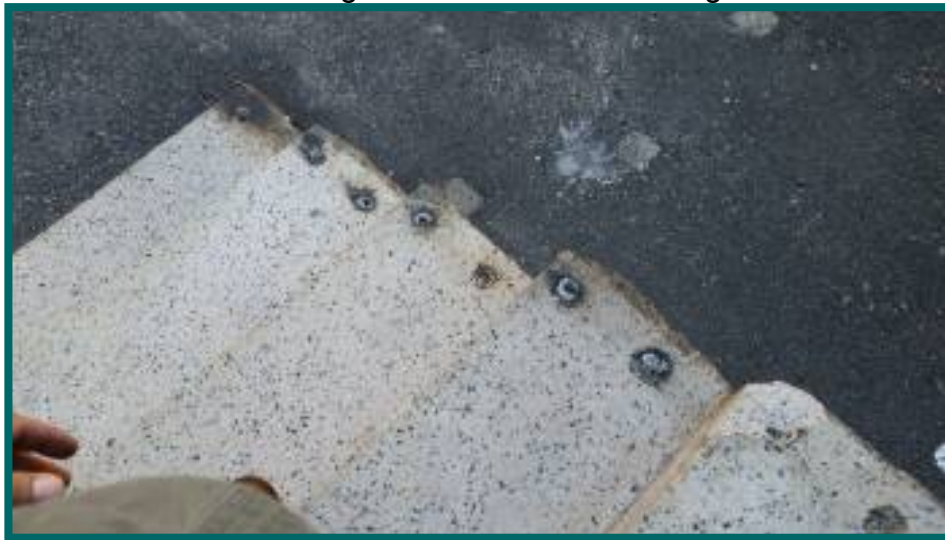
missing handrail side of building

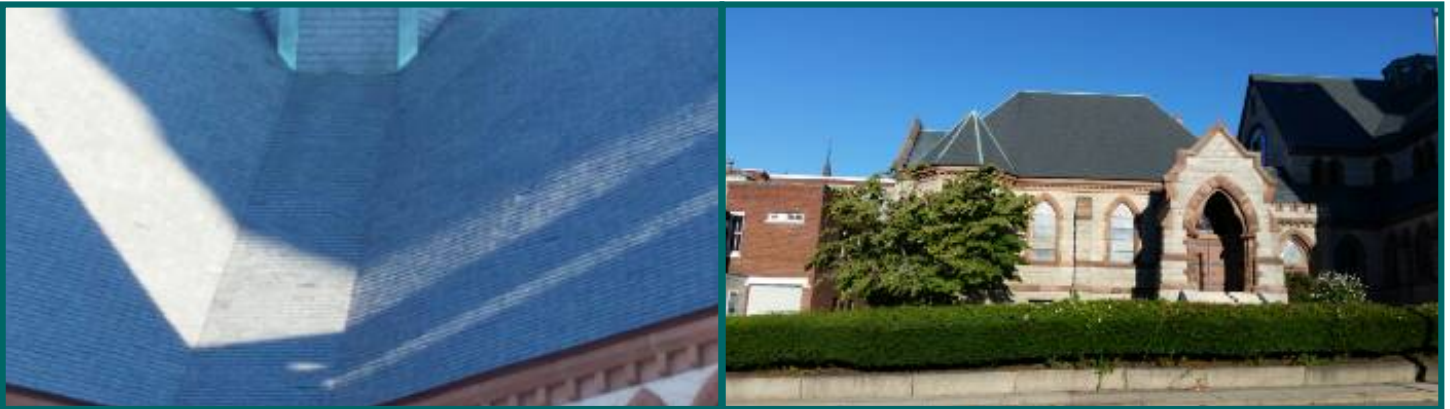
1.1. Several missing or damaged shingles. Recommend further investigation and repairs by a qualified roofing contractor.

areas of missing and damaged shingles on main  
roof front roof surface

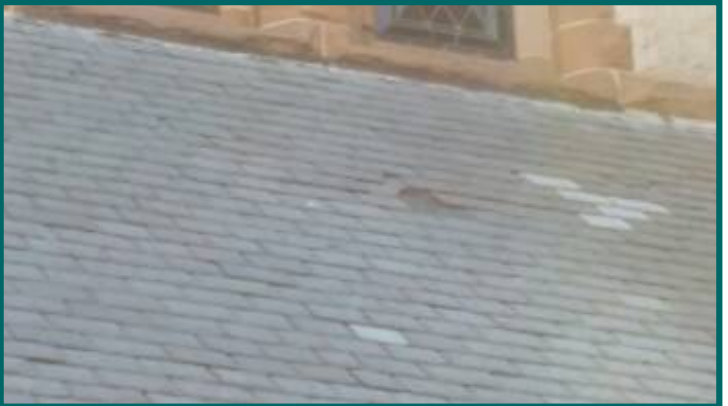
loose shingles front roof surface

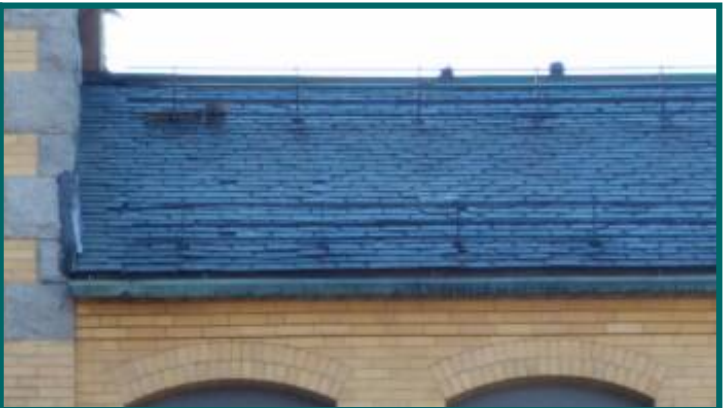
fallen shingles around building

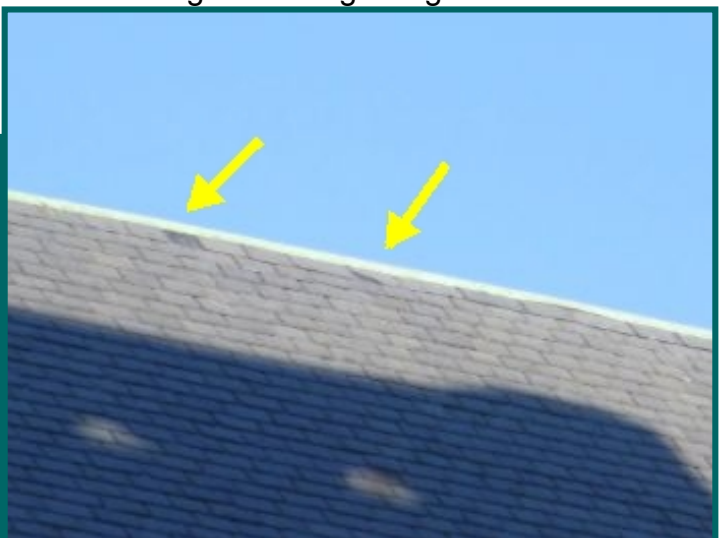
damaged missing shingles rear roof

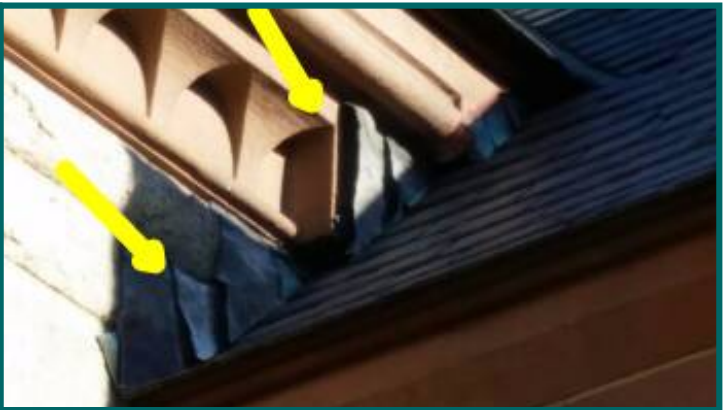
2.1. Damaged flashing at **drip edge** and transitions at one or more area of building, areas of suspected leaks. Recommend assessment and repairs by a qualified roofing contractor.

Front roof surface.

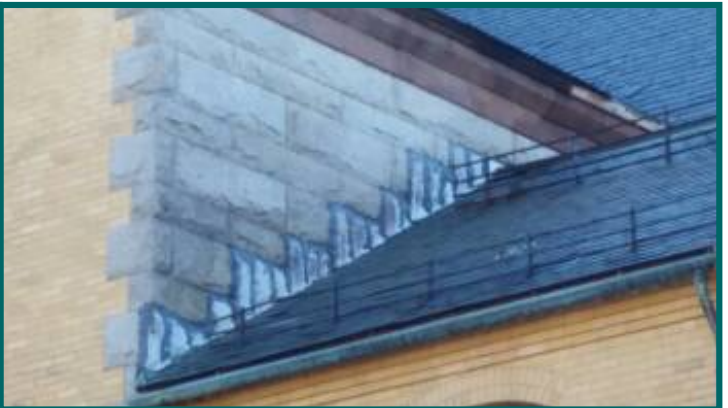
damaged flashing front of building

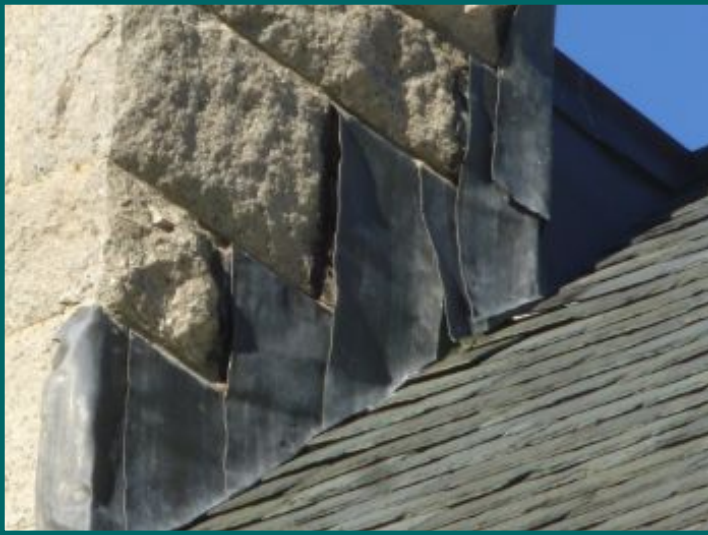
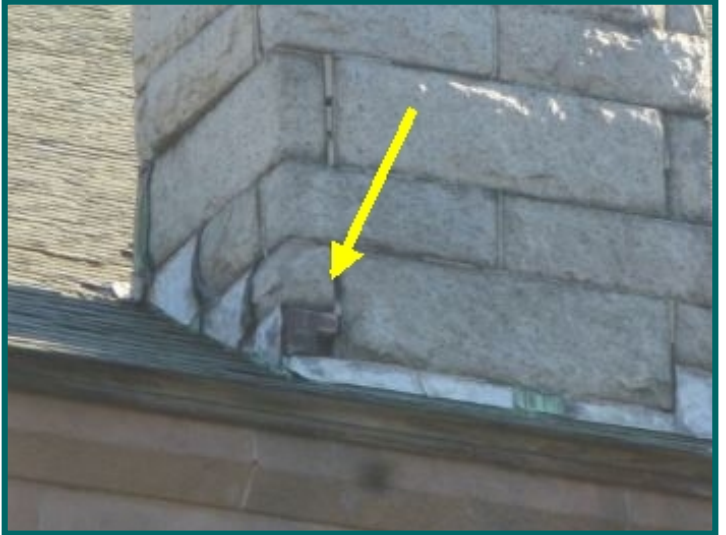
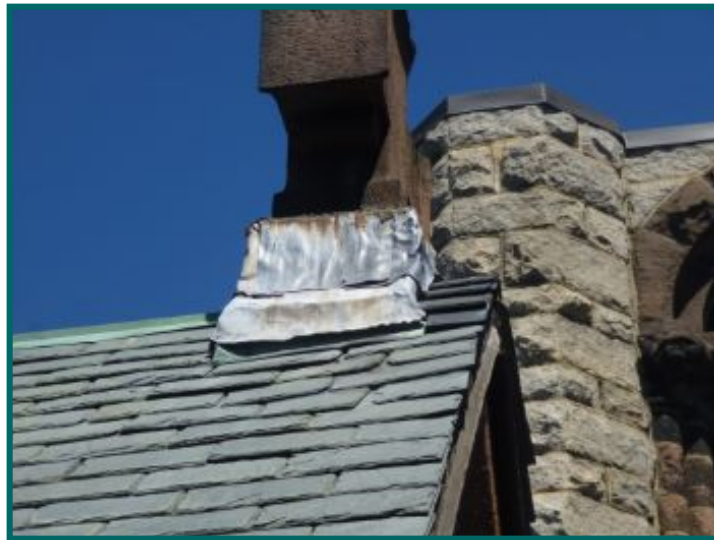
tar covered flashings will need to be monitored  
and serviced from time to time

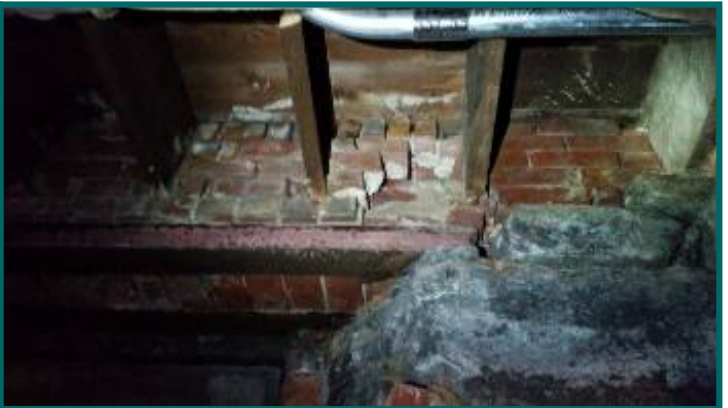
1.7. It was reported that bulkhead area has a history of leaking, current owner has installed a sump pump and dehumidifier. There is still active water intrusion in that area.

water staining near bulkhead

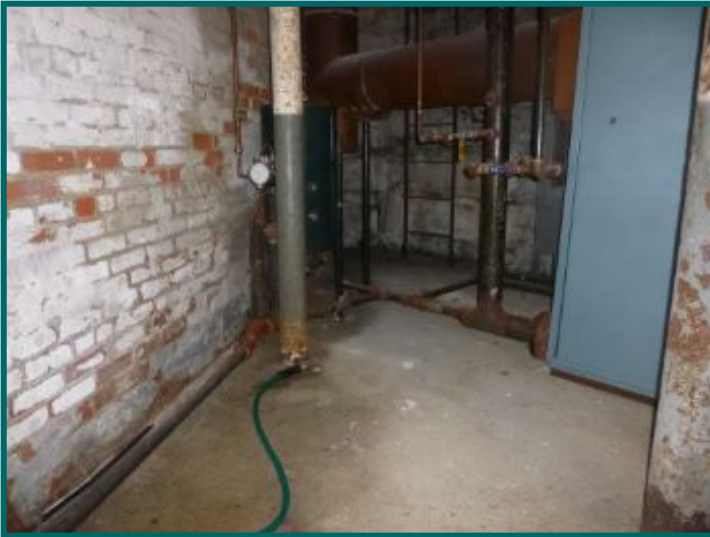
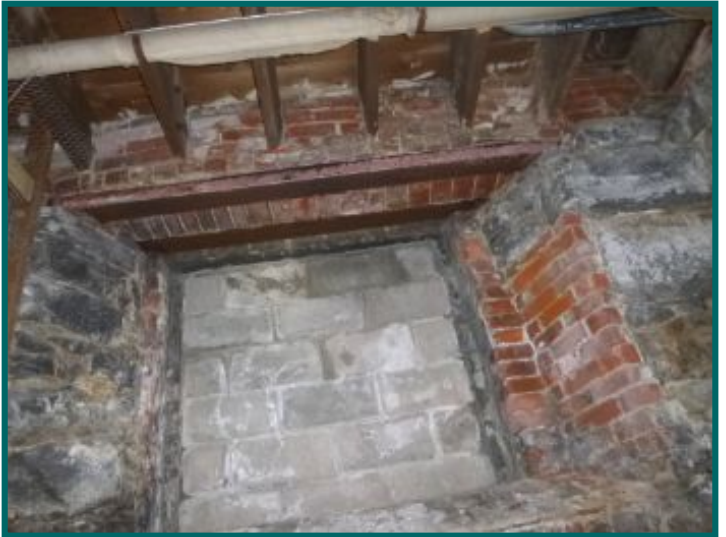
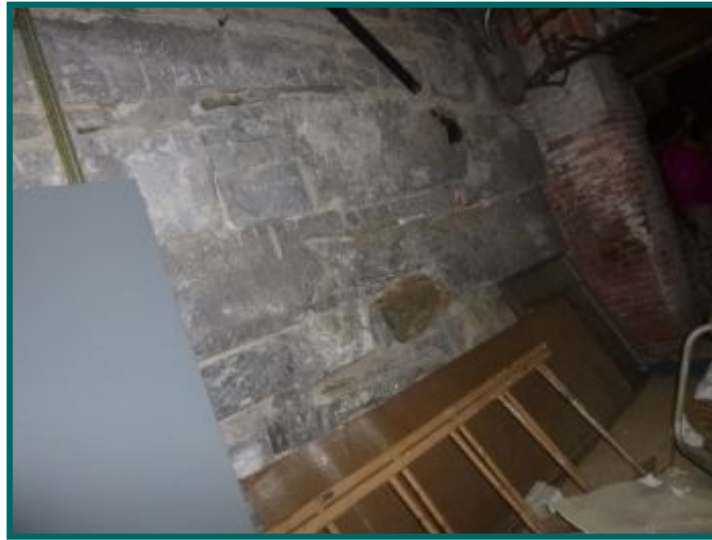
damage brick / alcove framing

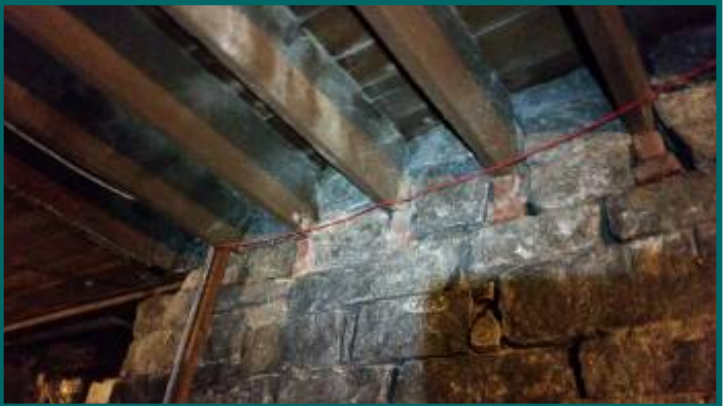
Corrosion on steel beams at bulkhead area

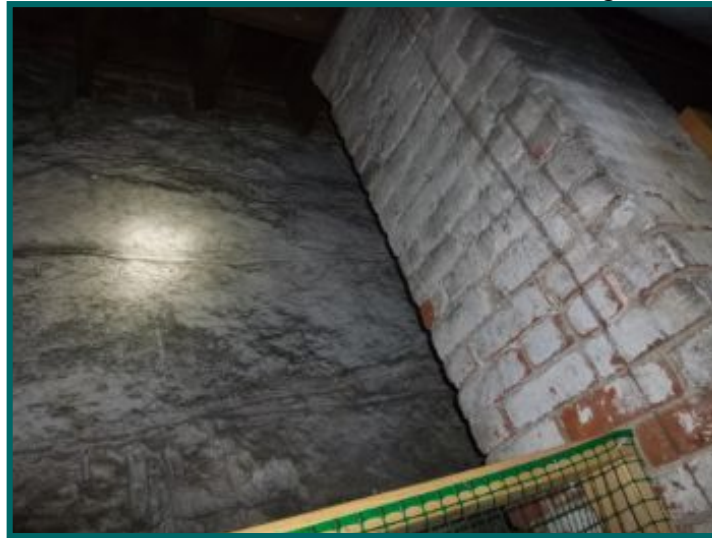
- 2.1. Beam Material: wood, steel.
- 2.2. Brick and stone support **columns**.
- 2.3. Limited visibility due to finish basement, insulation or cluttered conditions.
- 2.4. Water staining along perimeter framing, areas of suspected water intrusion, recommend assessment and repairs as needed by a qualified contractor.
- 2.5. Water staining at one or more area on ceiling dry at time of inspection, recommend assessment and repairs as needed by a qualified contractor.
- 2.6. There is corrosion, rot or damage at support framing components. Recommend full assessment and repairs as needed by a qualified contractor.

ceiling stains near bulkhead

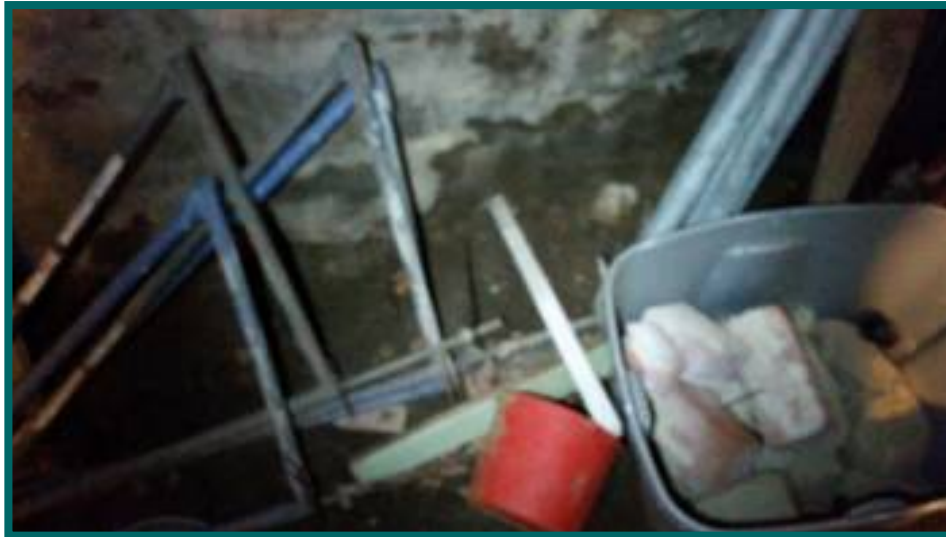
3.1. Wet conditions noted at one or more area. recommend further investigation by a qualified contractor. Wet conditions can cause unhealthy conditions in building and damage to building components.

damp conditions near bulkhead

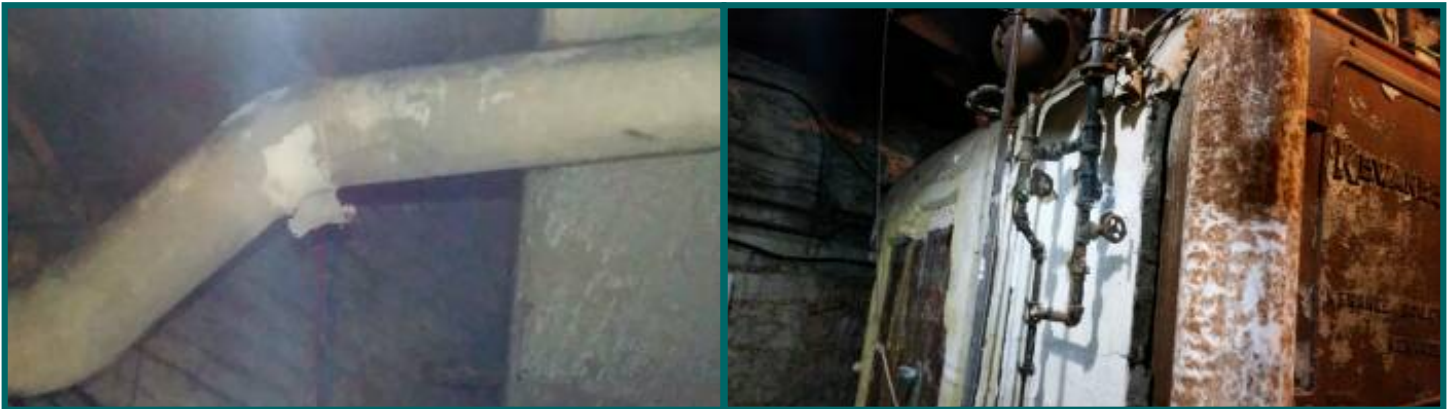
4.1. Insulation on heat pipes, ceilings, walls and old boiler in basement may contain asbestos. Recommend further investigation and encapsulation or proper removal if needed by a qualified asbestos remediation company.

suspected asbestos

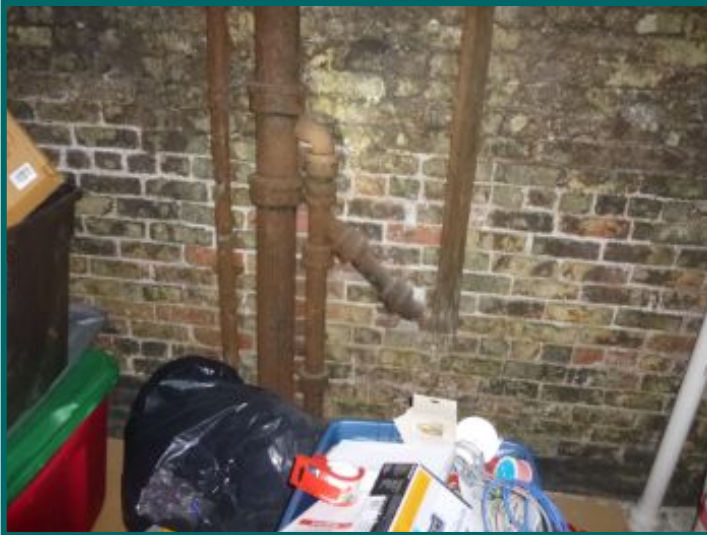
Corrosion on plumbing lines.

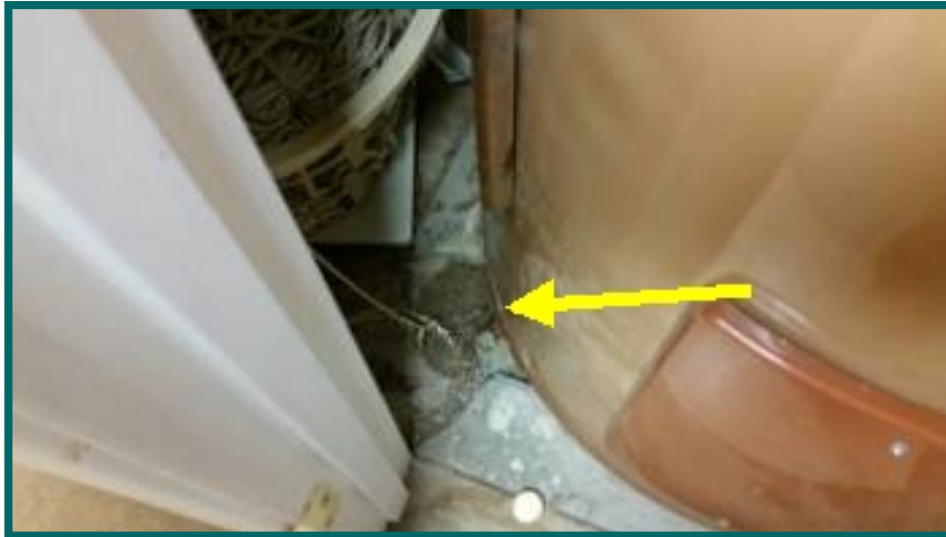
2.3. Temperature & Pressure relief pipe is leaking, recommend repair by a qualified plumber.

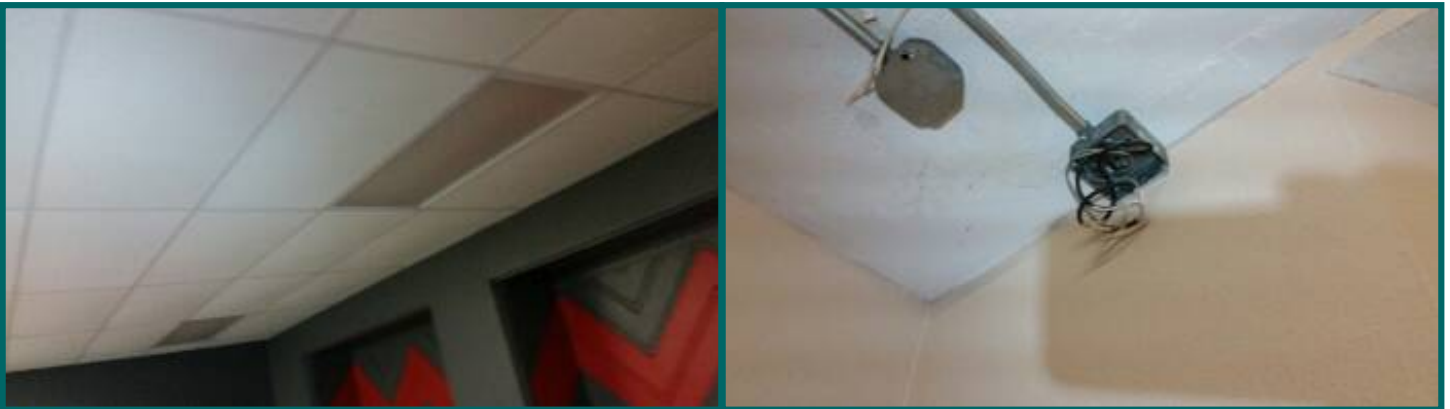
1.2. Open junction boxes were observed, which is a safety concern. Recommend installing proper covers, as needed, for safety.

Open junctions boxes in basement

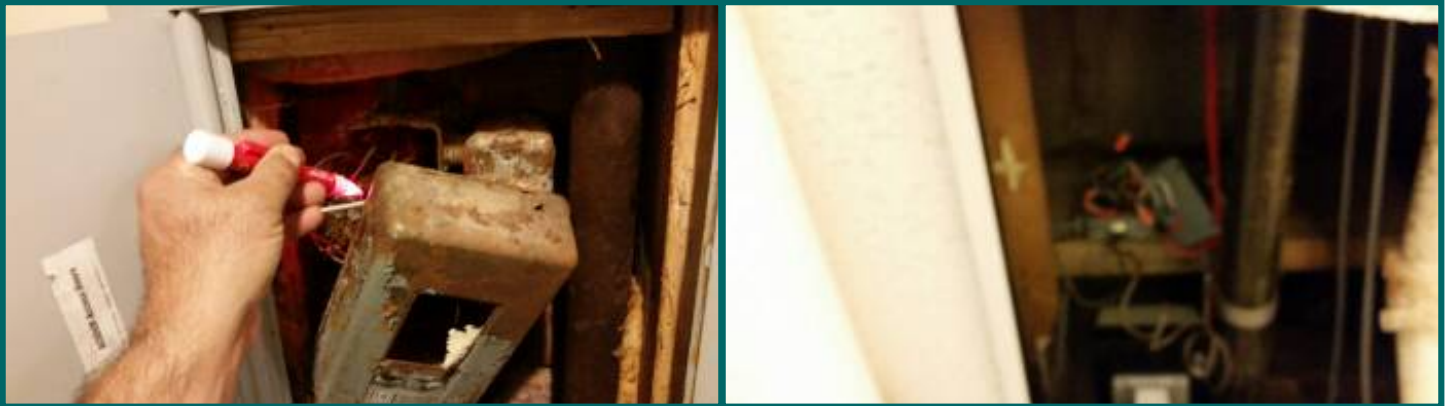
1.4. There is corrosion and damage on one or more electric box or wiring, recommend assessment by a qualified electrician.

Rust damaged electric box in basement.

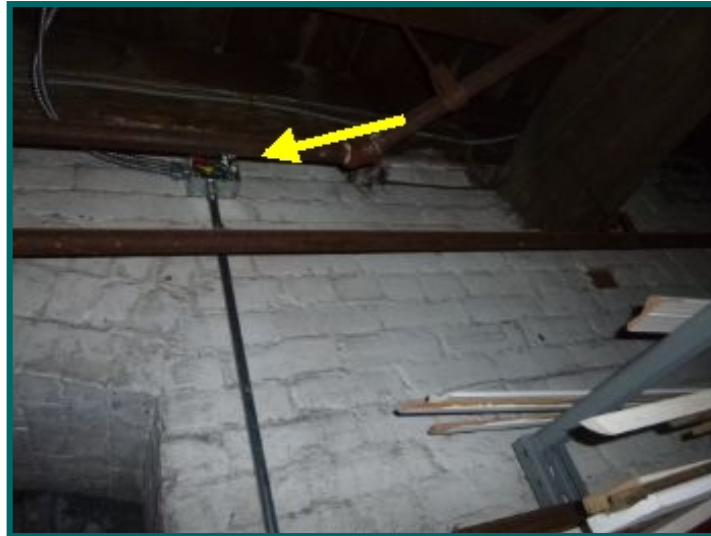
Open junctions boxes in basement

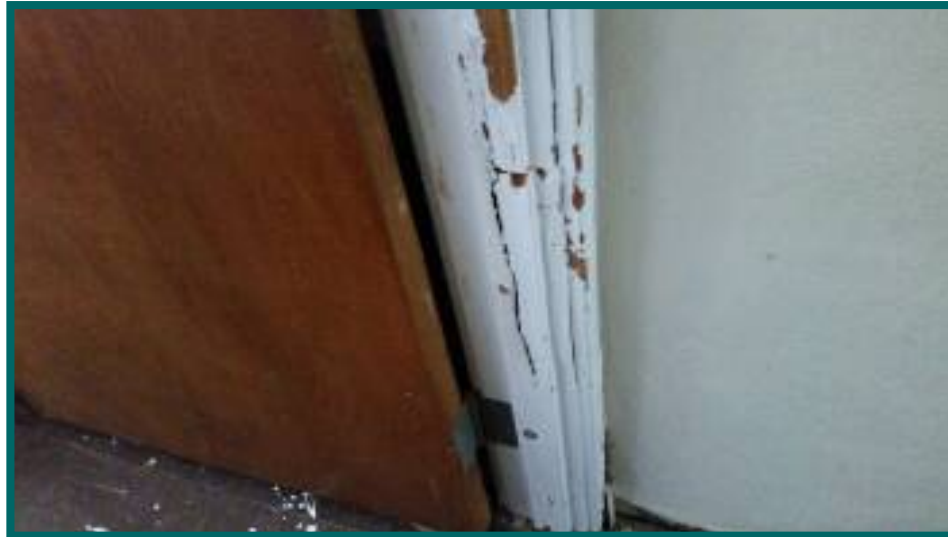
2.2. Noted damage to door and or door frame at one or more areas of home. Recommend assessment of interior doors and repairs by a qualified tradesman as needed.

damaged door frame left side hallway

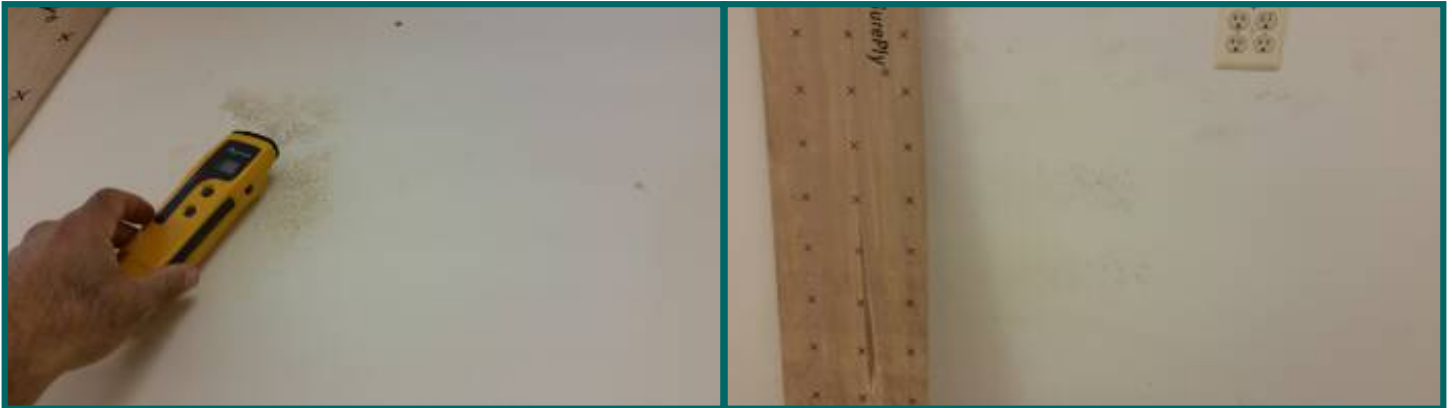
- 4.3. There is dark staining on walls at one or more area that appears to be mold, some areas of elevated moisture present. Recommend assessment, repairs and or treatment of any any affected areas by a qualified professional and monitoring for further water intrusion and staining.

Front basement walls stains elevated moisture

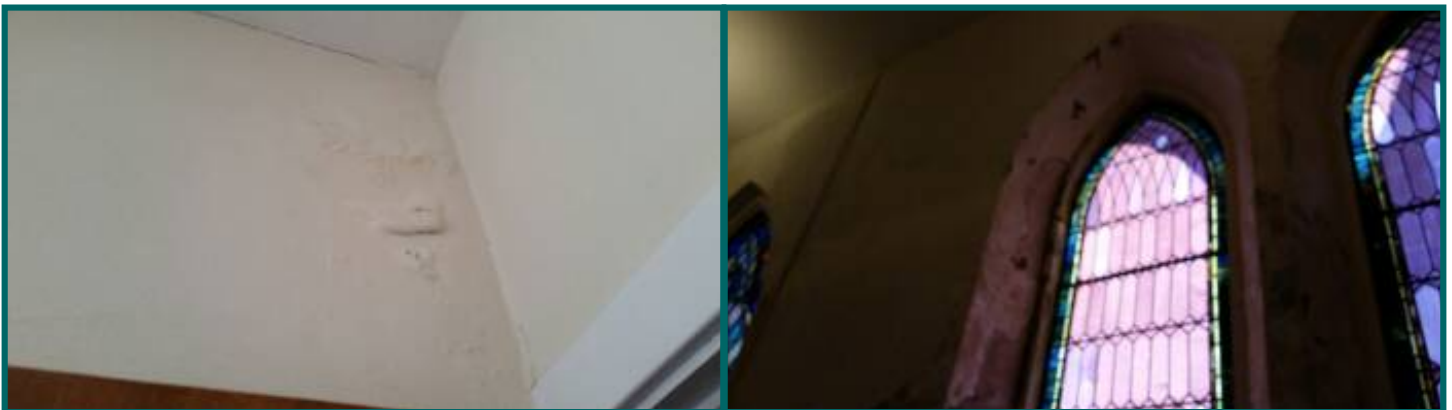
blistering paint left side hallway

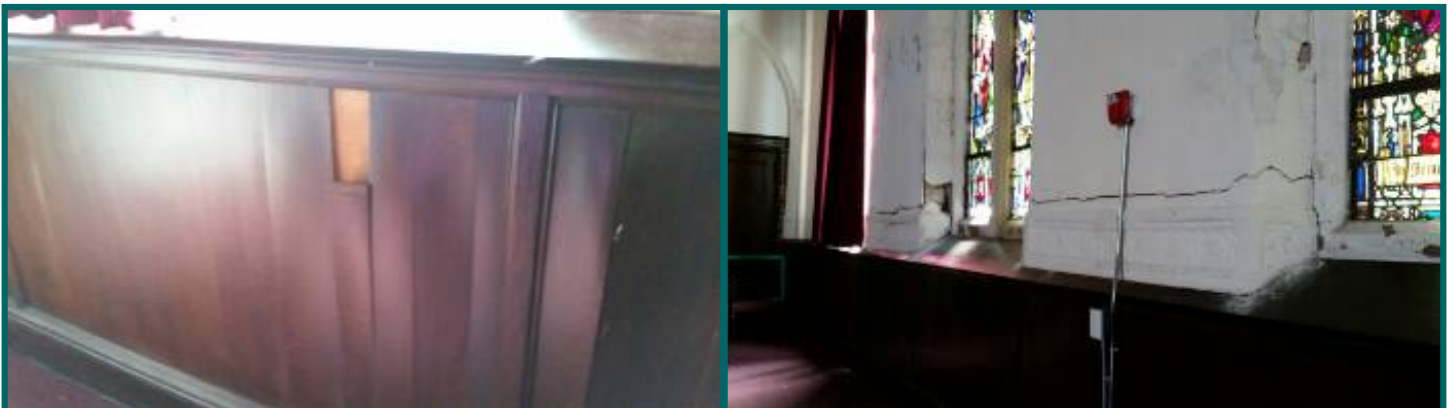
damage to finish trim front wall

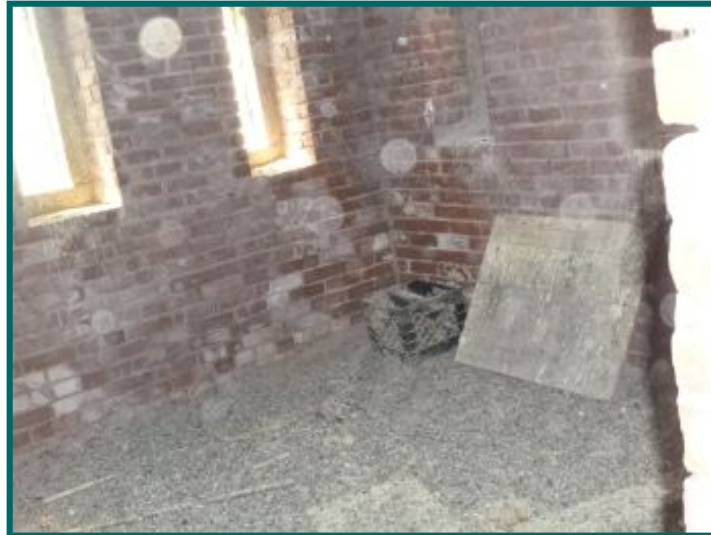
- 4.8. There are unsanitary conditions in left side front tower due to pigeon roosting. This area should be cleaned, repaired as needed and sealed to prevent further pest infestation.

Unsanitary conditions, thick layer of droppings from pigeons in left side tower.

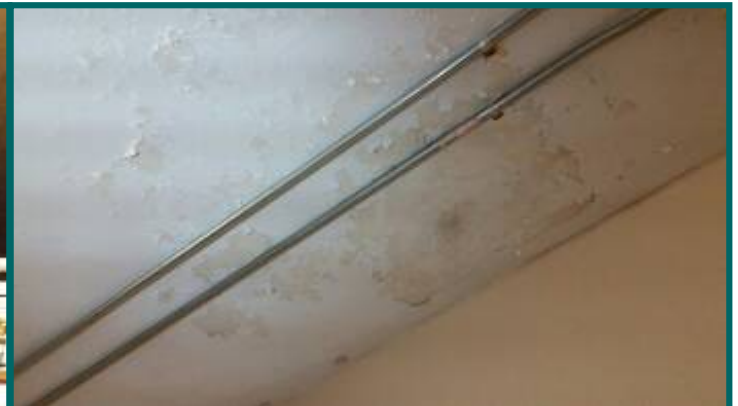
5.3. There is significant cracking or damage to ceiling surfaces in one or more locations, recommend repairs by a qualified contractor.

damaged ceiling in paint storage room

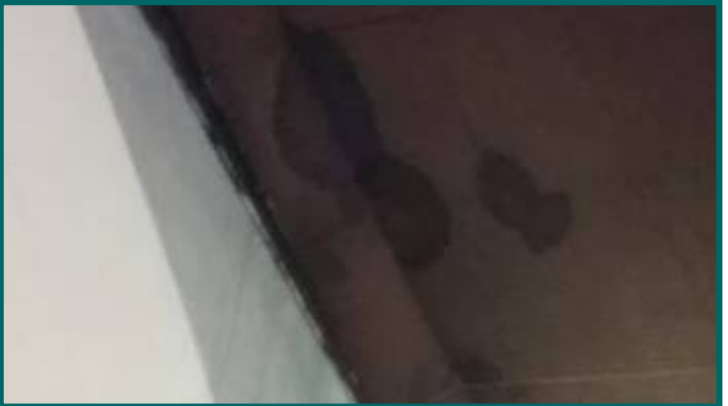
front basement ceiling area

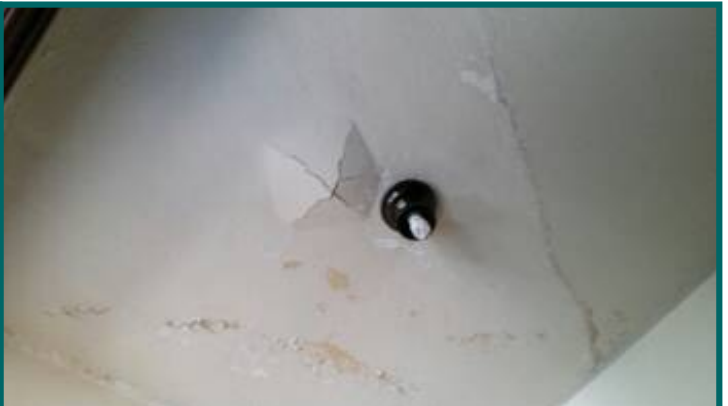
staining in sanctuary below area of roof repair

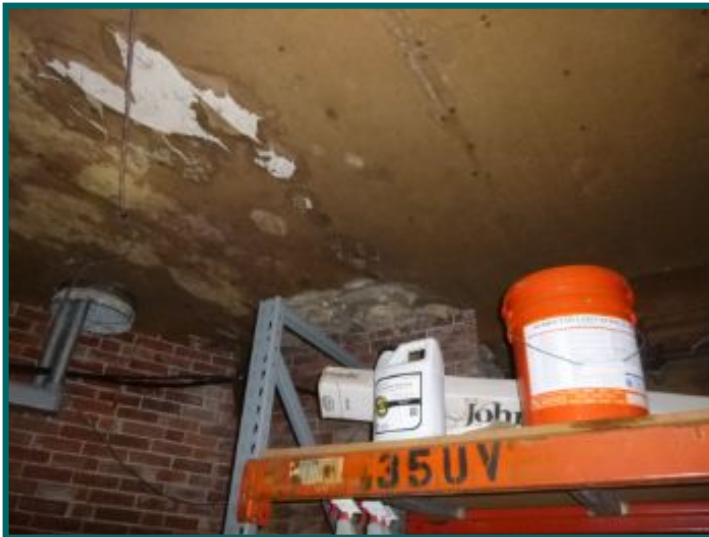
Many areas of ceiling damage in basement.

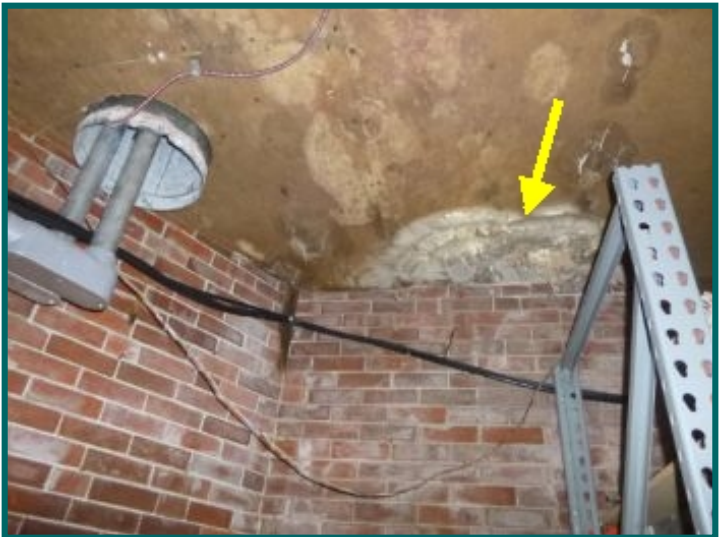
areas of ceiling damage in basement.

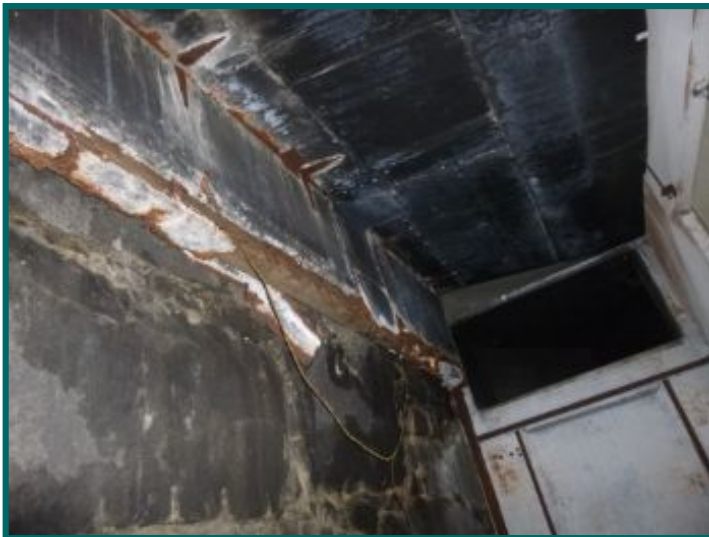
Suspected leaks at perimeter wall ceiling areas, suspected mold .

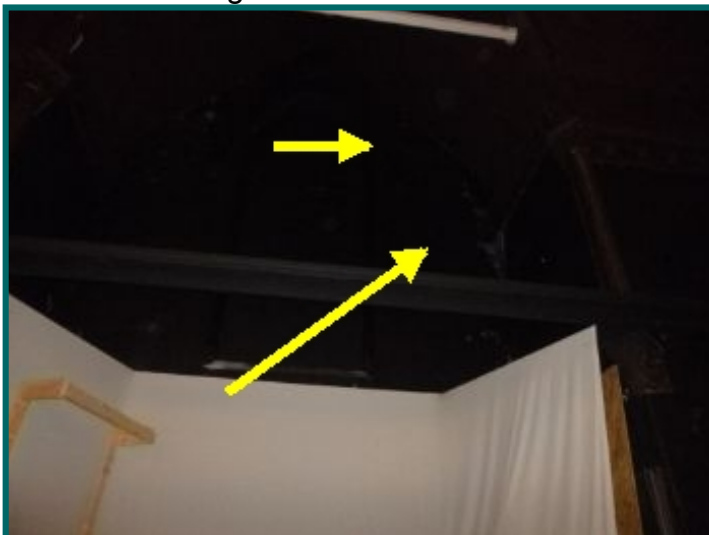
Damaged missing ceiling tiles.

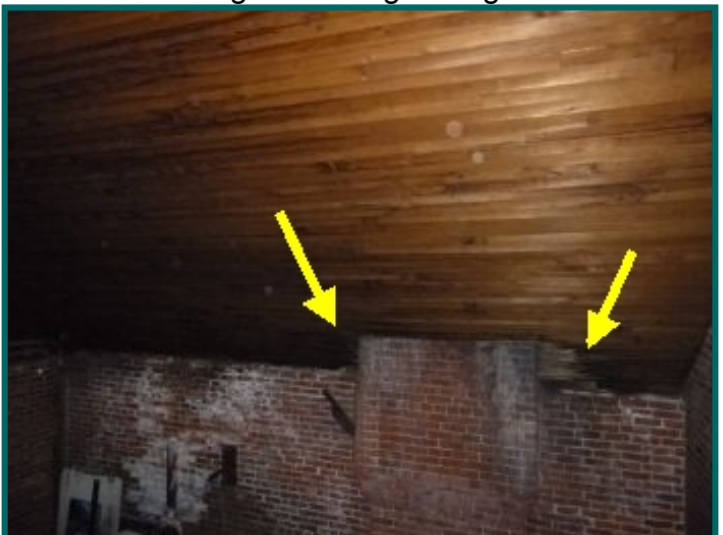
Efflorescence at wall ceiling transition. Evidence of water intrusion

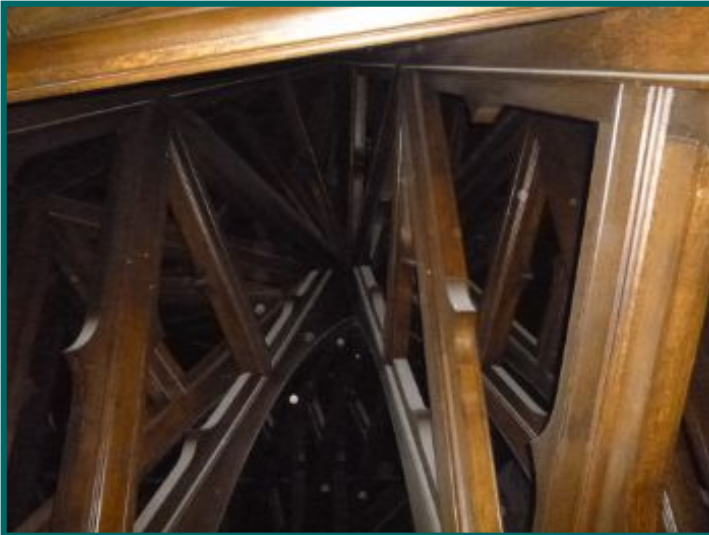
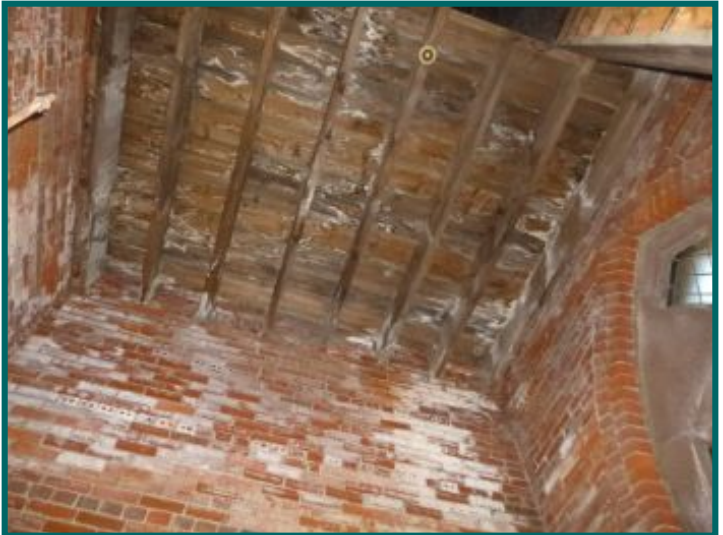
Staining around chimney transitions.

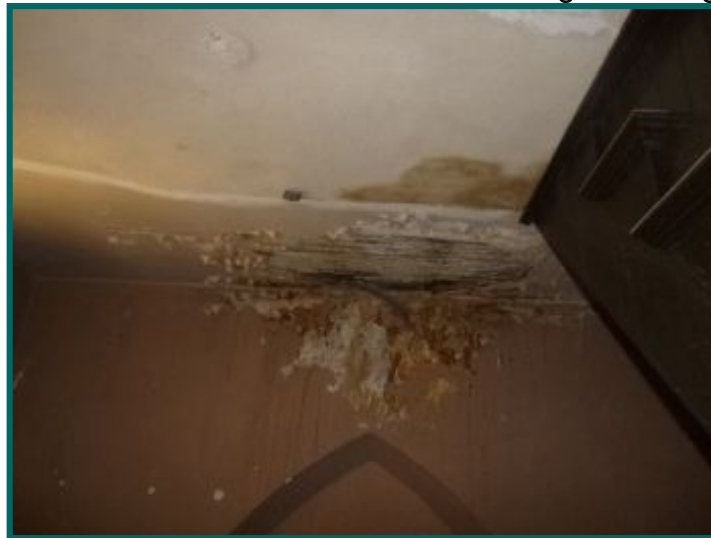
Staining on ceiling at right side tower.

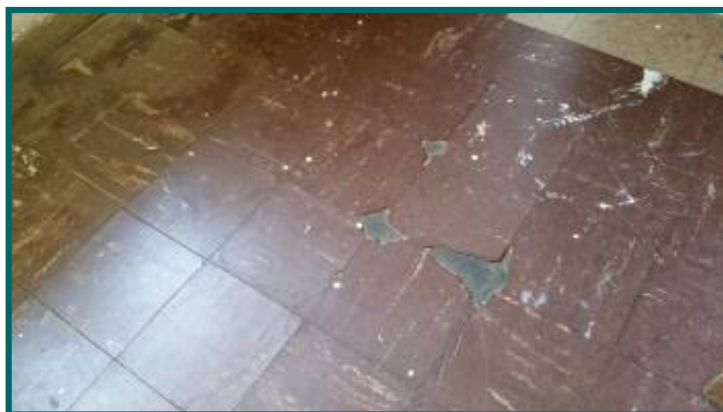
damaged 9 by 9 tiles left side hallway
