# *Alpha Home & Commercial Building Inspections*

## Property Inspection Report

Date of Inspection: 8/13/2015 Time: 9:00 AM  
Order ID: 2748

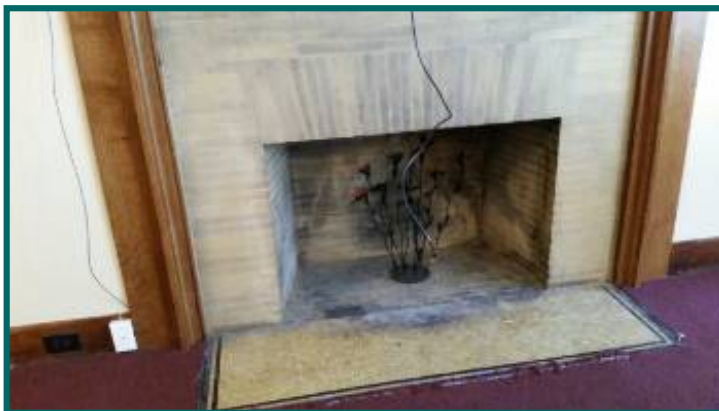
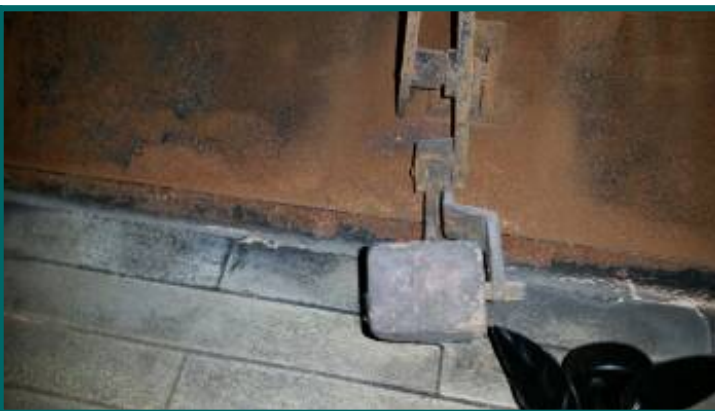
8.2. Damper is damaged or missing, recommend full inspection cleaning and repair by a qualified chimney contractor.

Damper damaged first floor fireplace

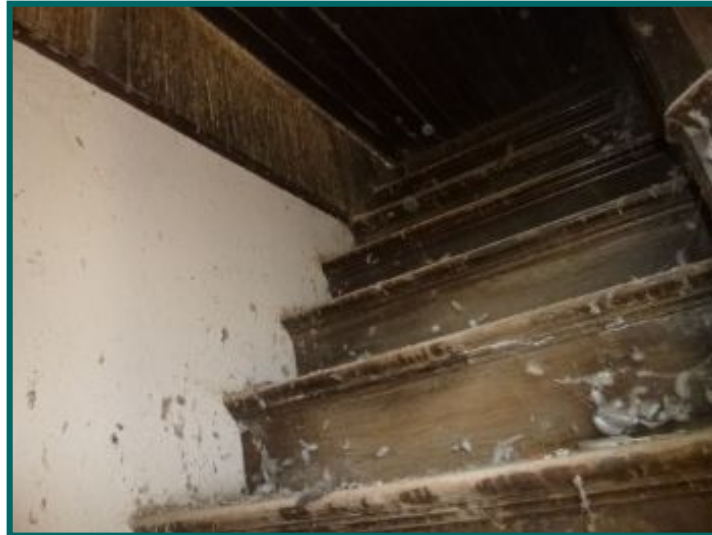
Pigeon activity at left side tower stairs.

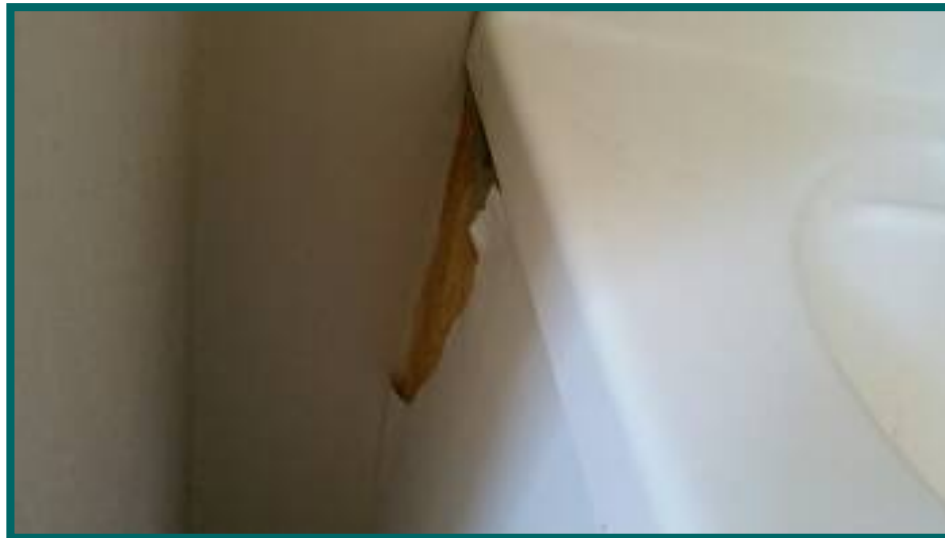
10.1. Cabinets / vanity is loose or damaged, recommend repairs by a qualified tradesman.

damage cabinet first floor bath
