Alpha Home & Commercial Building Inspections

Property Inspection Report

Sample 11 family apartment 100 years old, Manchester, NH 03103
Inspection prepared for: Sample Report
Real Estate Agent: -

Date of Inspection: 1/8/2016 Time: 9:00 AM
Order ID: 3168

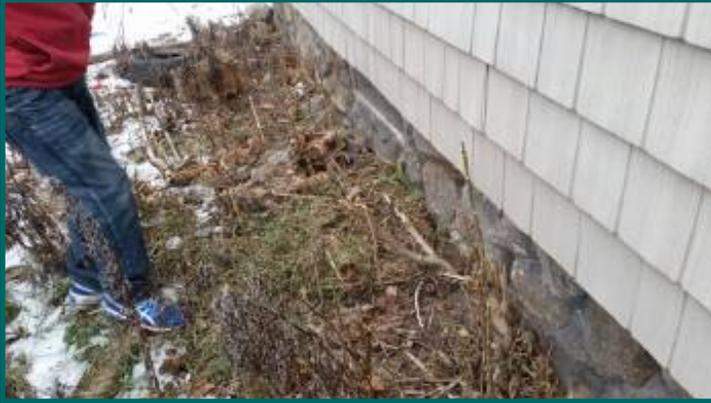
- 3.1. Vegetation such as trees, shrubs and/or vines are in contact with or less than one foot from the structures exterior. Vegetation can serve as a **conduit** for wood destroying insects and fungal growth and may retain moisture against the exterior after it rains. Vegetation should be pruned and/or removed as necessary to maintain a one foot clearance between it and the structures exterior.

roots stumps and vines at rear of building should be removed

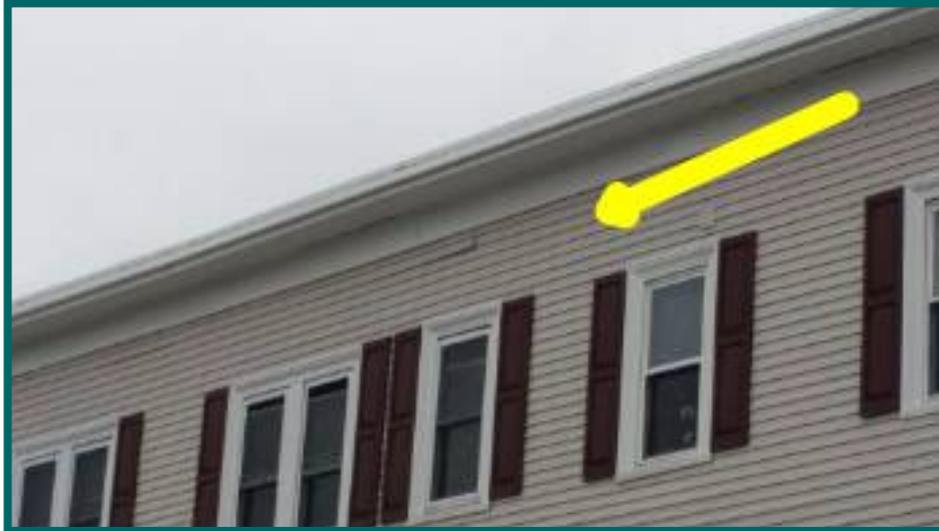
1.1. One or more areas of damage to exterior wall surfaces, recommend full assessment and repairs by a qualified contractor.

lifting siding at front wall surface

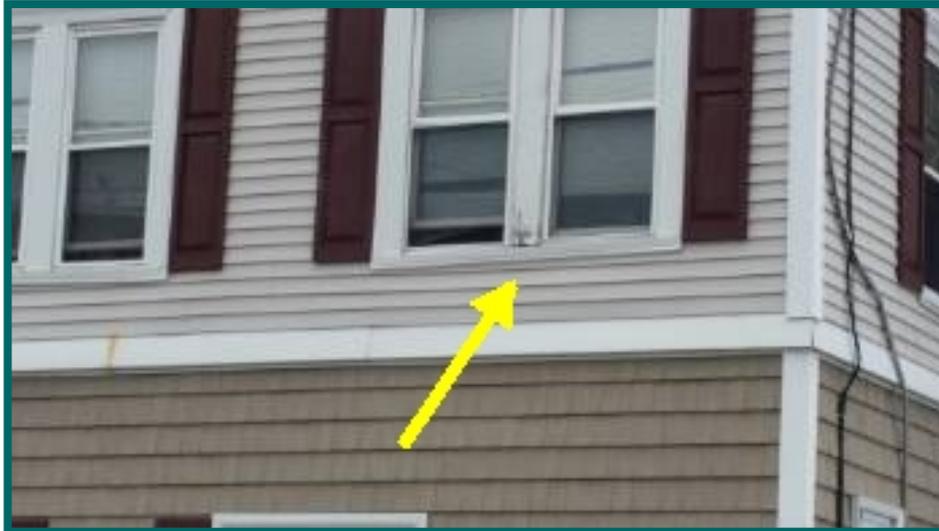
2.1. Deterioration of frames at one or more window, some peeling paint and gaps on exterior wall window frames. Recommend assessment of all windows and repairs as needed by a qualified contractor.

Frame rot at front window

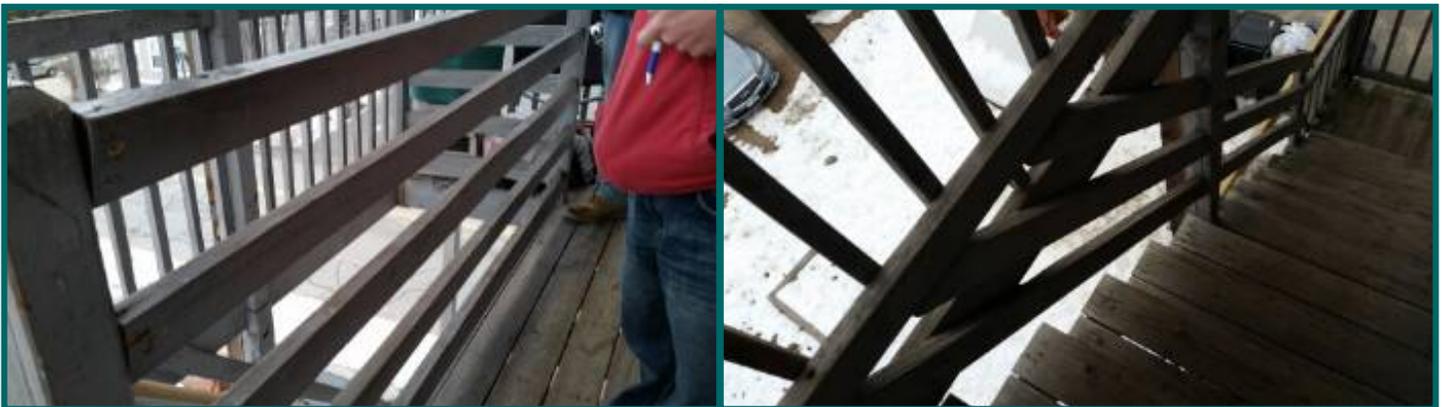
horizontal balusters

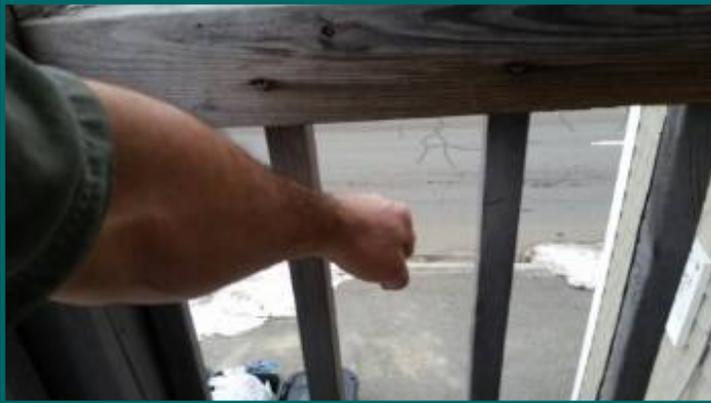
rail openings exceed four inches

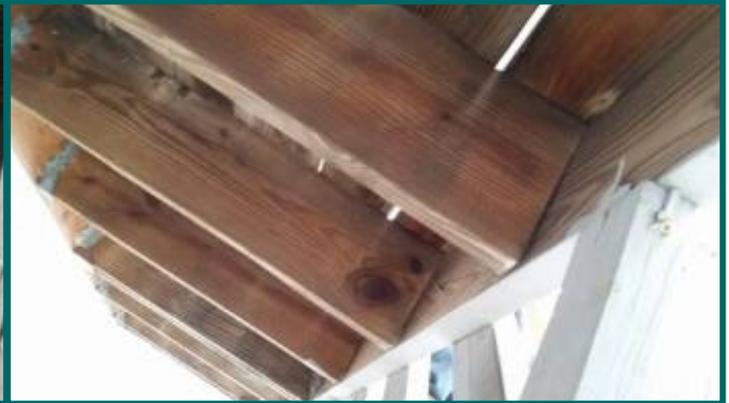
Missing Joist hangers.

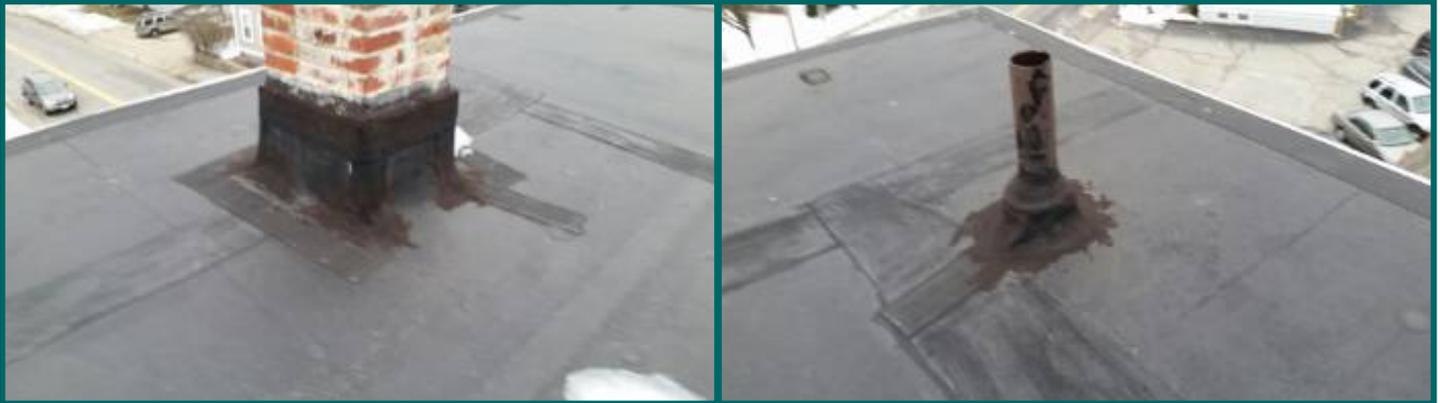
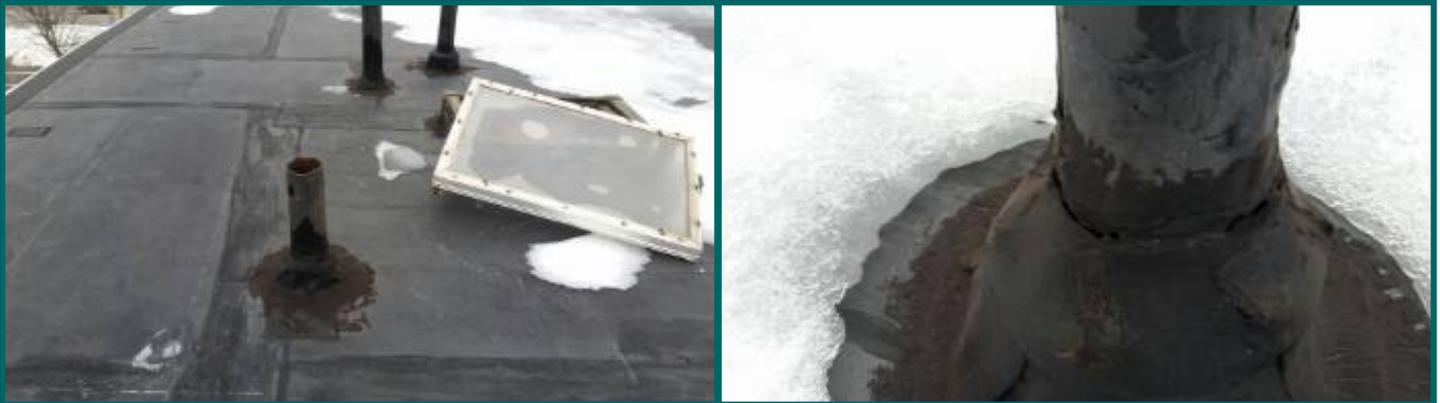
2.1. Sealant around roof penetrations is dried and cracking. Water intrusion hazard Recommend inspection and repairs by a qualified roofing contractor.

cracking in vent stack flashing needs to be resealed

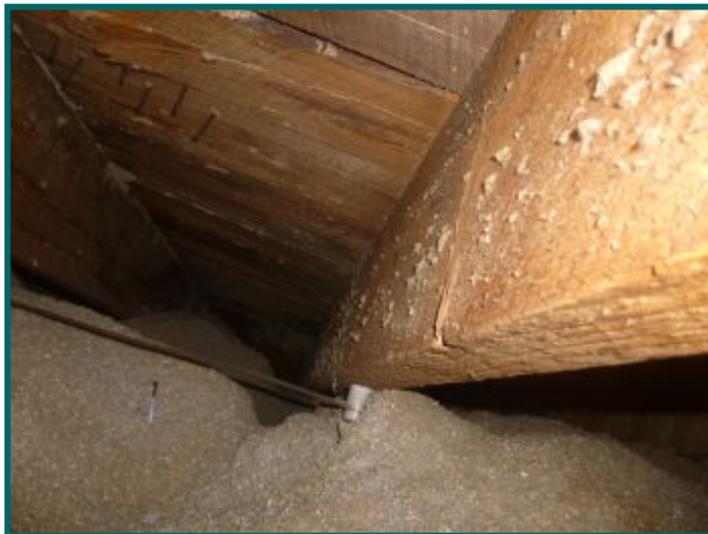
2.1. Knob and tube wiring in attic in contact with insulation, does not appear to be active, building owner reported no active knob and tube wiring in building. This type of wiring is at least 70 years old and is no longer considered safe. recommend further investigation and repairs by a qualified electrician if needed.

Mechanical chase viewed from roof hatch area knob and tube wiring appears to be terminated.

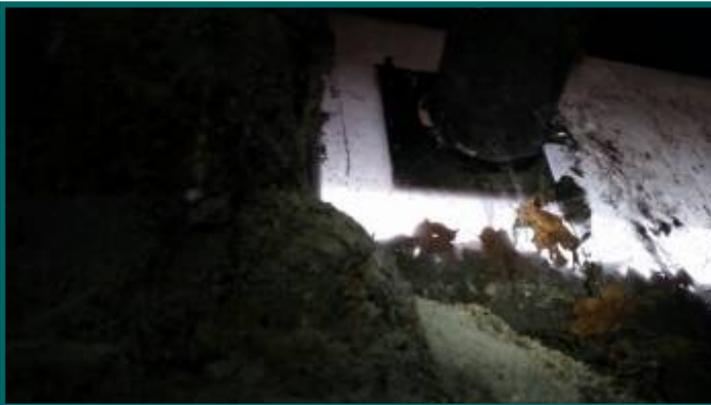
Front basement window dryer vent termination needs to be covered to prevent entrance of vermin.

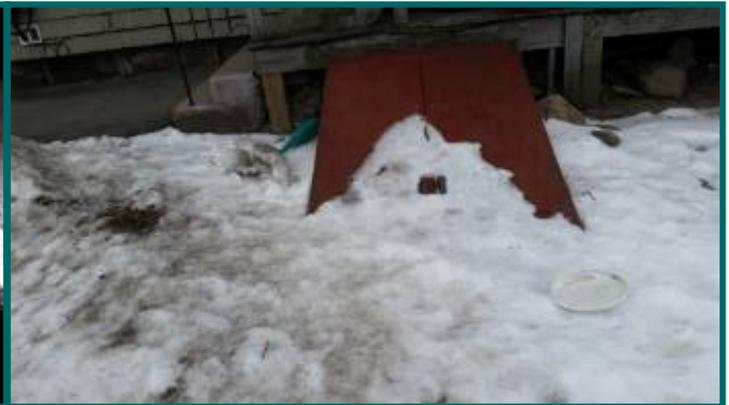
Bulk heads are commonly areas of water intrusion need to be monitored and sealed or repaired from time to time.

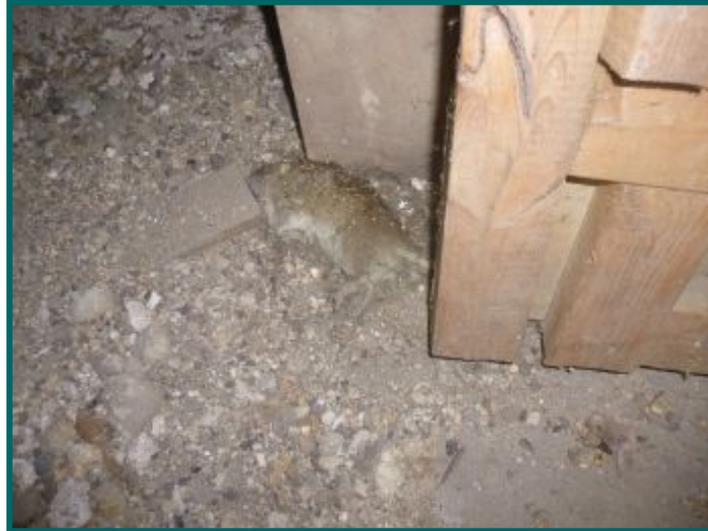
3.4. Evidence of rodent activity along framing and or insulation. Recommend inspection and treatment by a qualified pest control company.

Dead rat in basement.

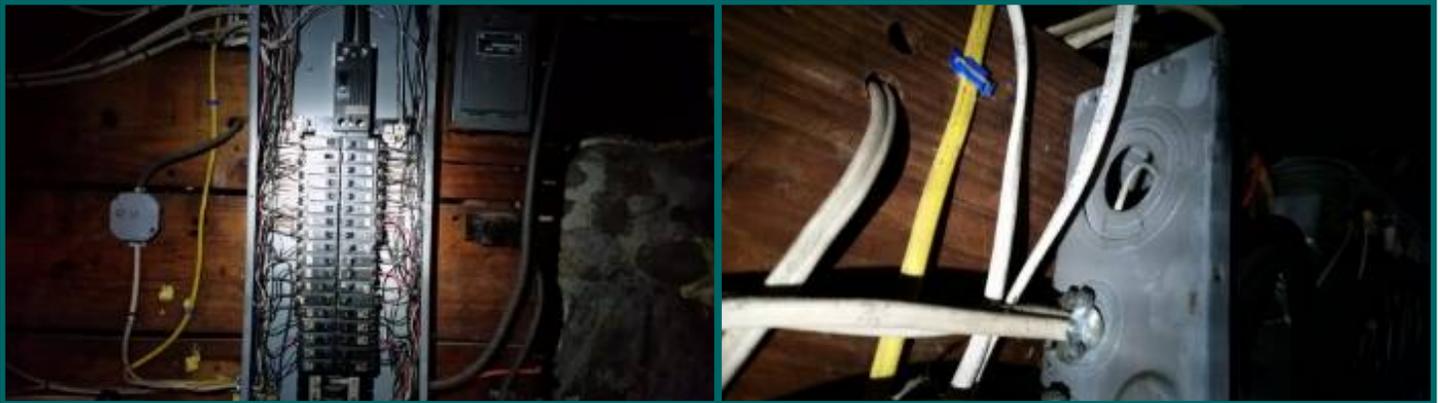
- There are open knock outs present one or more service panel enclosures. This is a potential safety hazard and can allow mice or insects into panel.
- Circuit breakers are not properly marked at one or more electric panel, recommend marking panels properly for safety.

open knock out

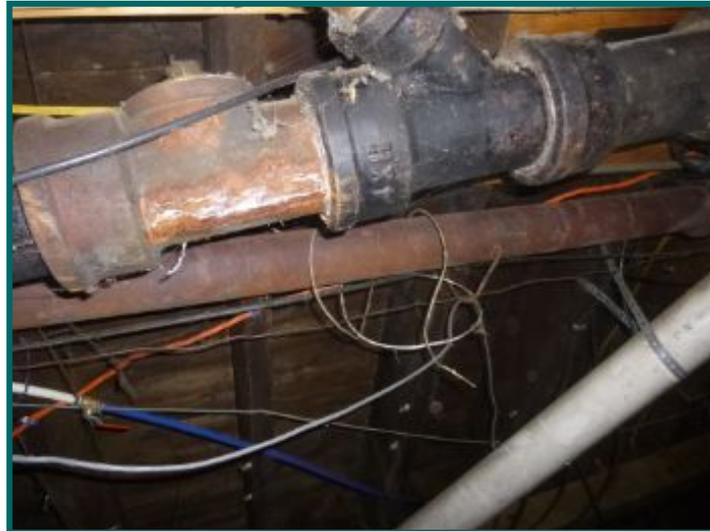
Corrosion on drain lines.

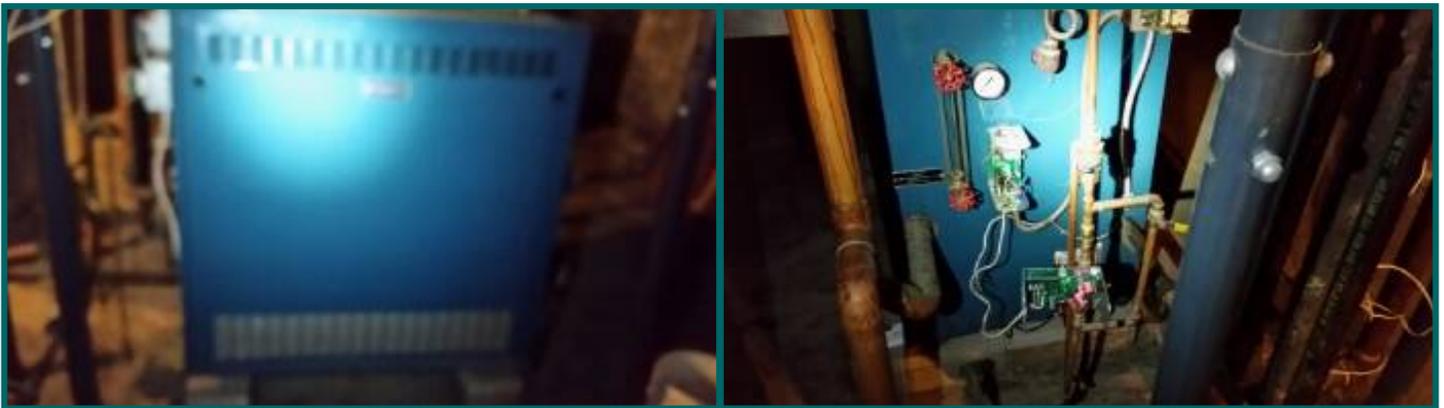
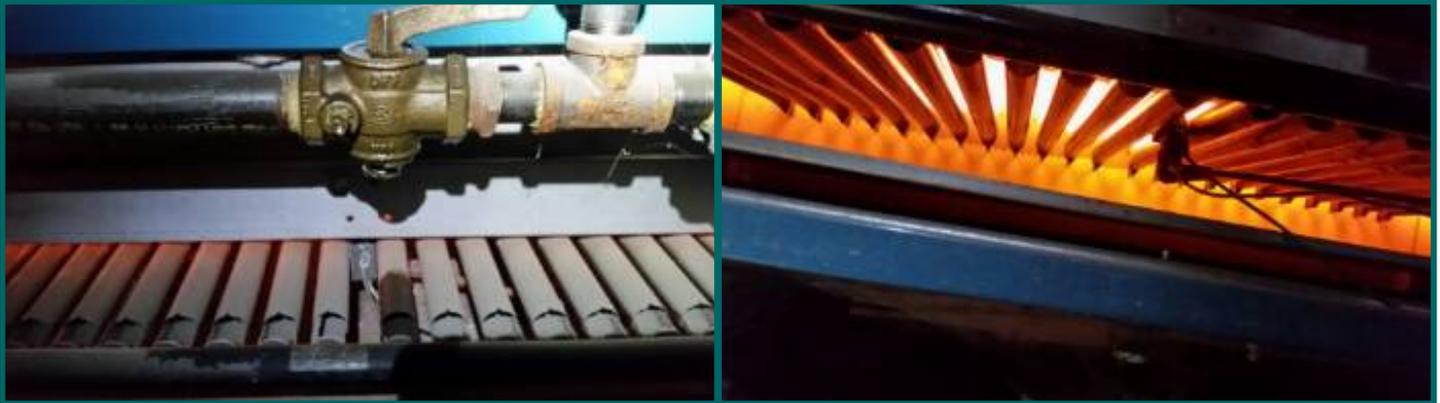
1.2. It was reported that boiler auto filler is working improperly, gas shut off valve in boiler burner cabinet is leaking fluid, recommend full assessment and repairs by a qualified plumbing / heating contractor. Building owner reported boiler is serviced twice a year. No service records or service company information was provided.

leak at gas shutoff valve inside boiler cabinet

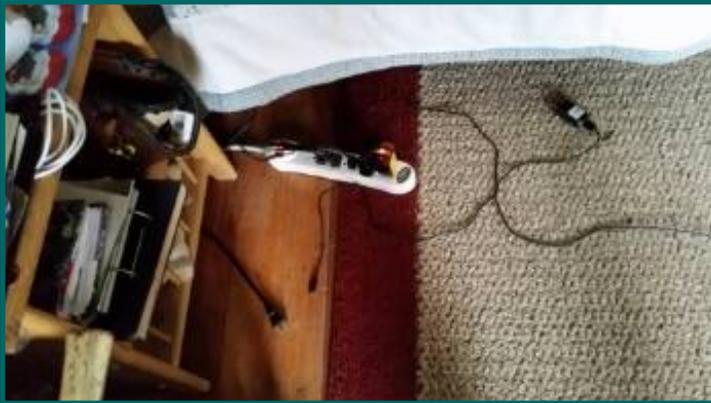
2.2. Ungrounded outlets present. Ungrounded outlets do not offer current standard of protection for equipment, especially for sensitive electronics. Recommend installing three prong grounded outlets where any sensitive electronics are being used, (Entertainment center, TV, computer etc.)

mostly ungrounded outlets throughout the building

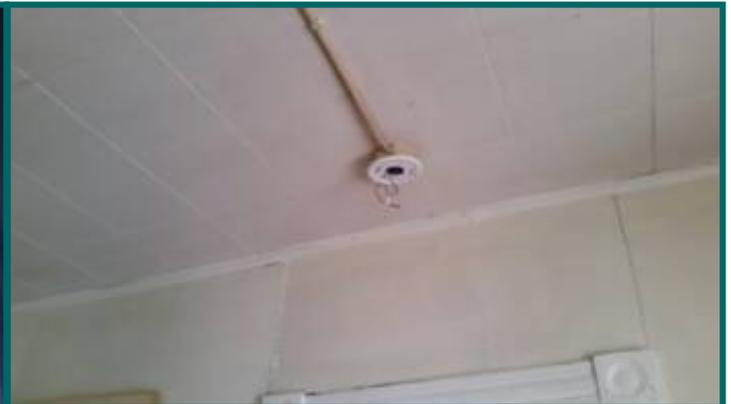
2.7. Smoke detectors missing at one or more locations, recommend repairs as needed by a licensed electrician.

unit 11 smoke detector missing

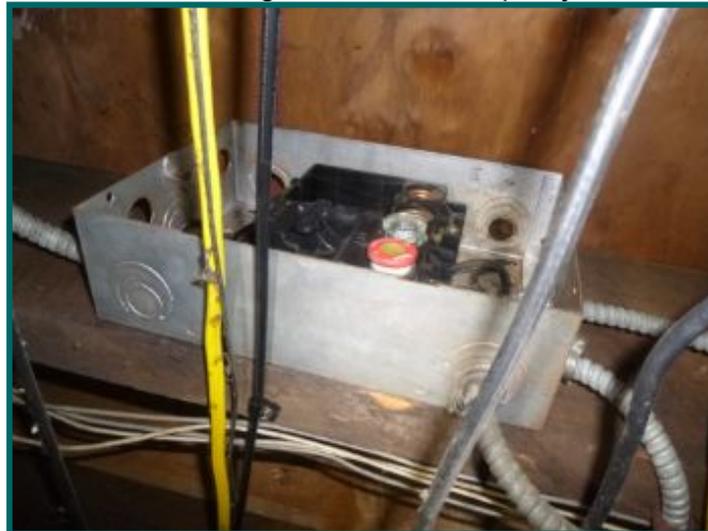
2.10. There is one or more older fuse panels present, these panels employ screw in fuses. These are considered to be unsafe because property owner may replace fuses with improper sized fuses creating a fire hazard. Recommend upgrading to current standards using circuit breakers.

Screw in fuse sub panel, missing cover.

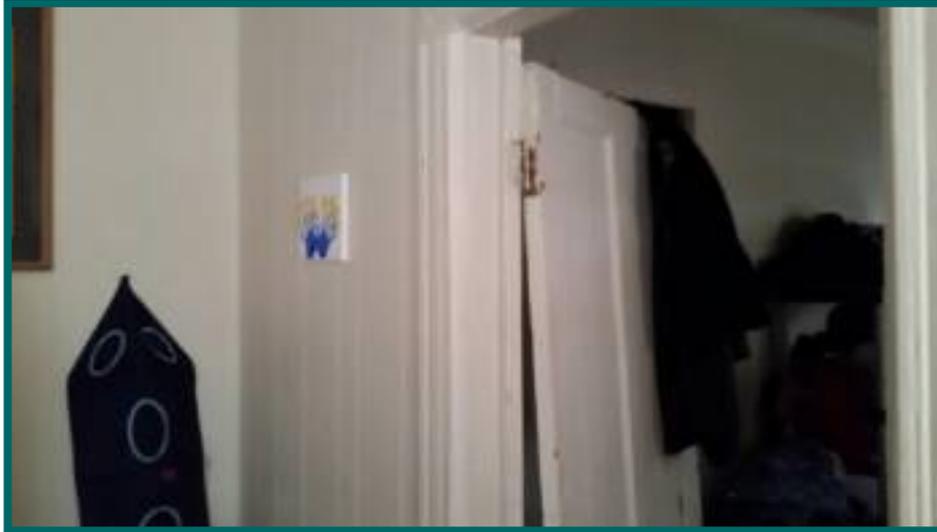
3.2. Noted damage to door and or door frame at one or more areas of home. Recommend assessment of interior doors and repairs by a qualified tradesman as needed.

unit 7 damage bedroom door

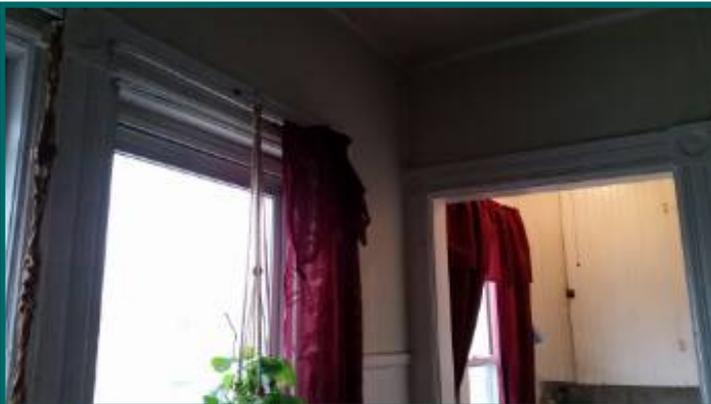
damage sashes unit 11

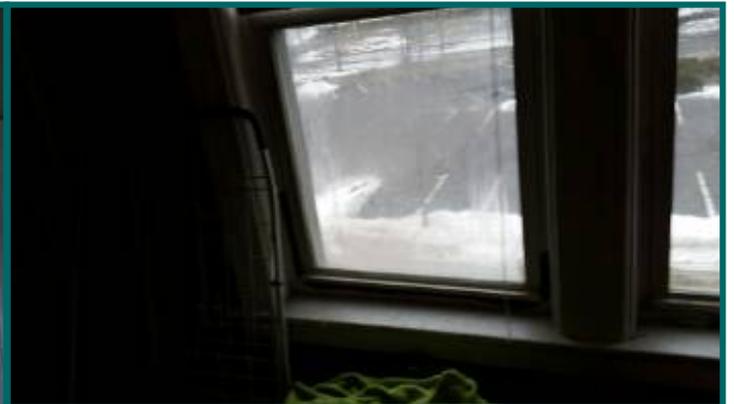
4.2. One or more windows have broken seals (fogged) this condition can diminish the energy efficiency of the window and cause permanent hazing to the glass, recommend repair by a qualified window contractor.

fog window unit 10

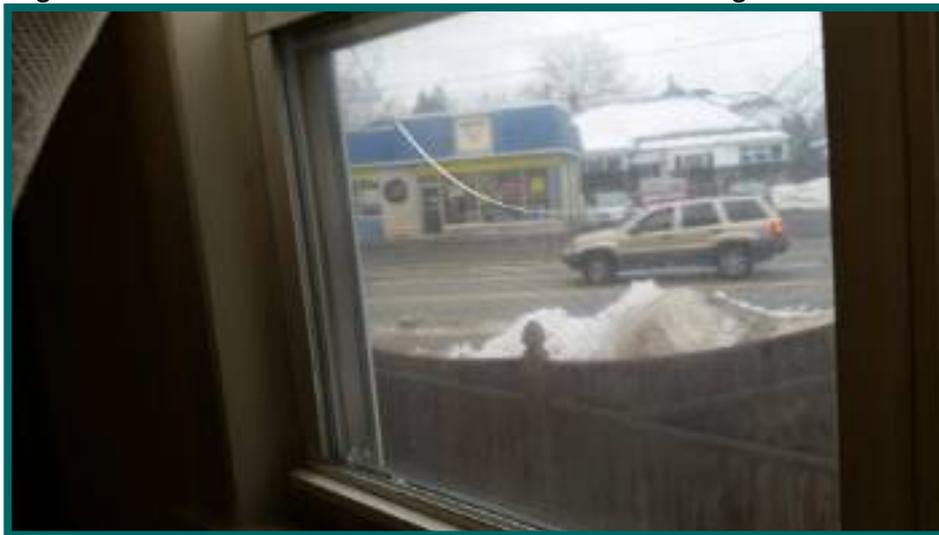
4.3. Window has broken pane in one or more area of building. Recommend assessment of windows and repair by a qualified tradesman.

broken glass unit 3 kitchen

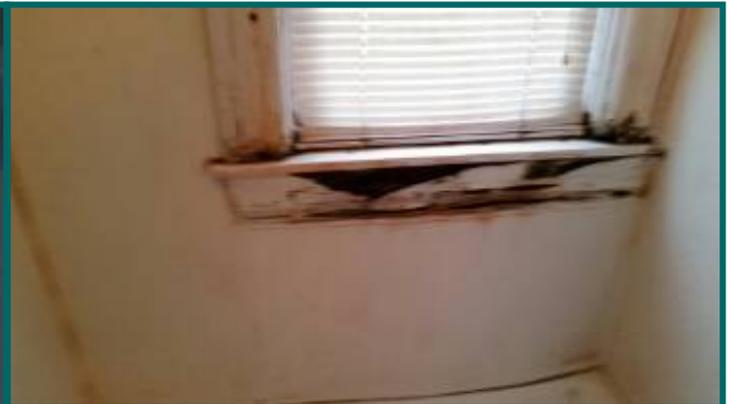
rot on window and wall unit 9 bathroom, requires immediate attention.

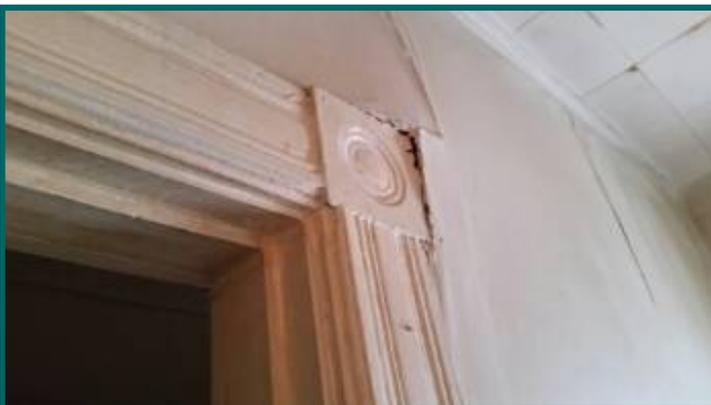
damage kitchen wall unit 9

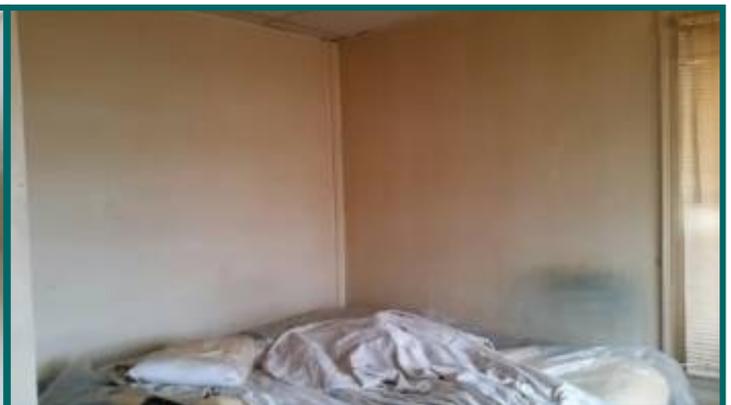
unit 9 nicotine staining on wall surfaces

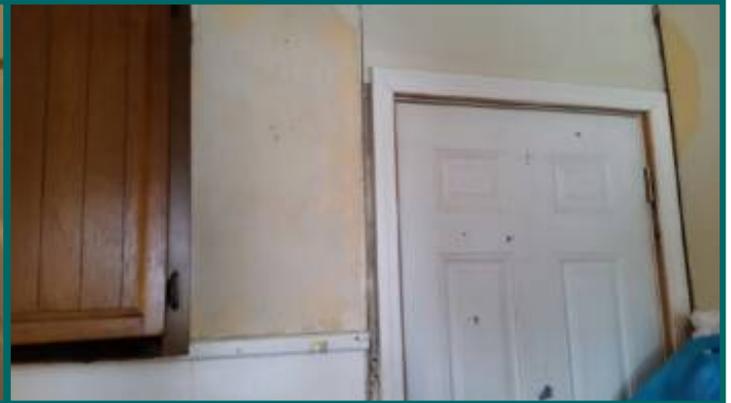
damaged surfaces and trim unit 11

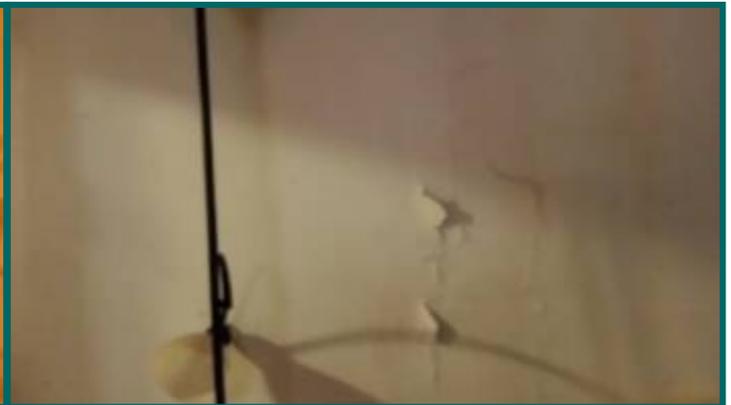
peeling paint damage unit 2

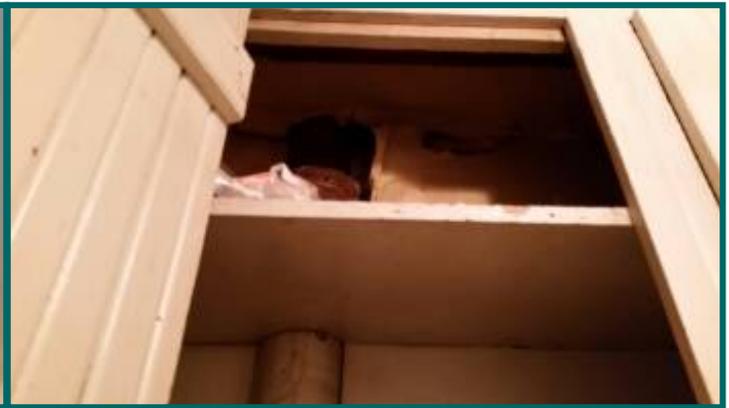
staining peeling paint unit 9 cabinet ceiling

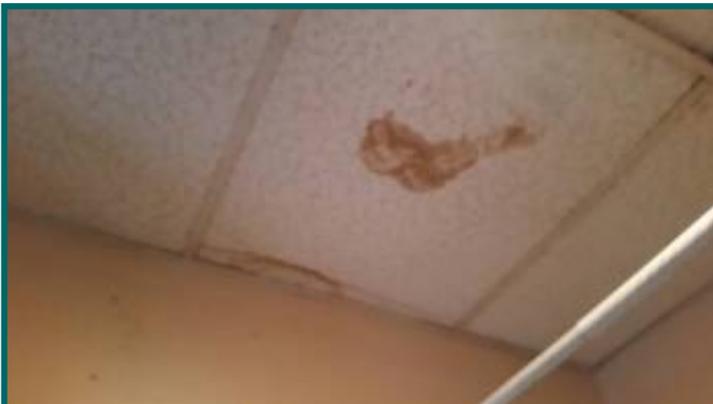
water staining tested drive unit 4 bathroom

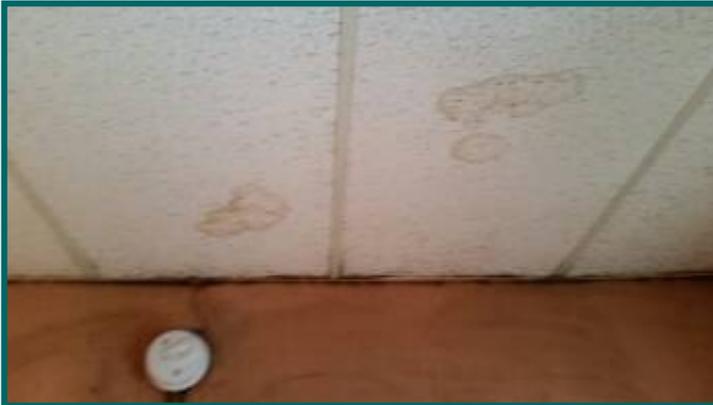
ceiling stains unit 6

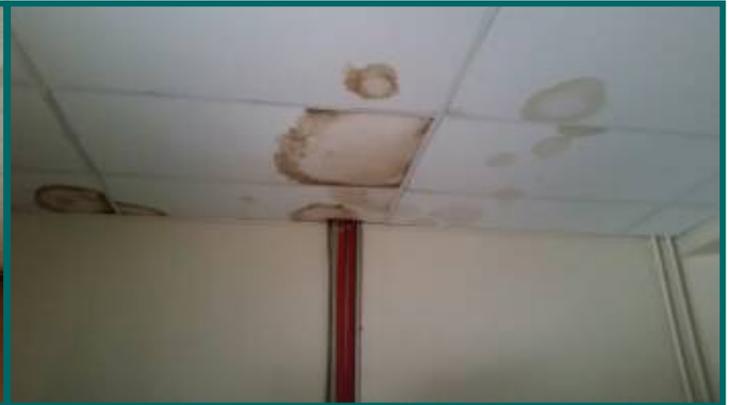
unit 3 bedroom ceiling stain

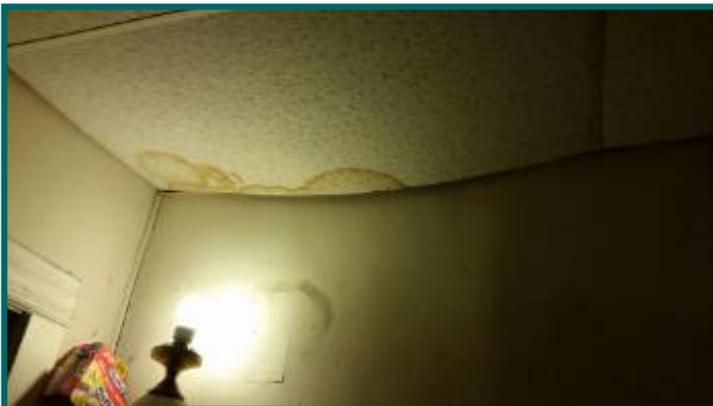
unit 1 ceiling stains

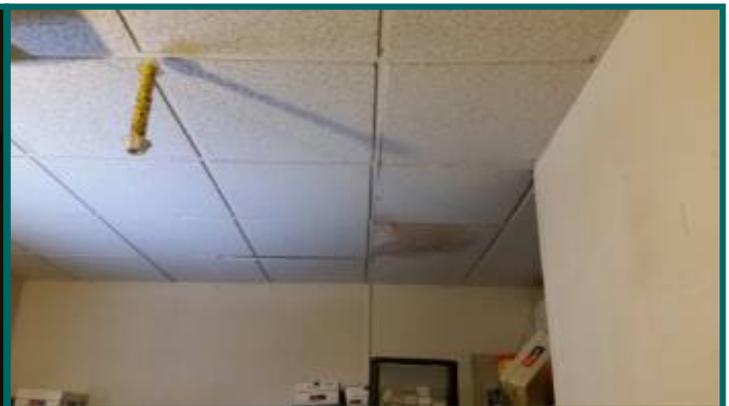
ceiling stain unit 1 bedroom

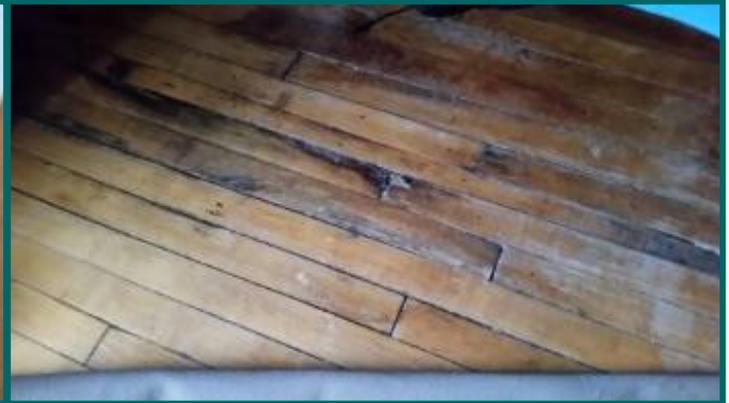
unit 3 floor damage in bedroom safety concern

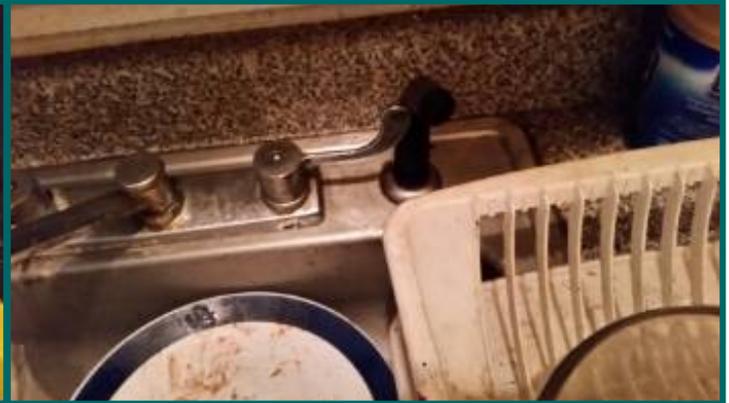
deterioration to faucet fixture damage spray wand
unit 9

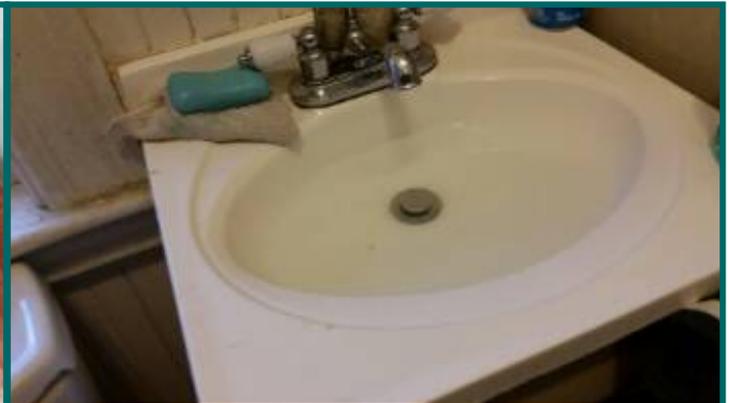
unit 11 slow drain bathroom sink

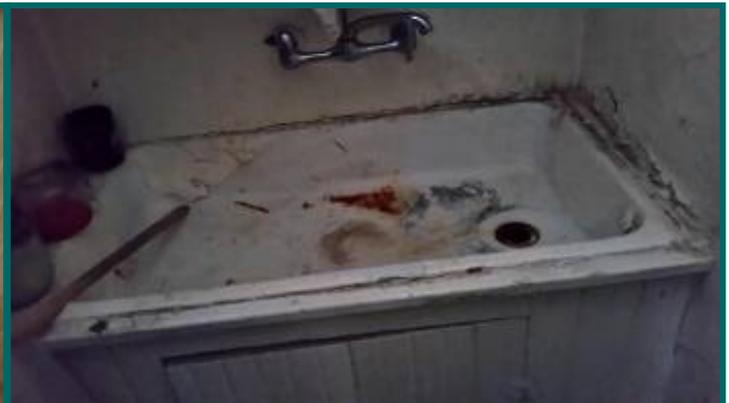
kitchen sink unit 6 damaged surfaces staining

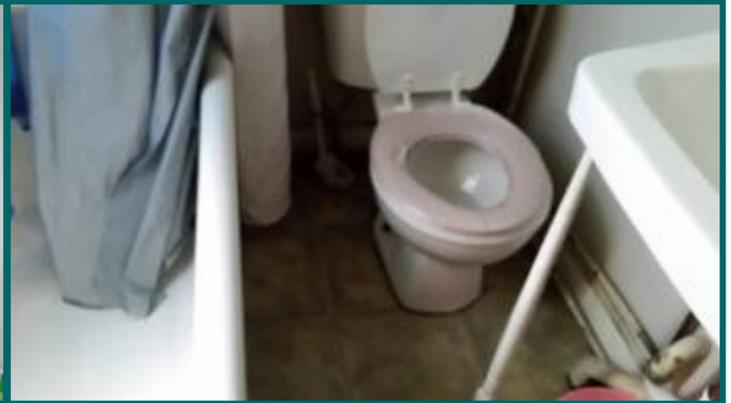
loose toilet unit 7

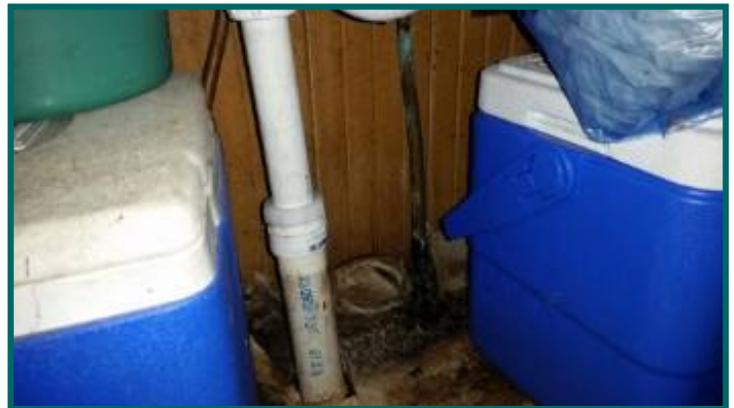
leak unit 1 kitchen sink

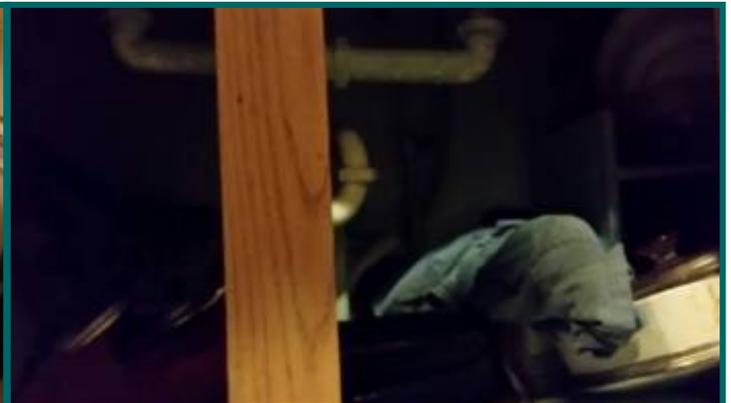
leak unit two kitchen sink

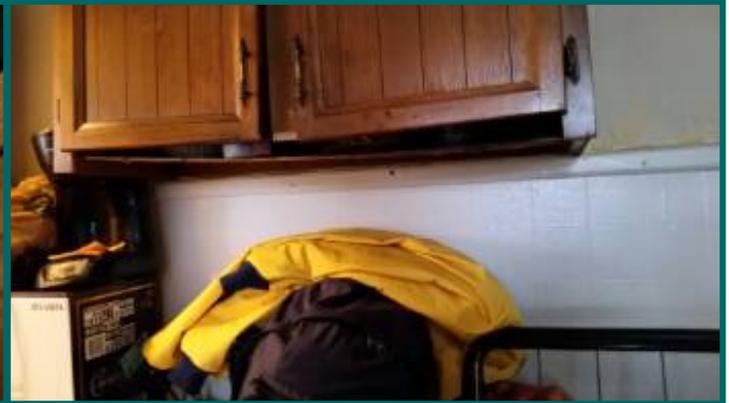
unit 11 kitchen cabinet damaged

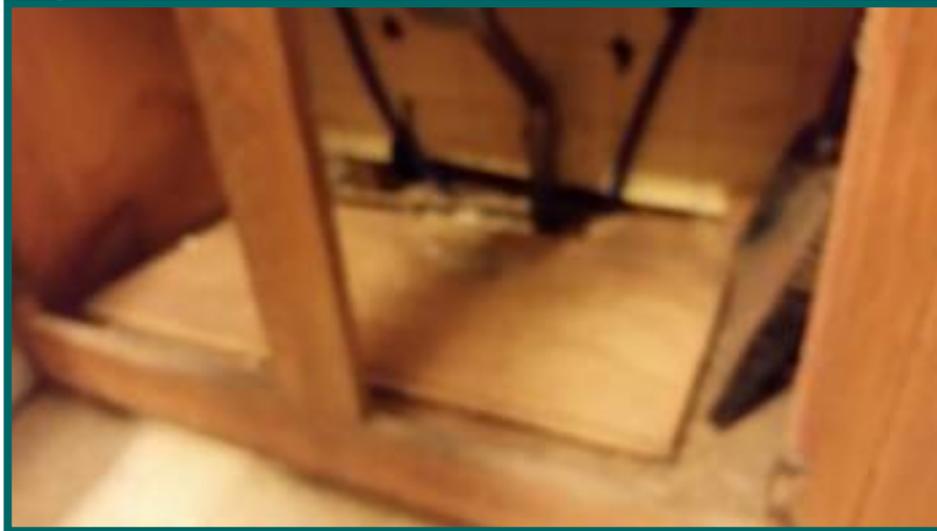
damage bathroom cabinet unit 1

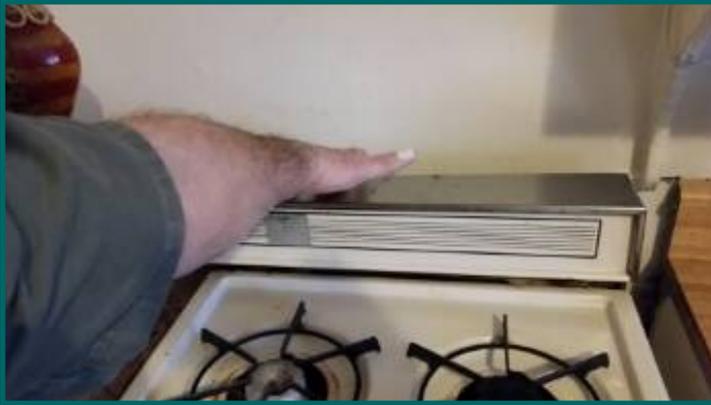
10.3. Oven is missing anti tip bracket, recommend installation of anti tip device to prevent stove from tipping over and causing injury

most ovens are missing anti-tip device

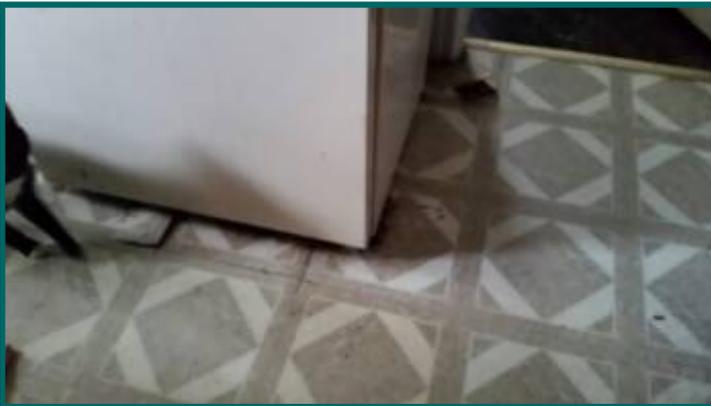
10.2. Refrigerator has crack in door gasket, water leak, recommend repair by a qualified appliance repair company.

unit 11 refrigerator has water leak on

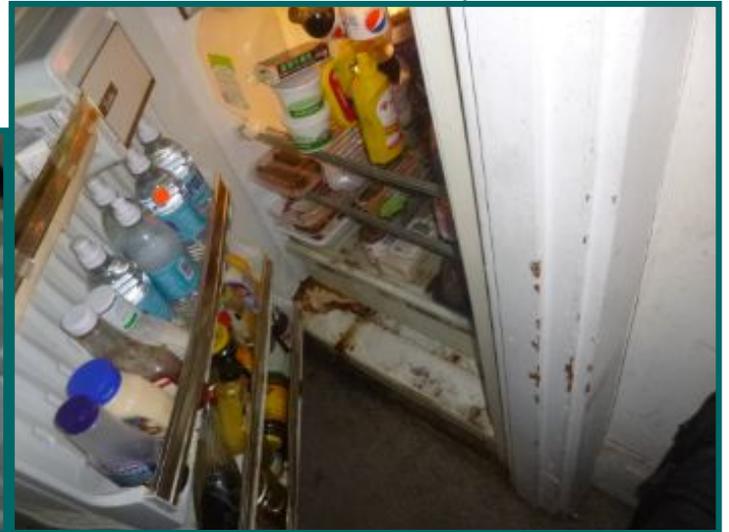
Dirty conditions apartment 1
