Alpha Home & Commercial Building Inspections

Property Inspection Report

Sample 25,000 SF Bed & Breakfast, NH 03846
Inspection prepared for: Sample Client
Real Estate Agent: -

Date of Inspection: 1/8/2015 Time: 9:00 AM
Age of Home: 2002 Size: 24500
Order ID: 1920

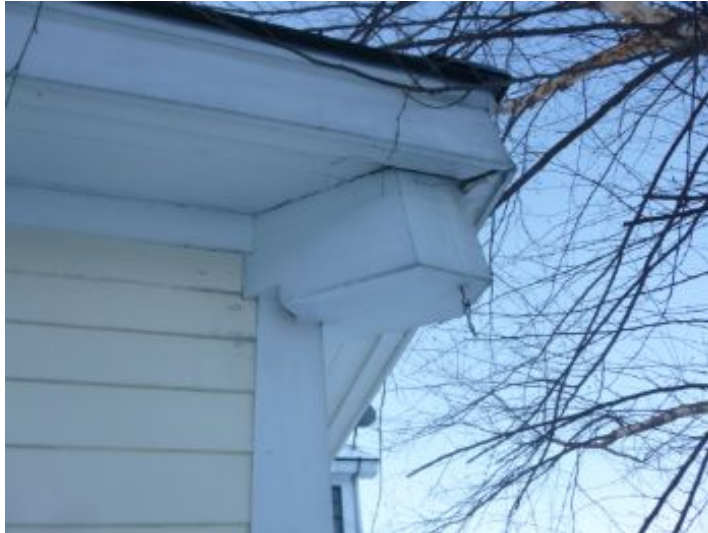
3.2. Vegetation such as trees, shrubs and/or vines are in contact with or less than one foot from the structures exterior. Vegetation can serve as a **conduit** for wood destroying insects and fungal growth and may retain moisture against the exterior after it rains. Vegetation should be pruned and/or removed as necessary to maintain a one foot clearance between it and the structures exterior.

Trees in contact with rear surface of building.

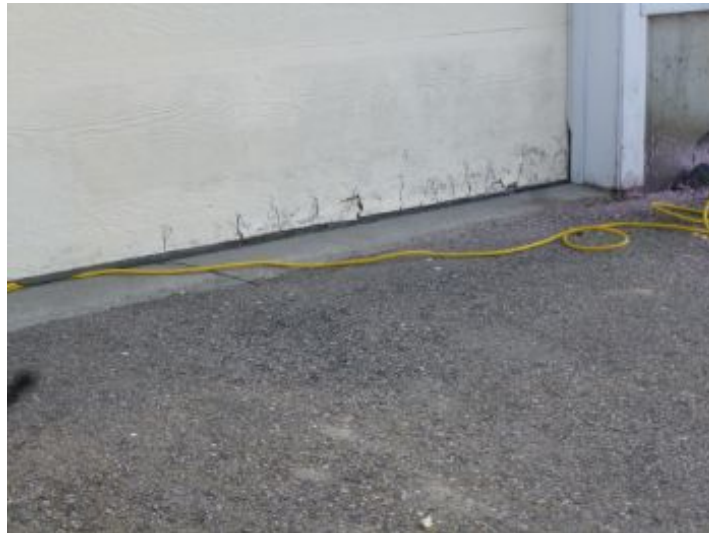
1.2. Over head garage door has water damage to bottom surface. Recommend monitor for further deterioration and repair by a qualified over head door company as needed.

Deterioration to lower overhead door at rear of building.

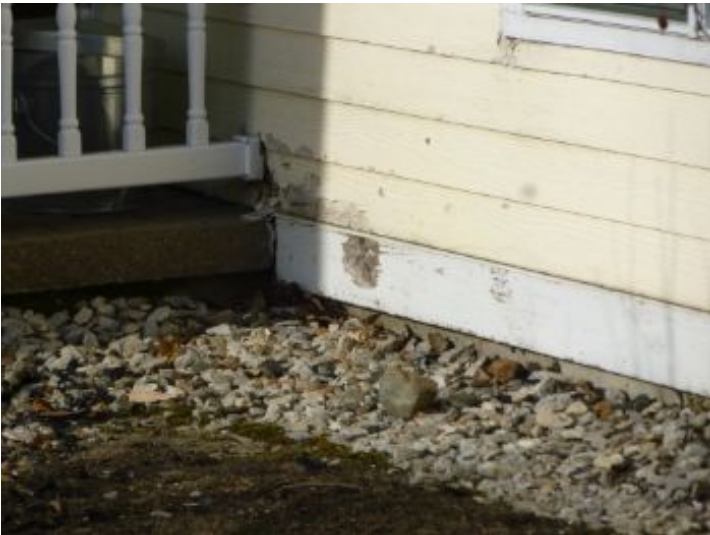
2.3. Some areas of exterior surface are composite board siding which when dented or damaged or in contact with plants can swell and become water damaged. There are areas of damage and swelling along lower rows of siding or at roof to wall transition, many areas need scraping and painting. Recommend further investigation and repairs by a qualified contractor.

Deterioration to composite board siding at front building surface.

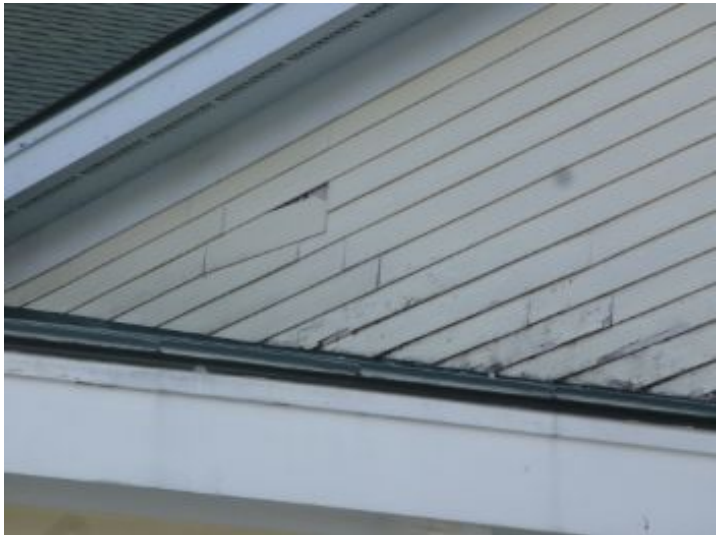
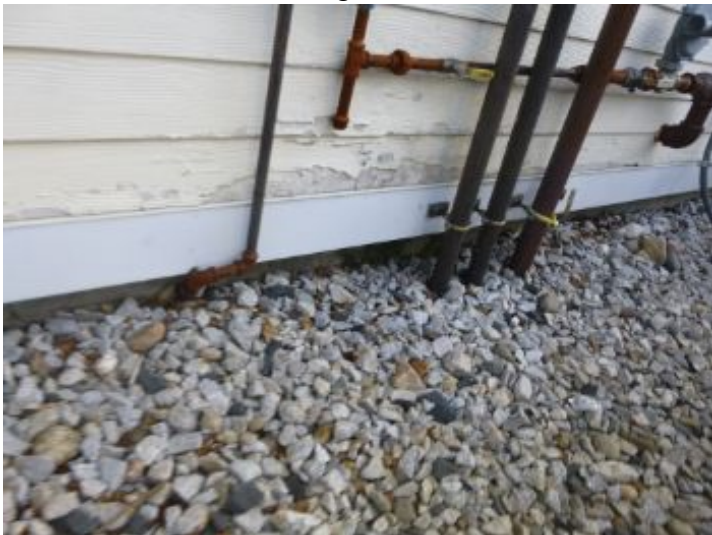
Peeling paint deterioration to siding at rear building surface.

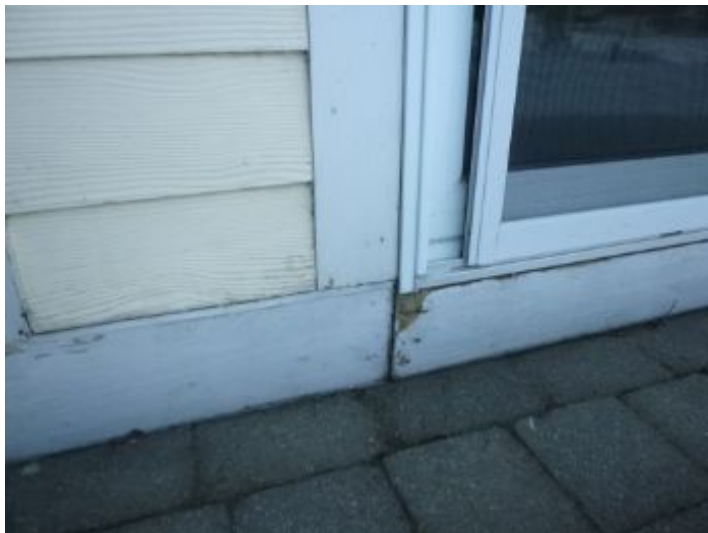
Damaged trim and siding at exterior wall of pool room.

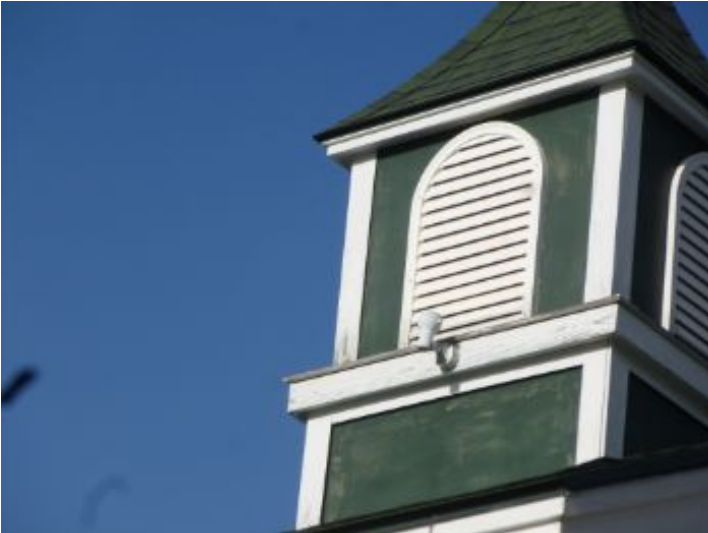
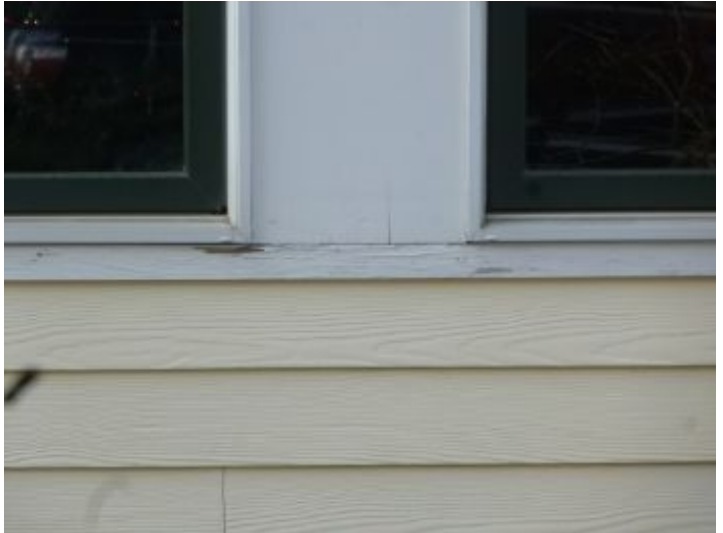
3.1. Peeling paint observed on siding and trim, suggest scraping and painting as necessary.

Peeling paint at front surfaces.

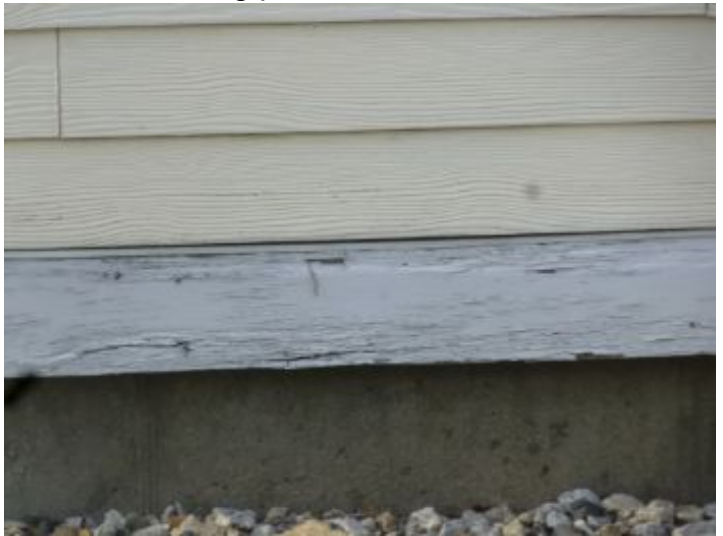
Peeling paint at front surfaces.

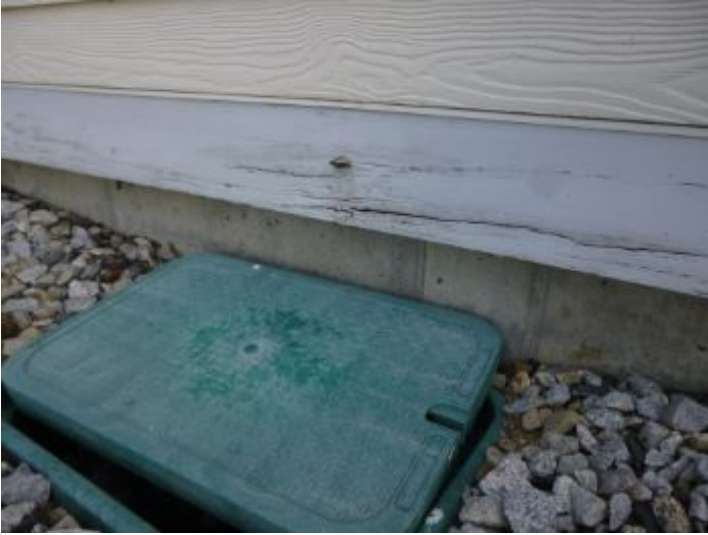
5.1. Trim boards have areas of damage and or deterioration, recommend assessment and repair by a qualified contractor.

Damaged lower trim at rear building surface.

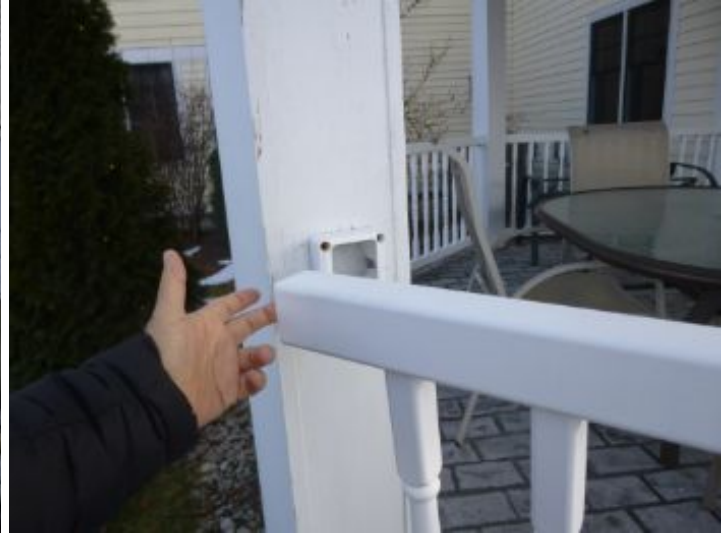
Damaged hand rail at rear of building.

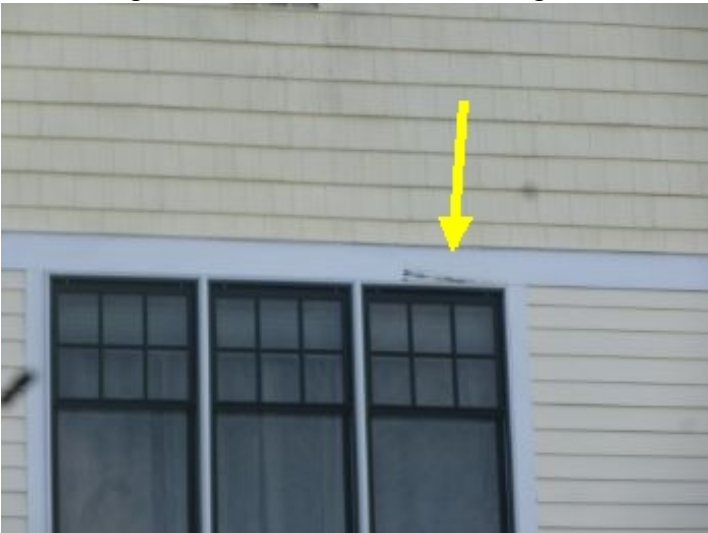
Damaged trim over rear window.

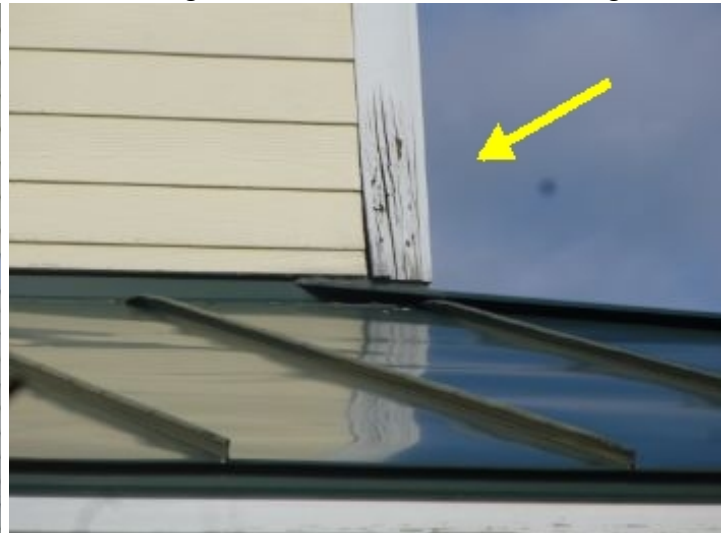
Damaged trim at left side surface.

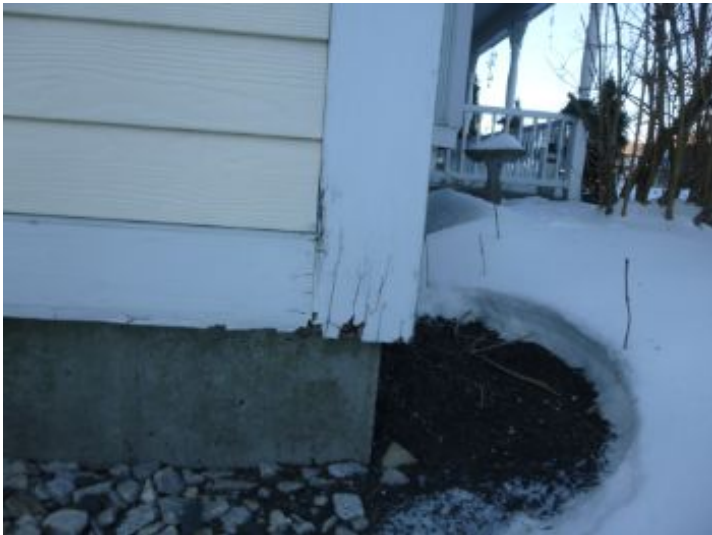
Damaged trim at front of building.

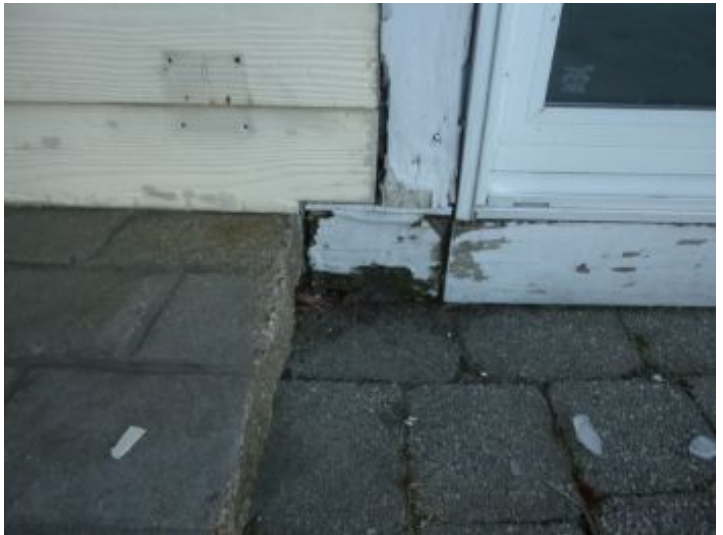
Damaged trim and siding at exterior wall of pool room.

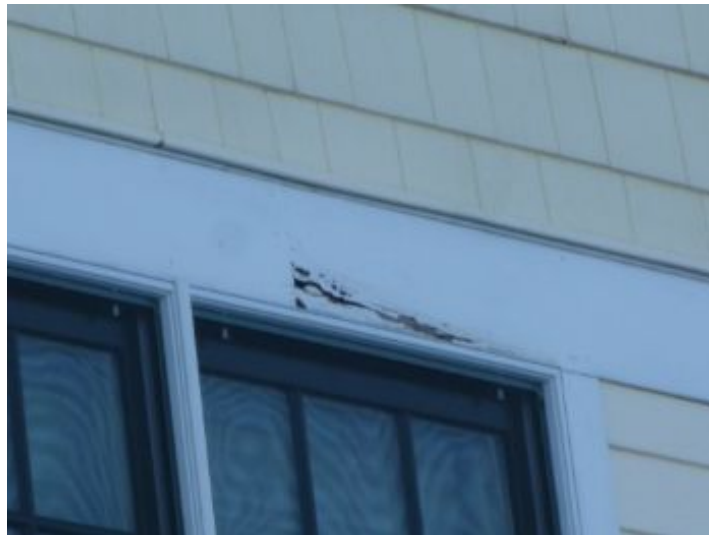
Damaged trim over rear window.

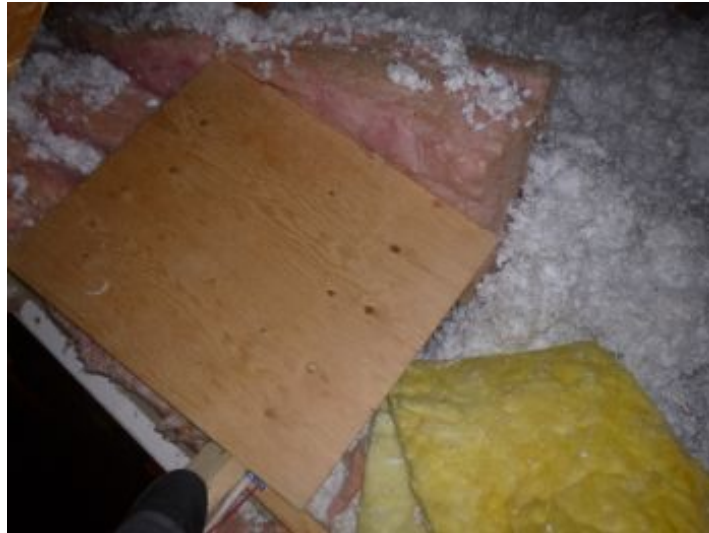
1.2. Recommend insulating the back of attic access cover to reduce **condensation**, heating and cooling costs

Scuttle covers should be insulated.

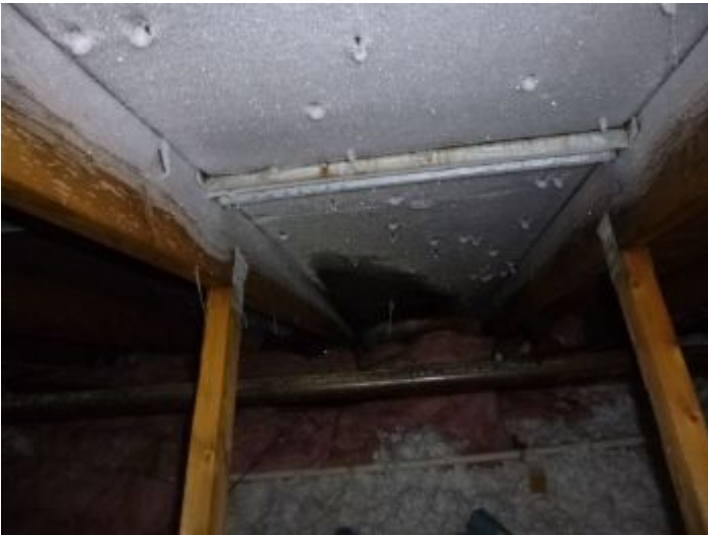
2.4. Water staining on attic sheathing, wet / leaking at time of inspection. It appears the mechanical **chase** for the pool venting equipment may be bleeding warm air into attic causing condensation.

2.5. There is frost on nails at roof sheathing and or on sheathing. This is caused by condensation and is an indication that there are high levels of moisture in attic and more attic ventilation or insulation would be beneficial. Recommend full assessment and repairs by a qualified contractor.

Frost , staining, wet surface at maid closet attic area

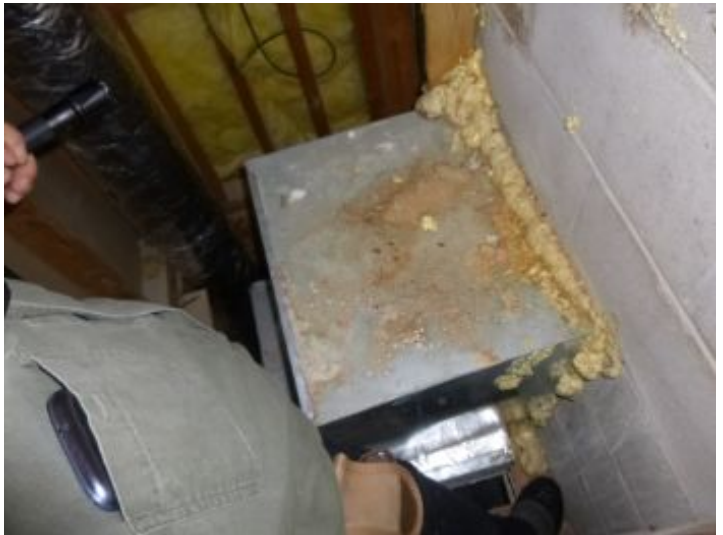
Mechanical chase for pool ventilation equipment, appears to be causing moisture into attic.

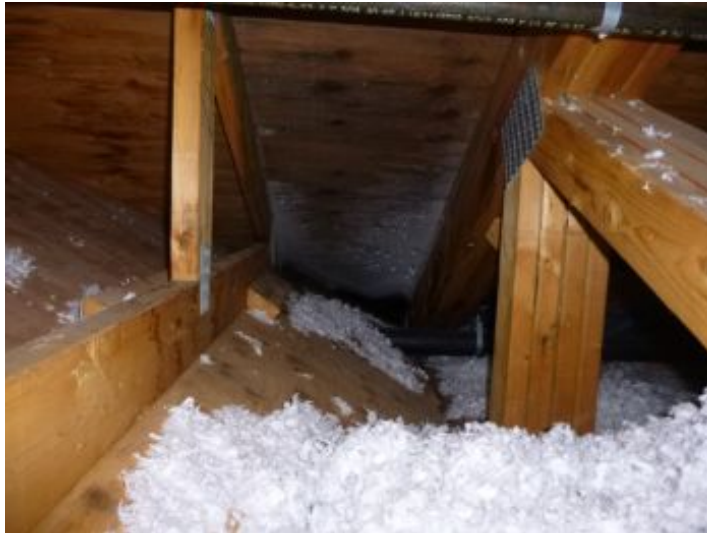
Frost , moisture staining on attic above owners quarter.

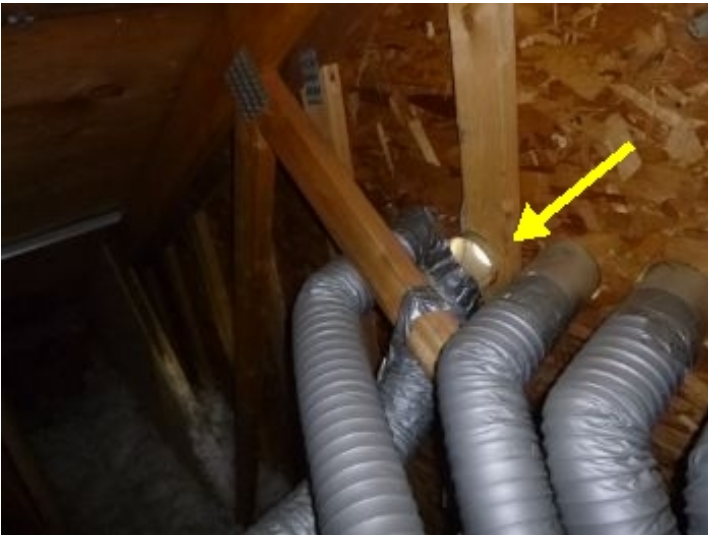
3.3. Bath fans venting is damaged in one or more area and venting directly into attic. This can cause condensation, staining and fungal growth on attic framing as well as be a contributing factor to ice damming. Recommend repair properly terminating bath fans to exterior of building by a qualified contractor.

Damaged bath fan termination at middle hall attic area.

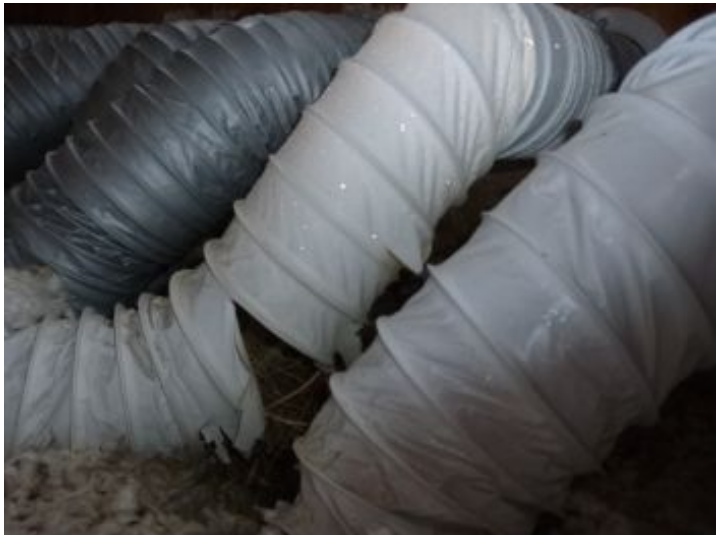
Damaged bath fan vent, nesting in vent, at maid closet attic area.

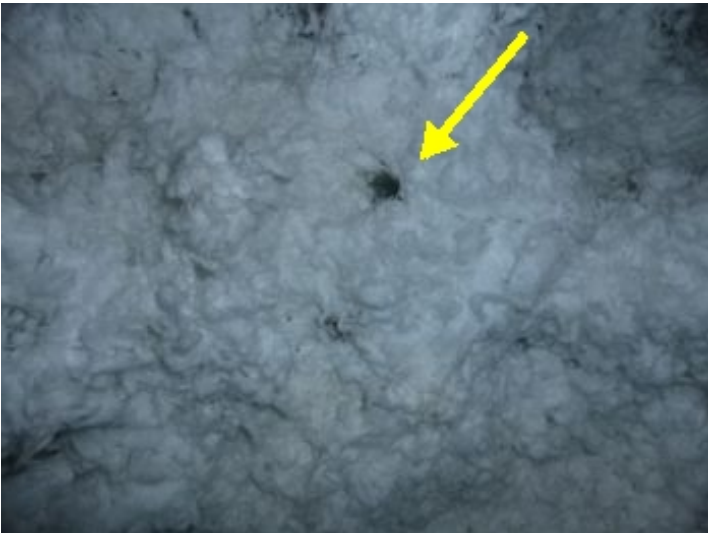
4.1. Rodent activity observed in the attic. Vermin can damage insulation & electrical wiring. Recommend a professional pest contractor evaluate for treatment.

Rodent tunnels.

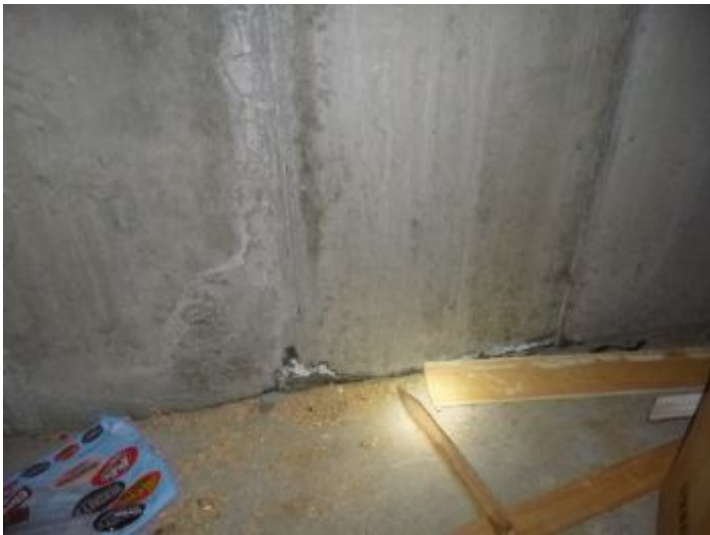
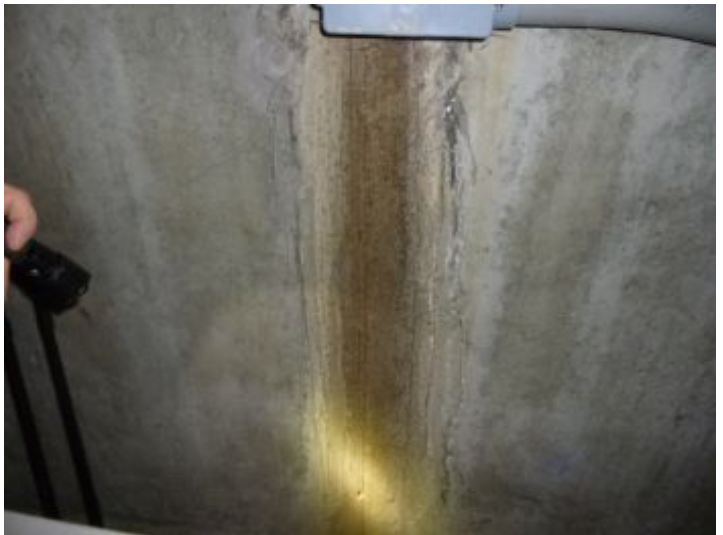
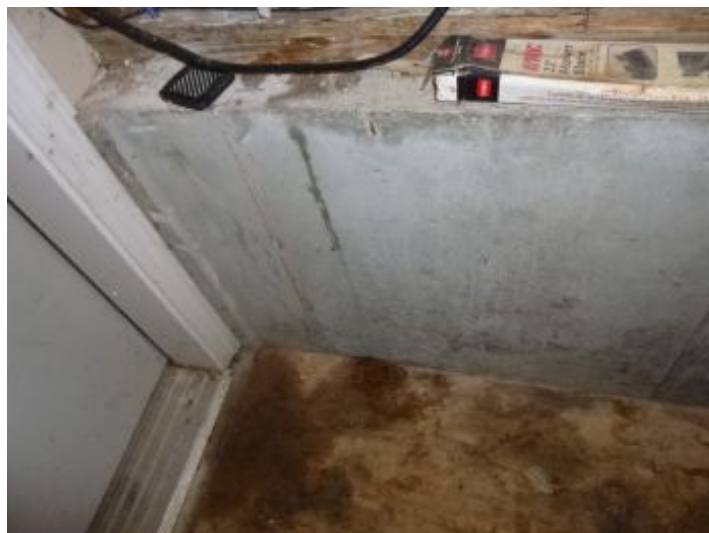
1.4. Areas of streaking / staining on walls, this is evidence of past or present water intrusion. It was reported that during conditions of heavy rain, water leaks into back wall and has to be pumped out, recommend assessment and repairs as needed to prevent water intrusion into the building by a qualified contractor.

Water on wall at rear basement door.

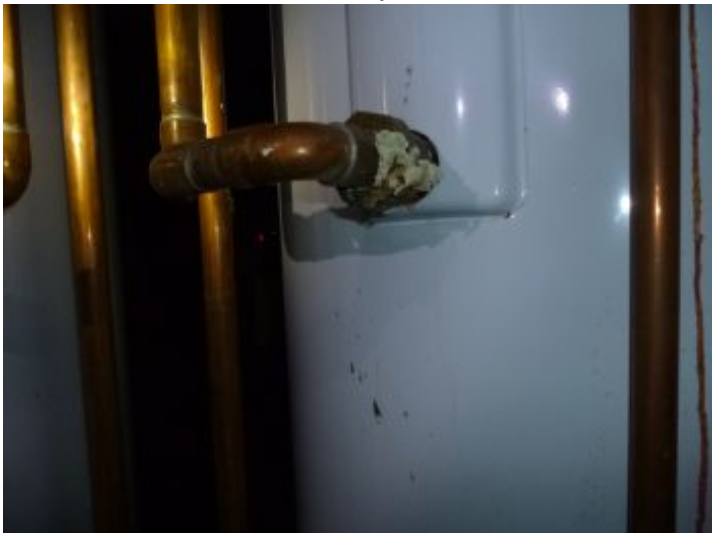
1.3. Corrosion on water heater fittings and cabinets noted, recommend monitor for further signs of water and repair by a licensed plumber as needed.

Corrosion on fitting.

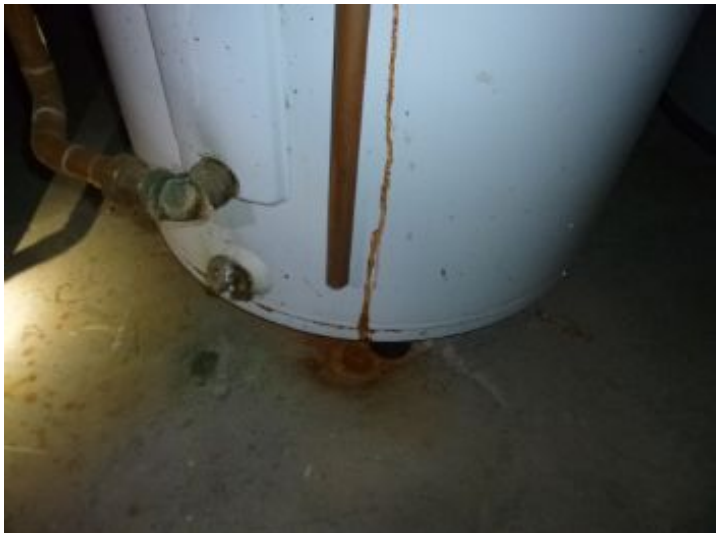
Staining on cabinet.

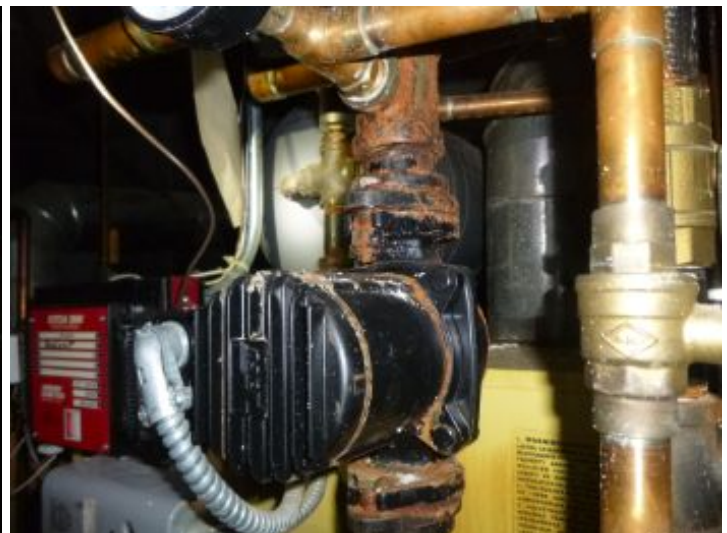
Some staining on boiler fittings.

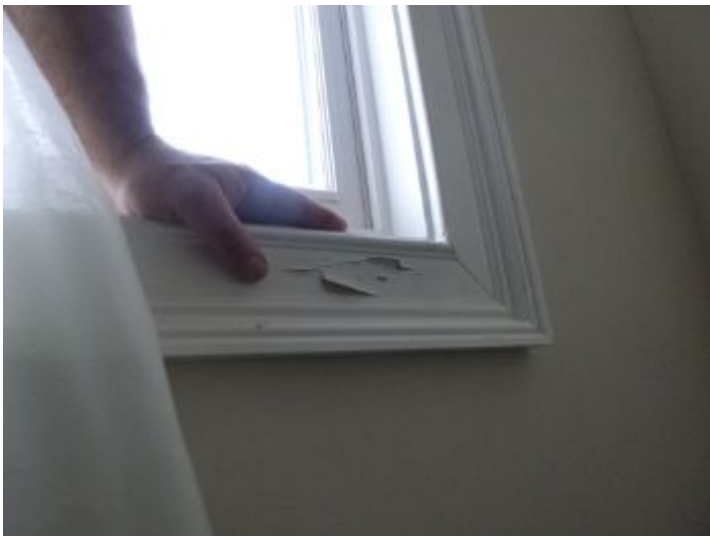
Peeling paint guest room window.

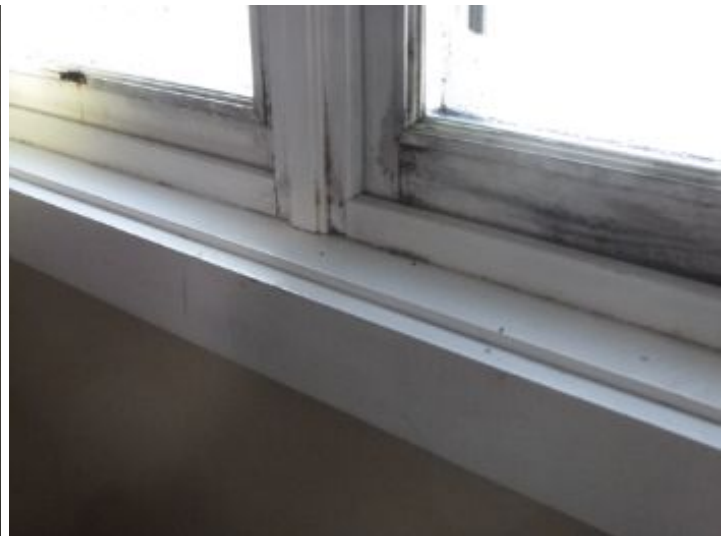
2.3. There are areas of significant condensation on window surfaces. Dark staining on window at one or more location that appears to be mold-like bio growth. Recommend cleaning or replacing any affected areas, professional testing & evaluation may be advised.

Condensation , staining on pool room windows.

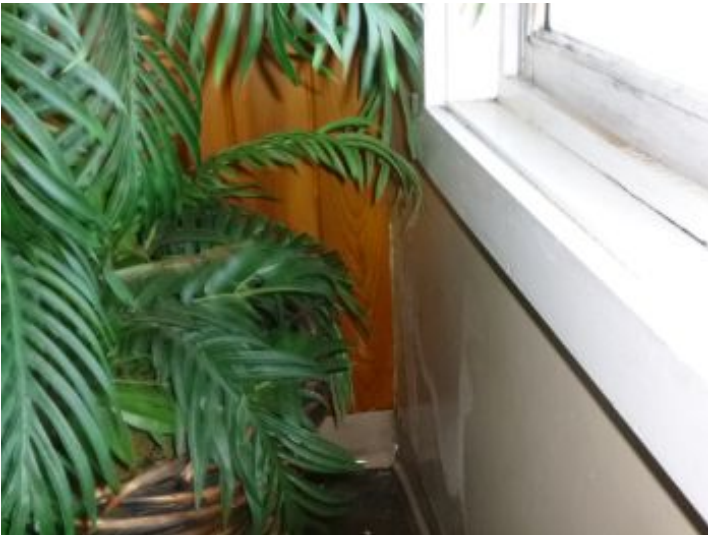
Condensation , staining on pool room windows.

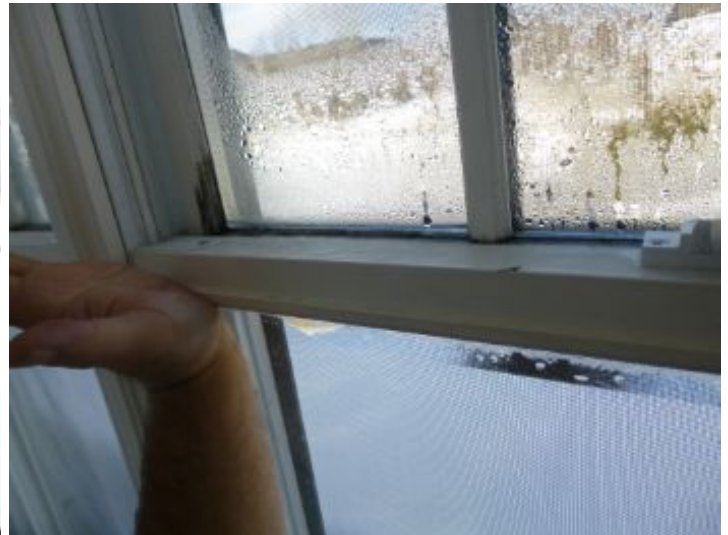
2.2. Window is sealed closed at one or more areas of building. Recommend assessment of windows and repairs by a qualified tradesman.

One or more window in owners apartment would not open during inspection.

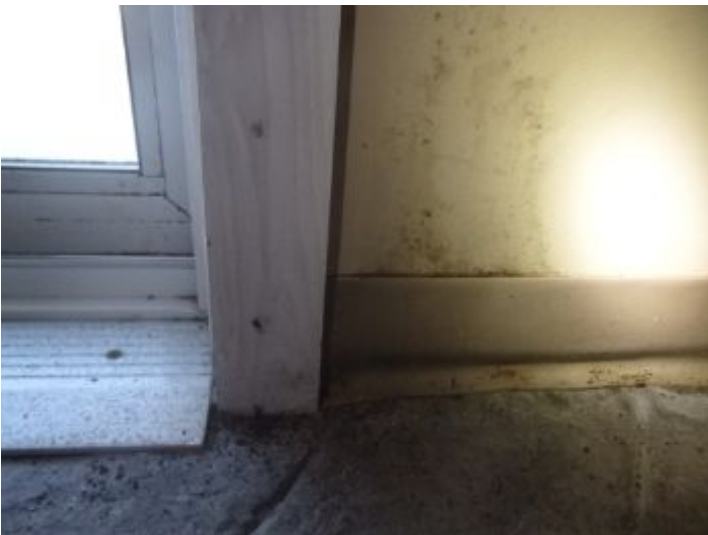
3.2. Damage and or elevated moisture levels to wall and ceiling surfaces at one or more areas, mainly in the pool room. Recommend assessment of the pool room surfaces, structure and dehumidification system by a contractor experienced with construction and repairs of indoor pool facilities.

High moisture, dark staining , deterioration to wall surface in pool room.

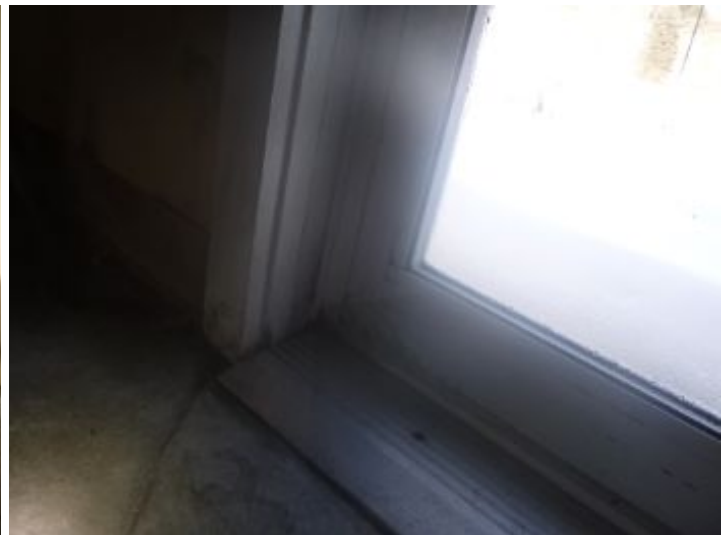
High moisture, dark staining , deterioration to wall surface in pool room.

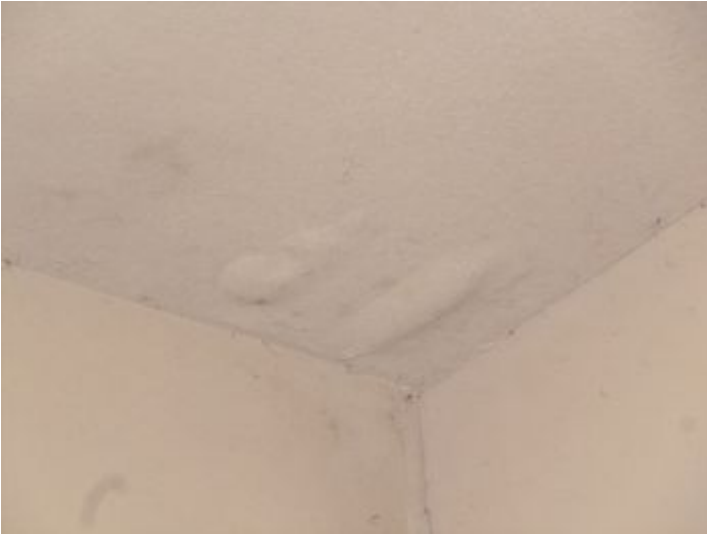
4.2. Stains noted at one or more area of the ceilings. This is evidence of past or present leaks. Most tested dry at the time of the inspection. Elevated moisture levels were observed in pool room. Source of all staining was not determined. Recommend repair and or painting of all affected areas and monitor for further water staining.

Blistering ceiling surface in garage bay,

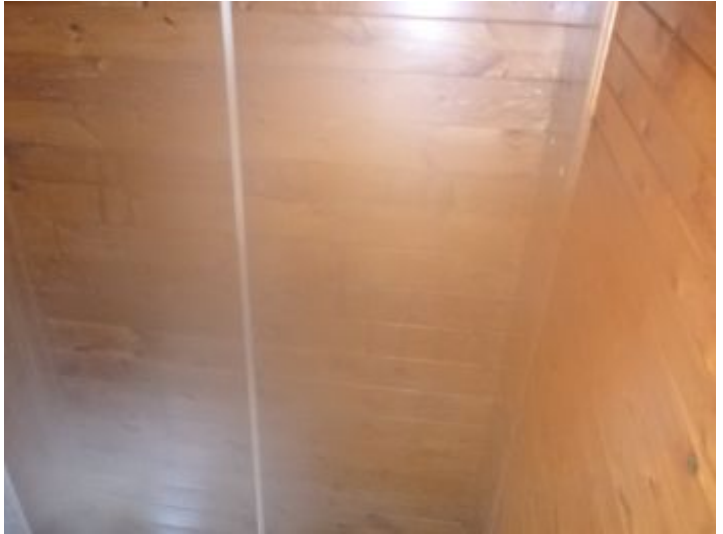
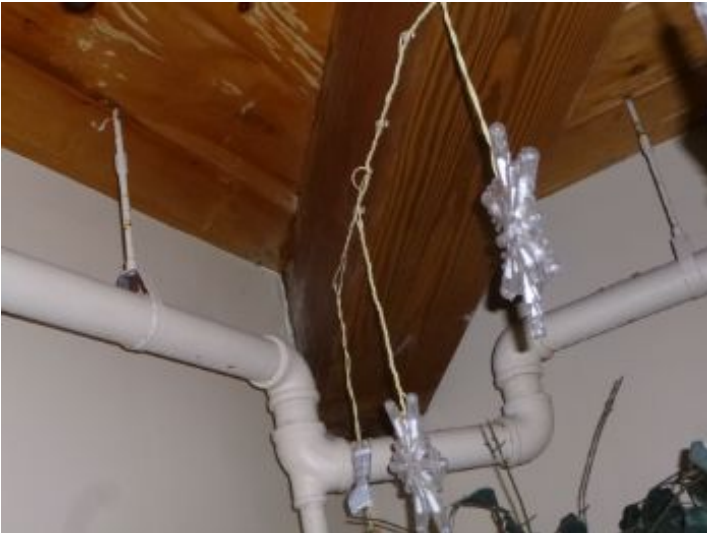
High moisture damage to ceiling panel boards in pool room.

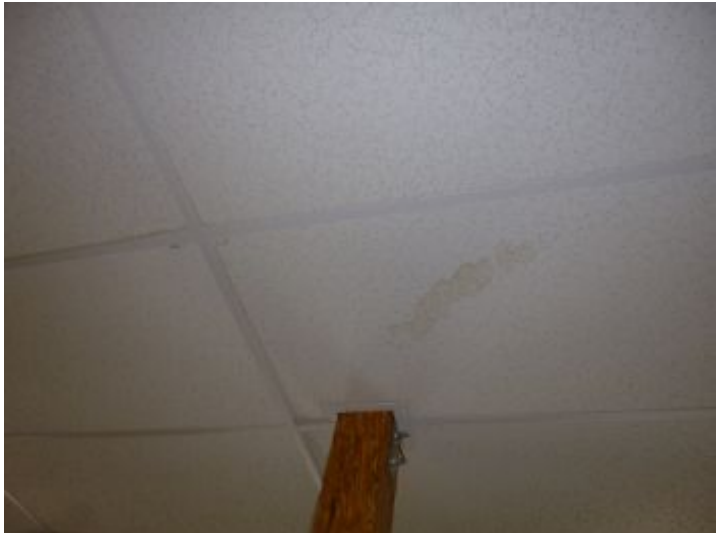
Stain in health club.

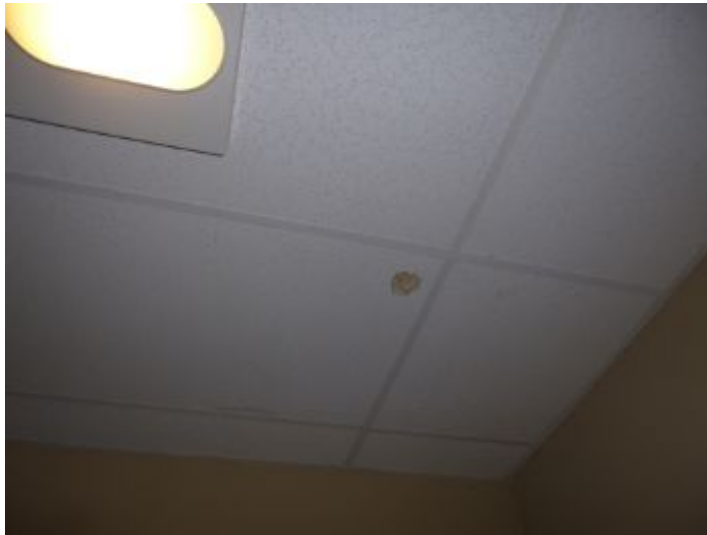
Stain in health club.

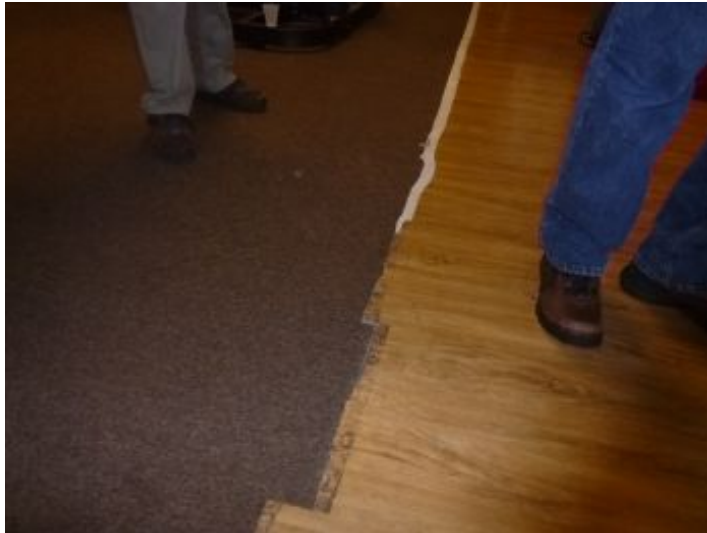
Laminate flooring in health club is loose, missing transition trim.

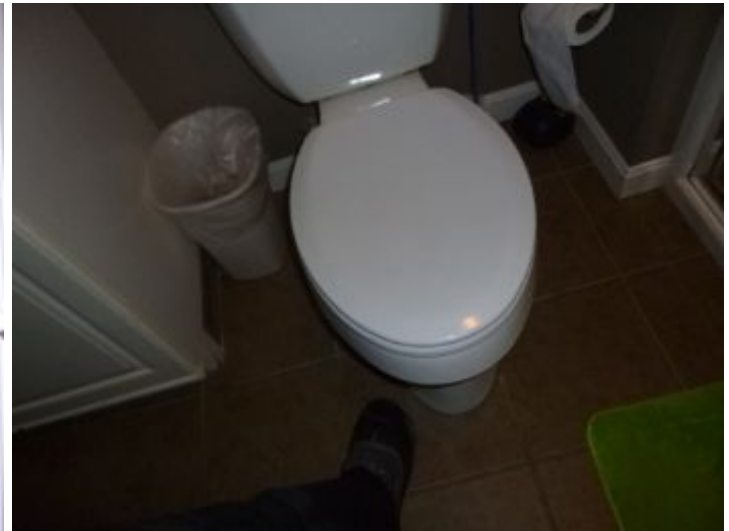
Loose toilet in owners quarter bath.

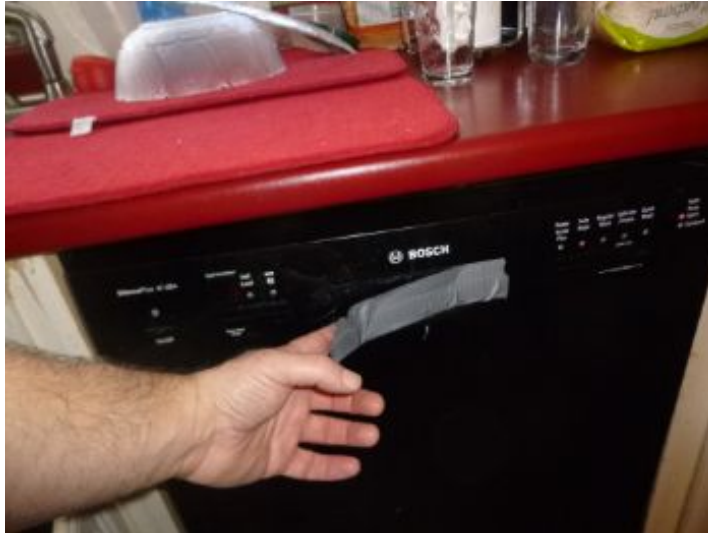
Damaged door at owners dishwasher was not operated.
