# Alpha Home & Commercial Building Inspections

## Property Inspection Report

Sample Garden Condo Portsmouth NH, Portsmouth, NH 03801

Date of Inspection: 8/14/2017 Time: 9:00 AM

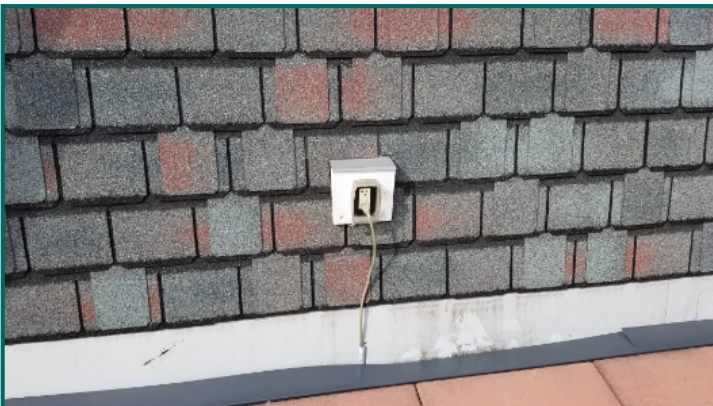
3.3. One or more exterior outlet has damaged or missing weatherproof cover, recommend repairs by a licensed electrician.

Missing weather proof outlet cover at upper deck

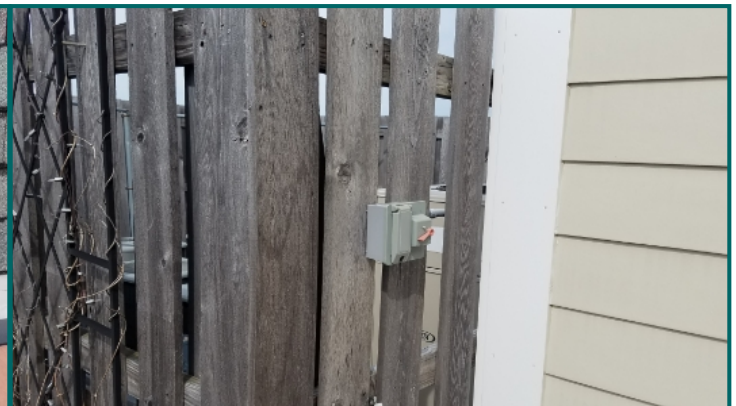
3.2. One or more switch has unknown function, recommend consulting the home owner for clarification on what they control.

Switch has unknown function at upper deck

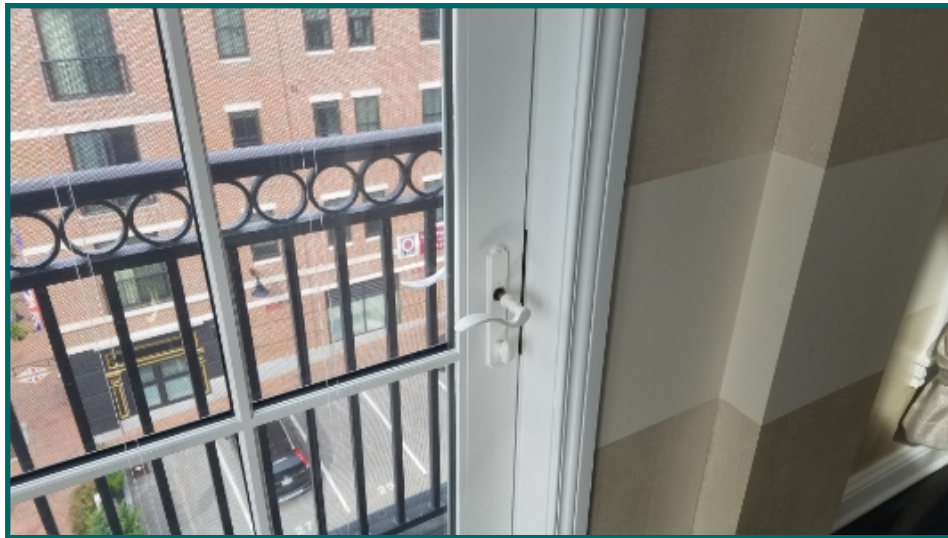
1.2. One or more door has loose or damaged door knob or handle. Recommend repairs by a qualified tradesman.

Loose hardware at living room area

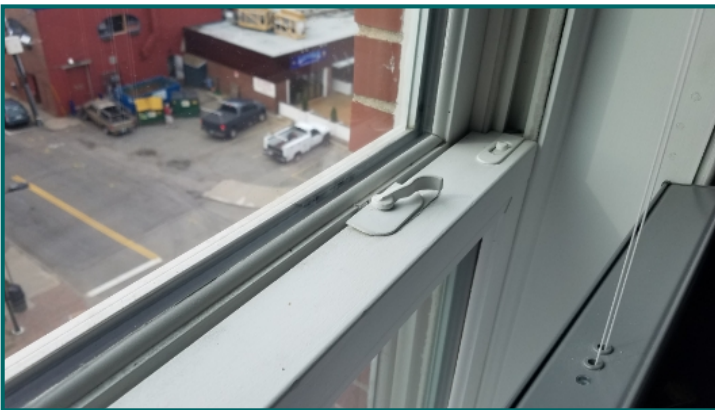
2.3. Windows at one or more area did not lock/latch properly, recommend repairs for enhanced security/safety to occupants.

Broken lock at kitchen area

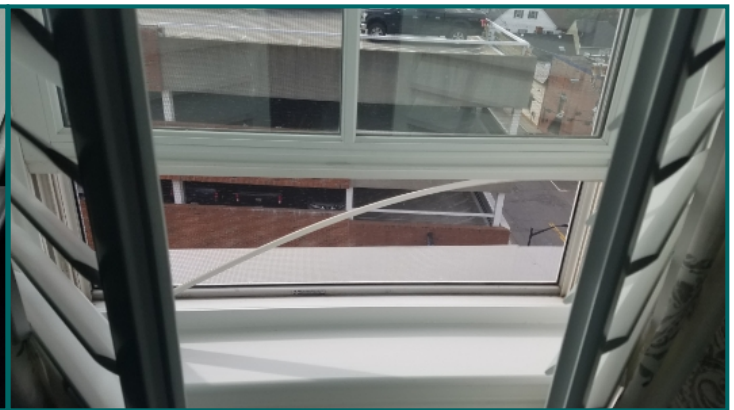
2.4. Windows have damaged weather stripping at one or more location. Recommend assessment of windows and repair by a qualified window contractor.

Damaged weather stripping at middle bedroom

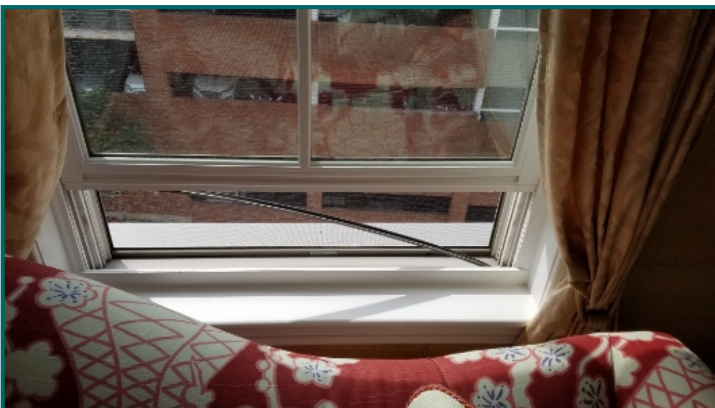
Damaged weather stripping at master bedroom

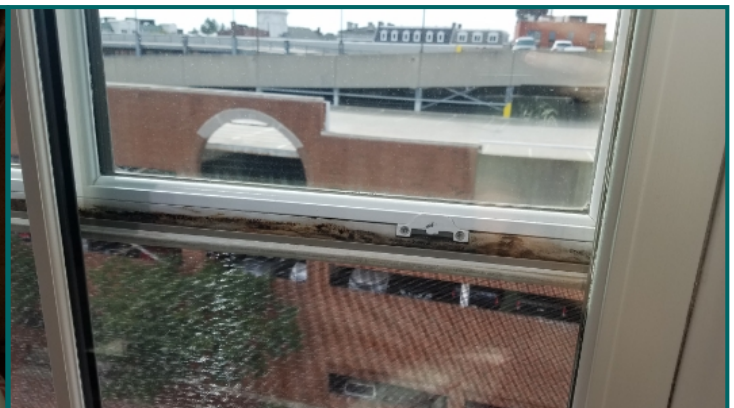
2.2. Window has moisture intrusion and / or wood damage to window or frame at one or more area of the home. Recommend assessment of windows and repairs by a qualified tradesman as needed.

Damaged sash at master bedroom

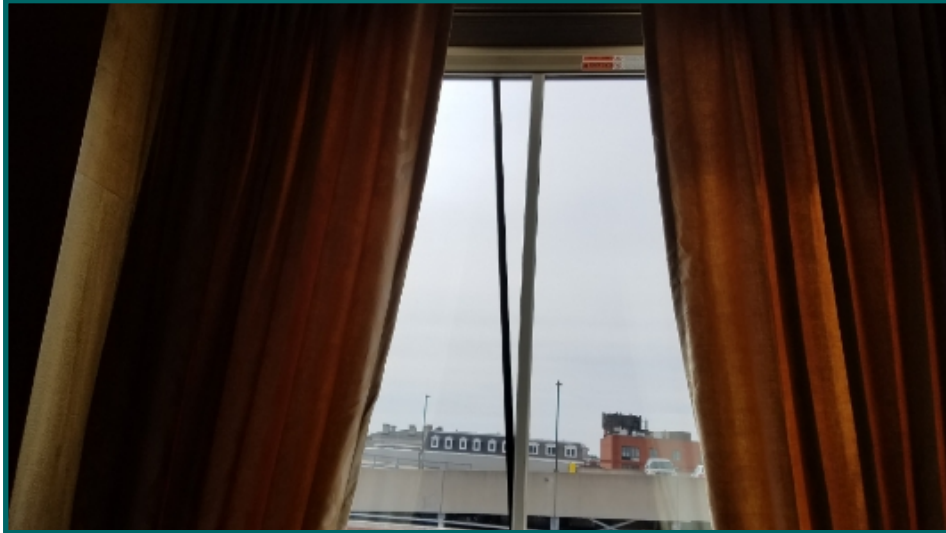
2.5. One or more windows have damaged gaskets, recommend repairs by a qualified window contractor.

Damaged gasket at master bedroom

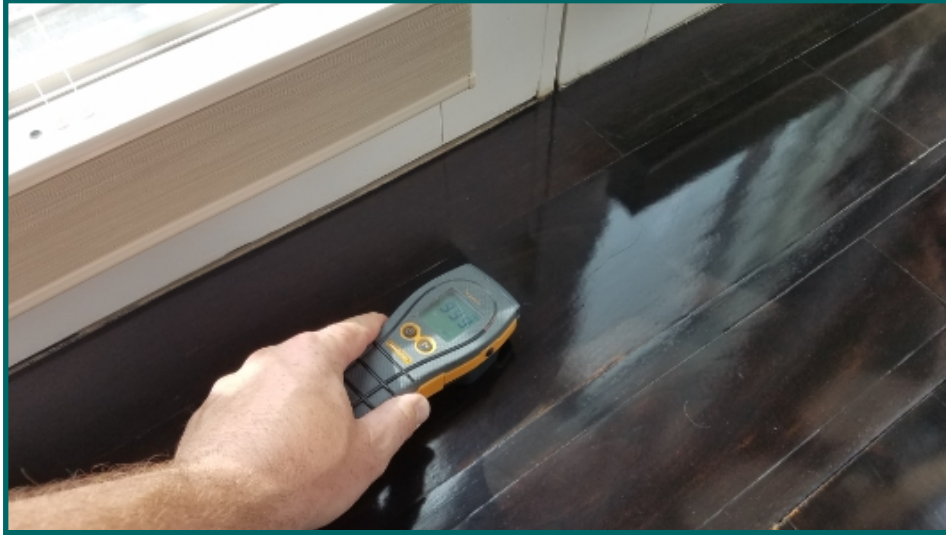
5.2. Elevated moisture levels detected at one or more area of the home, recommend asking current home owner for the source and history of any leaks or water intrusion and assessment and repairs of any affected areas by a qualified tradesman.

Elevated moisture levels at living room doors

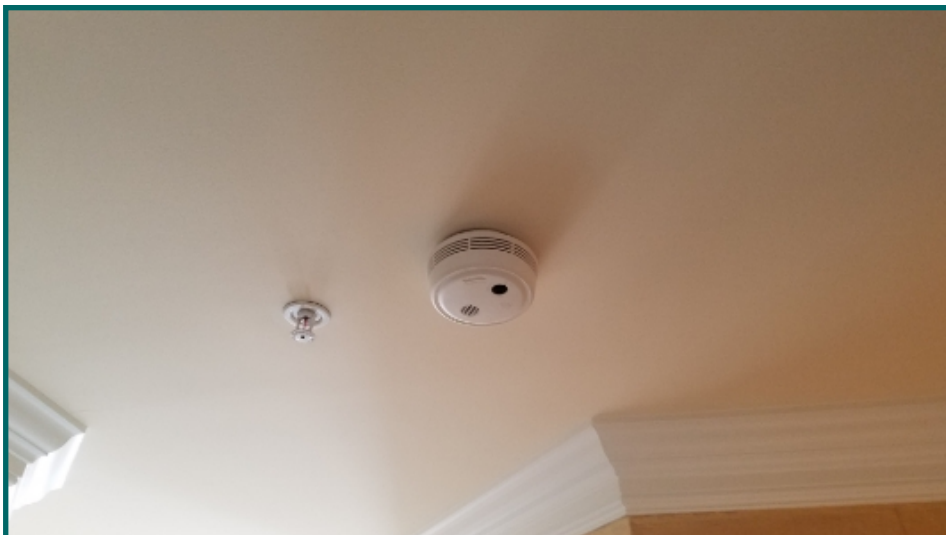
7.2. Smoke detectors were not tested, it was reported they may be tied to the security system, recommend testing on a regular basis by a qualified security company. Today's safety standard for smoke detectors is hard wired interconnected smoke detectors replaced every 10 years, one on each floor and one in each bedroom and one CO detector on each floor all interconnected. If battery operated smoke detectors are used the battery should be replaced and tested twice a year when clocks are changed. For more information, visit <http://www.cpsc.gov/cpscpub/pubs/5077.html>

Smoke detectors not tested.

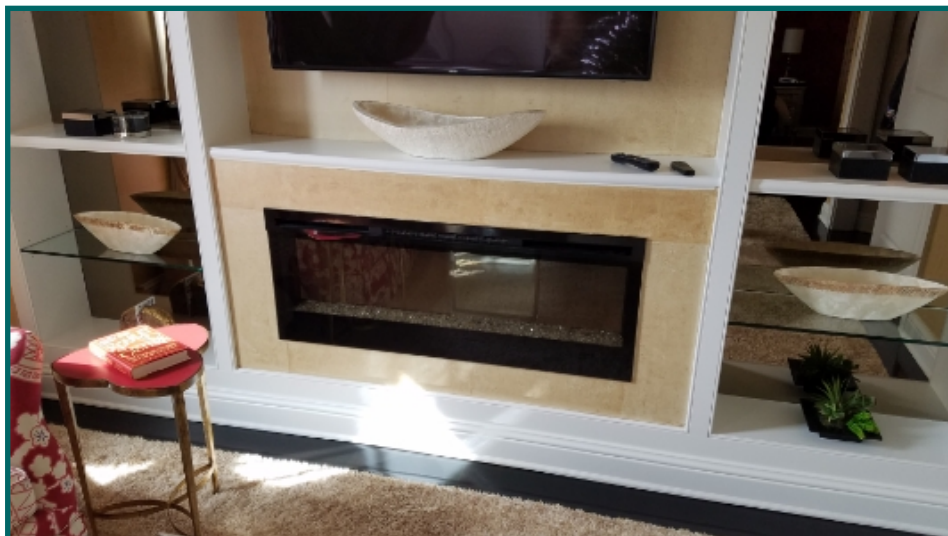
10.1. Electric fire places would not operate using normal controls, recommend assessment by a qualified appliance contractor.

Built in electric fireplaces did not operate when tested.

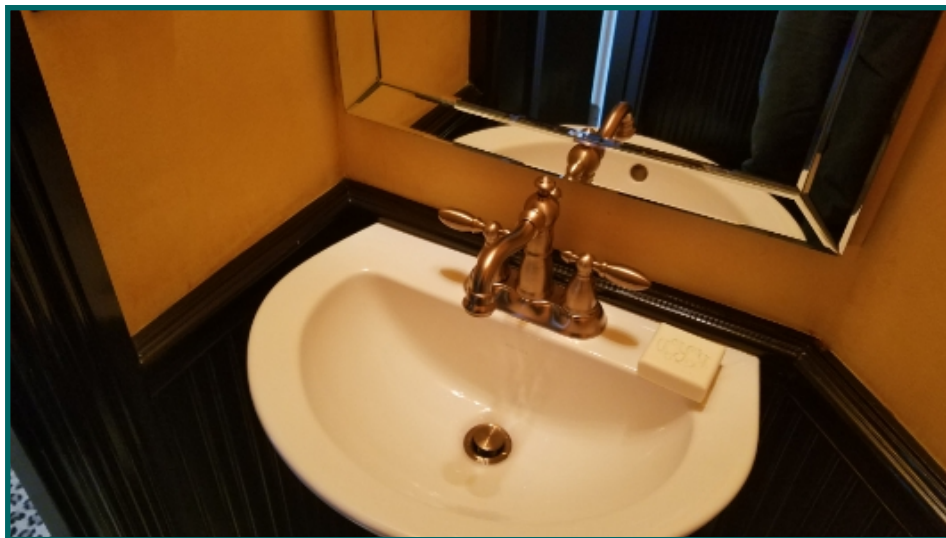
4.2. Sink stopper at one or more bathroom does not work properly. Recommend repair/replacement by a qualified plumber.

Stopper damaged at hall bathroom

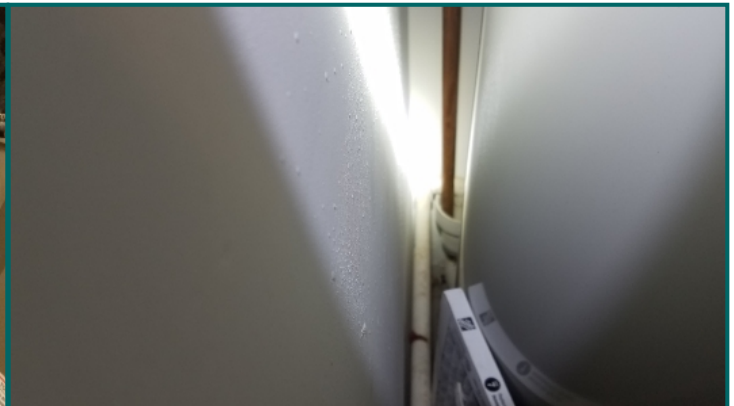
Condensate drain line termination behind water heater. Final termination was not located

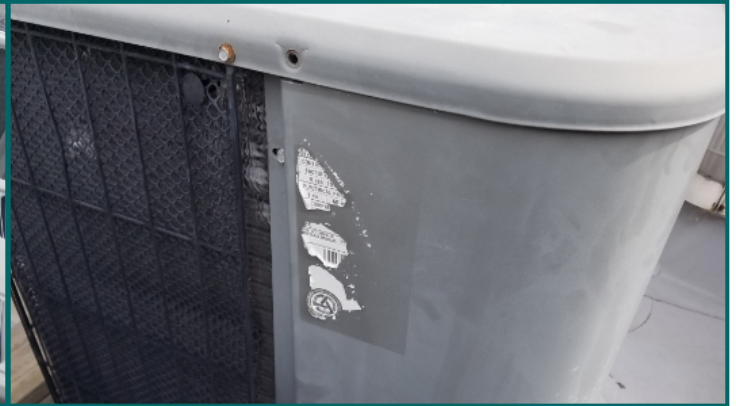
5.3. Compressor is approaching or beyond its design life, recommend monitor operation and full inspection and service by a qualified HVAC contractor as needed.

Data plate not legible

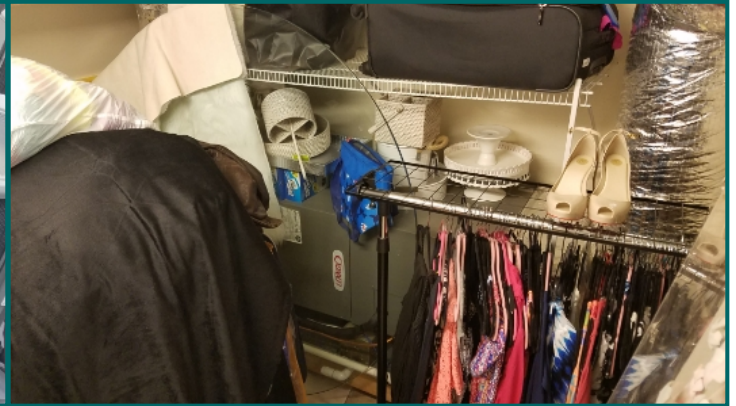
Second floor air handler providing conditioned air only. Limited inspection due to stored items.
