Alpha Home & Commercial Building Inspections

Property Inspection Report

Sample Townhouse , Hooksett, NH 03106

Date of Inspection: 11/30/2017 Time: 1:00 PM

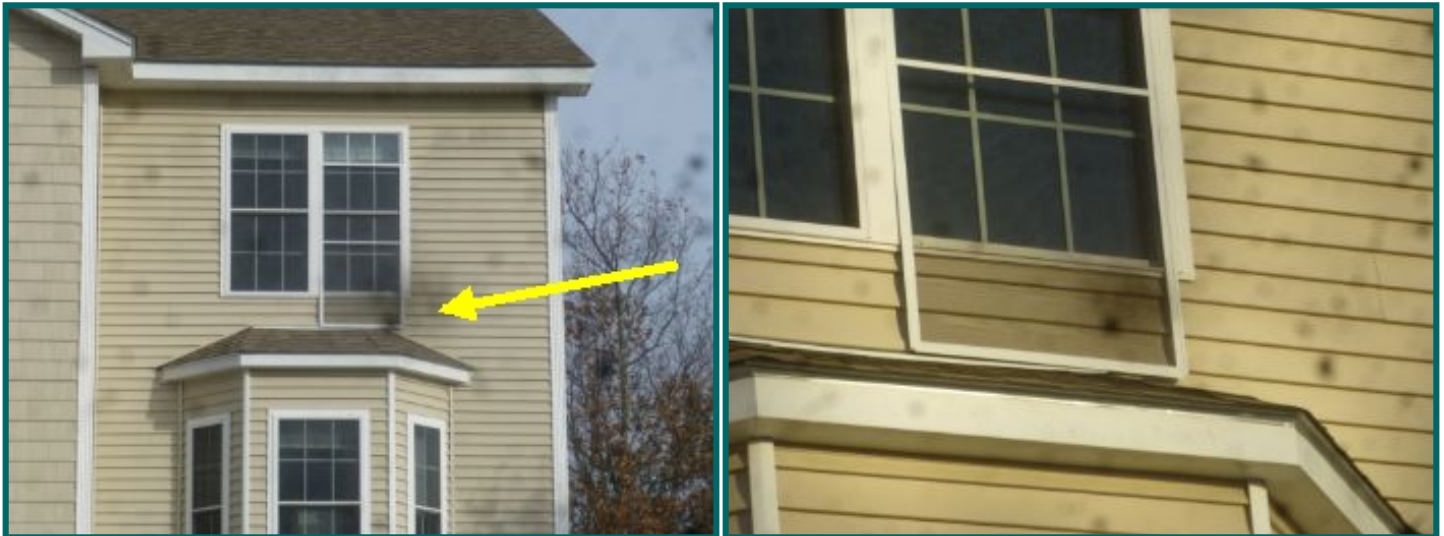
Loose or damaged screen at front window

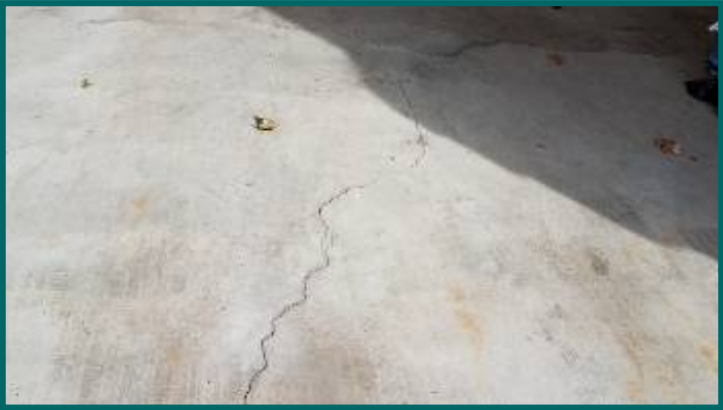
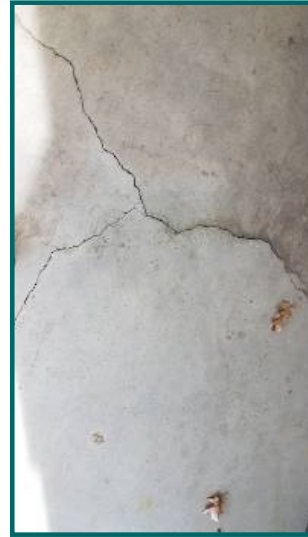
5.1. Typical settlement cracks noted, recommend monitor condition for further cracking and water intrusion and repairs as needed by a qualified contractor.

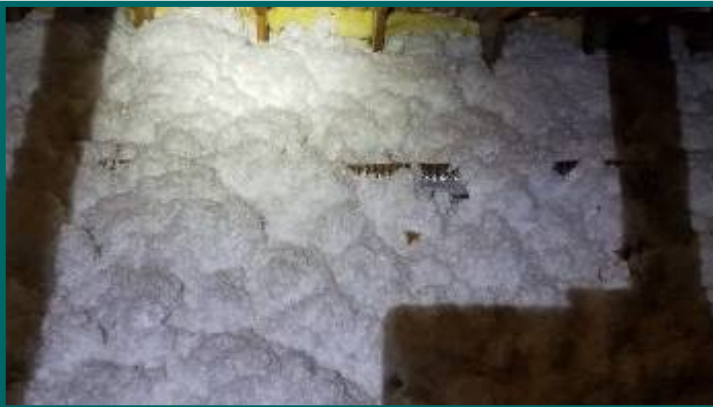
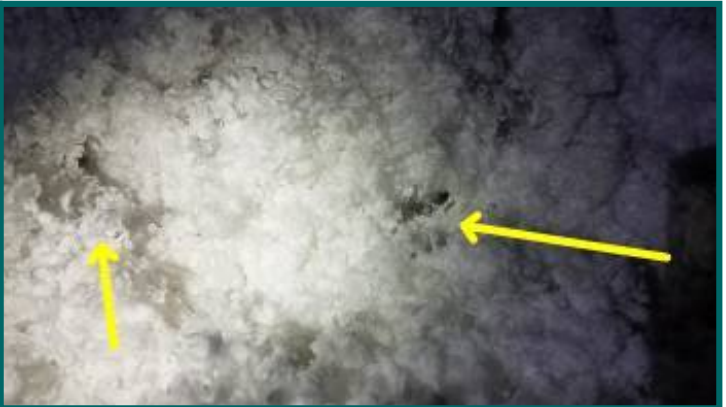
3.1. Rodent activity observed in the attic. Vermin can damage insulation & electrical wiring. Recommend a professional pest contractor evaluate for treatment.

Rodent tunnels

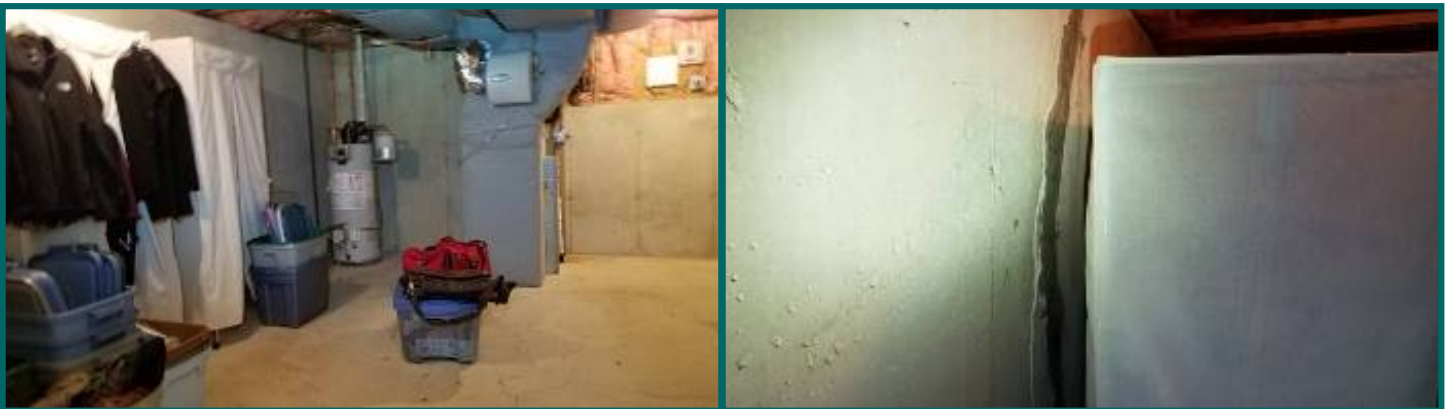
1.4. Vertical cracks with prior repair on one or more wall. recommend monitor for further movement and or water intrusion and sealing / repairs as needed.

repaired crack on rear wall

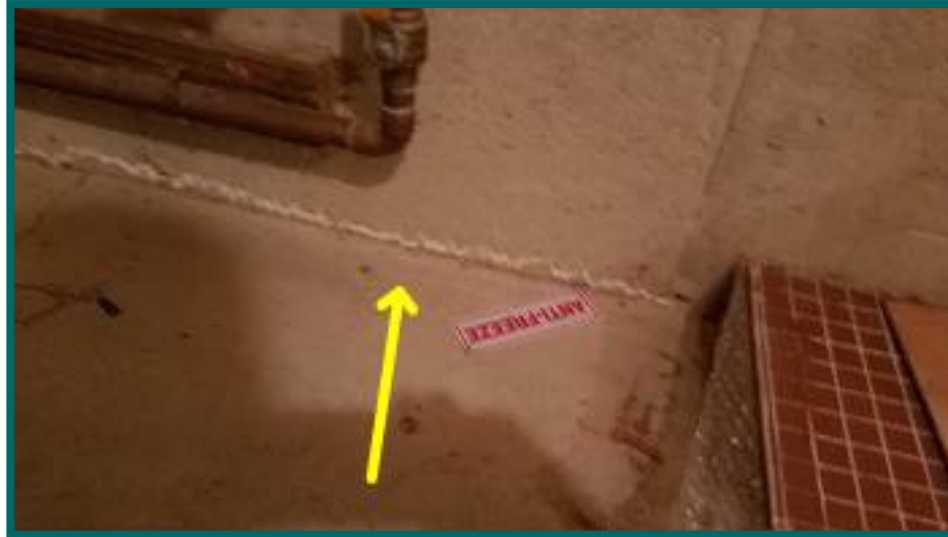
1.3. Areas of efflorescence on foundation wall, this is white hazing on wall surfaces, evidence of past or present presence of water. Recommend asking current home owner for the source and history of any leaks or water intrusion, and monitor condition for further water intrusion and repairs as needed by a qualified contractor.

Efflorescence

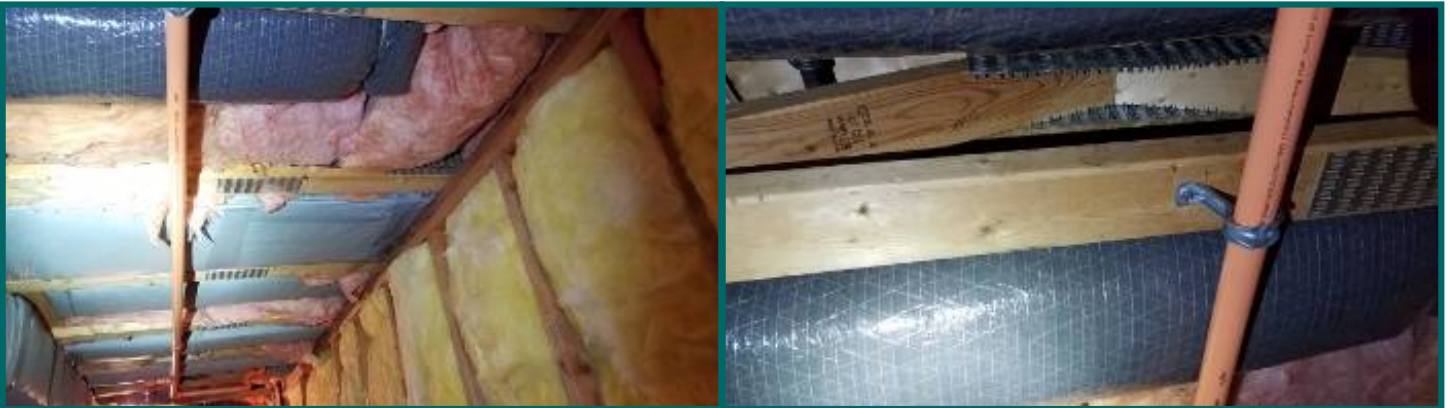
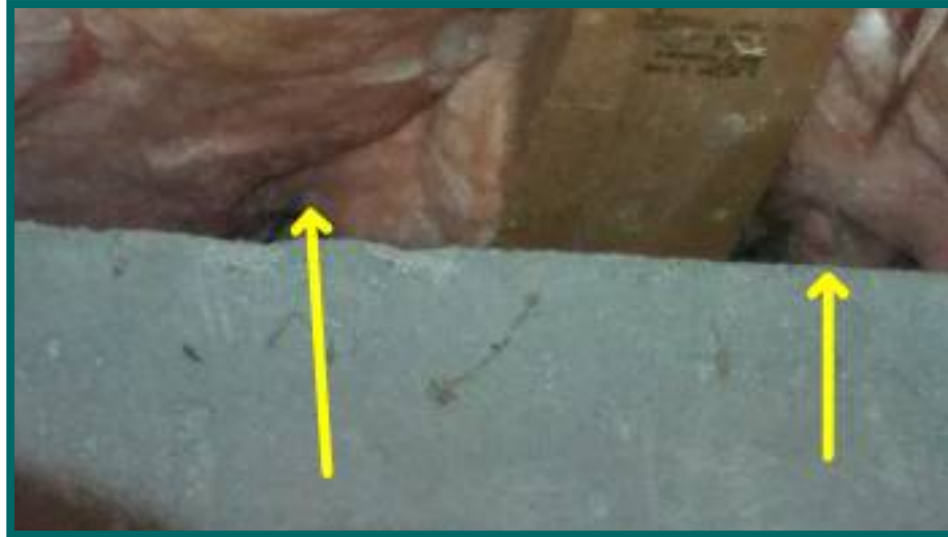
- 2.1. Limited visibility due to finish basement, insulation or cluttered conditions.
- 2.2. Engineered wood truss floor joists
- 2.3. Rodent traps and or activity noted along framing and or insulation. Recommend inspection and treatment by a qualified pest control company.

rodent tunnels in underfloor insulation along rear wall

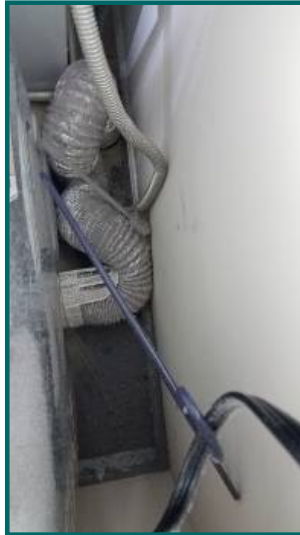
2.2. The clothes dryer is equipped with an accordion-type, flexible exhaust duct. The U.S. Consumer Product Safety Commission considers these types of ducts to be unsafe, and a fire hazard. These types of ducts can trap lint and are susceptible to kinks or crushing, which can greatly reduce the air flow. This duct should be replaced with manufacturers recommendation or with a rigid or corrugated semi-rigid metal duct, and by a qualified contractor if necessary. Most clothes dryer manufacturers specify the use of a rigid or corrugated semi-rigid metal duct. For more information on dryer safety issues, see <https://www.cpsc.gov/s3fs-public/5022.pdf>

2.3. There is excessive lint at dryer vent termination, recommend inspection and cleaning as needed.

Accordion type dryer hose, excessive lint behind dryer, possible dryer vent damage.

2.1. Recommend regular inspection and cleaning of dryer vent to help prevent fire hazard.

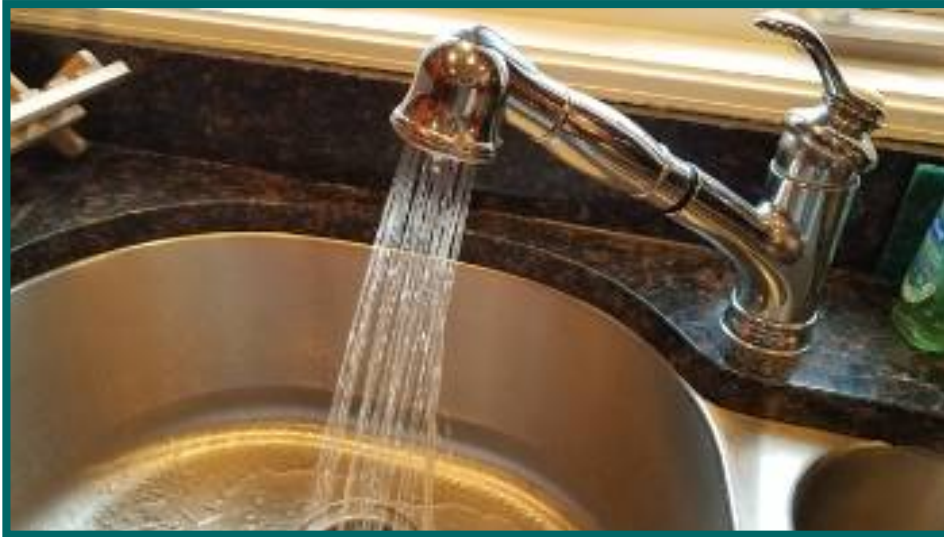
7.2. Spray wand is damaged, recommend repair as needed.

Sprayer wand does not properly divert from spray to stream

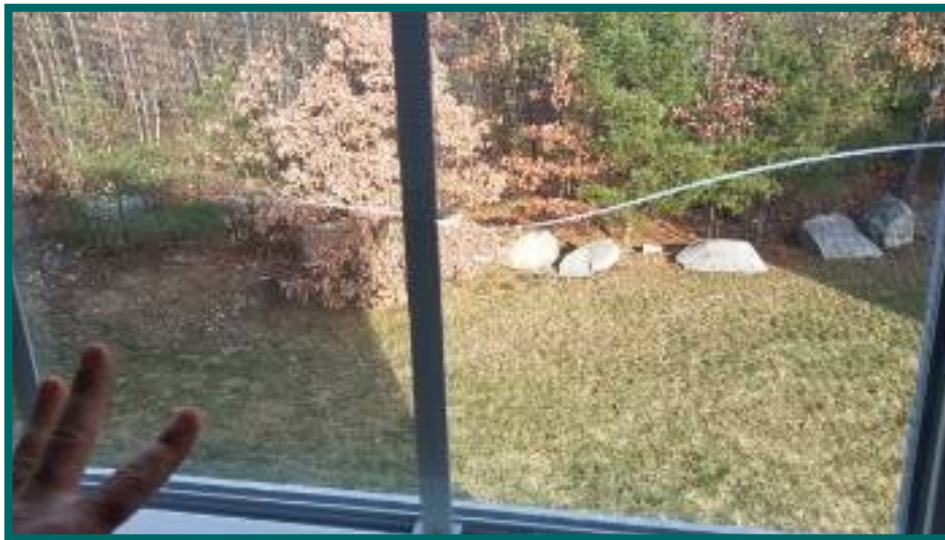
2.2. Window has broken pane in one or more area of home. Recommend assessment of windows and repair by a qualified tradesman.

Broken glass at rear bedroom rear wall

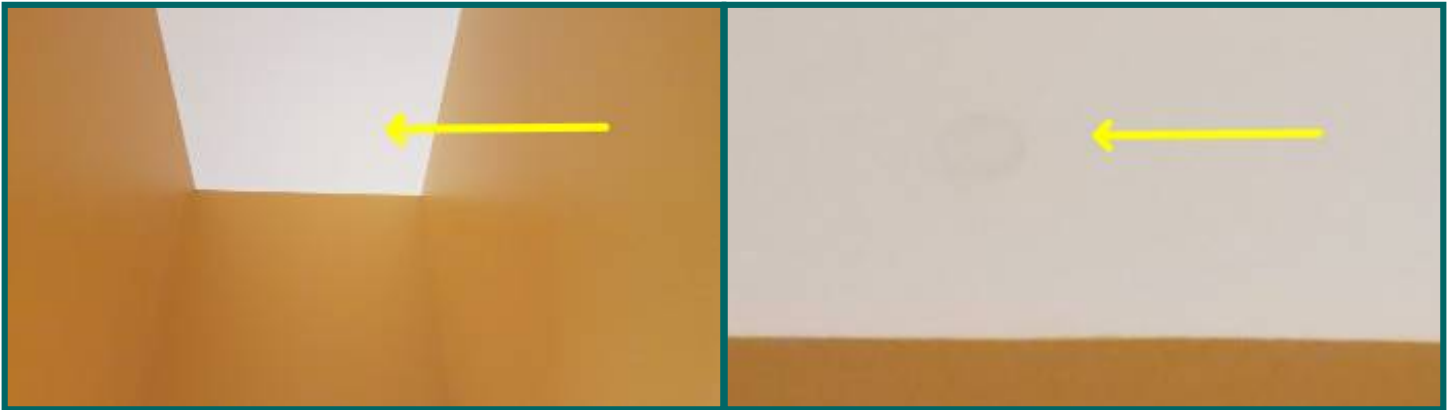
4.2. Stains noted on ceilings in one or more area of home. This is evidence of past or present leaks. They tested dry at the time of the inspection. Recommend asking current home owner for the source and history of any leaks or water intrusion, assessment and repairs by a qualified contractor of any affected areas and monitor for further water staining.

Stains on ceiling tested dry at second floor stair

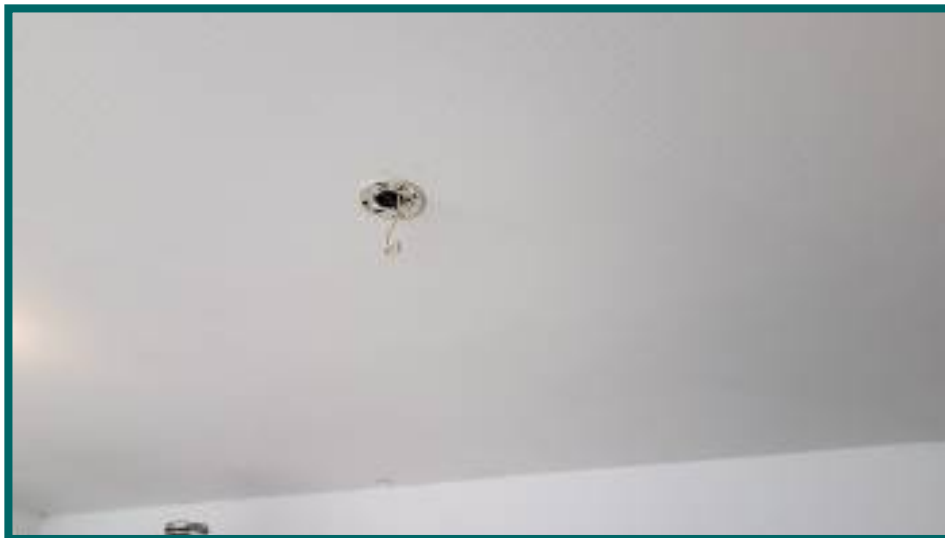
7.2. Smoke detectors not working or not present at one or more location. Recommend repairing and installing smoke detectors by a licensed electrician where needed for safety.

Smoke detector missing at garage

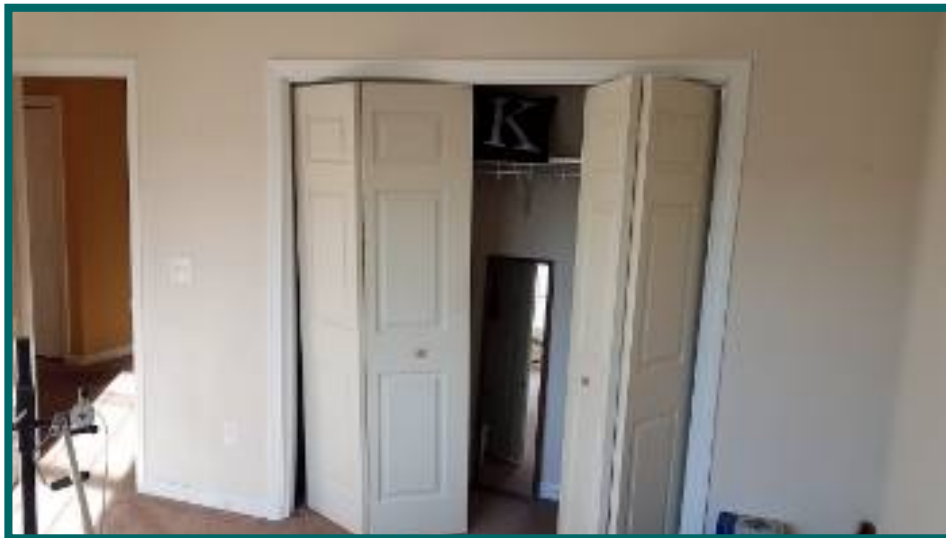
11.1. One or more closet door is off of track, recommend repair by a qualified tradesman.

Closet doors do not open and close properly front bedroom

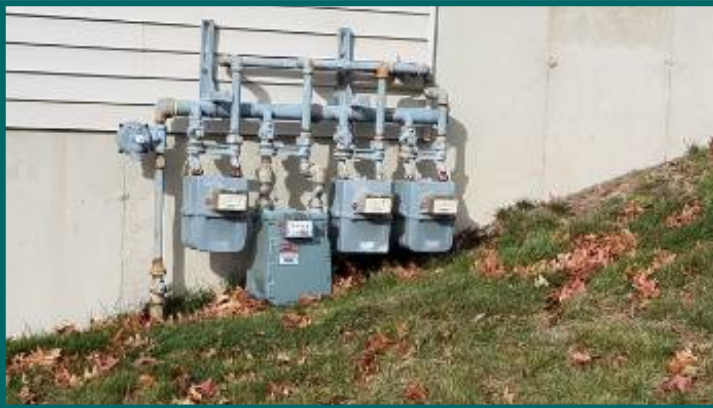
gas meters not individually labeled

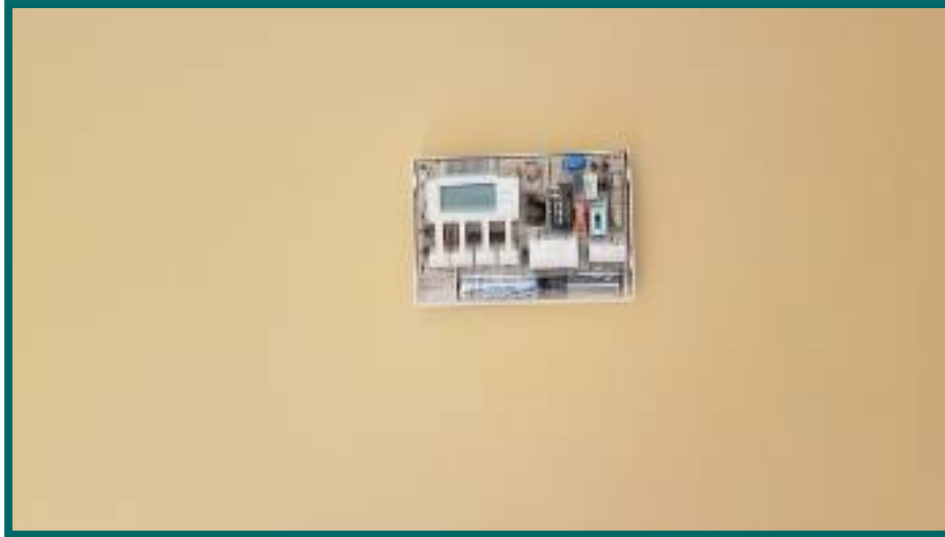
the batteries are dead at 2nd floor hall thermostat, I had to pull batteries out of first floor thermostat to get heat to turn on in that zone.
