Alpha Home & Commercial Building Inspections

Property Inspection Report

Inspection prepared for: Office Inspection Sample
Real Estate Agent: -

Date of Inspection: 6/25/2015 Time: 9:00 AM
Order ID: 2262

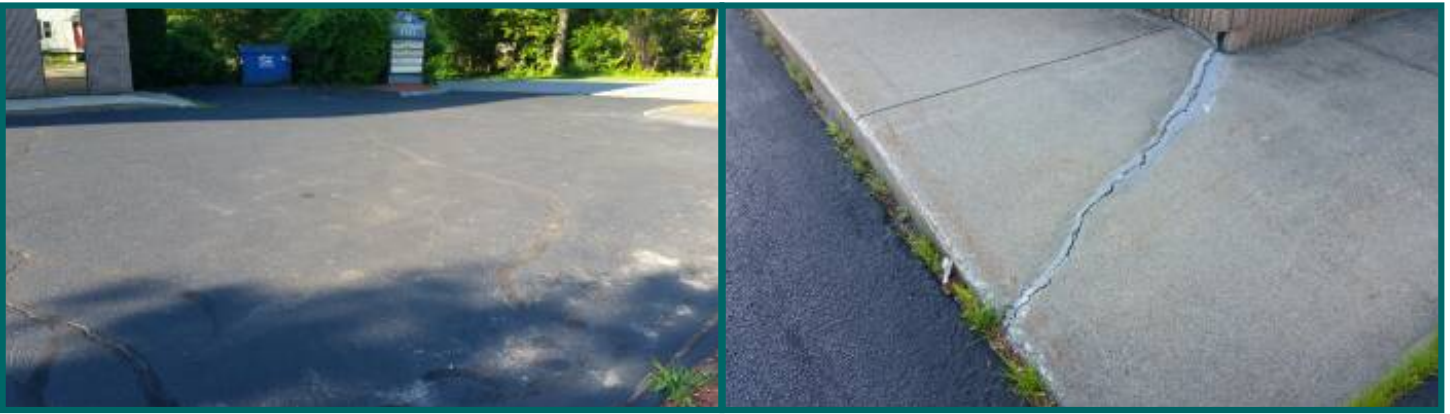
1.2. Typical deterioration was observed at the lot surfaces. Further deterioration will occur as water expands and contracts from freeze and thaw cycles. Recommend re grading to prolong the life.

Settlement crack at front walkway

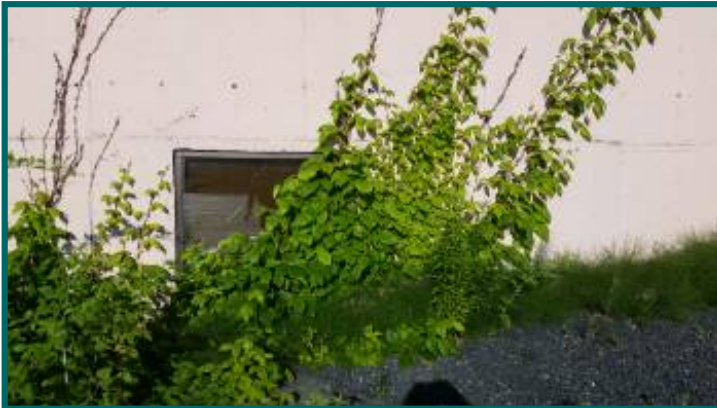
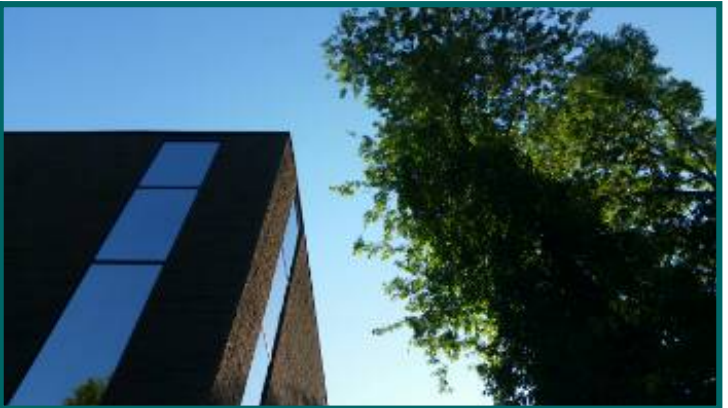
3.2. Vegetation such as trees, shrubs and/or vines are in contact with or less than one foot from the structures exterior. Vegetation can serve as a **conduit** for wood destroying insects and fungal growth and may retain moisture against the exterior after it rains. Vegetation should be pruned and/or removed as necessary to maintain a one foot clearance between it and the structures exterior.

Trees overhanging roof should be cut back or removed.

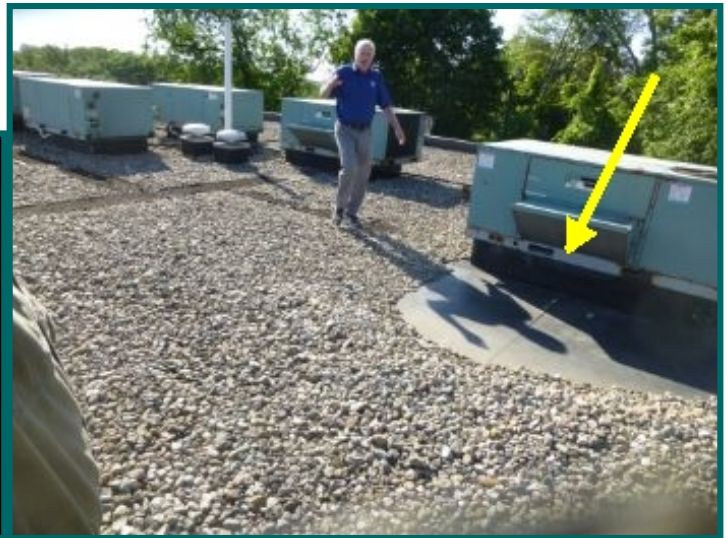
Stone ballast should be evenly spread

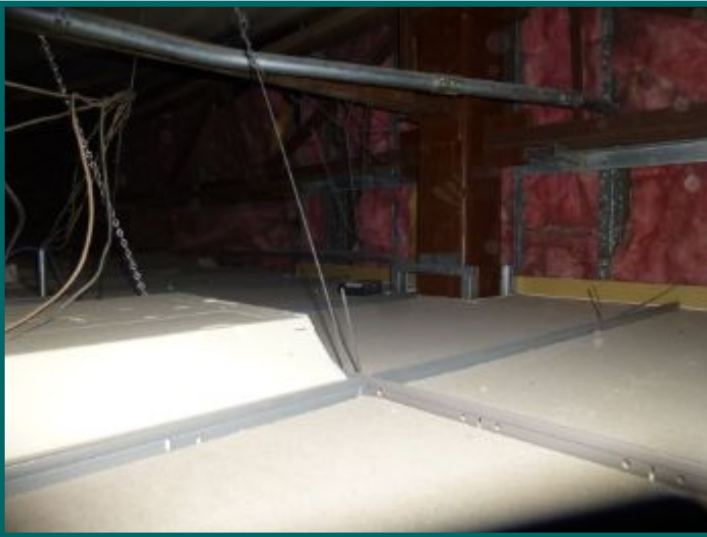
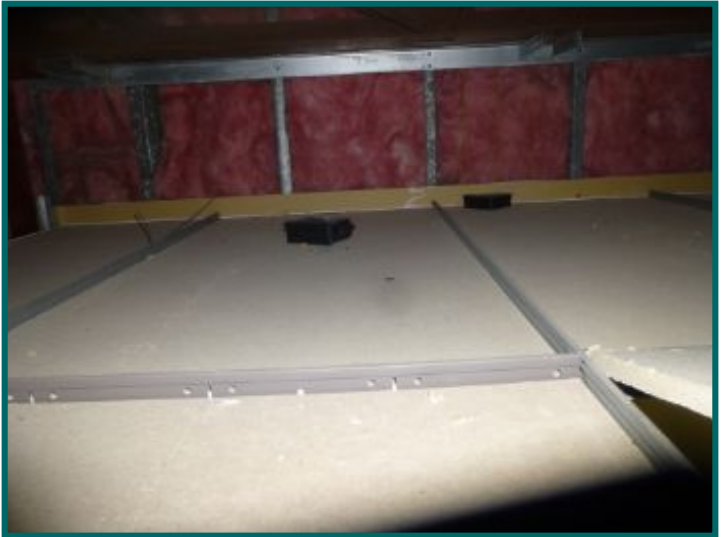
1.3. Rodent or pest trap stations in attic, recommend requesting treatment history from home owner and continue treatment as needed.

Rodent traps

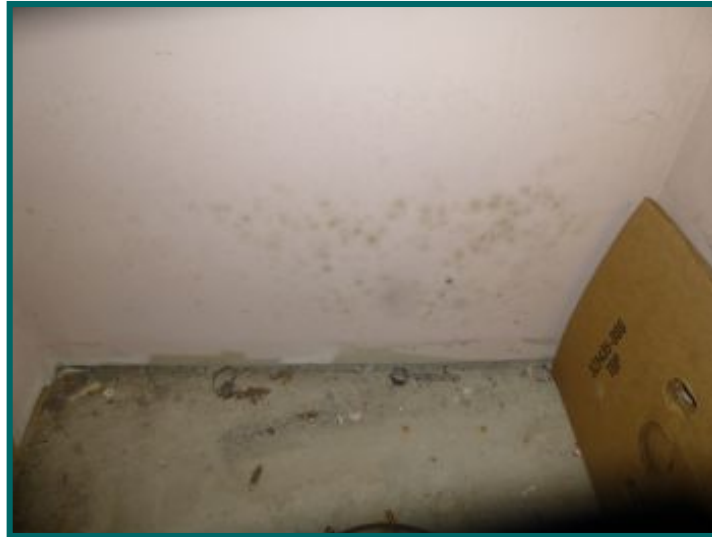
1.3. There is dark staining on foundation walls that appears to be mold, no moisture present at time of inspection. Recommend cleaning or removing any affected areas and monitoring for water intrusion and staining and further investigation and treatment if needed by a qualified professional.

Staining in water heater closet.

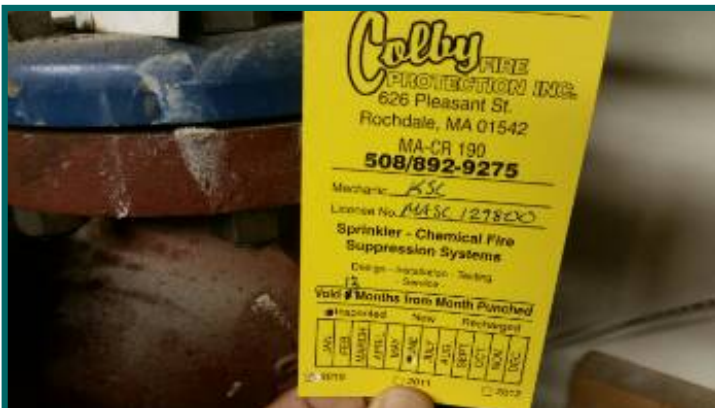
1.2. There is a fire suppression system present, not assessed. The system requires annual maintenance and inspection by a qualified contractor. Last maintenance service is 4 years out of date.

Fire suppression service tag expired in June 2011

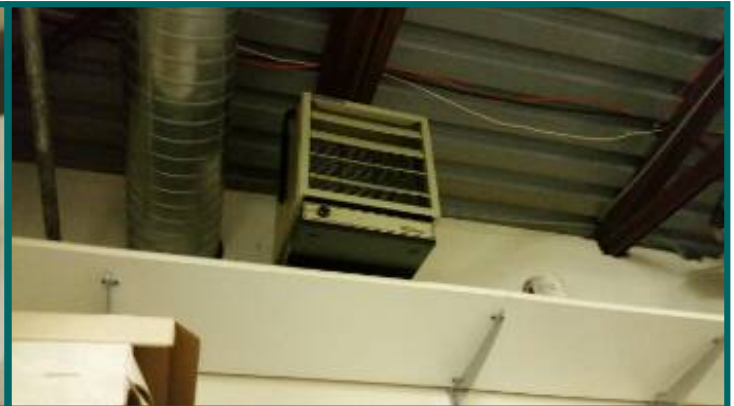
Ceiling mounted electric space heater in basement service room reported does not work.

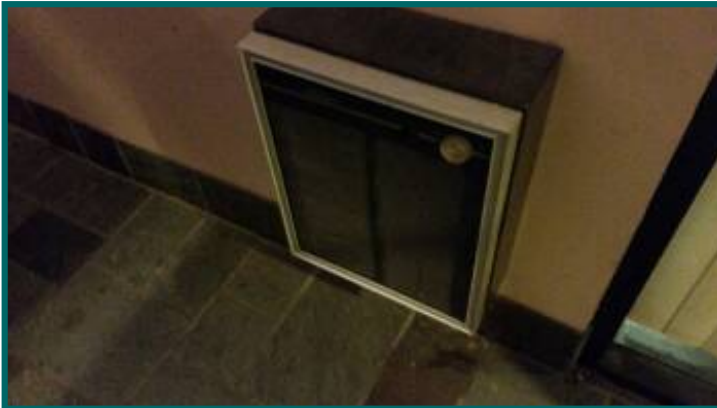
Electric space heaters in common hallway reported not working

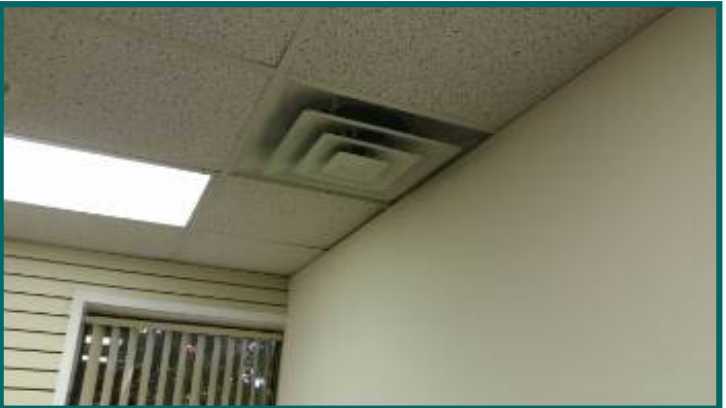
Heat and air in basement did not come on

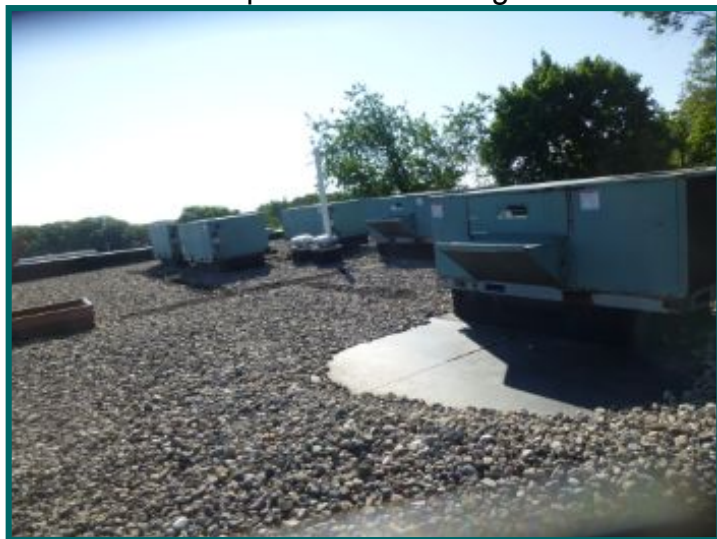
1.1. There are five roof top gas-fired heating and cooling package units. All are reported to be original to building 30 years old. Typical design life for these systems is 20 to 25 years. It was reported that quarterly maintenance is done by Victory HVAC Service. Last maintenance service visit has itemized condition of existing equipment and recommendations with pricing for repairs or replacement as needed. I have requested this report and was told it has been forwarded to client. Not all systems were tested not all systems started and operated properly basement system and 2nd floor left hand system did not start when calling for heat and air conditioning at the thermostat. Recommend the client contact Victory Heating and Cooling Services for further information and review their report most recent report.

Five roof top air handlers

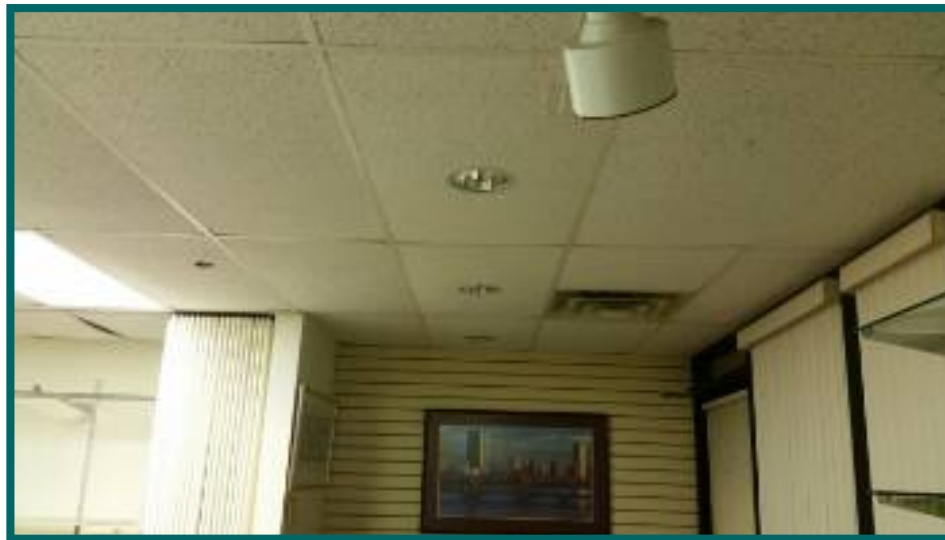
1.5. One or more ceiling light fixtures not working at time of inspection. Recommend changing bulb and repair/ replacement by a qualified electrician as needed.

One line of recessed cans in basement would not come on

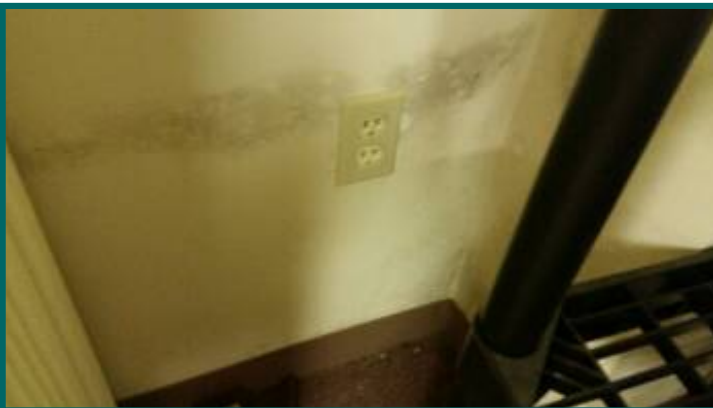
4.2. There is dark staining on walls at one or more area that appears to be mold, no moisture present at time of inspection. Recommend cleaning or removing any affected areas and monitoring for water intrusion and staining and further investigation and treatment if needed by a qualified professional.

Dark staining basement wall front right corner

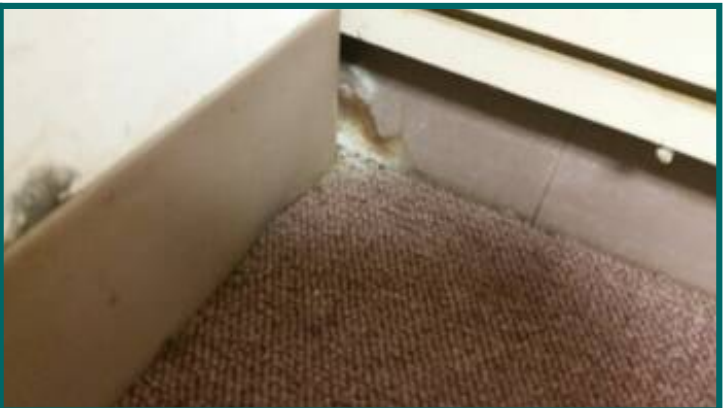
Water staining at left side basement wall tested dry

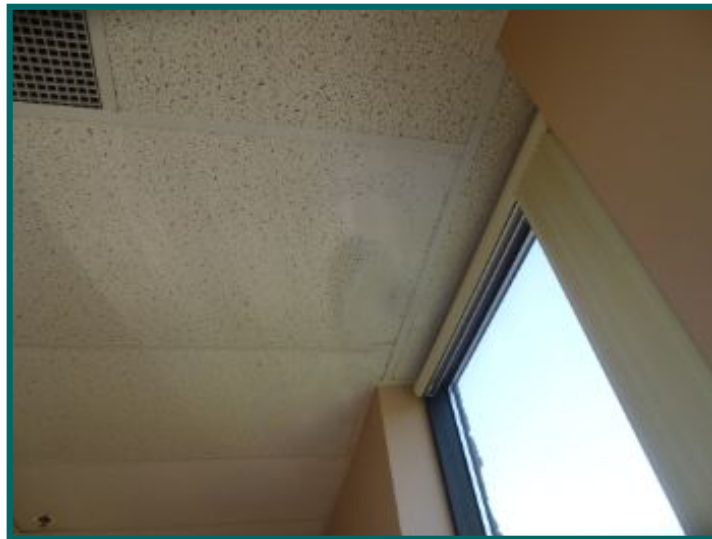
5.2. Stains noted at one or more area of the ceilings. This is evidence of past or present leaks. They tested dry at the time of the inspection. Source of all staining was not determined. Recommend repair and or painting of all affected areas and monitor for further water staining.

Second floor painted over stains on ceiling.

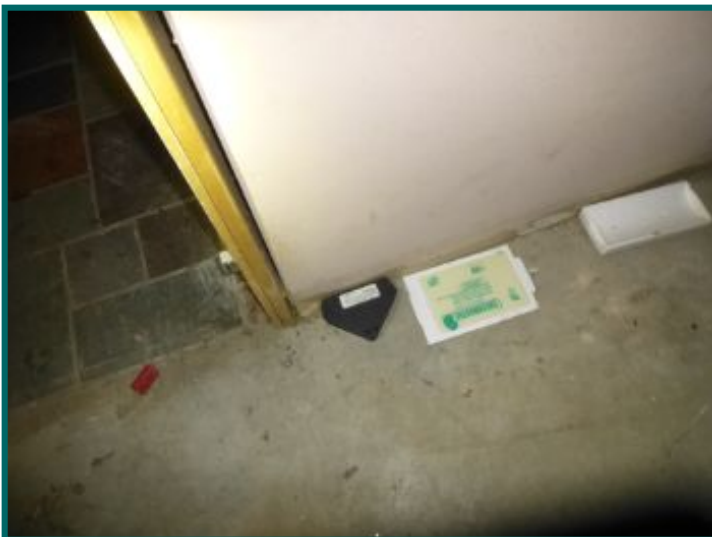
6.2. Rodent bait stations inside building, recommend maintenance of bait stations by a qualified pest control company.

Rodent stations.

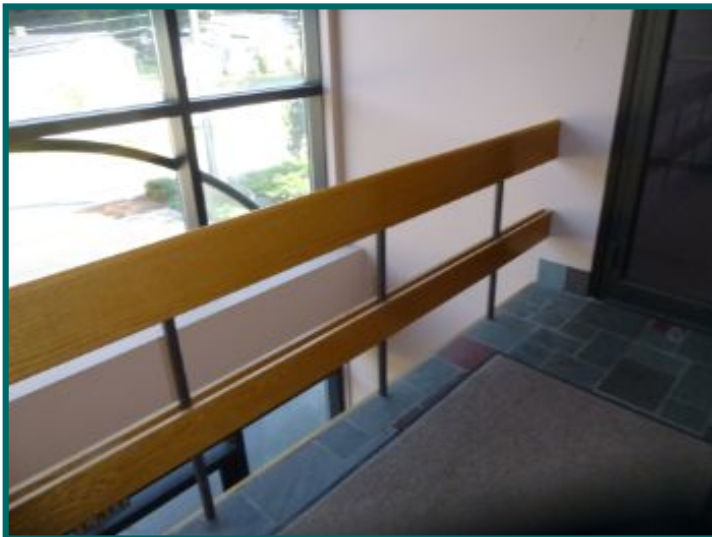
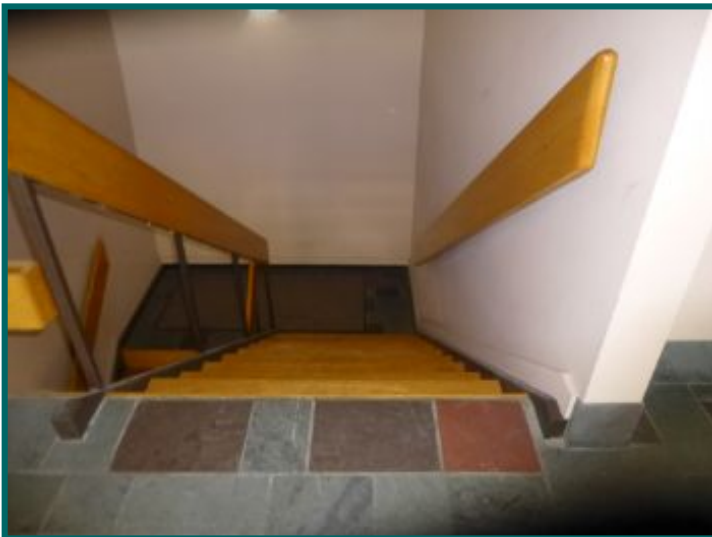
8.1. Rail opening on stairs is greater than 4 inches, this is a safety hazard for young children. By todays construction and safety standards vertical ballusters should be installed no greater than 4" apart.
