Alpha Home & Commercial Building Inspections

Property Inspection Report

industrial building 57,000 sf circa 1984 , Peterborough, NH 03458
Inspection prepared for:
Date of Inspection: 9/4/2020 Time: 9:00 AM
Order ID: 11349

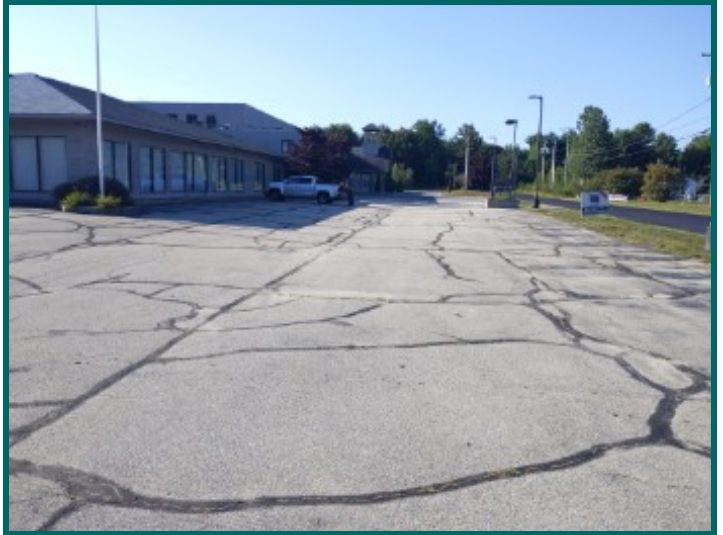
Left side parking

1.2. Excessive deterioration and cracking was observed at the asphalt surfaces. Recommend assessment and repairs by a qualified asphalt contractor.

Damaged asphalt surfaces throughout left side parking.

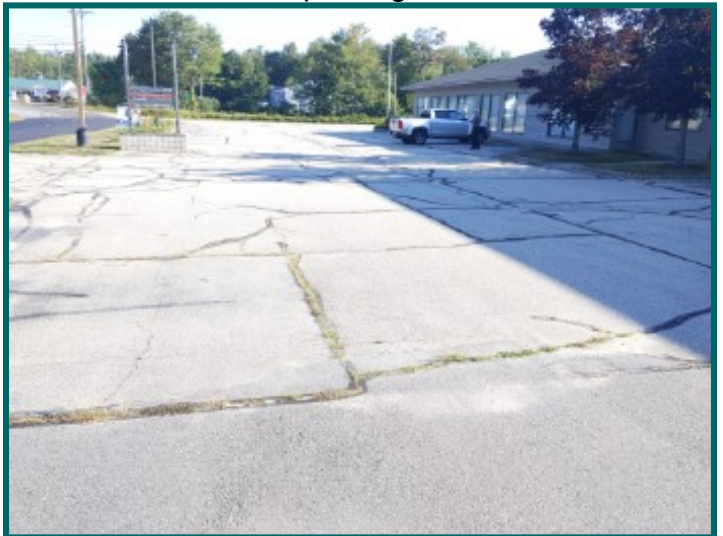
Front parking

Cracks / damaged surface at front and left side of building

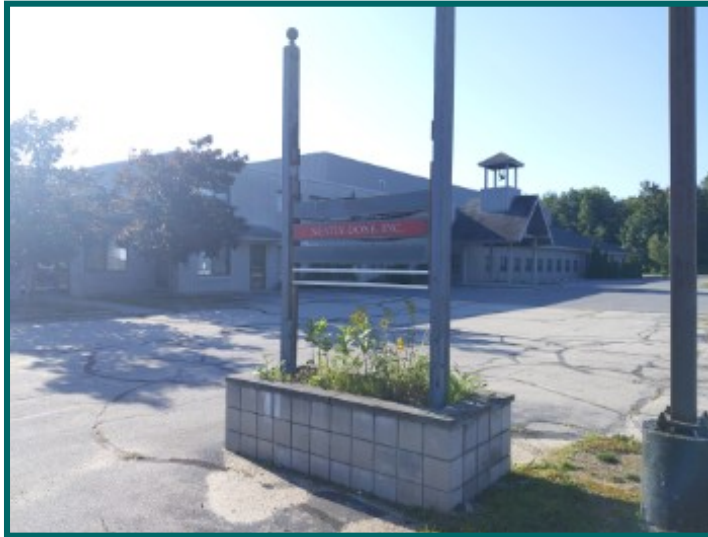
5.1. Damaged wood signage at front of building, recommend repairs as needed.

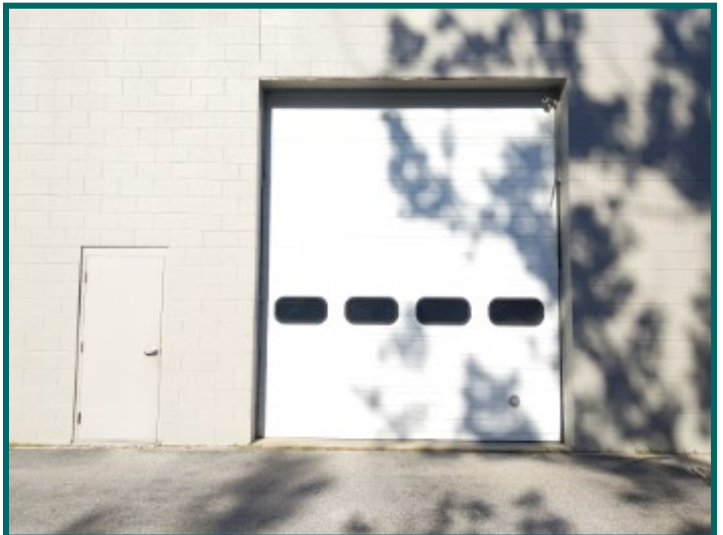
Rear left overhead

Impact damage at rear overhead door/door does not seal well

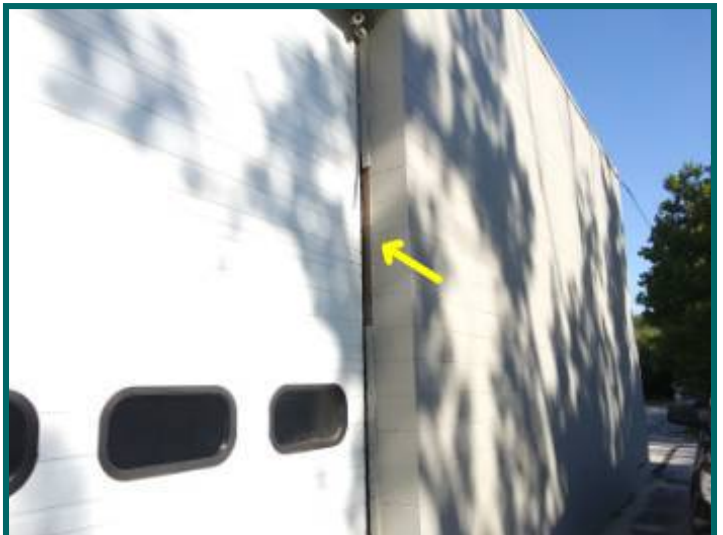
Damage to door and or trim at rear garage

Damage to door and or trim at rear garage door

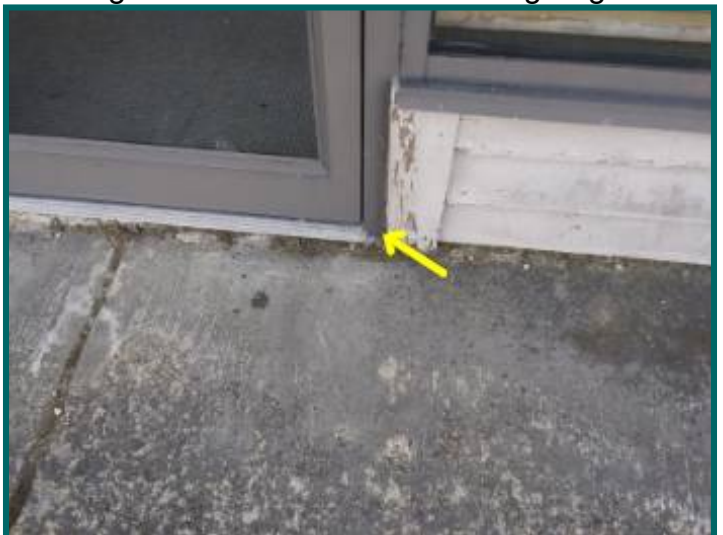
Left side

Damage, rot on trim at left side

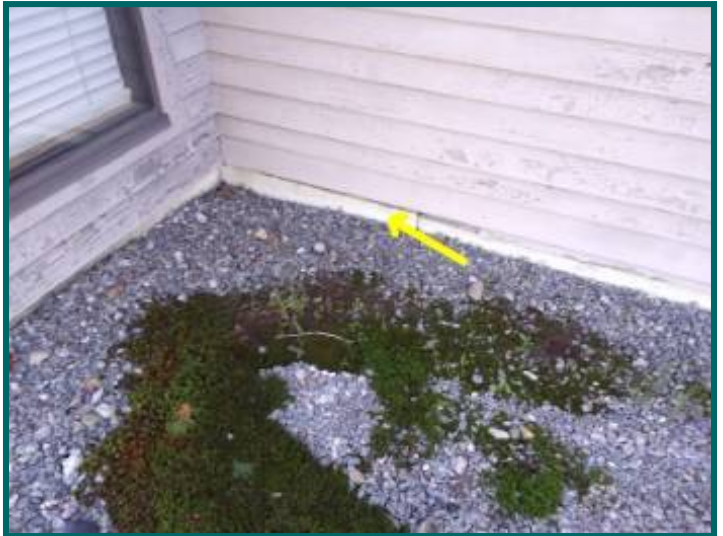
Damage to exterior surfaces in contact with
finished grade at left front.

Missing trim front left building

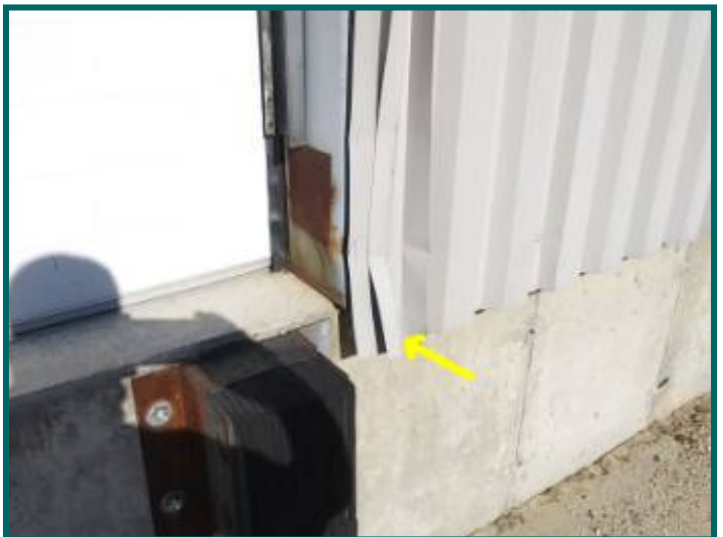
Damage to exterior surfaces at front

Damage to exterior surfaces at loading dock

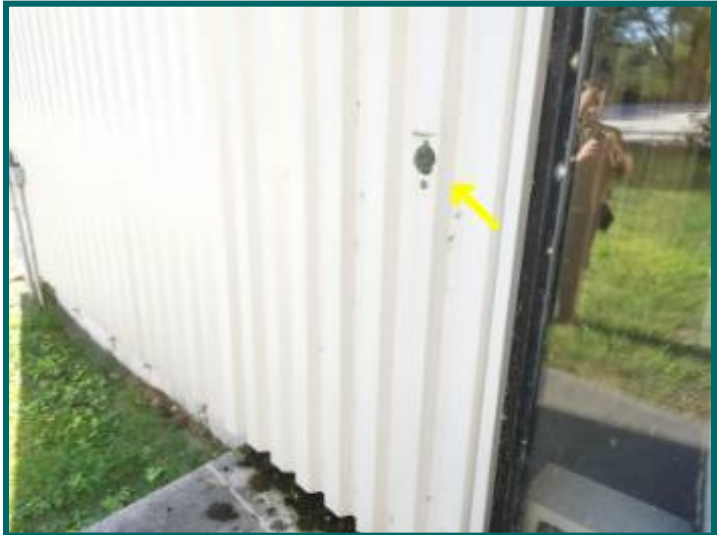
Damage to exterior surfaces at loading dock

Damage to exterior surfaces at warehouse side door

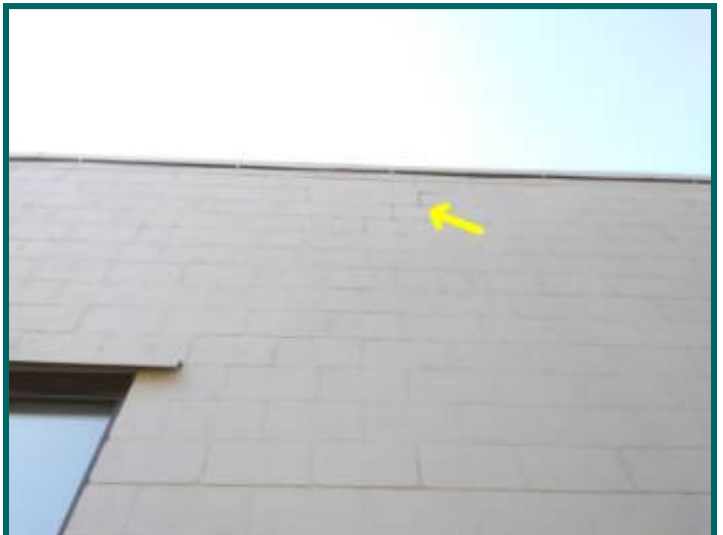
2.4. There is vertical and or step cracking at one or more areas of exterior wall, recommend assessment and repairs by a qualified masonry contractor.

Step cracking at rear

Step cracking rear left

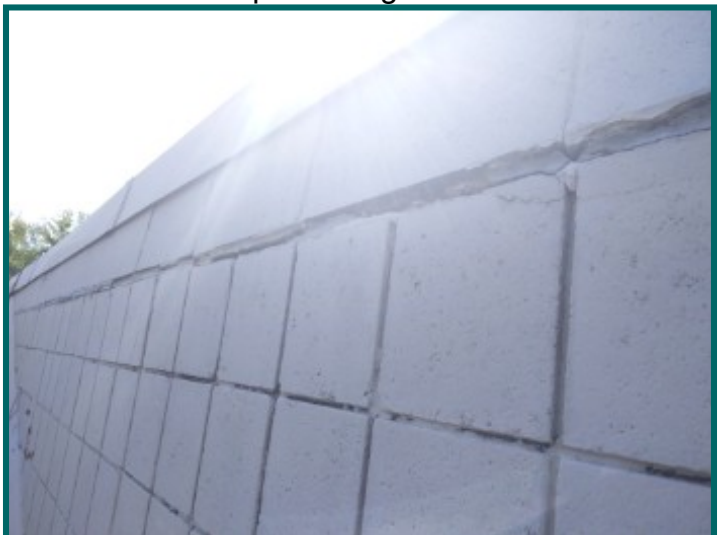
damaged block and mortar at front of middle building

Damaged block / horizontal cracking at front / left side of middle building

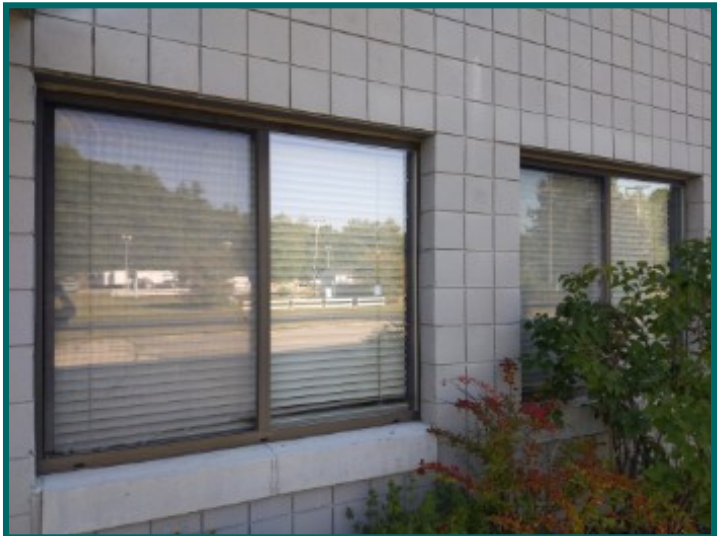
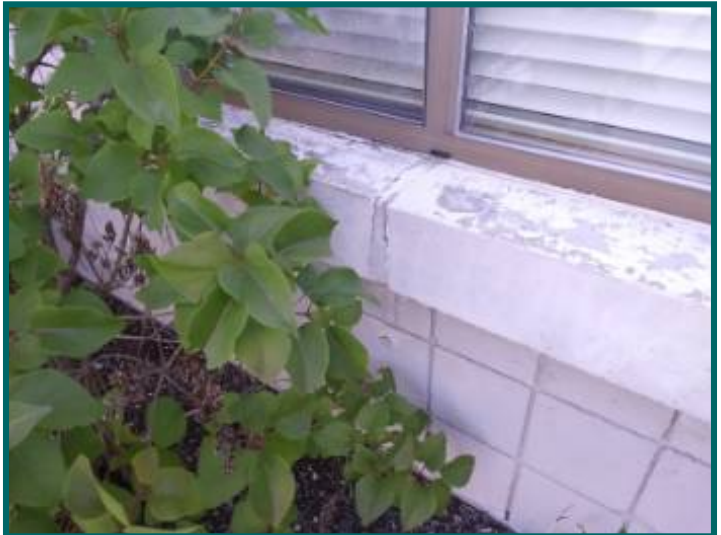
Needs caulking front of left building

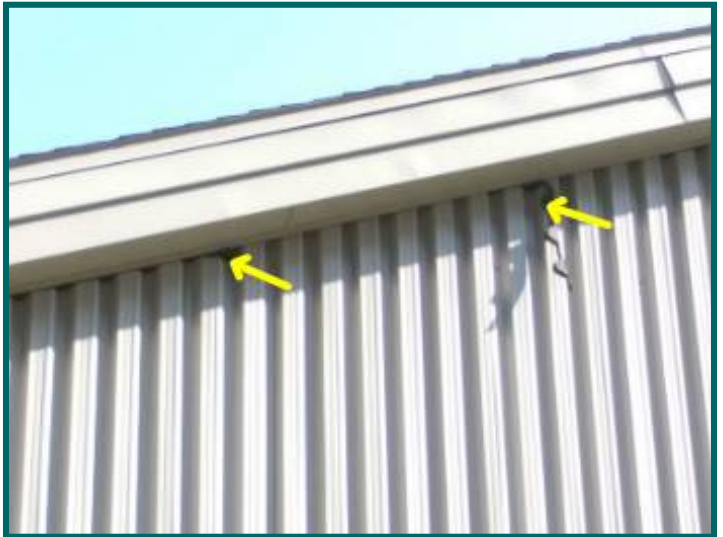
Damage, rot on trim at left front

Deterioration to trim at right side

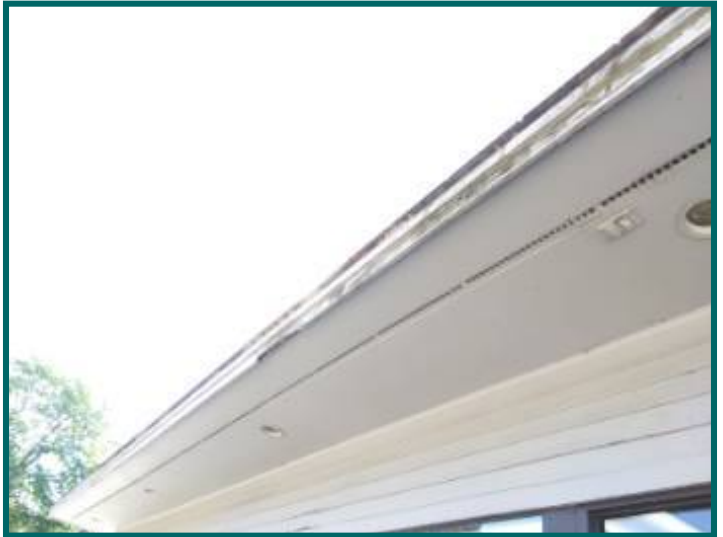
Damage, rot on trim at rear

Deterioration to trim at left side

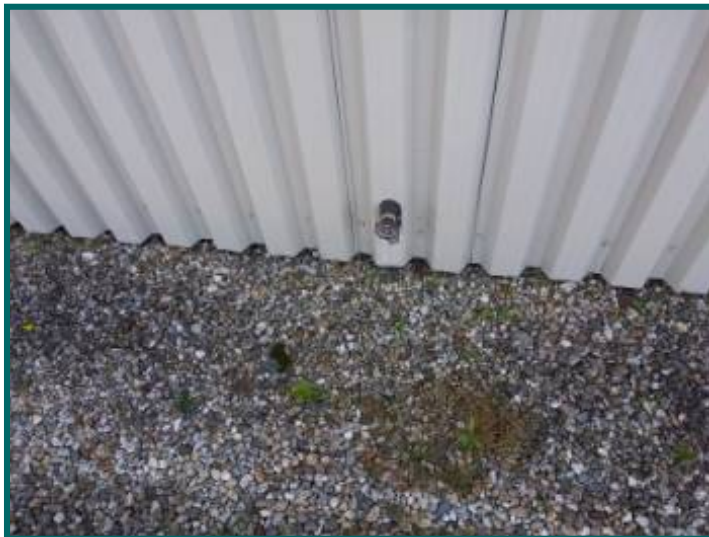
No water to exterior faucet at front

Damaged faucet handle at rear

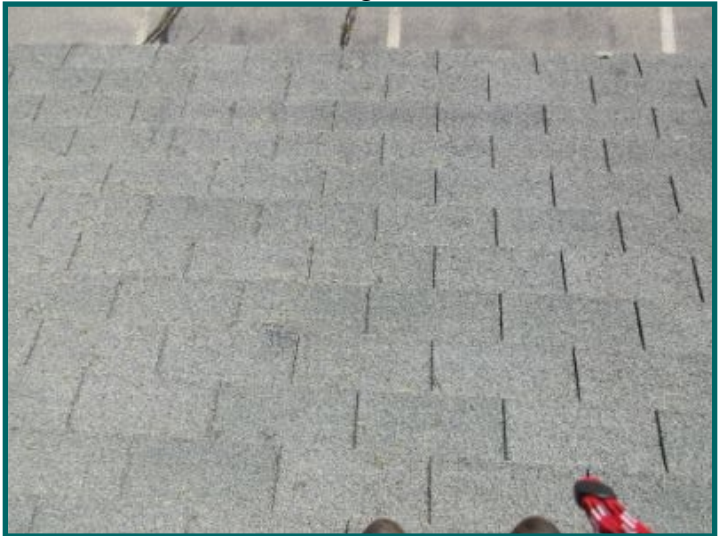
damaged surface / granular loss and fungal growth at left building

damaged surface / granular loss at left building roof

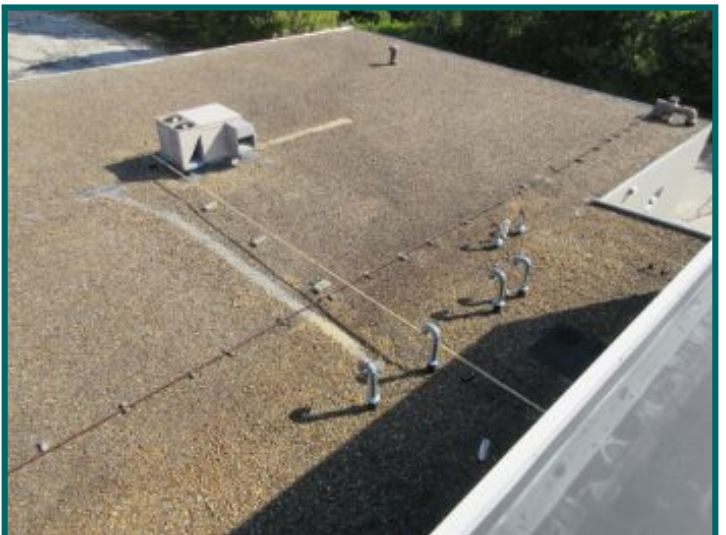
Middle building roof is beyond its design life.

Water intrusion / leaks at interior of middle building.

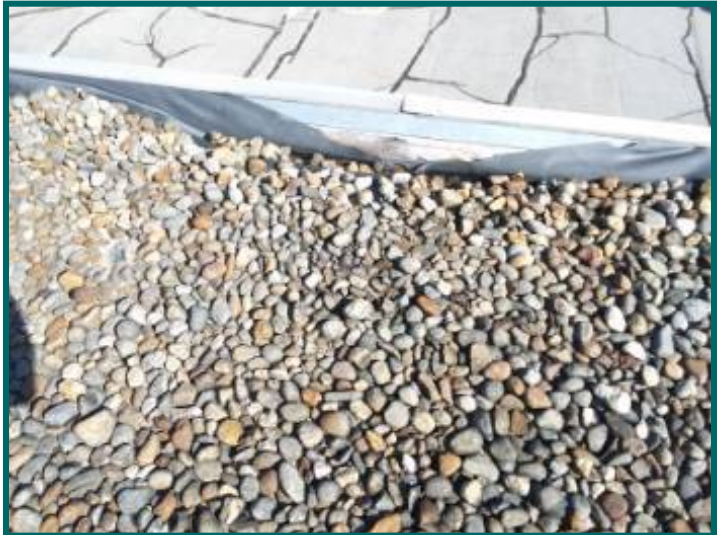
Damaged rubber roofing middle building

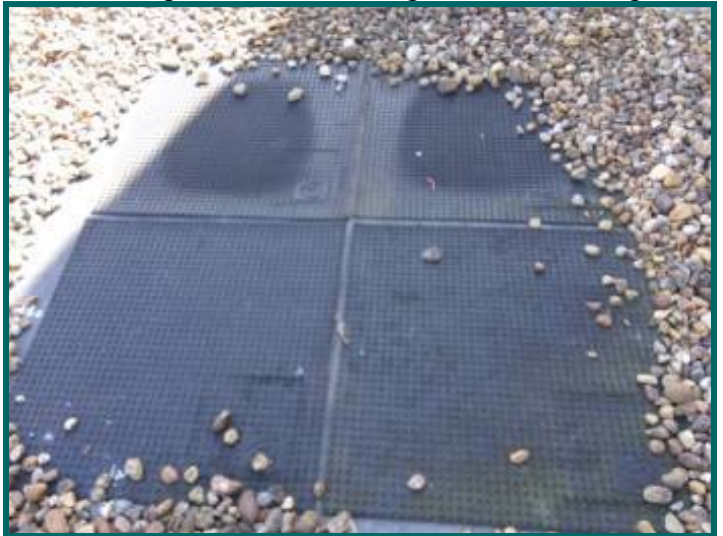
Damaged rubber roofing middle building

Areas of missing ballast and prior repairs at
middle building

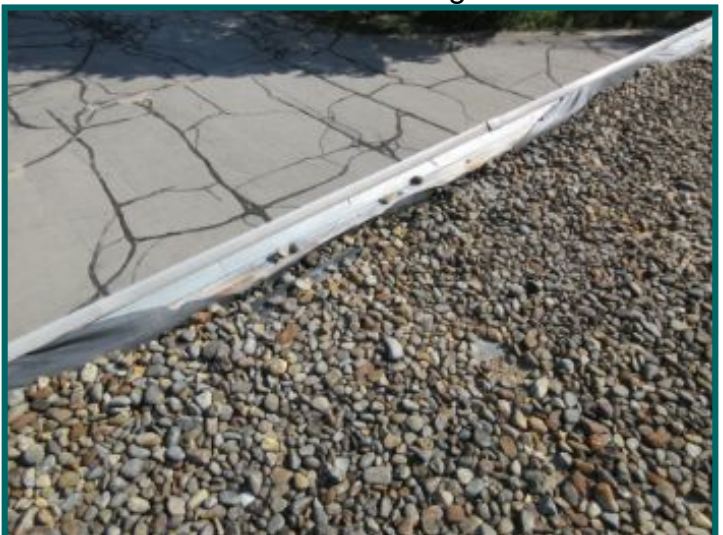
beyond design life / water intrusion at interior

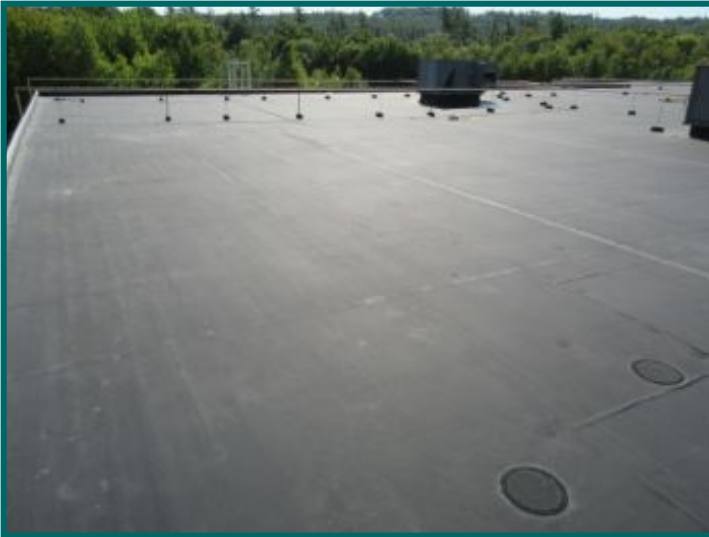
damaged roof surface

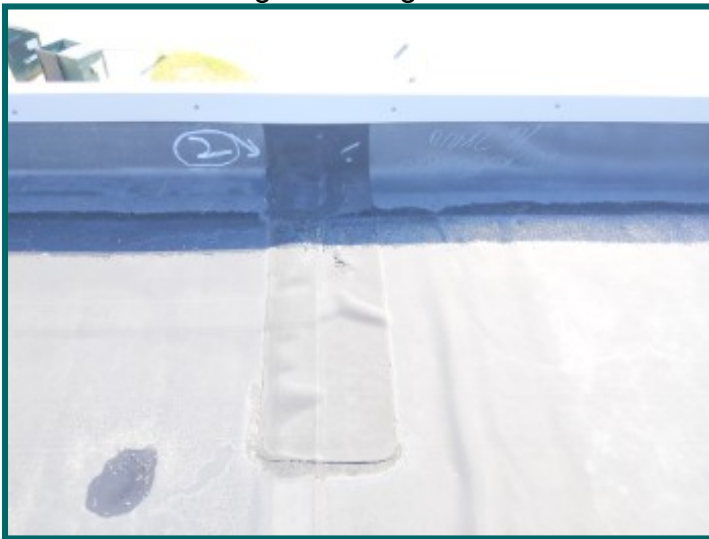
Prior repairs at right building roof.

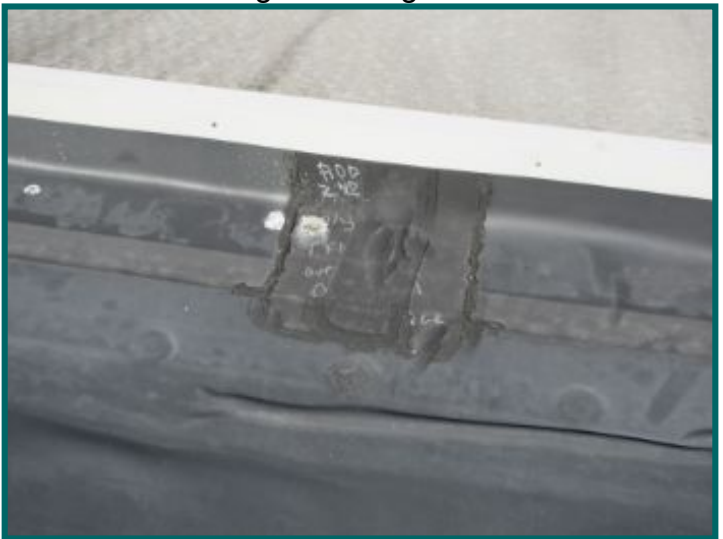
prior repair at right building roof

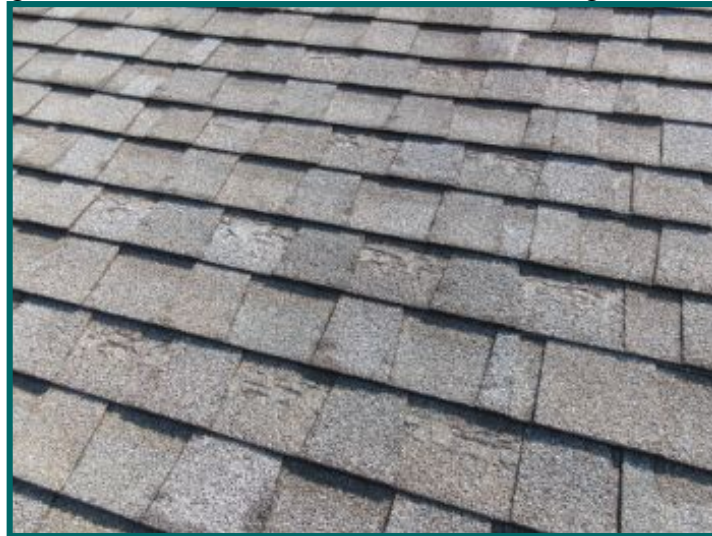
damaged surface at right building front roof

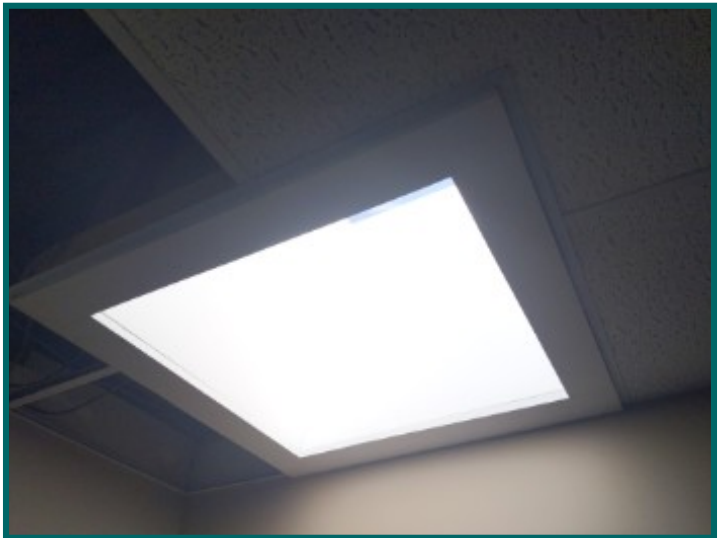
Fogged skylight middle building

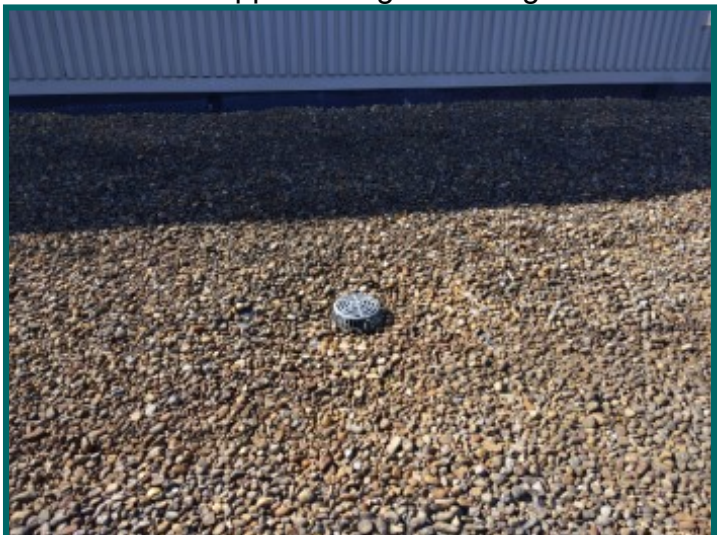
Missing downspouts at scuppers

Internal roof drains at middle building.
Termination was not located.

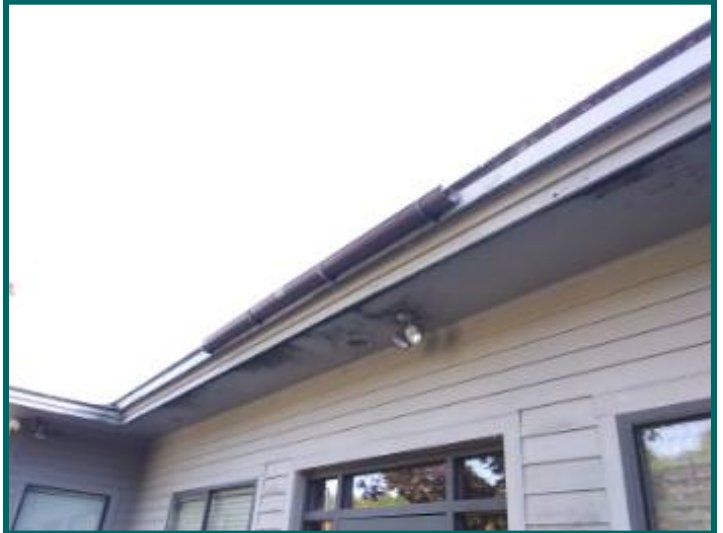
Gutter terminates onto walkway at rear of building.

Missing downspout on gutters

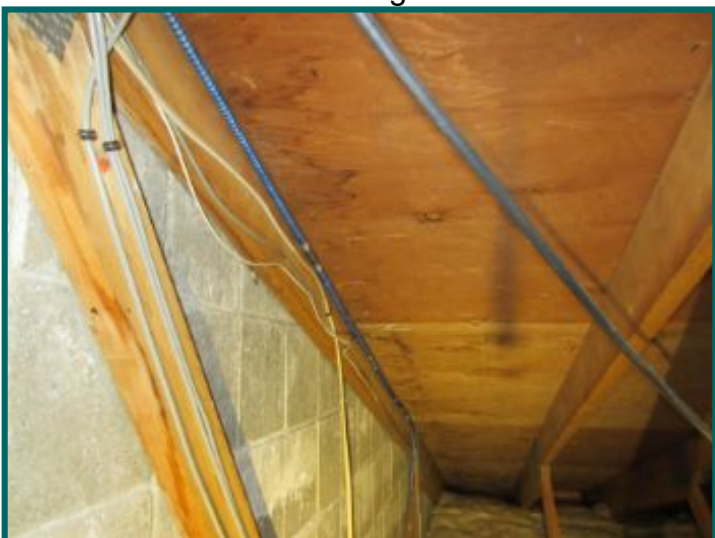
Cut/altered truss

Stains tested dry

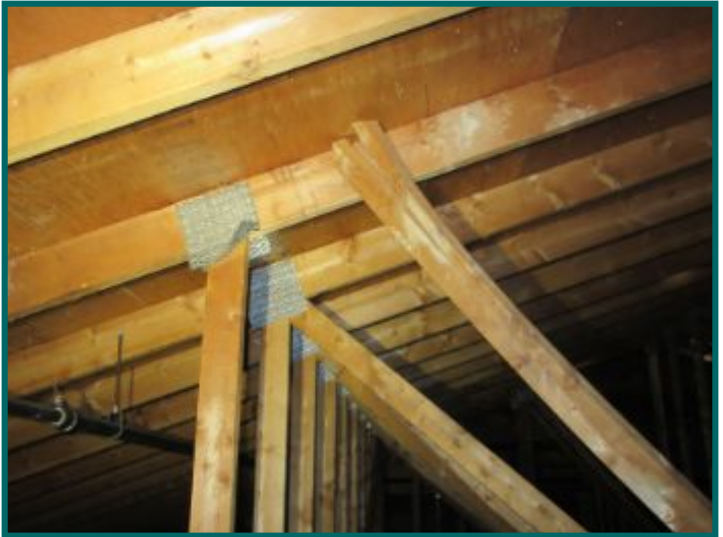
Stains tested dry

Damaged truss in left building attic

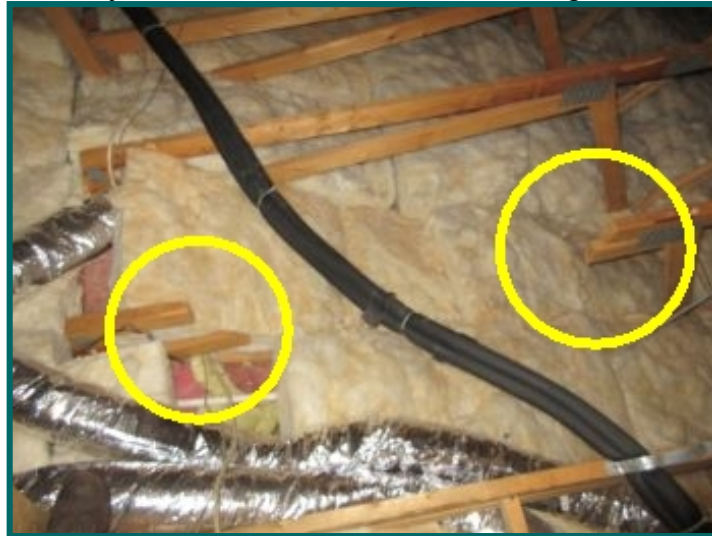
2.4. One or more roof trusses are damaged, have been cut, or altered; this may compromise the integrity of the structure. We recommend review by a licensed structural engineer for evaluation and repair or replacement, as necessary, prior to close.

damaged / cut truss in left building attic

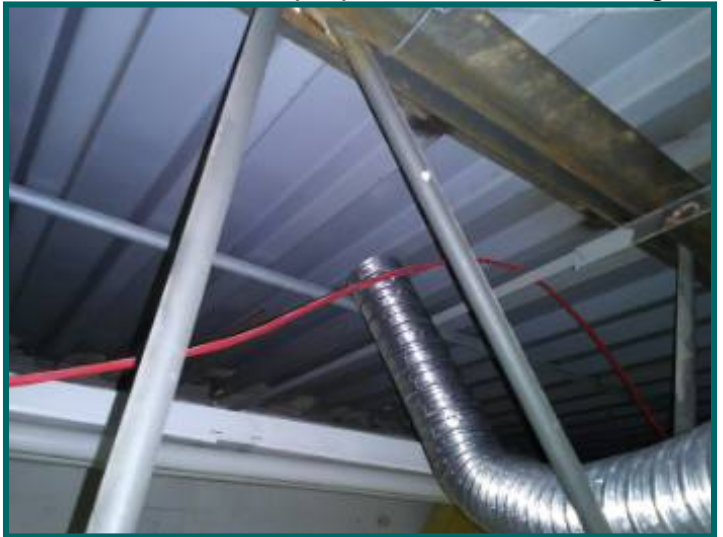
vent terminating in attic at left building

Inproper bath fan termination middle rear bath

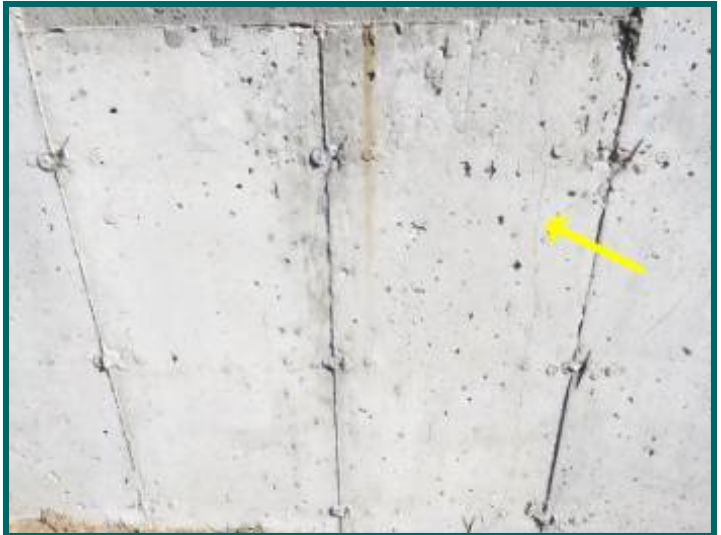
Vertical cracks at right side wall

Vertical crack on side wall.

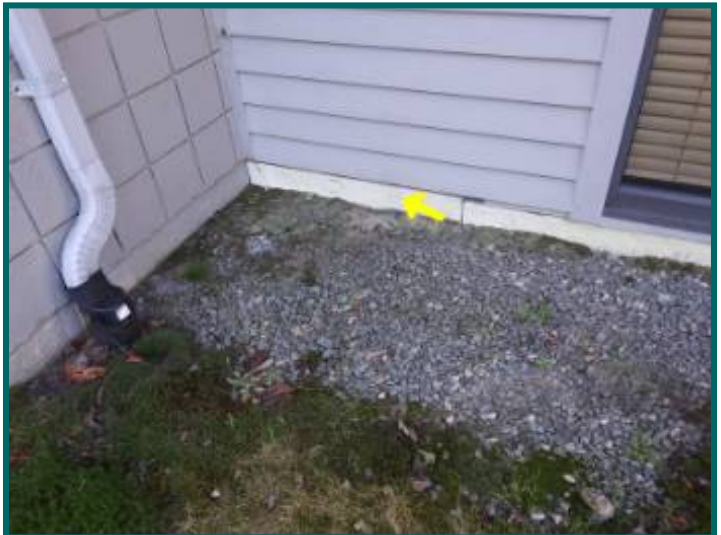
Vertical crack on rear wall

insulation in contact with ground and wood siding

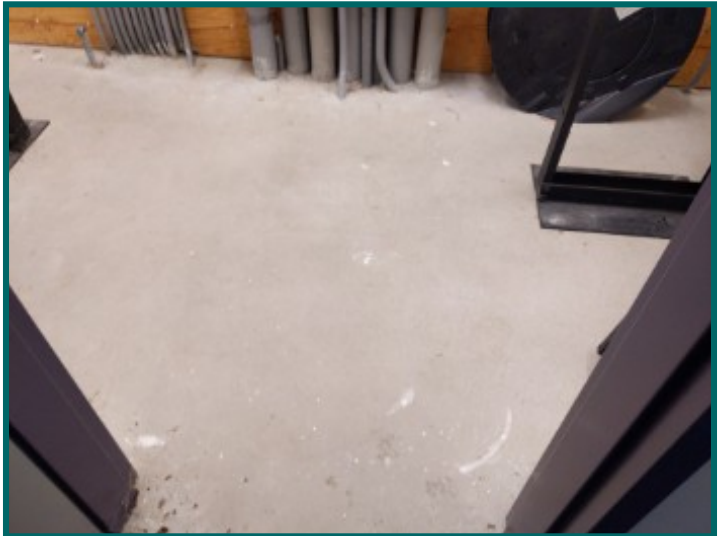
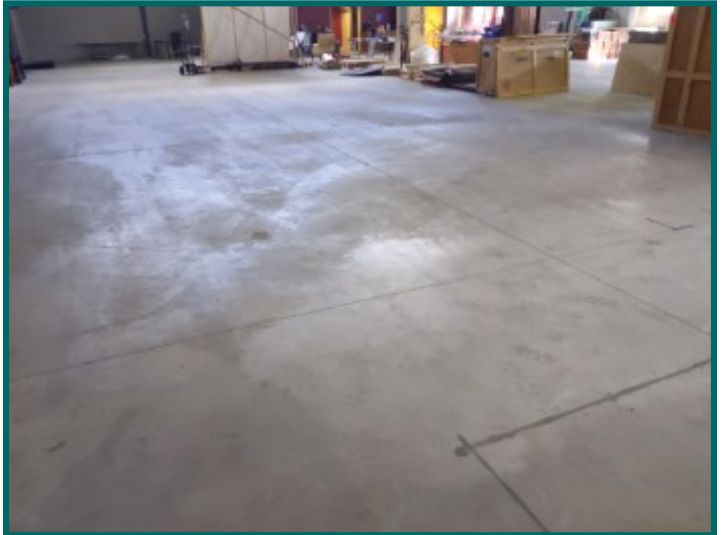
2.5. Dirt floor with no vapor barrier, this is conducive to moisture and insect intrusion. Recommend installation of vapor barrier and ballast, (plastic sheeting and crushed stone) by a qualified tradesman.

Incomplete finish / dirt floor without vapor barrier
at front right.

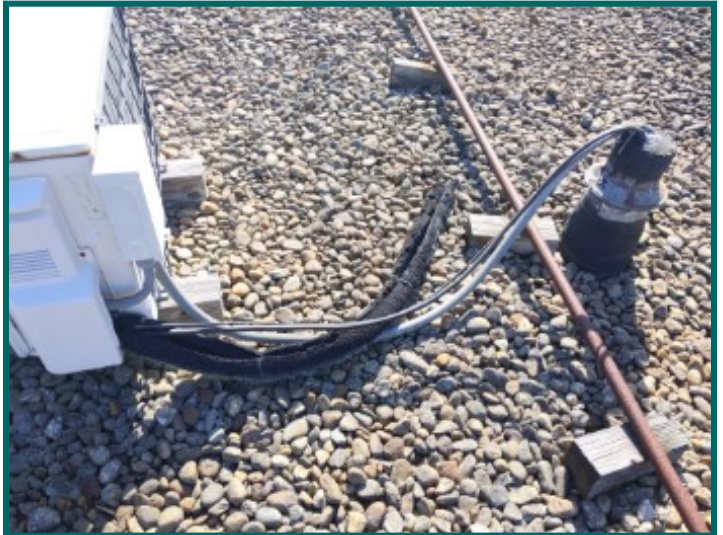
Damaged/missing insulation at rear of building.

Damaged / mission insulation at rooftop mini split.

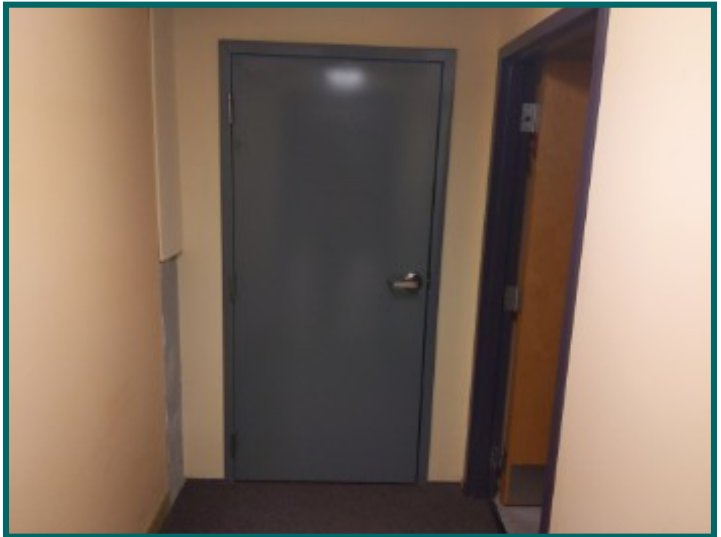
Broken glass at warehouse rear door

Door between front entry and warehouse was locked / would not open

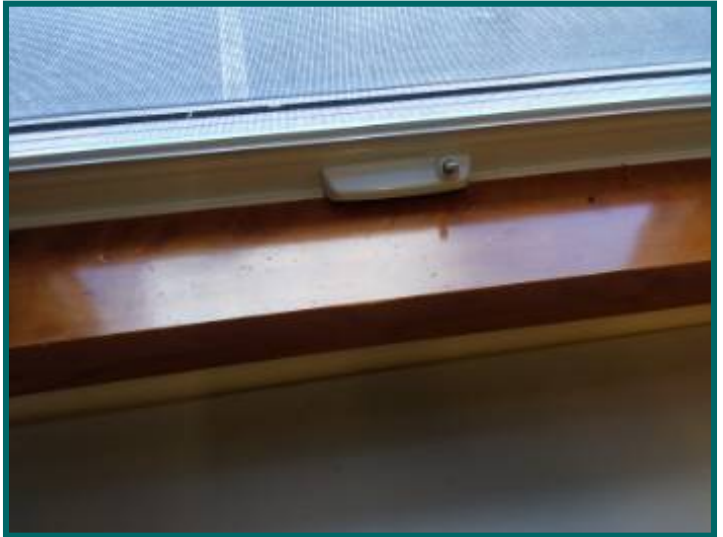
Damaged window crank at middle front

Damaged window crank at middle front office

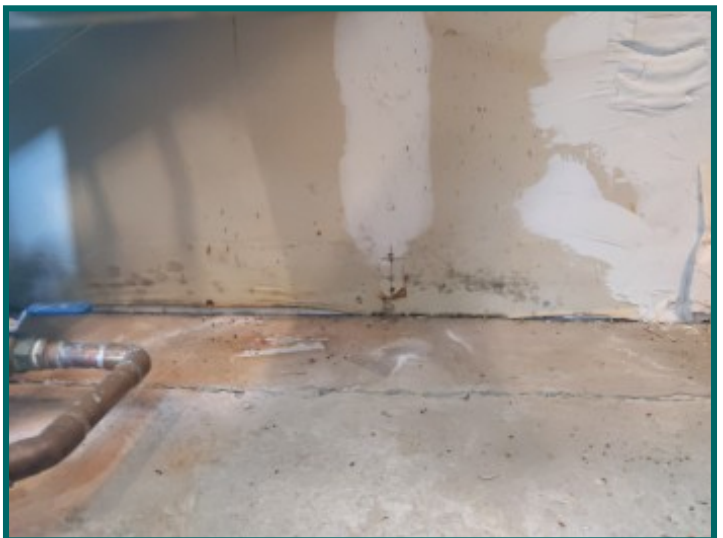
Incomplete finish at front right

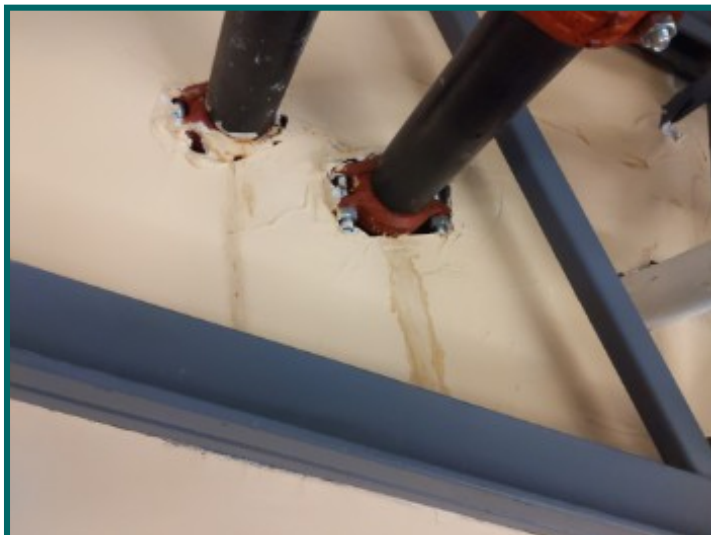
Suspected mold staining in boiler room tested dry

Water staining at right building front office area
second floor tested dry

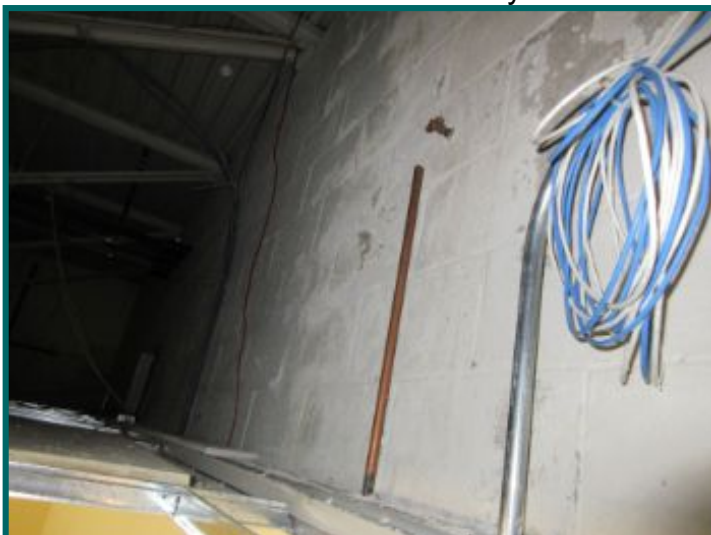
Wet conditions and suspected mold staining at
middle building rear room

water staining / efflorescence and wet conditions
at middle building right wall

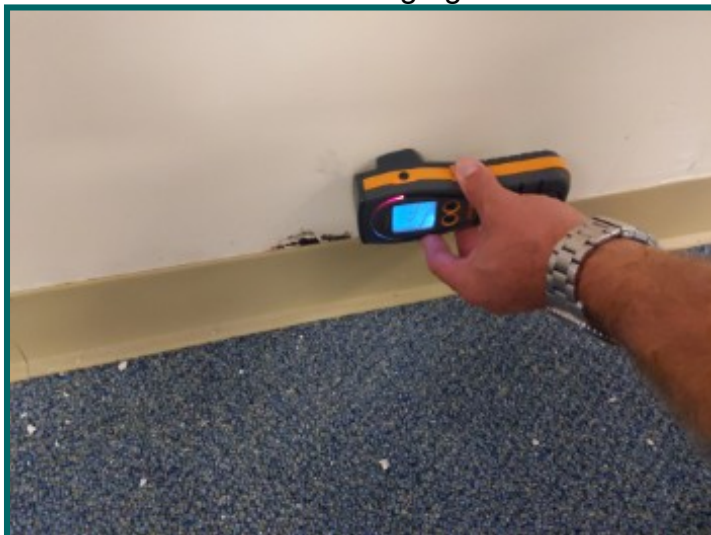
water staining / efflorescence and wet conditions
at middle building right wall

Wet conditions and suspected mold staining at
middle building rear room

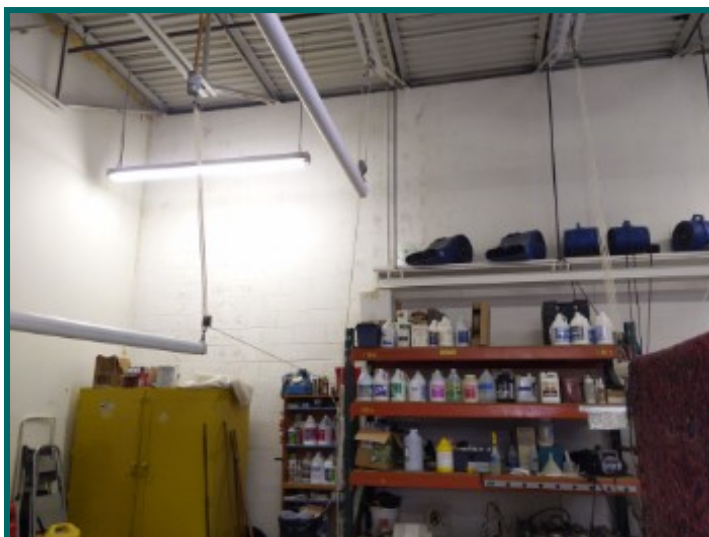
Water staining / efflorescence at Neatly Done right side wall.

Water staining / efflorescence at neatly done left wall

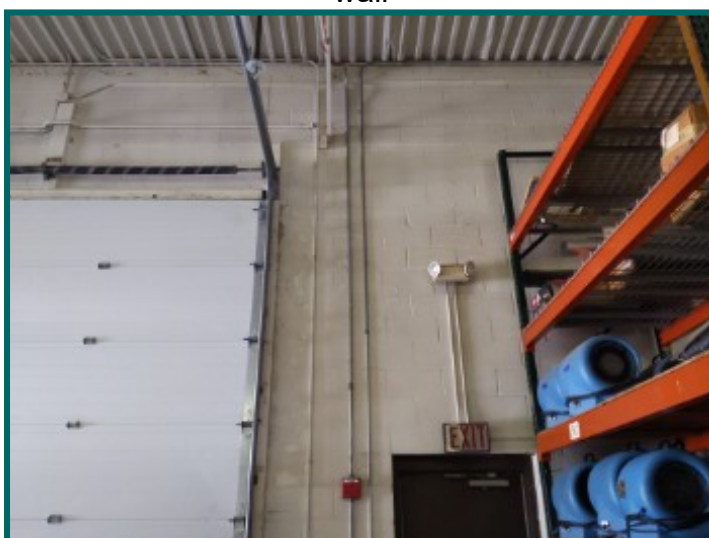
Water staining / efflorescence at neatly done rear wall

Water staining / efflorescence at Neatly Done rear wall

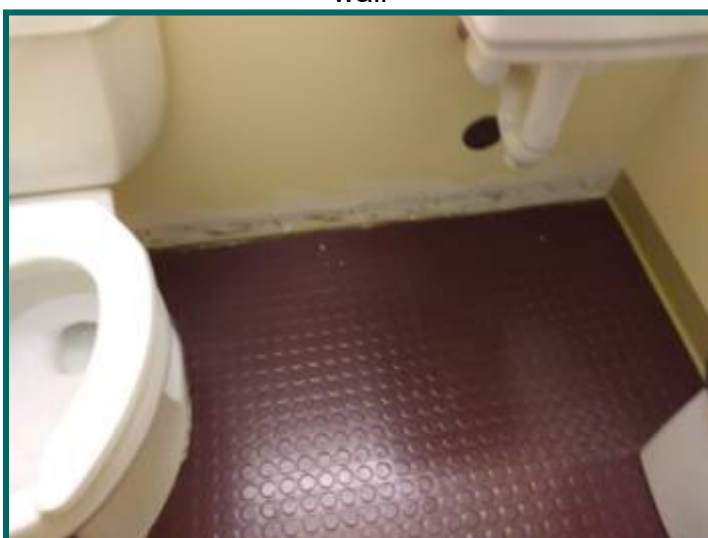
Damage to wall at middle rear ladies room

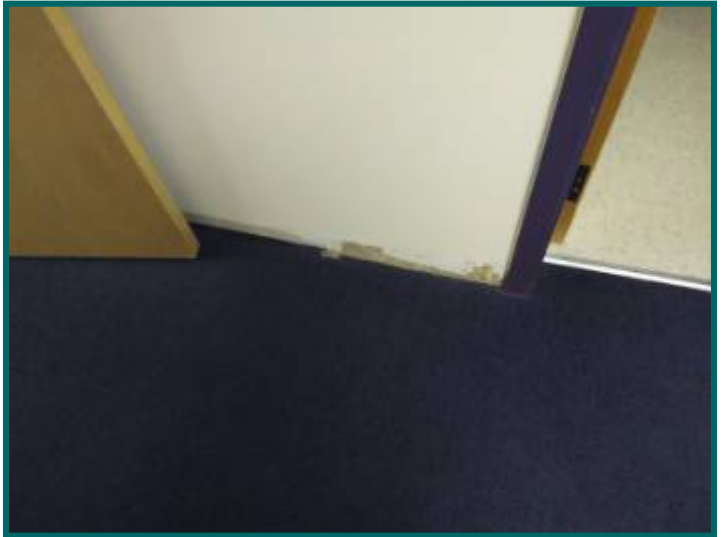
Damage to wall at Mount Washington room

Damage to wall at second floor hallway

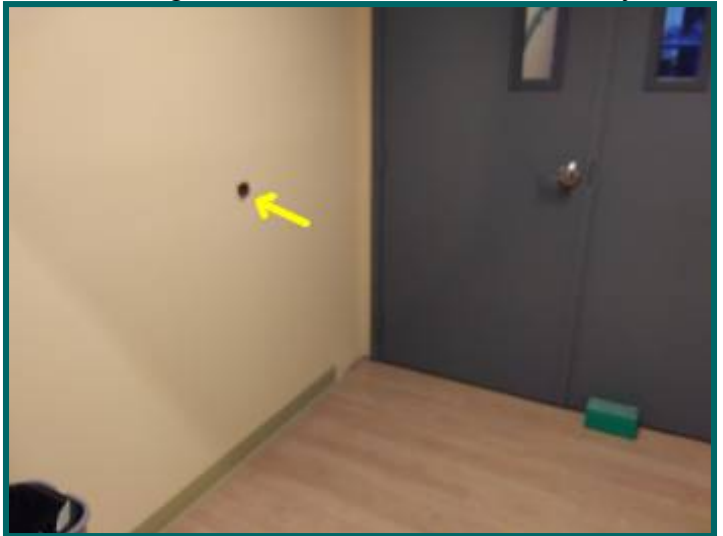
Incomplete finish second floor middle building rear

Damage to wall at middle building hallway at
warehouse entrance

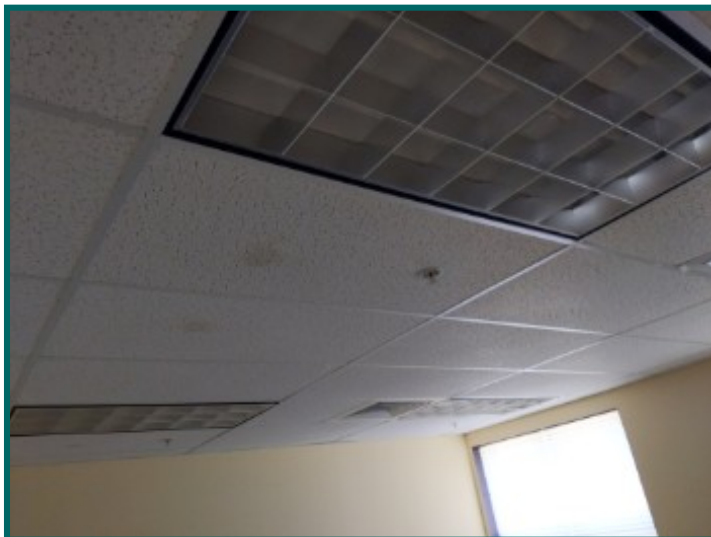
Water staining at right building front office ceiling
tested dry

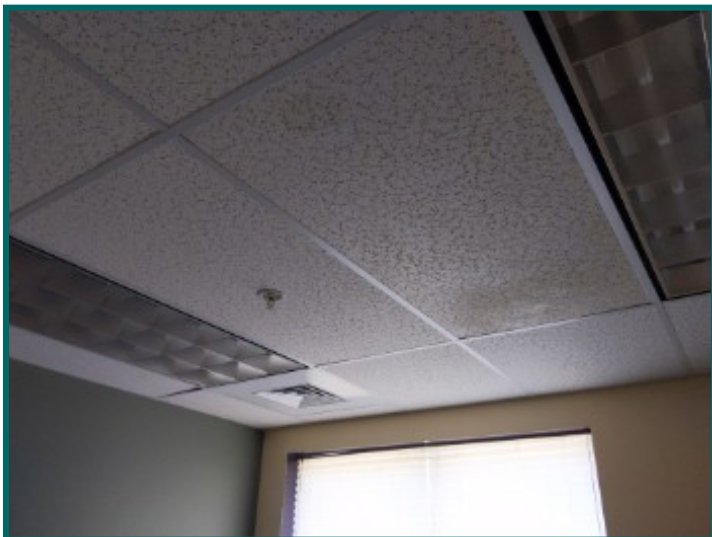
Water staining at right building front office ceiling
tested dry

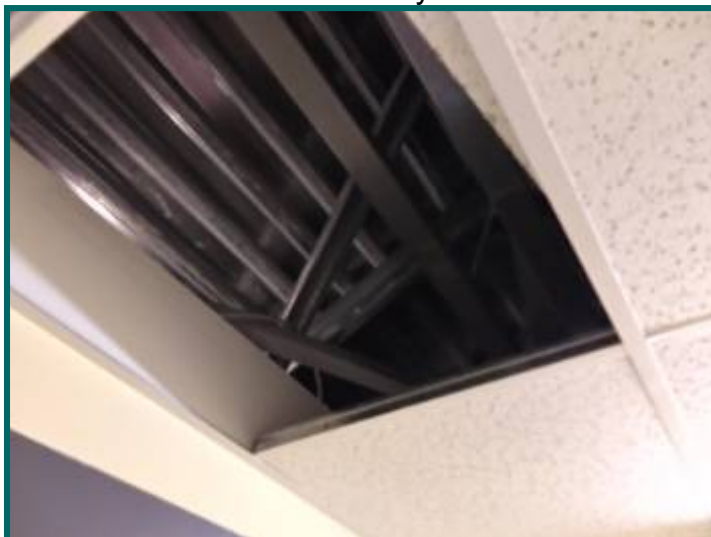
Missing ceiling tiles janitor room middle building

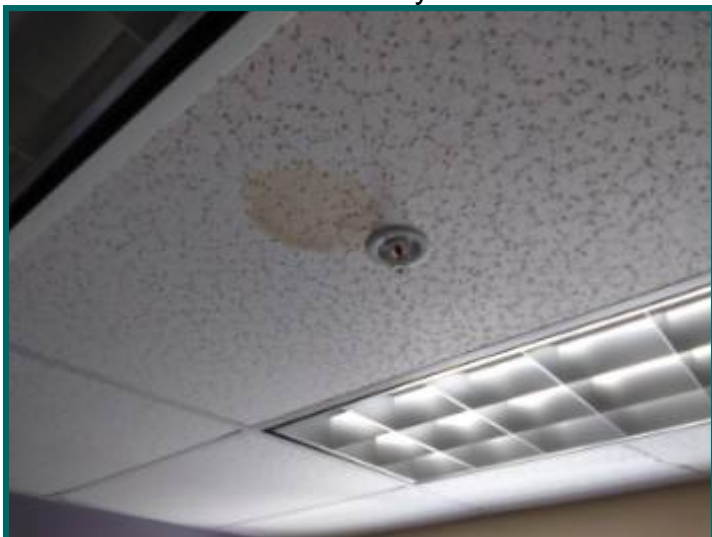
Stains on ceiling tested dry at warehouse office

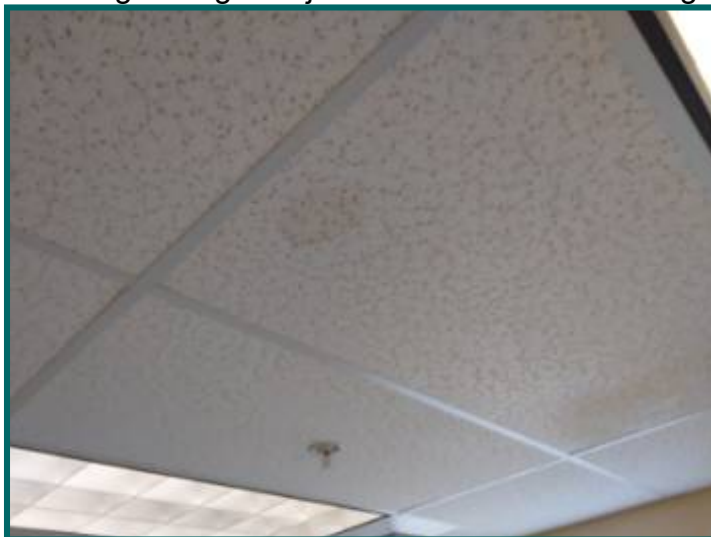
Stains on ceiling tested dry at front middle office

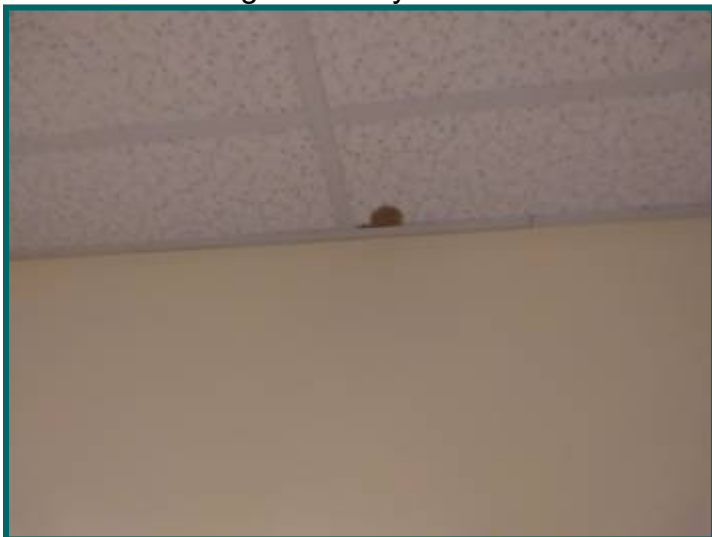
Stains on ceiling tested wet at right rear middle
building

Leak / wet condition at plumbing above right rear office middle building

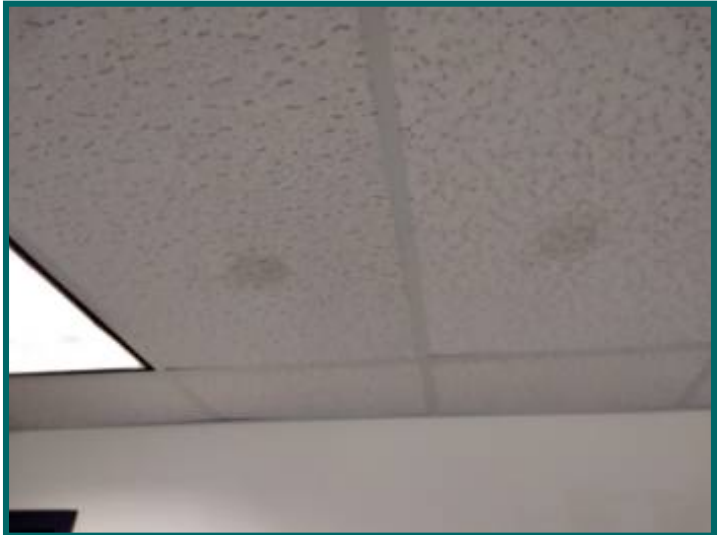
Stains on ceiling tested dry at middle office

Stains on ceiling tested dry at middle front

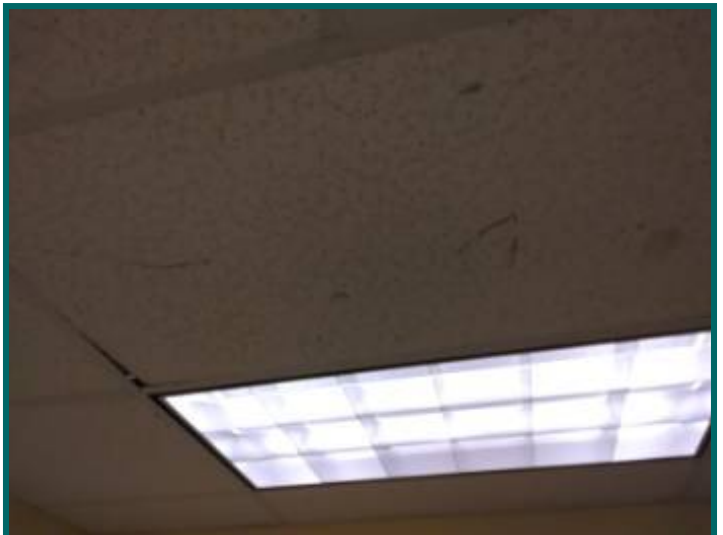
Damage to ceiling at left rear office middle building

Stains on ceiling tested dry at middle rear
