Alpha Home & Commercial Building Inspections

Property Inspection Report

industrial building 57,000 sf circa 1984 , Peterborough, NH 03458
Inspection prepared for:
Date of Inspection: 9/4/2020 Time: 9:00 AM
Order ID: 11349

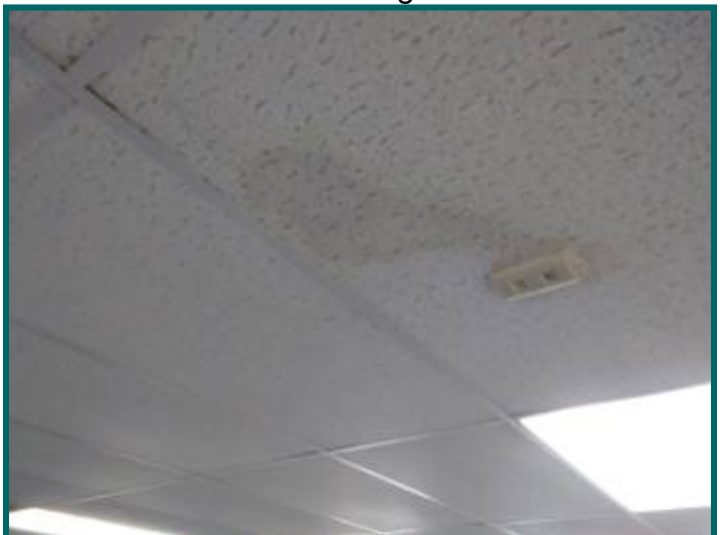
Stains on ceiling tested dry at Mount Washington room

Damaged ceiling tiles at mount Washington room

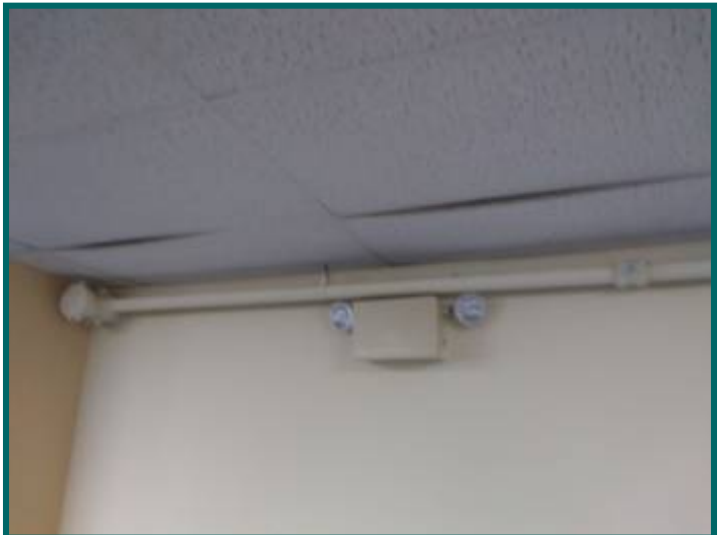
Damaged ceiling tiles at mount Washington room

Stains on ceiling tested dry at Mount Monadnock room

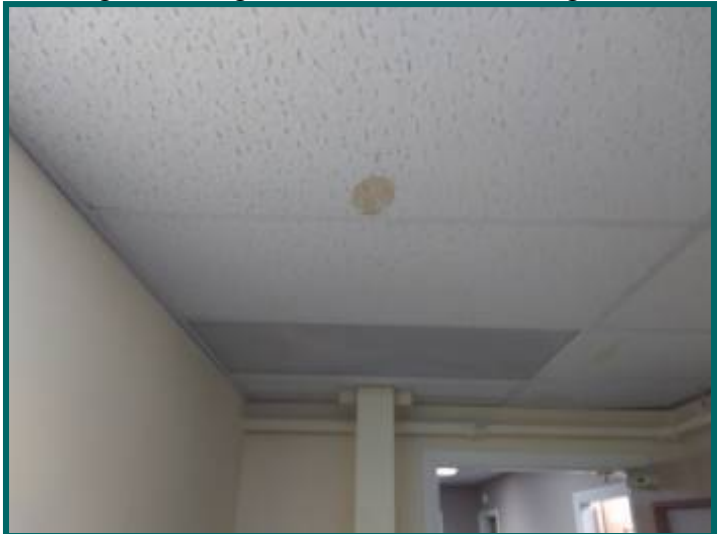
Stains on ceiling tested dry at Mount Monadnock room

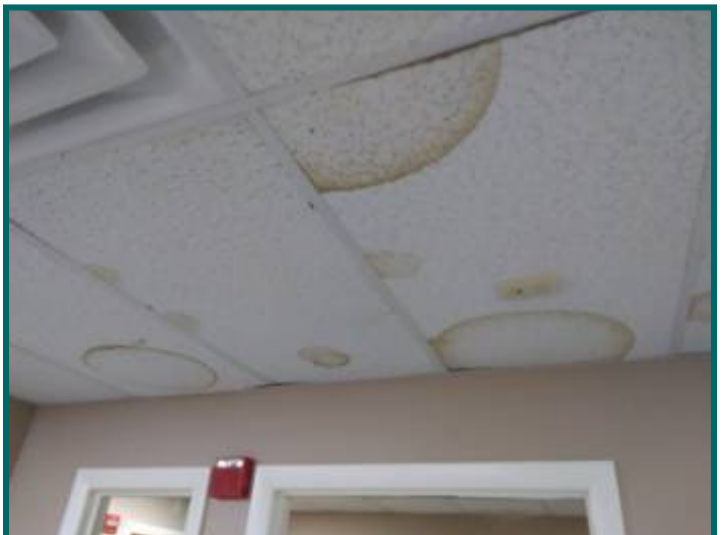
Middle front left second floor

Stains on ceiling tested dry at left building Brad Wuorinen office

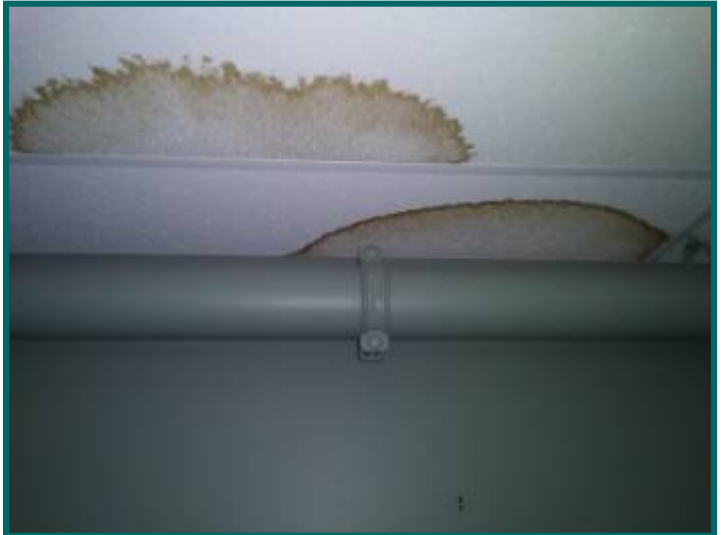
Stains on ceiling tested dry at left building middle

Damage to ceiling at left building middle office

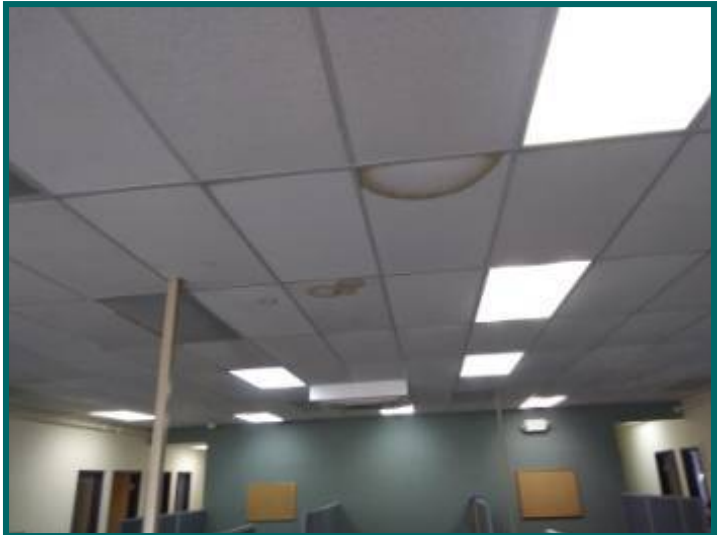
Water staining throughout left building.

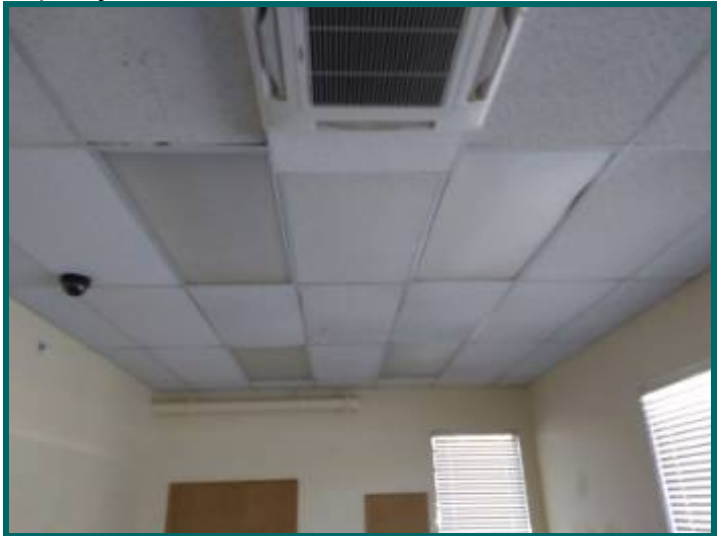
Plate covers missing at left building front office.

Lights are out throughout left building.

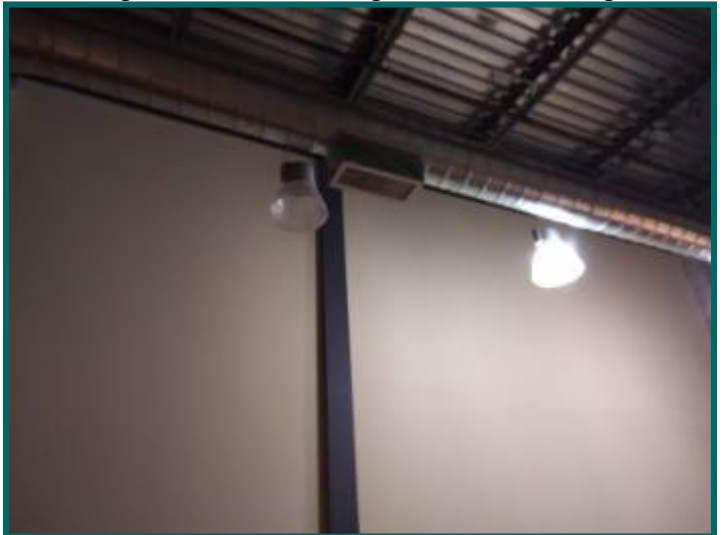
Missing plate cover left building rear

Lights out middle building hallway

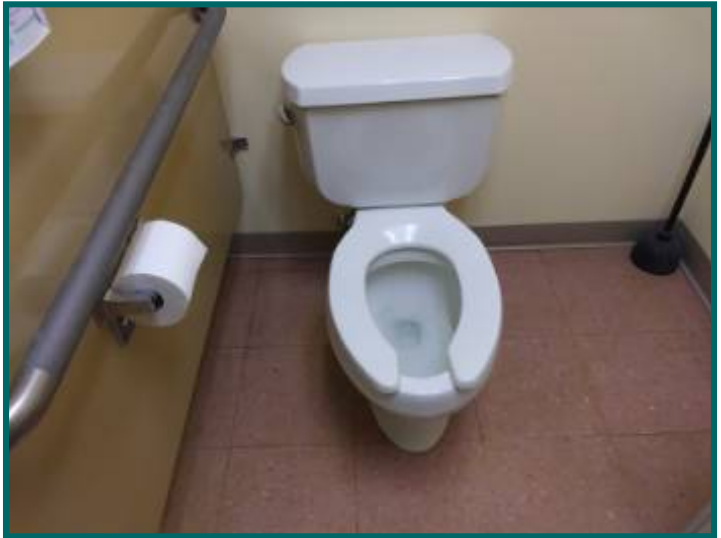
Loose toilet restroom next to Tom Mason room

Bad flusher second floor middle building ladies room

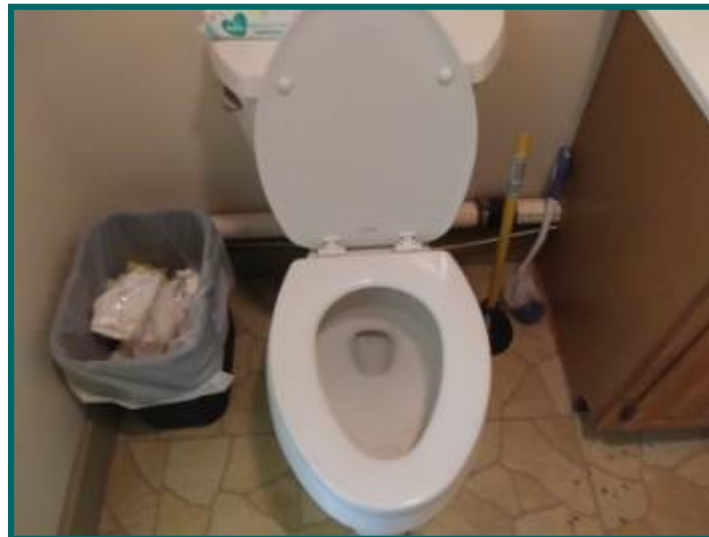
Loose toilet Neatly Done

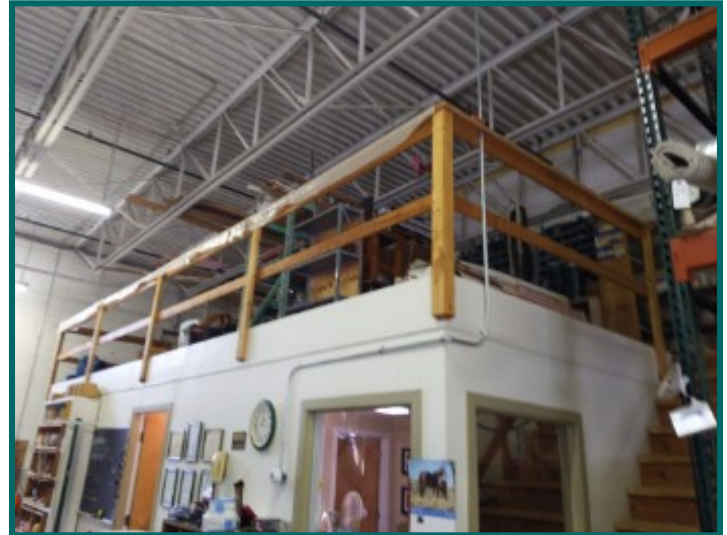
Missing graspable handrail and unsafe rail openings at Neatly Done.

Unsafe rail openings at neatly done mezzanine.

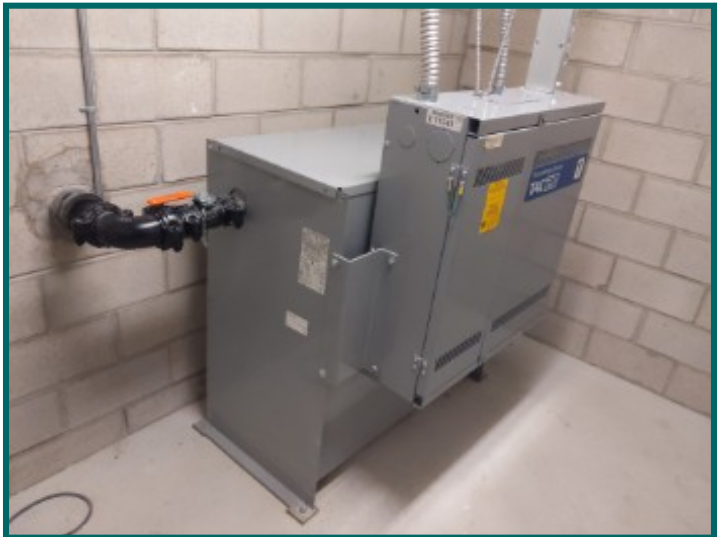
9.1. Elevator was not operating at the time of inspection. Recommend full evaluation and repairs by a qualified elevator company.

9.2. Elevators require minimum annual state inspection and regular maintenance. Last state inspection expired 5-17-17. Last service tag 5-15-19. Recommend full inspection and service as needed by a qualified elevator company.
