Alpha Home & Commercial Building Inspections

Property Inspection Report

Date of Inspection: 11/4/2020 Time: 11:00 AM
Order ID: 11820

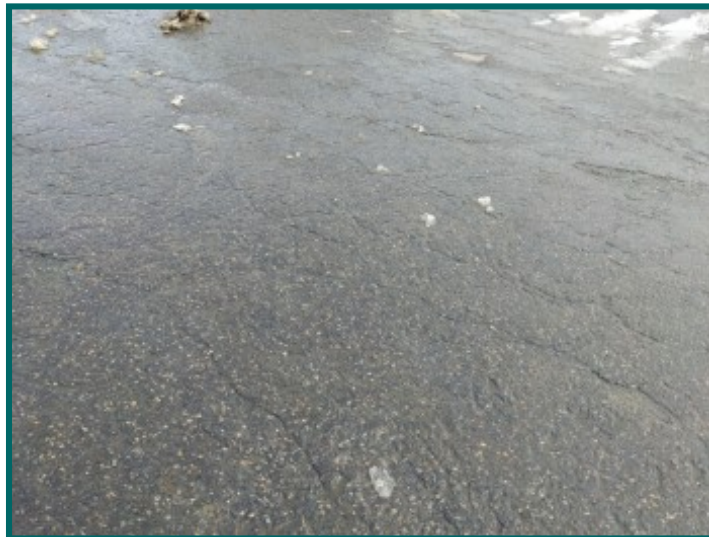
Front parking

1.2. Typical deterioration was observed at the lot surfaces. Further deterioration will occur as water expands and contracts from freeze and thaw cycles. Recommend assessment by a qualified asphalt surfacing contractor.

Cracking in surfaces

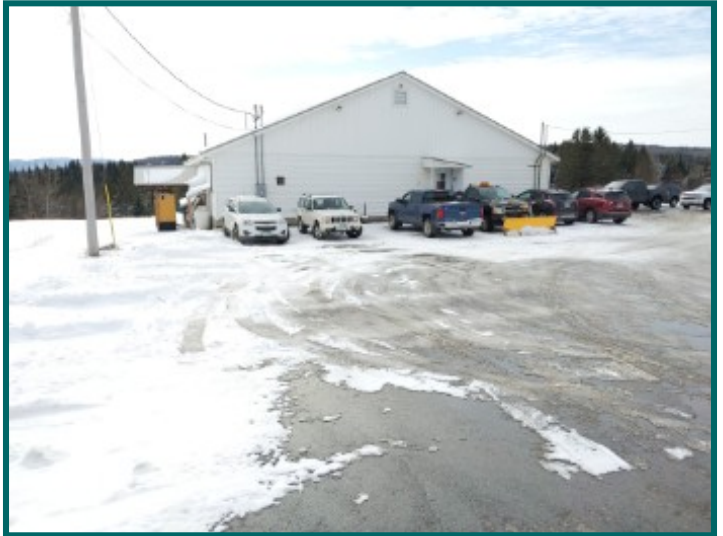
2.2. Grading at left side of building has improper slope towards foundation, this is conducive to water intrusion, hazardous icing conditions and damage to building components. Recommend monitoring condition and take measures to divert water away from this area as needed.

Grading at left side of building is toward the foundation

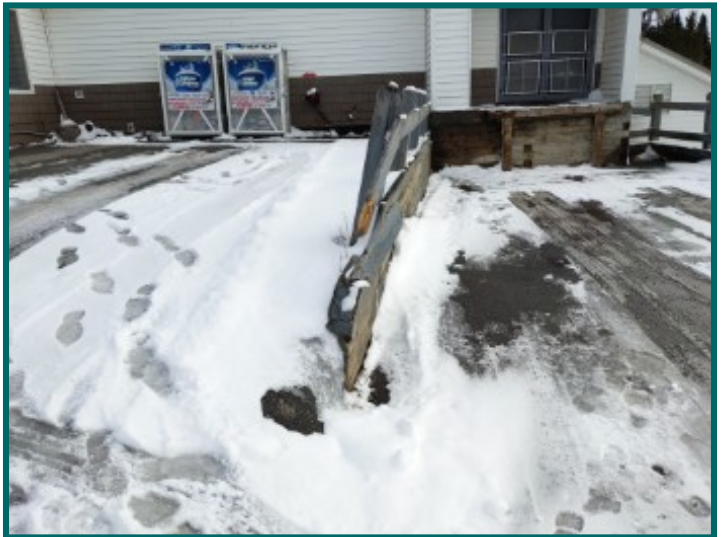
4.3. There are cracks, damage or evidence of movement in retaining walls. Recommend further investigation and repair as needed by a qualified masonry contractor.

Front retaining wall at loading dock is leaning

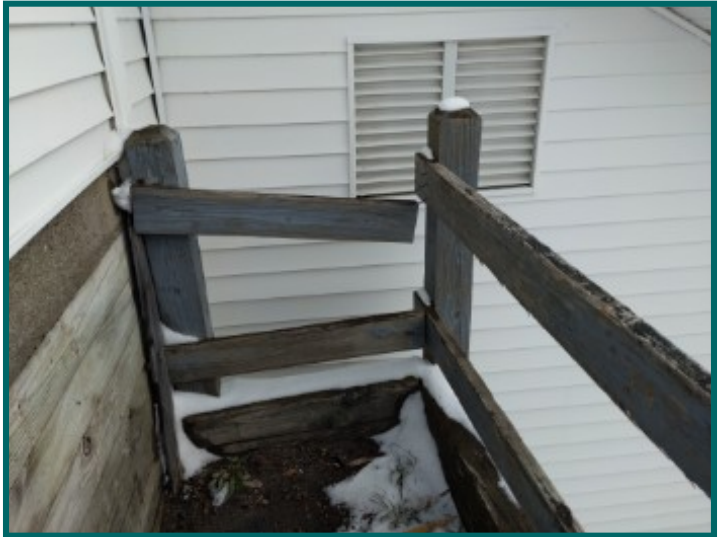
4.2. One or more areas of guardrail have damage to post or panels. Recommend assessment and repairs by a qualified contractor.

Damaged guardrail

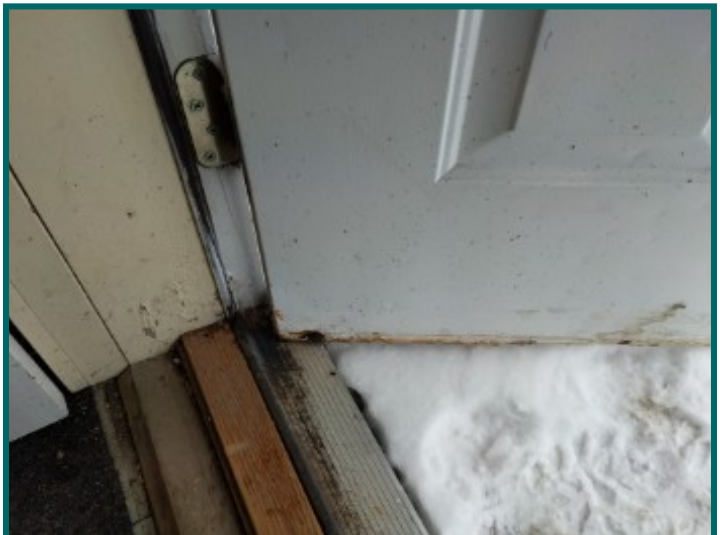
Left side door

Corrosion / damage at left side door

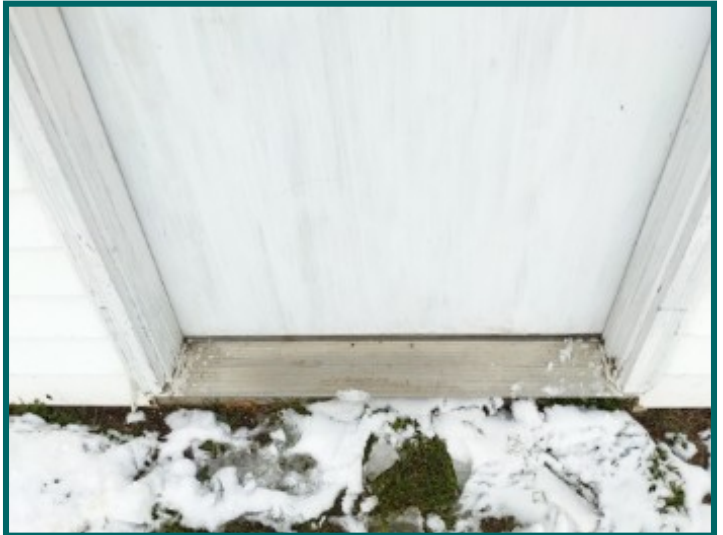
Right side lower level door

Damage at lower door and frame and peeling paint at right side lower level door.

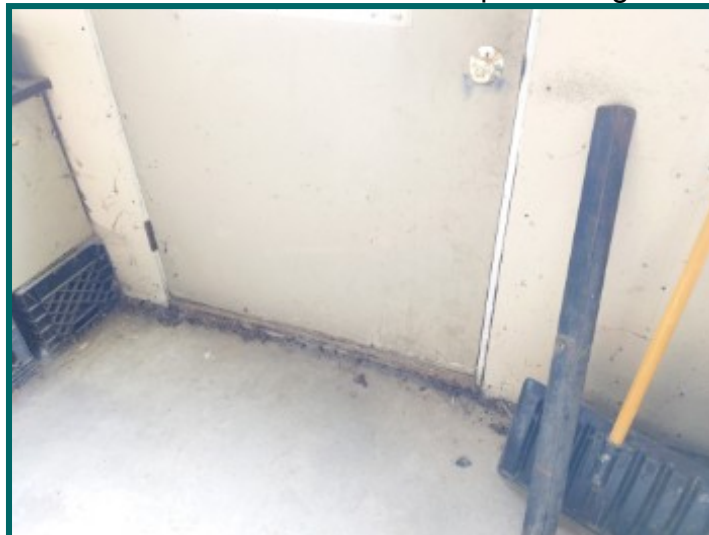
1.4. One or more exterior door does not seal well. This can be an energy drain and allow vermin into building. Recommend repair / adjustment by a qualified contractor.

Right side / basement door does not seal well.

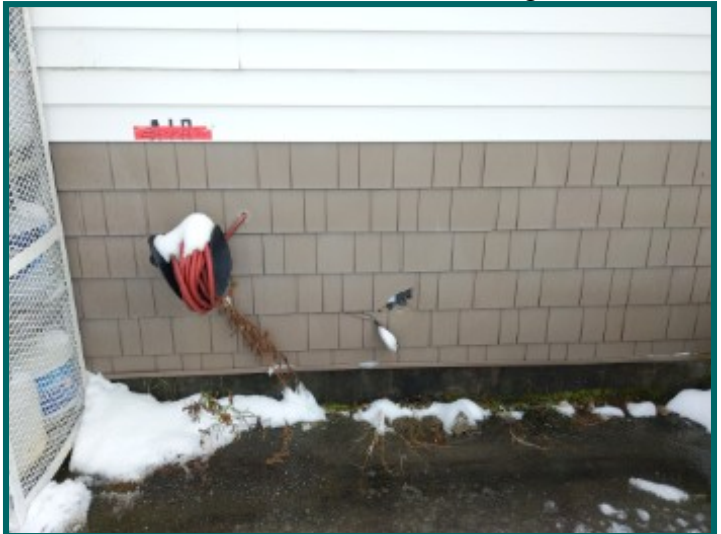
Damaged siding in front of building

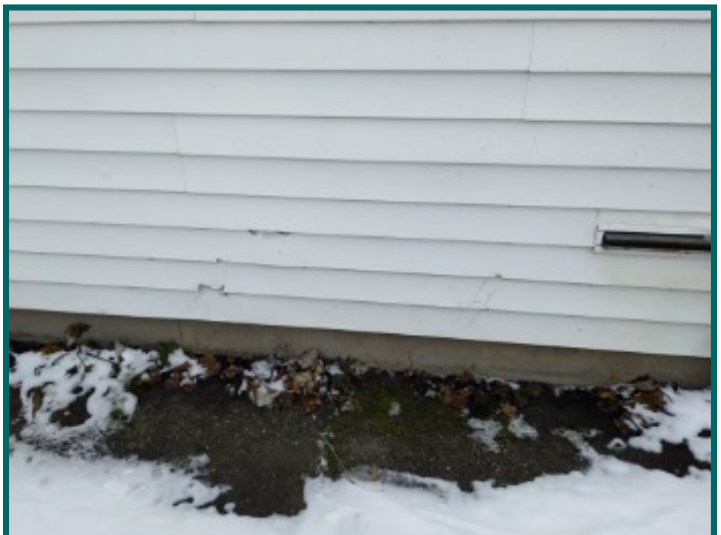
Damaged siding at left side of building

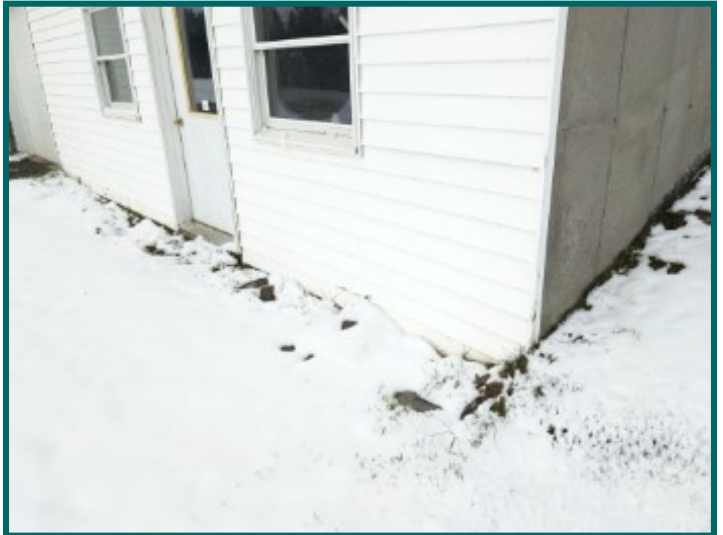
2.4. Siding is in contact with finish grade at one or more area of building, this is conducive to moisture and insect intrusion, recommend monitor area and have repaired as needed by a qualified contractor.

Damaged siding and siding in contact with ground at right side of building

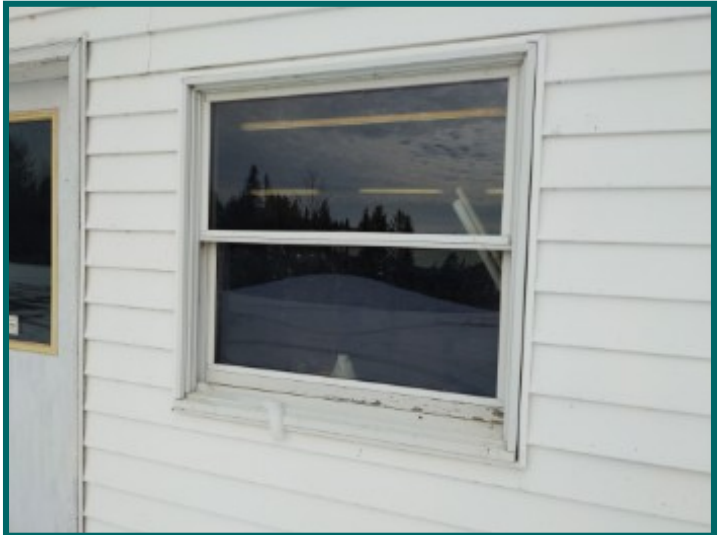
3.2. Peeling paint observed, suggest scraping and painting as necessary.

Peeling paint at right side windows.

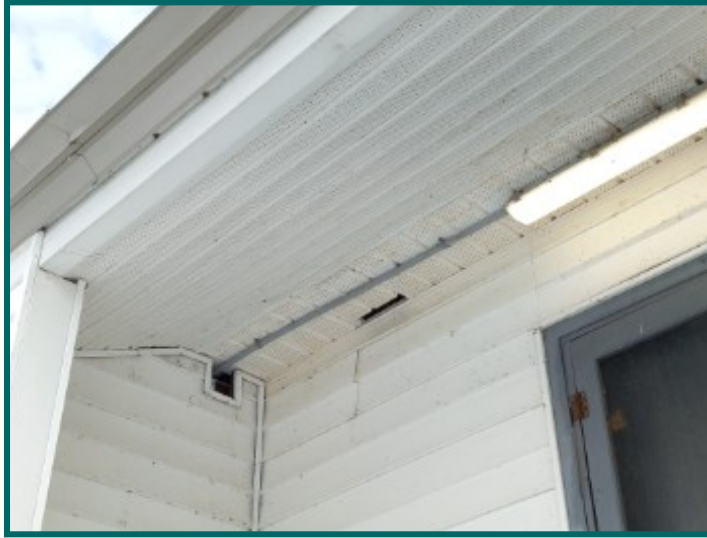
4.2. Soffit trim is gapped in one or more area, this is conducive to insect and animal intrusion, recommend repair by a qualified tradesman.

Gap in soffit at front of building

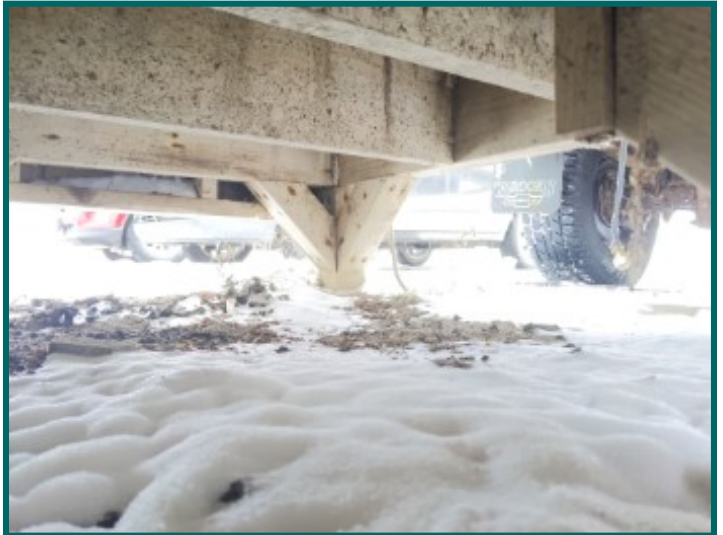
- 6.2. Porch and stairs were snow covered limiting visibility.
- 6.3. One or more support joists are missing properly installed mechanical hangers, recommend installation and proper nailing of joist hangers by a qualified contractor.

Missing joist hangers and footings were not located at left side porch/landing.

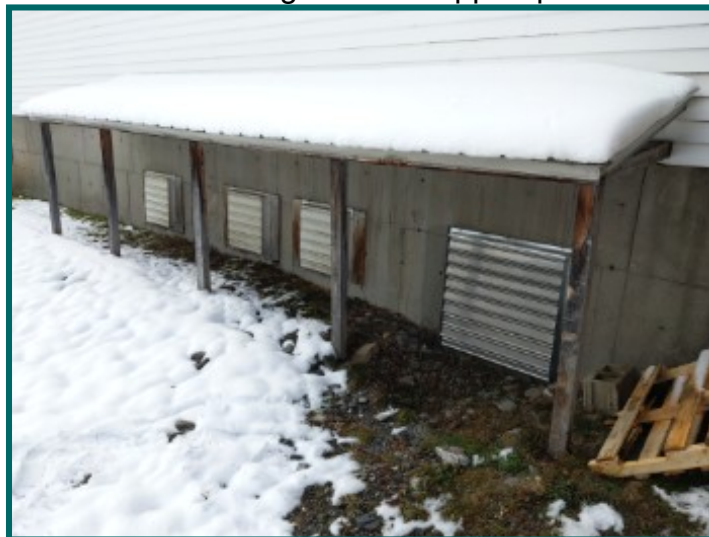
- 6.6. There are areas of settlement to decks and or porches, recommend assessment by a qualified tradesman and repairs as needed.
- 6.7. Areas of movement or damage at deck/porch framing, recommend assessment and repairs by a qualified contractor.

Settlement at rear overhang / missing footings

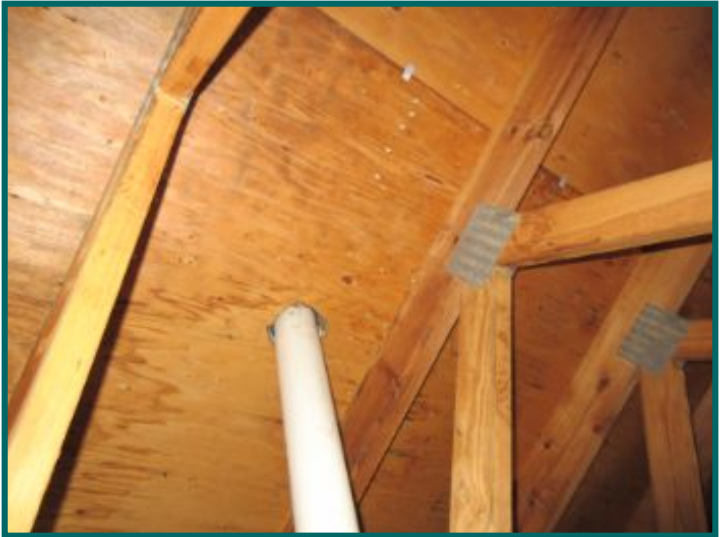
2.4. Stains were found in one or more attic surface areas, no elevated levels of moisture were found. The stain(s) may be due to past or present roof and/or plumbing leaks. Recommend asking the property owner about history of water intrusion and or assessment of any affected areas by a qualified contractor and repairs as necessary.

Stains tested dry

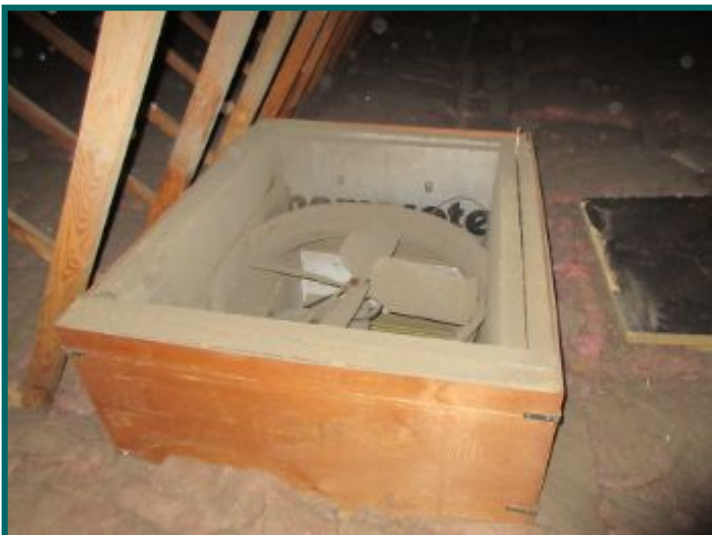
recommend insulating vent fan in winter

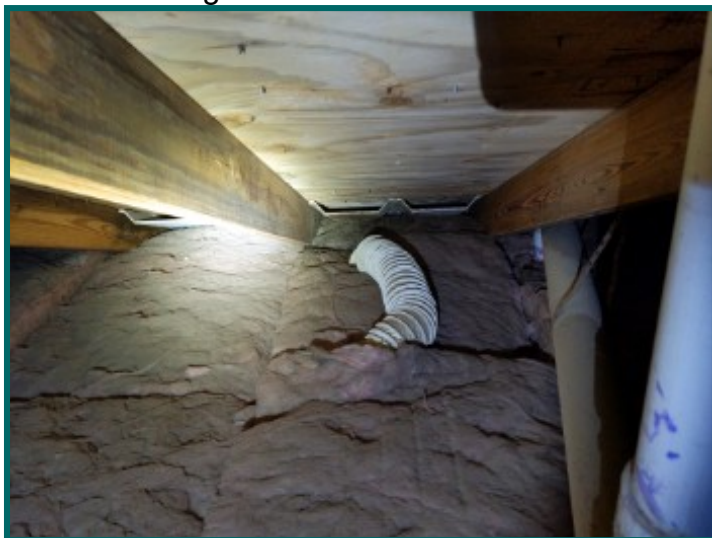
3.6. One or more bathroom / interior vent fans terminate directly into attic. This can cause condensation, staining and fungal growth on attic framing as well as be a contributing factor to ice damming. Recommend repair properly terminating bath fans / vent fans to exterior of building by a qualified contractor.

Improper bathroom vent fan termination

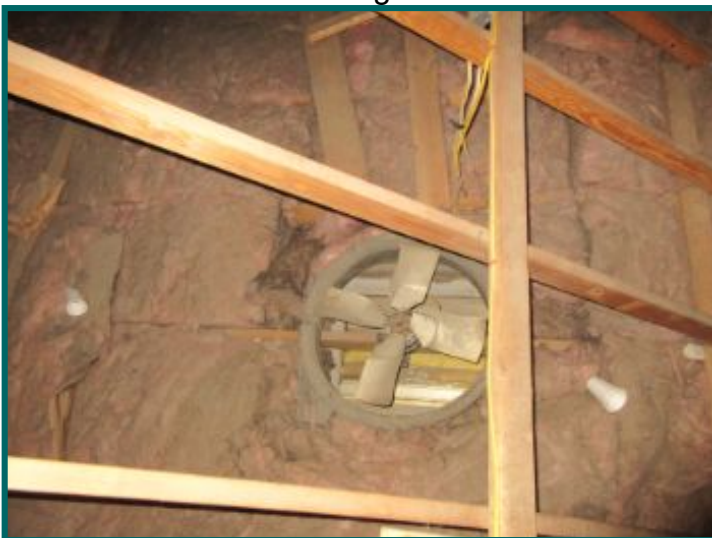
deli area fan improperly terminates in attic

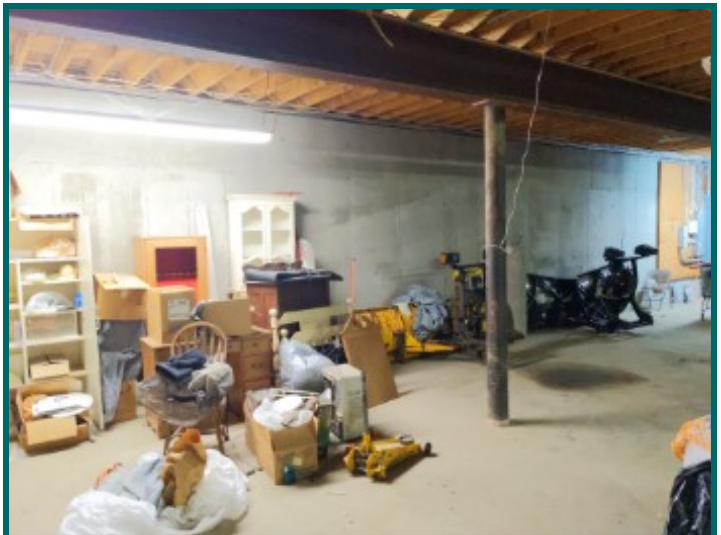
1.6. Vertical cracks noted on foundation wall at one or more location, recommend monitor for further movement and or water intrusion and sealing / repairs as needed.

Cracking at left side wall

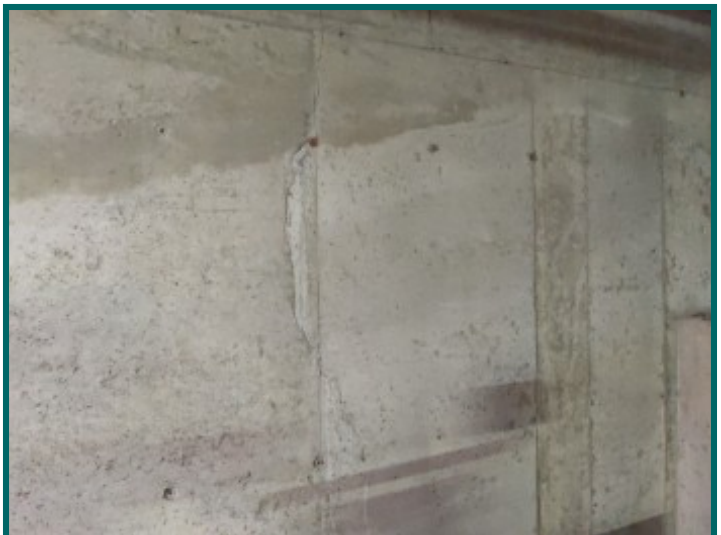
Vertical crack and water staining at left side wall

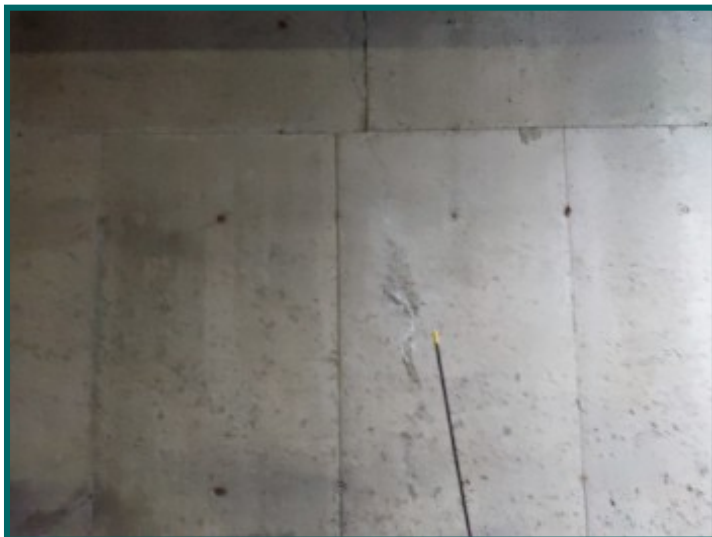
1.4. Areas of efflorescence on foundation wall. This is white hazing on wall surfaces, evidence of past or present presence of water, recommend monitor for water intrusion and assessment and repairs as needed by a qualified professional.

Vertical crack and water staining / efflorescence at left side wall

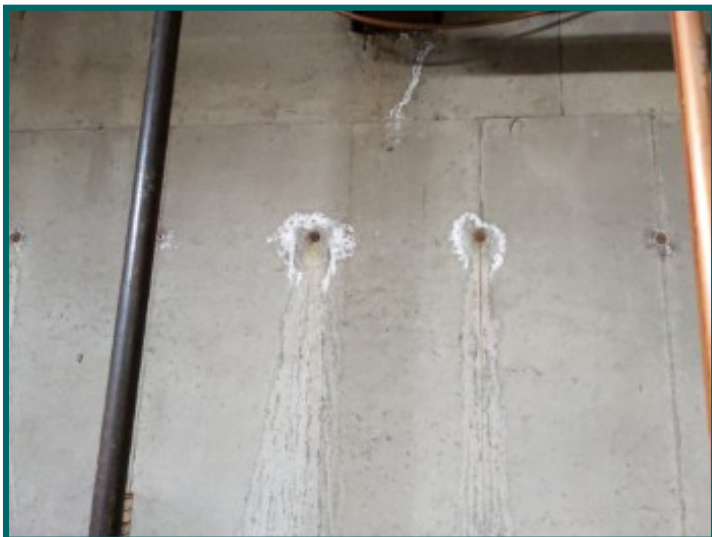
Efflorescence / water staining at rear wall

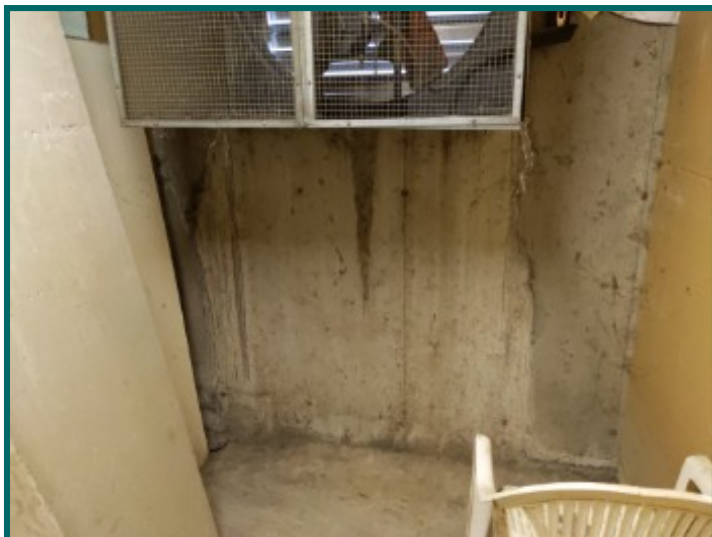
Cracks with water staining / efflorescence

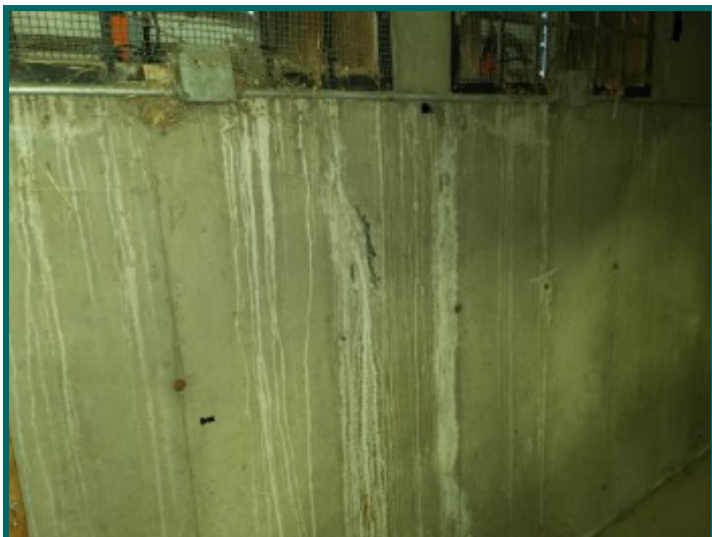
Water staining at vents.

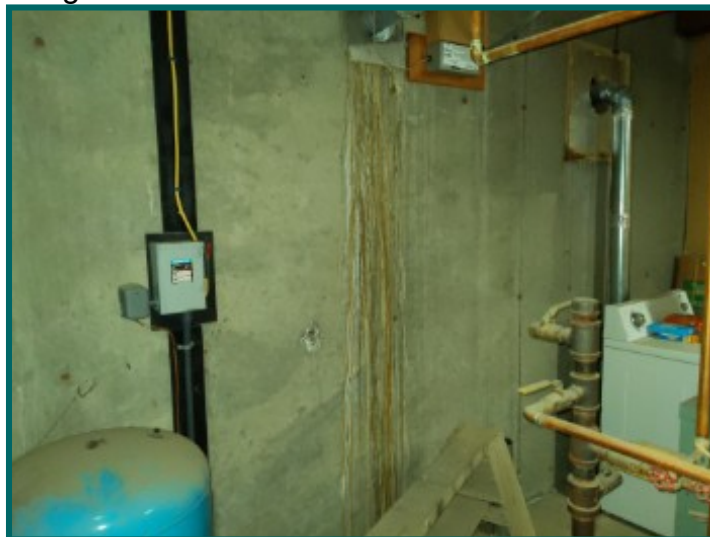
Water staining around boiler vent

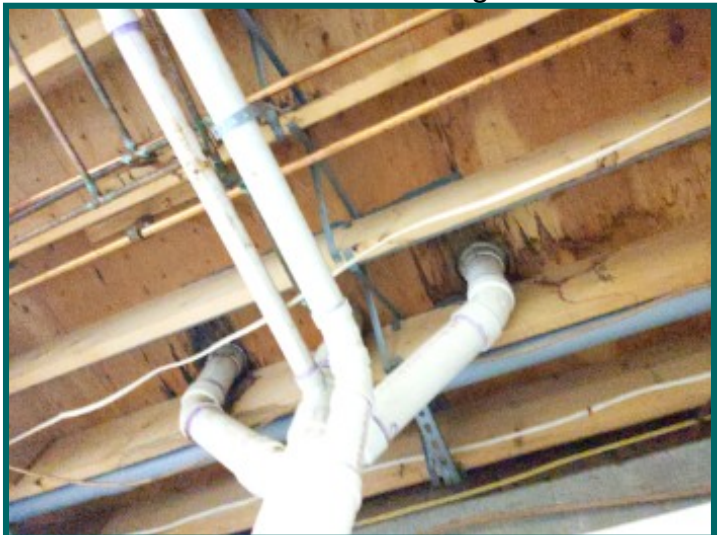
Water staining below bathrooms

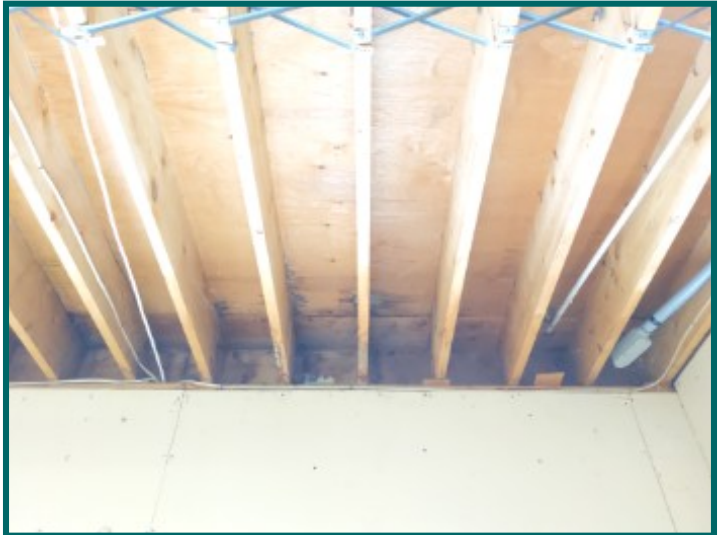
Water staining at right side of basement

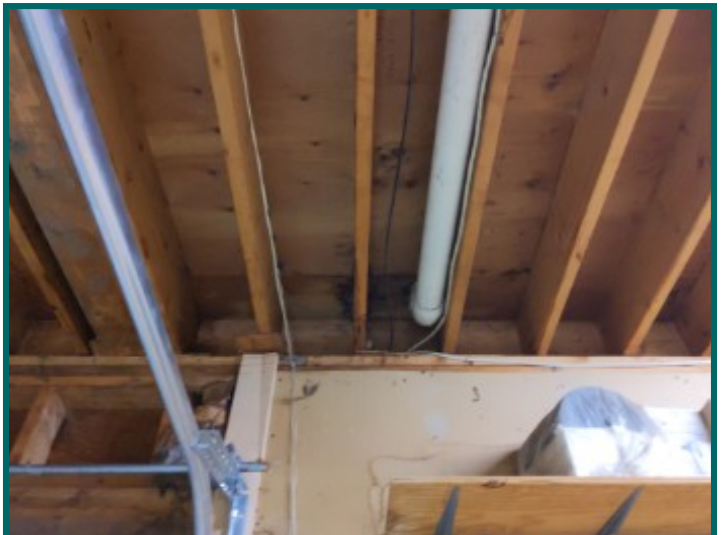
Water staining at right side of basement

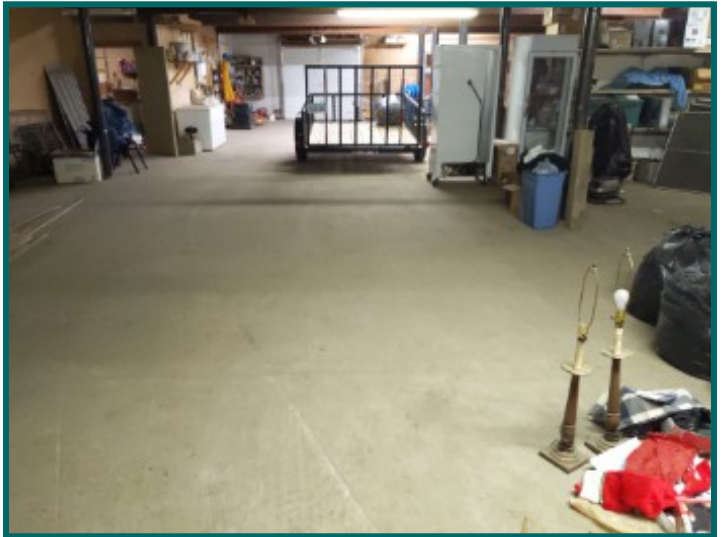
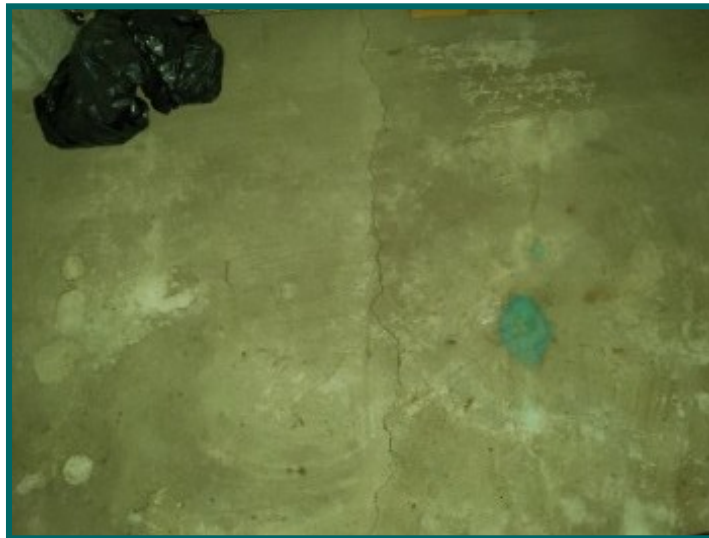
3.3. Typical settlement cracks, recommend monitor for further movement and water intrusion and repairs by a qualified contractor as needed.

Typical cracks

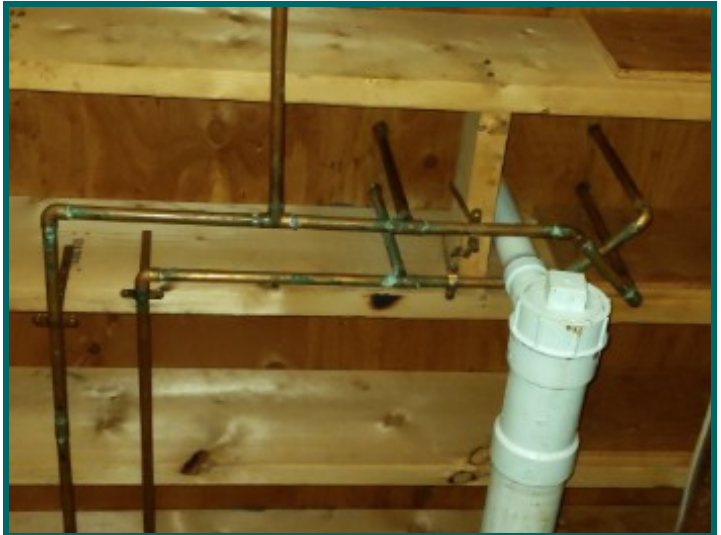
1.1. There is corrosion on one or more plumbing line or fitting in basement, recommend monitor for any further corrosion and leaking and have repairs by a licensed plumber as needed.

Corrosion on plumbing through basement

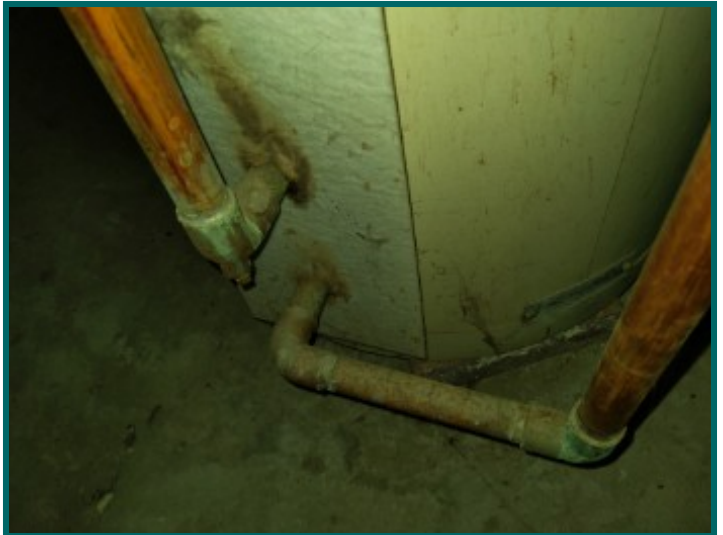
1.3. Corrosion on water line connection at one or more water heater, recommend monitor for further signs of water and repair by a licensed plumber as needed.

Corrosion at water heater plumbing lines / fittings.

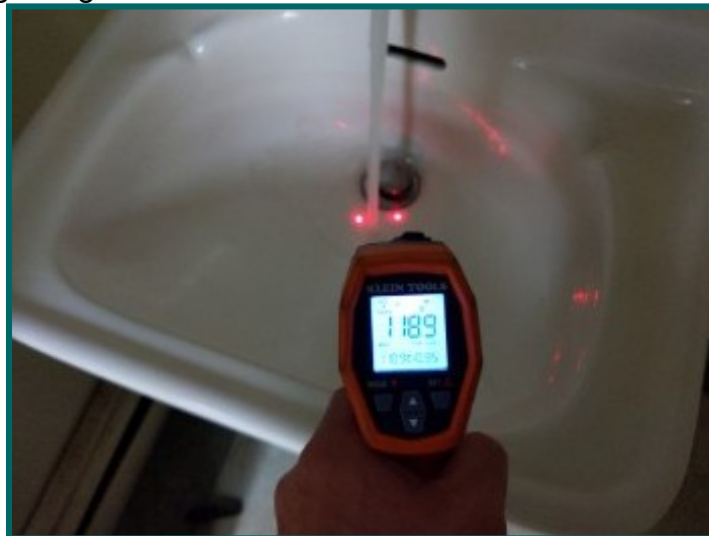
1.4. Water temperature is between 110 and 125 degrees, this is an acceptable temperature. Should be set minimum of 110 degrees for comfort and 125 degrees to prevent scalding hazard, particularly for very young and very old.

Water temperature

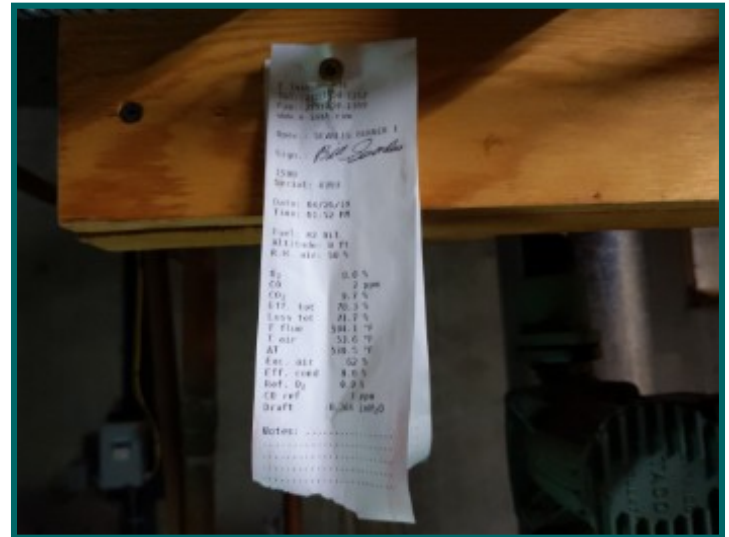
Most recent service tag.

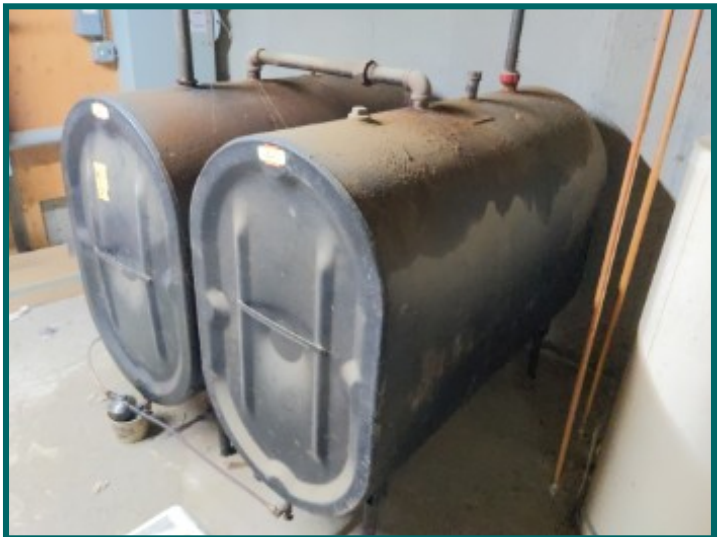
3.6. There is oil staining, wet oil on tank, oil lines / fittings, and or floor. Oil tank should be fully inspected by a qualified oil burner company and replaced or repaired as needed.

Staining on oil tanks in basement

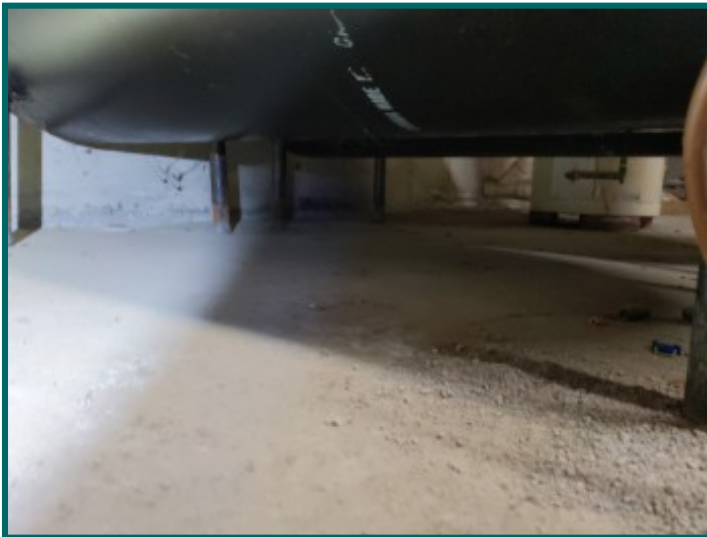
Underside of oil tanks

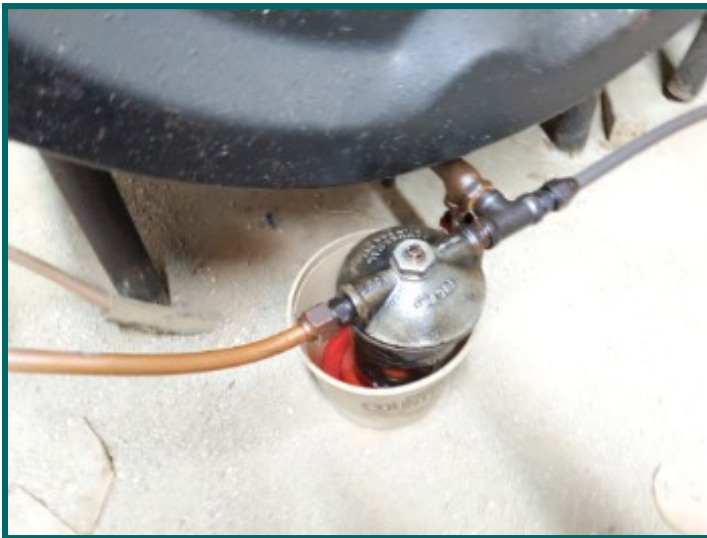
Oil leak at shut off valve/filter

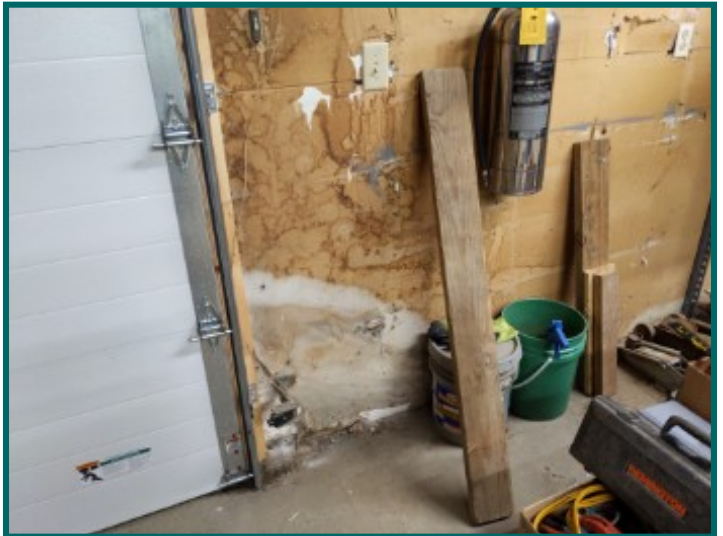
Water staining and damage to wall at overhead door. Area tested dry.

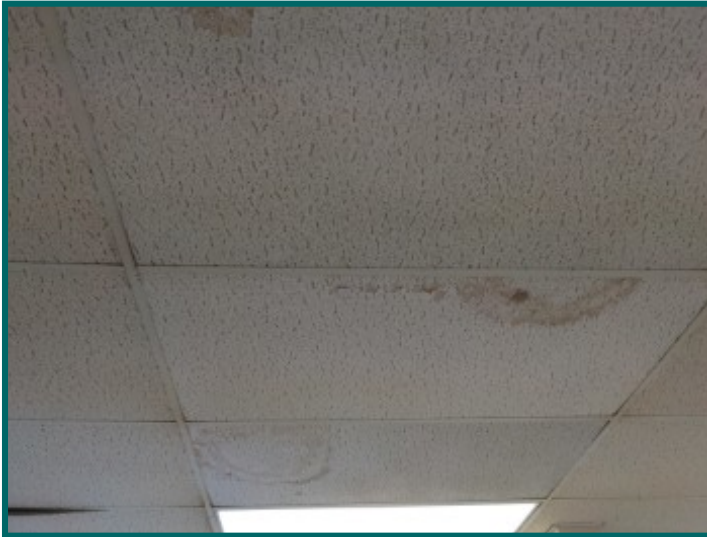
Stains on ceiling throughout

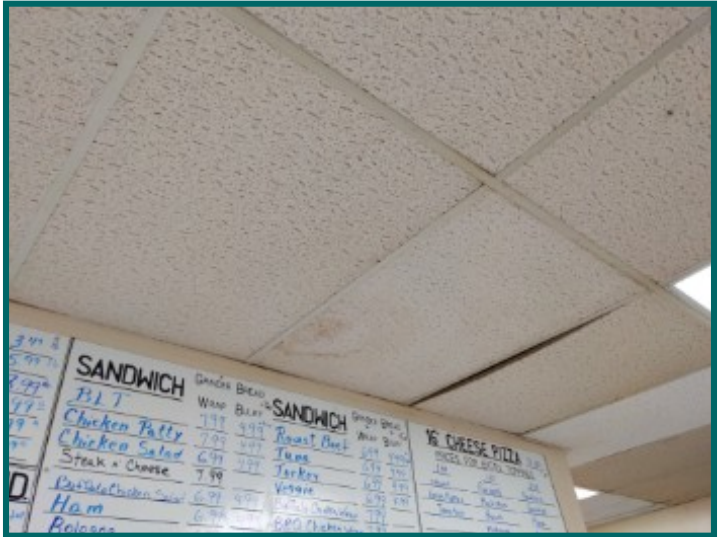
Water staining on ceiling above deli

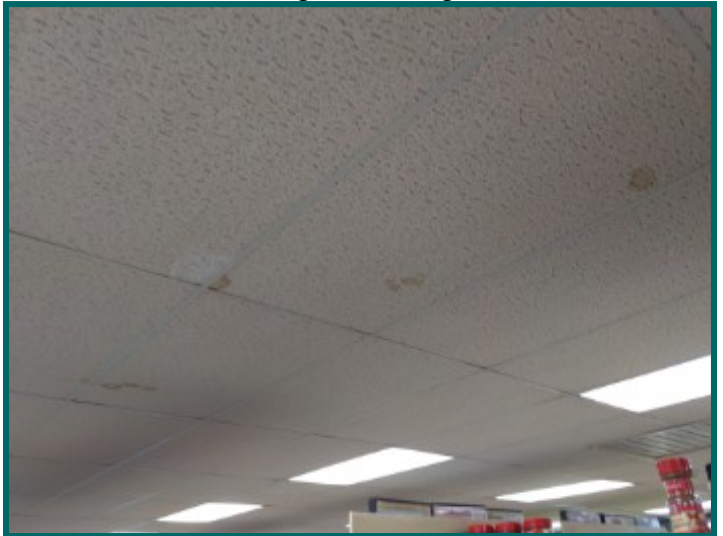
Water staining

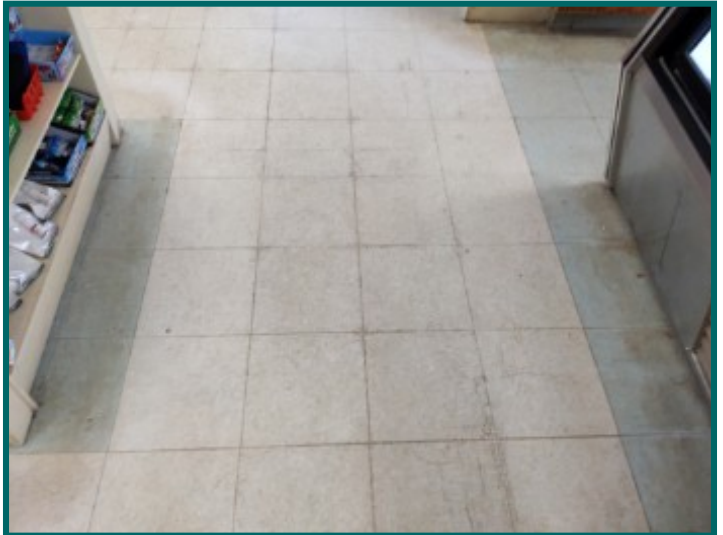
Worn flooring

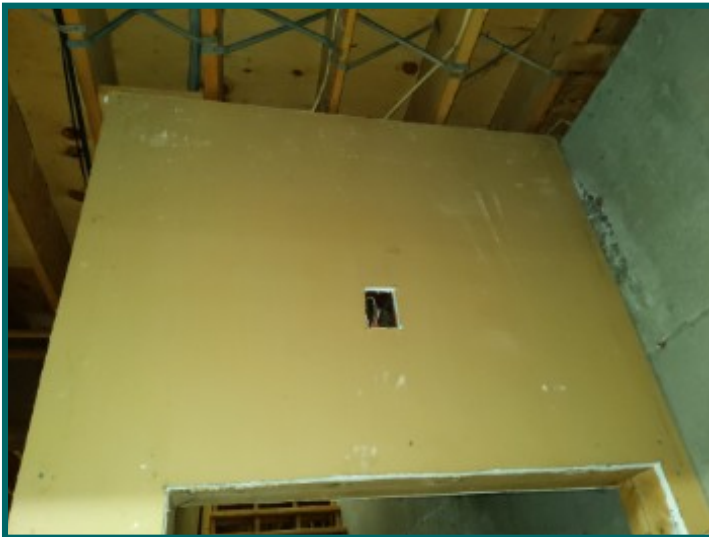
Open junction boxes in basement

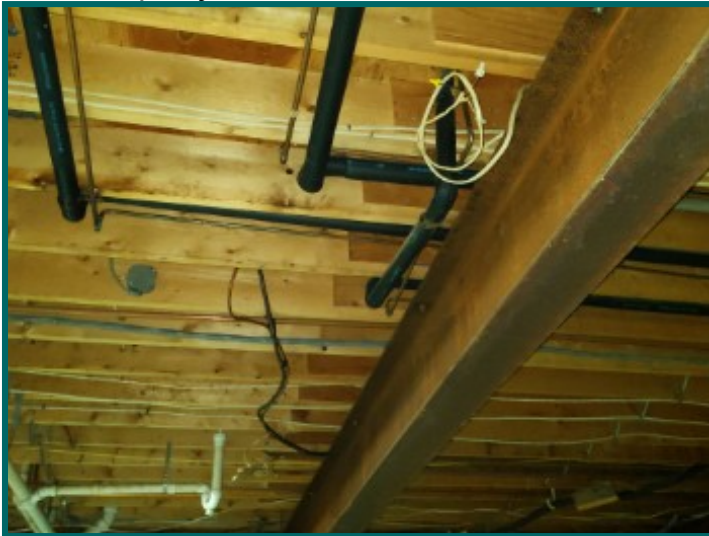
Improperly terminated wires in basement.

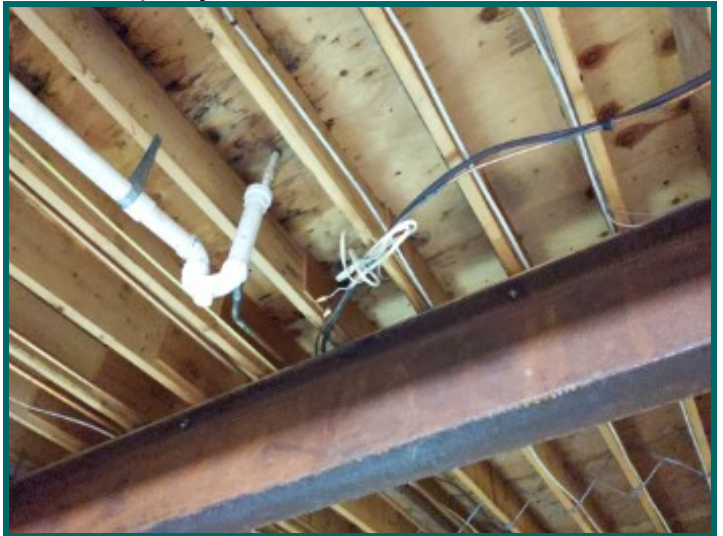
Improperly terminated wires in basement.

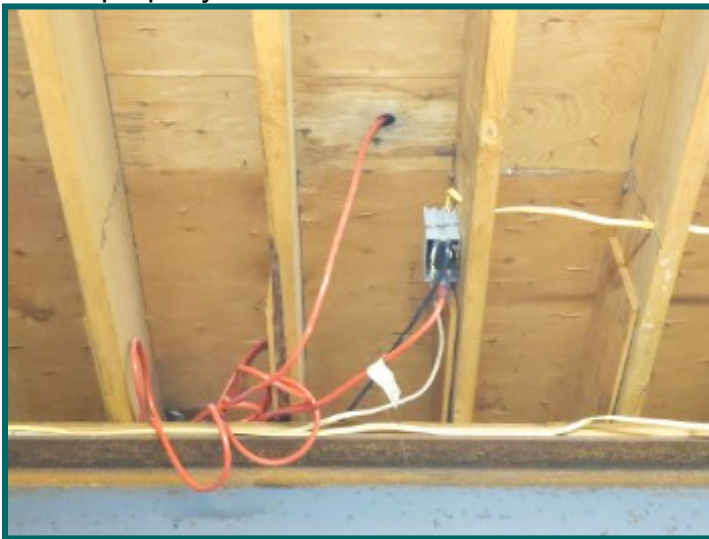
- 6.5. Improper use of extension cord observed. Extension cords should not be permanently installed or be routed through walls, floors or partitions.
- 6.6. Open junction boxes were observed, which is a safety concern. Recommend installing proper covers, as needed, for safety.

Improper use of extension cord in basement.

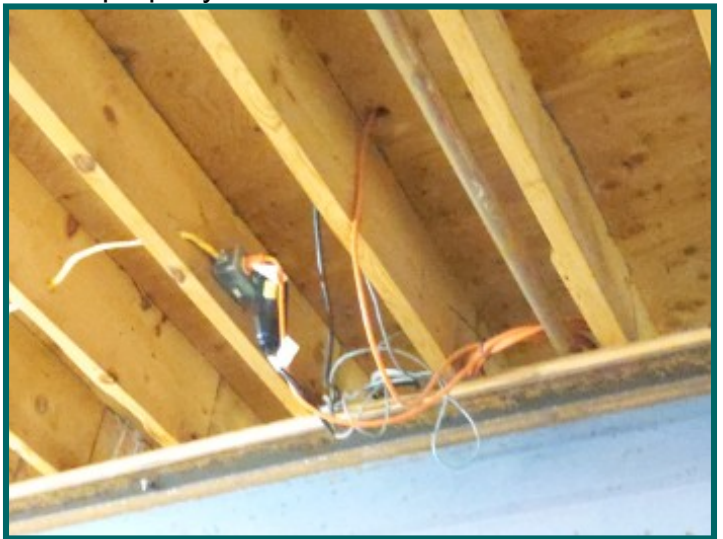
Improper use of extension cord in basement.

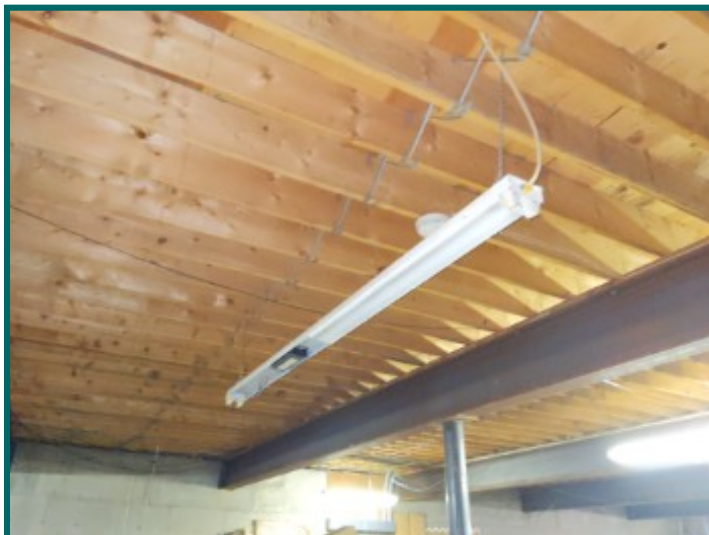
- 6.7. One or more lights is damaged, not working or improperly wired, recommend having repaired by a licensed electrician if needed.

Several damaged fixtures / lights out in basement.

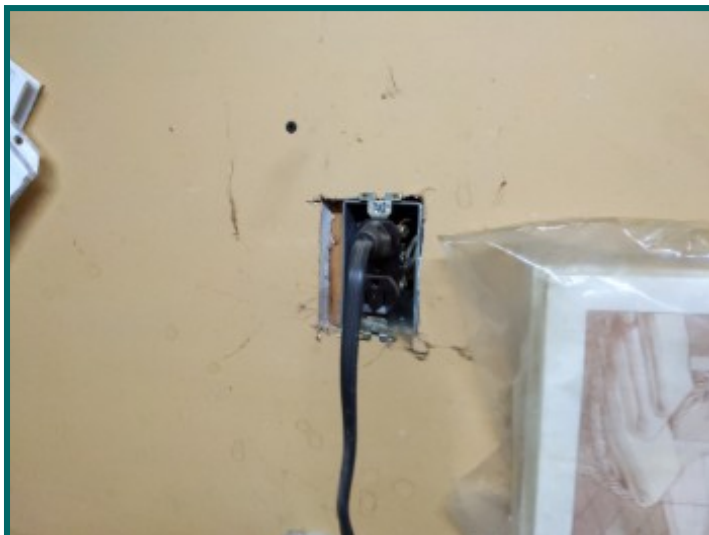
Several missing outlet covers / switch covers throughout.

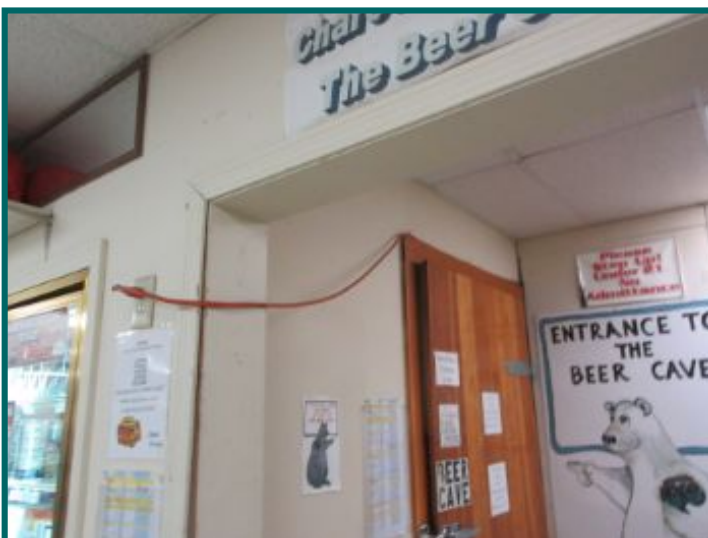
improper use of extension cord

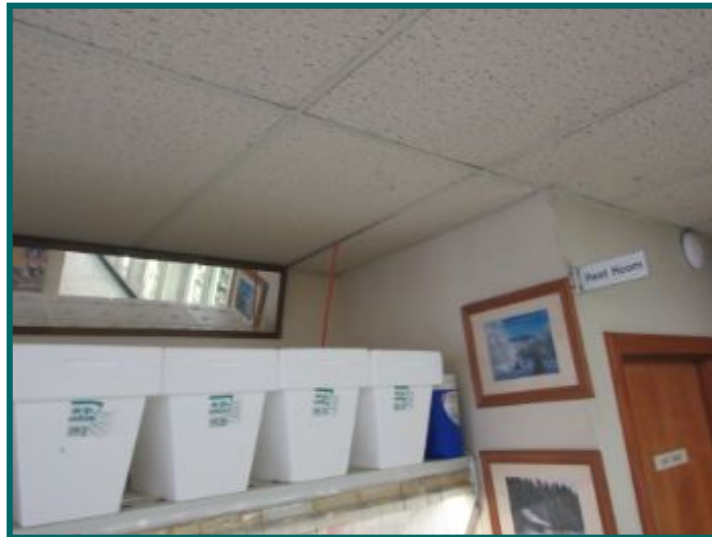
improper use of extension cord

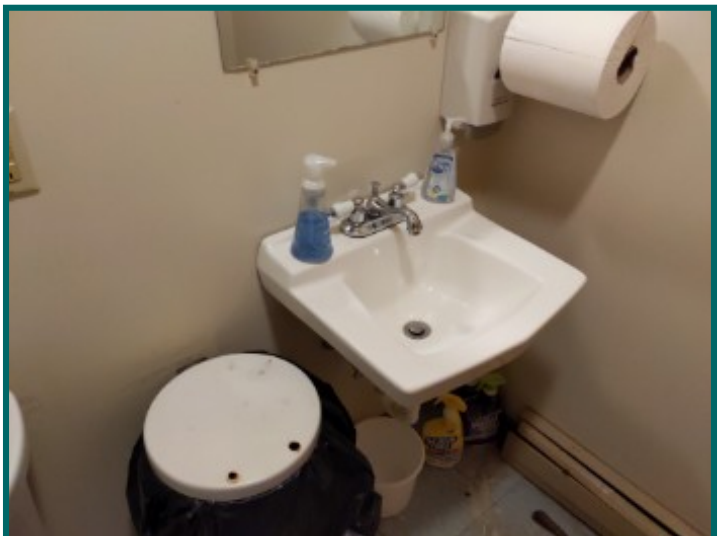
Loose sink in employee bathroom.

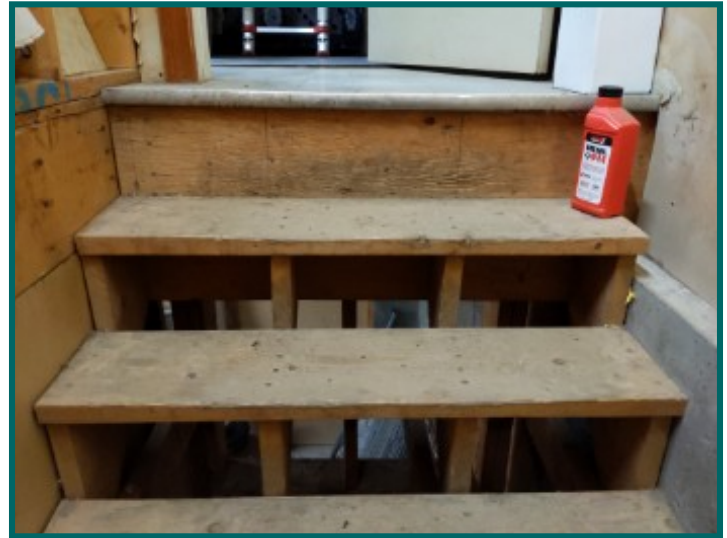
Uneven riser heights / stairs are not built to today's safety standards.
