PROPERTY INSPECTION REPORT

Steve Mangekian License # 0054 Alpha Home & Commercial Building Inspections

Date of Inspection: 8/12/2020

The subject property is a free-standing building operating as a church approximately 10,900 sq ft, reported to be constructed in 1970., Lowell, MA

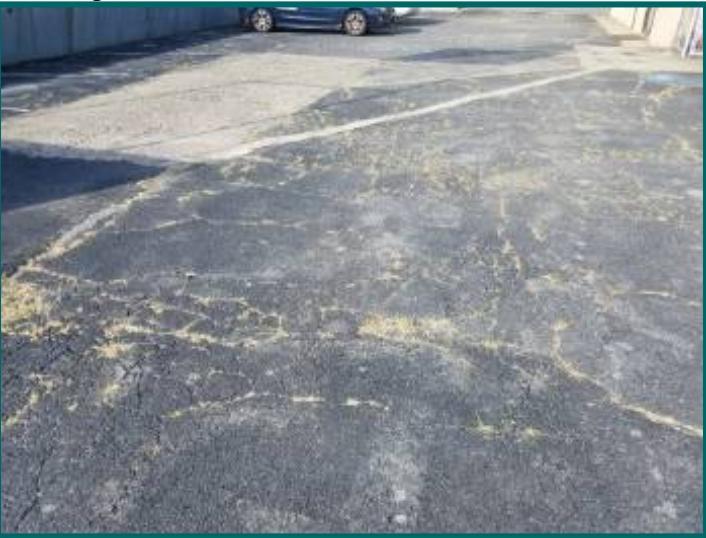
1.2. Excessive deterioration and cracking was observed at the asphalt surfaces. Recommend assessment and repairs by a qualified asphalt contractor.

Cracking in surfaces

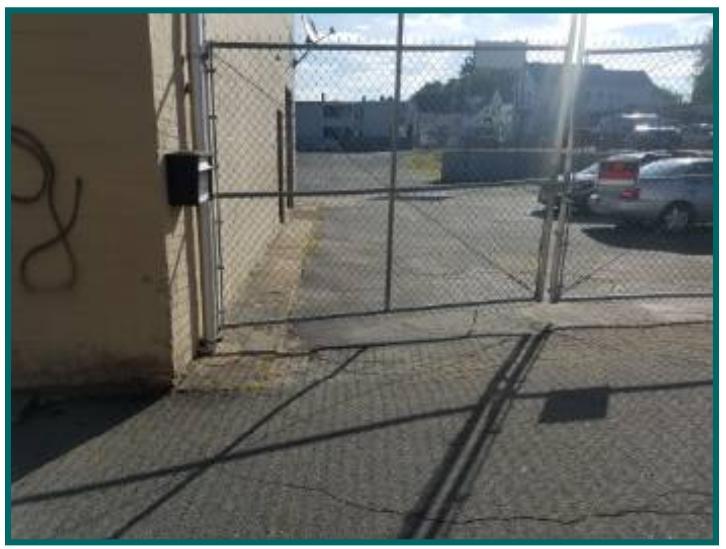
2.2. Grading at one or more area of property has neutral slope, this may be conducive to ponding of water against foundation, recommend monitoring condition and take measures to divert water away from this area as needed.

Neutral grading at front

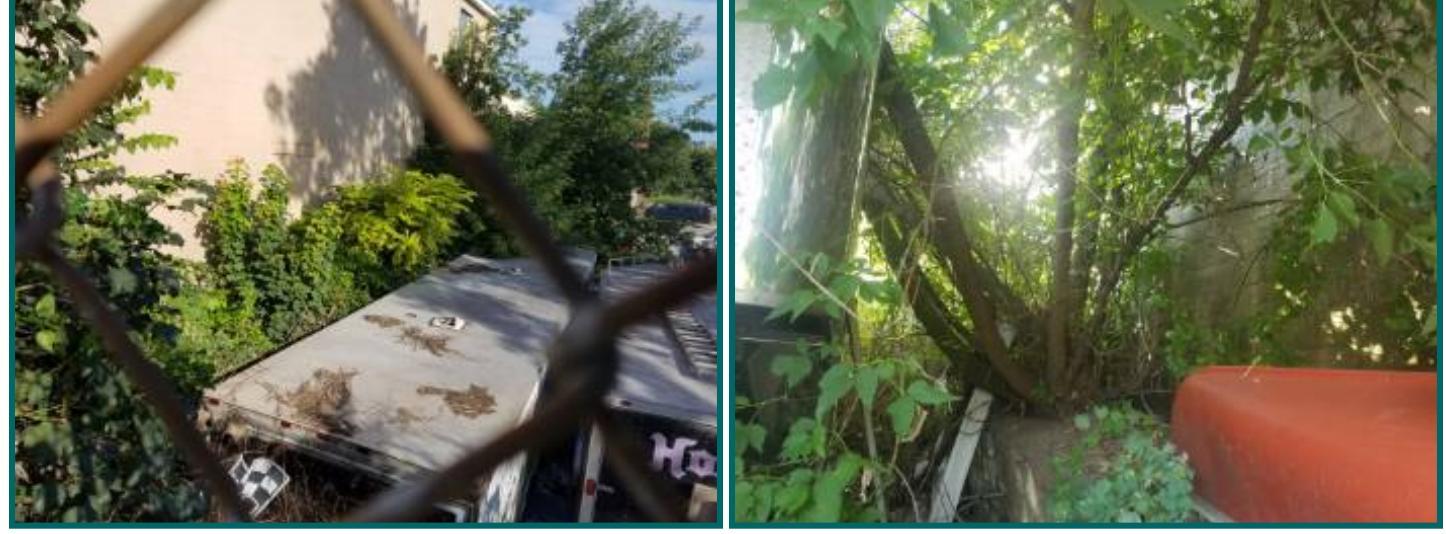
3.2. There is one or more large tree in lot; the roots may cause problems with the plumbing, asphalt surfaces, and or foundation. Recommend assessment by a qualified tree removal company.

3.3. Vegetation such as trees, shrubs and/or vines are in contact with or less than one foot from the structures exterior. Vegetation can serve as a conduit for wood destroying insects and fungal growth and may retain moisture against the exterior after it rains. Vegetation should be pruned and/or removed as necessary to maintain a one foot clearance between it and the structures exterior.

Dense vegetation at right side

Large tree at right side

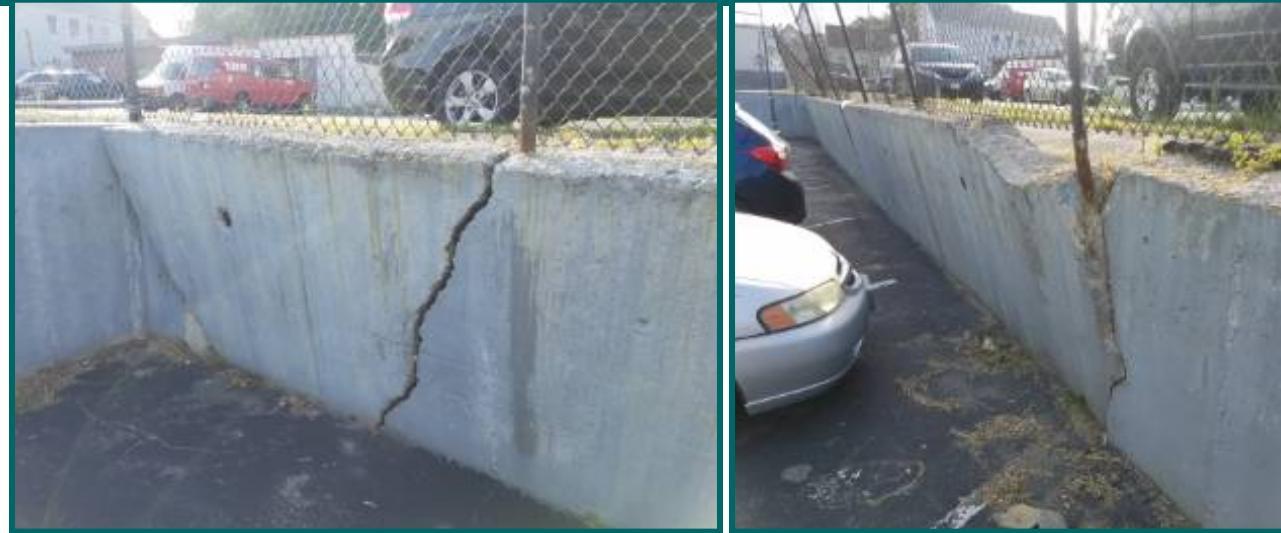
4.2. There are cracks, damage or evidence of movement in retaining walls. Recommend further investigation and repair as needed by a qualified masonry contractor.

Large cracks

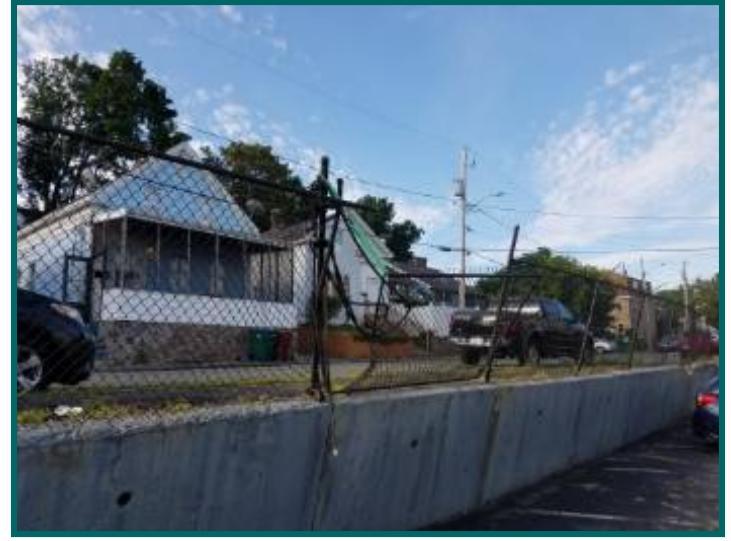
4.3. One or more areas of fencing have damage to post or panels. Recommend assessment and repairs by a qualified fence contractor.

Damaged fence sections

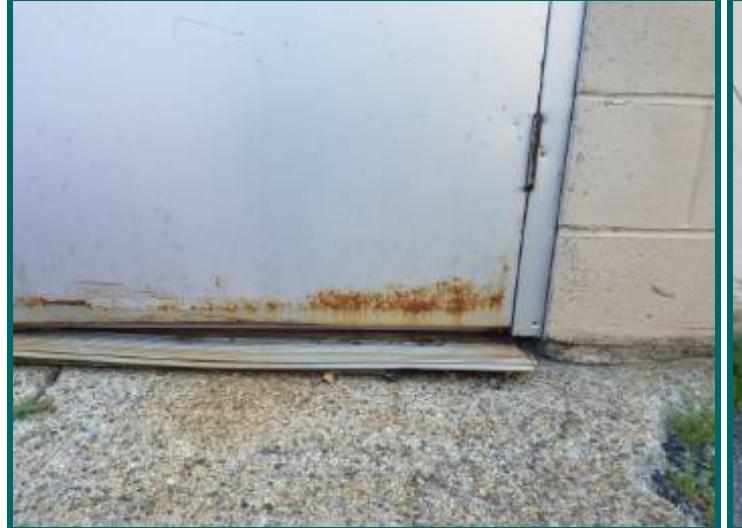
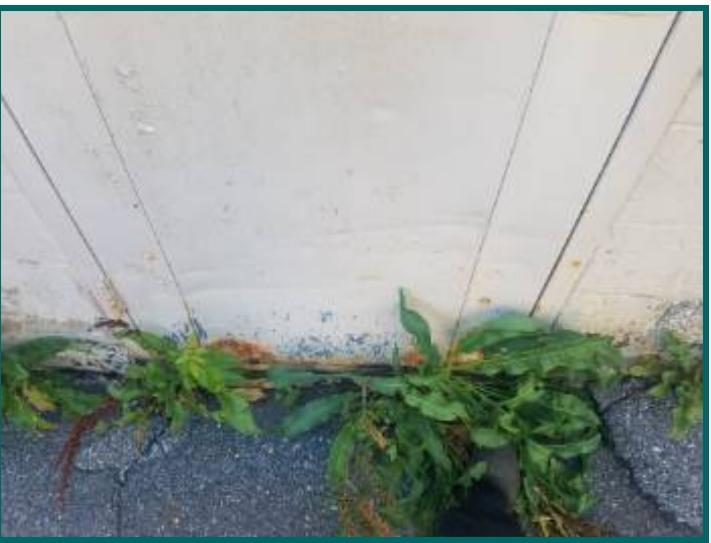
1.2. Corrosion, damage or deterioration on surface of door and or door frame at one or more area. Suggest repairs/replacement as needed.

Corrosion on door and damaged threshold at left Damage/corrosion to door and or trim at left side side entry

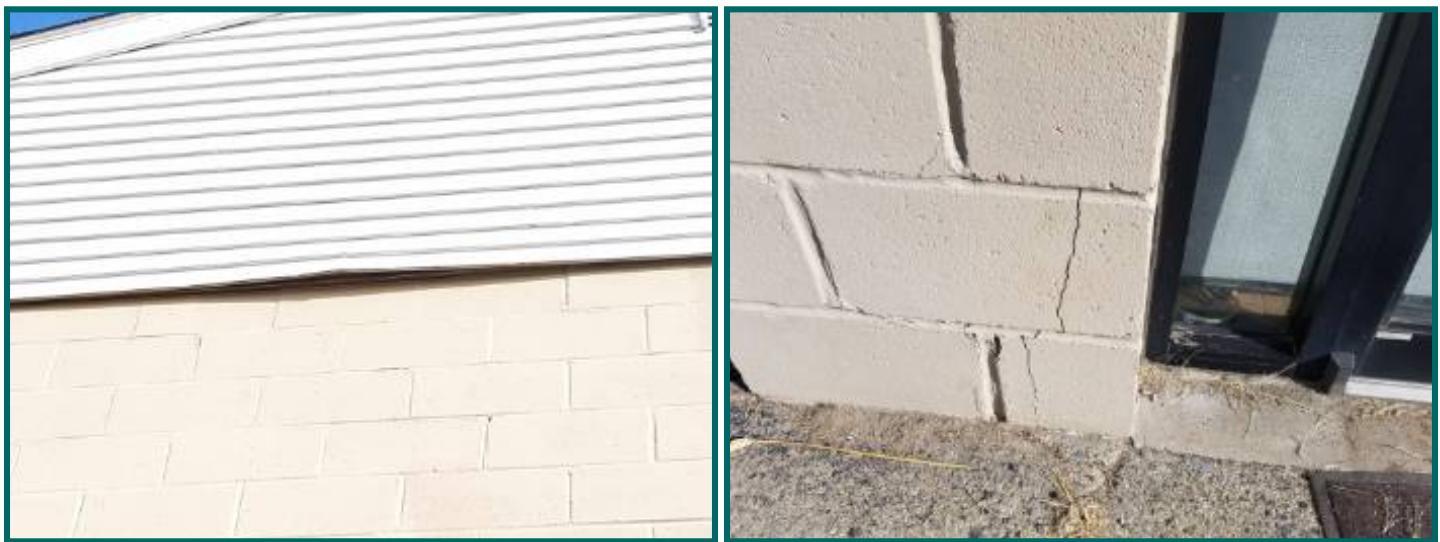
2.3. There is vertical and or step cracking at one or more areas of exterior wall, recommend assessment and repairs by a qualified masonry contractor.

Lifting siding at front

Step cracking at front

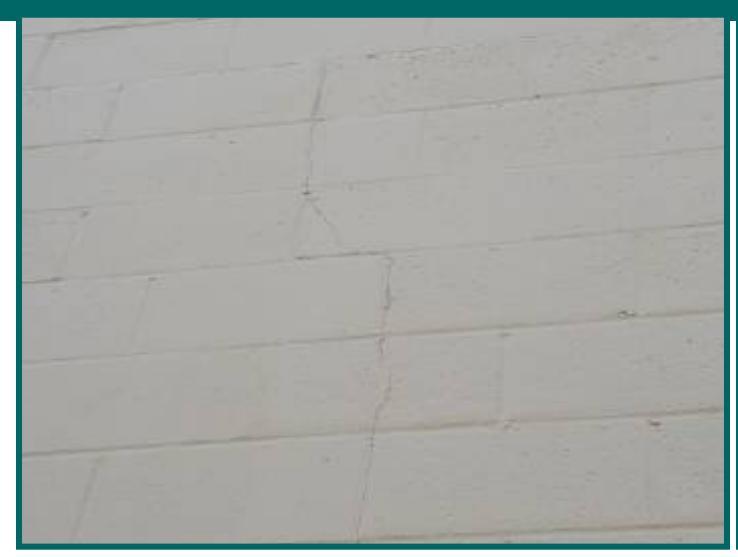
Several small vertical and step cracks at left side

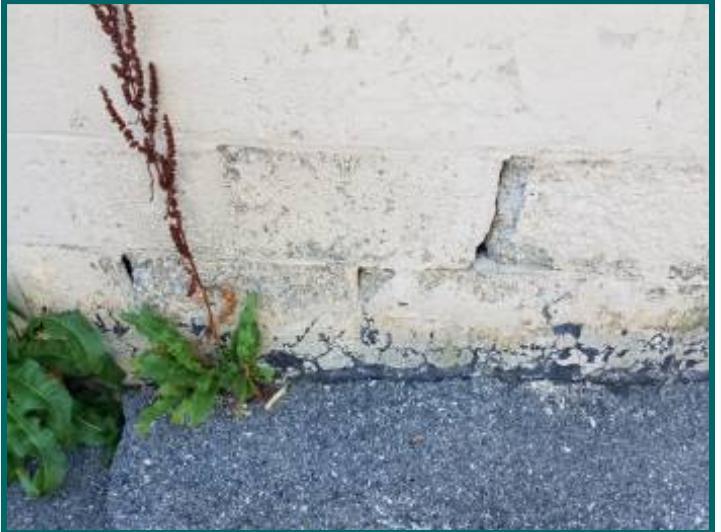
Damage to exterior surfaces at left side

Vertical and step cracking

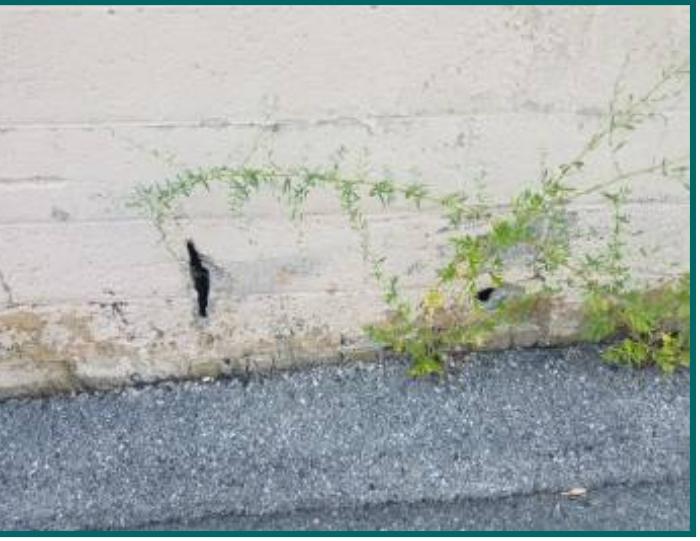
Damage to exterior surfaces at left side

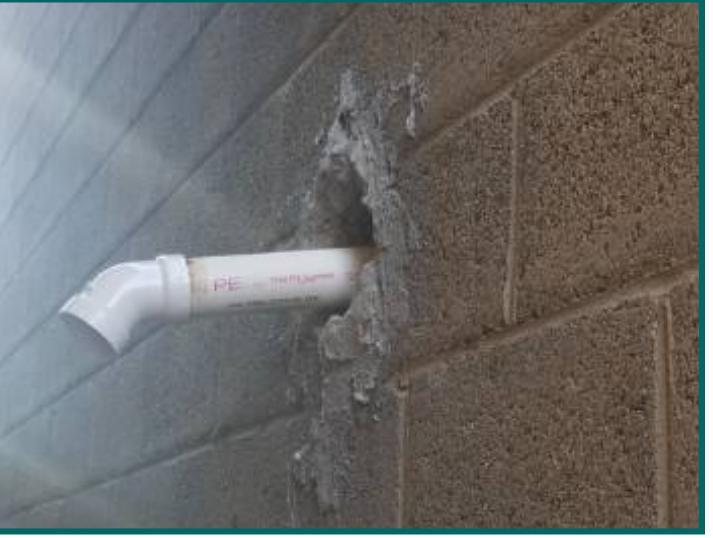
2.4. Gaps exist at one or more openings around the exterior, such as those where outside faucets, utility supply pipes penetrate the exterior or at transitions or flashings. Gaps should be sealed as necessary to prevent moisture intrusion and entry by vermin.

Penetration gaps should be sealed at rear

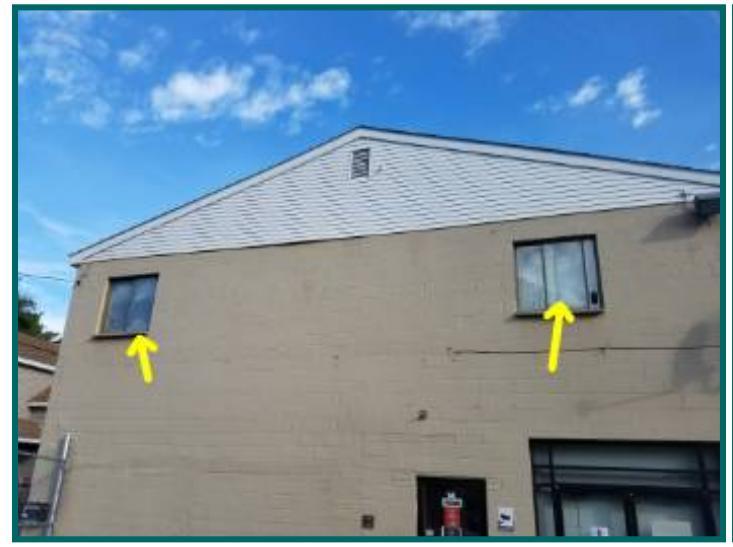
3.3. One or more windows have broken seals (fogged), this condition can diminish the energy efficiency of the window and cause permanent hazing to the glass, recommend repair by a qualified window contractor.

Fogged windows at front

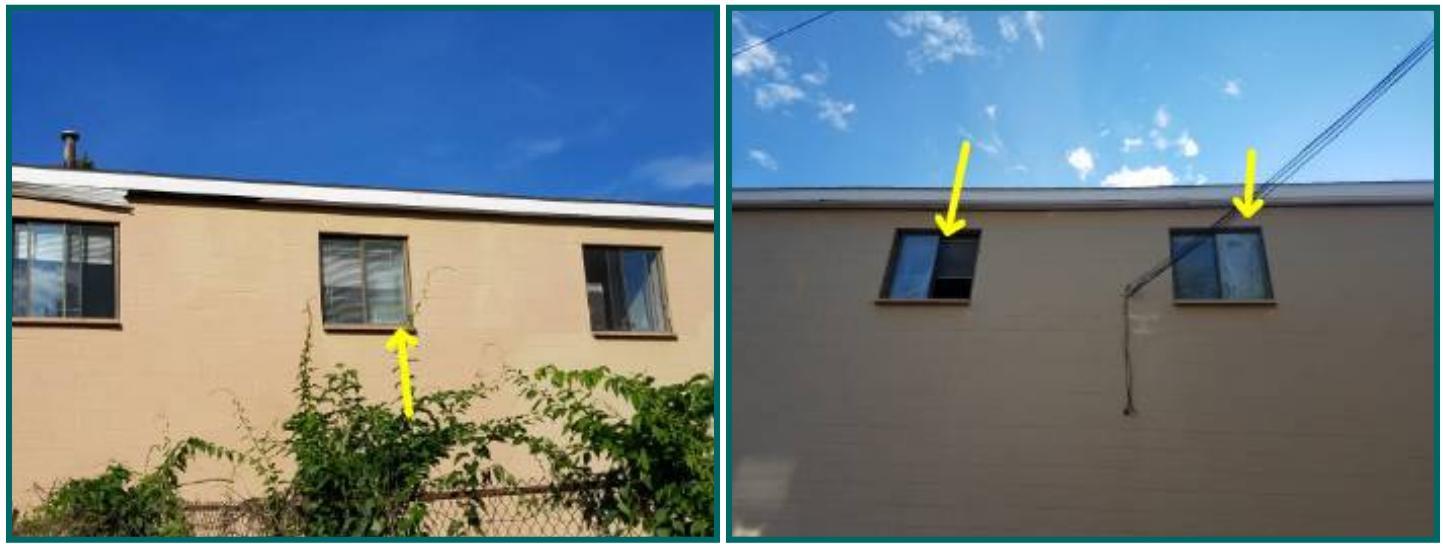
Fogged window at right side

Fogged windows at left side

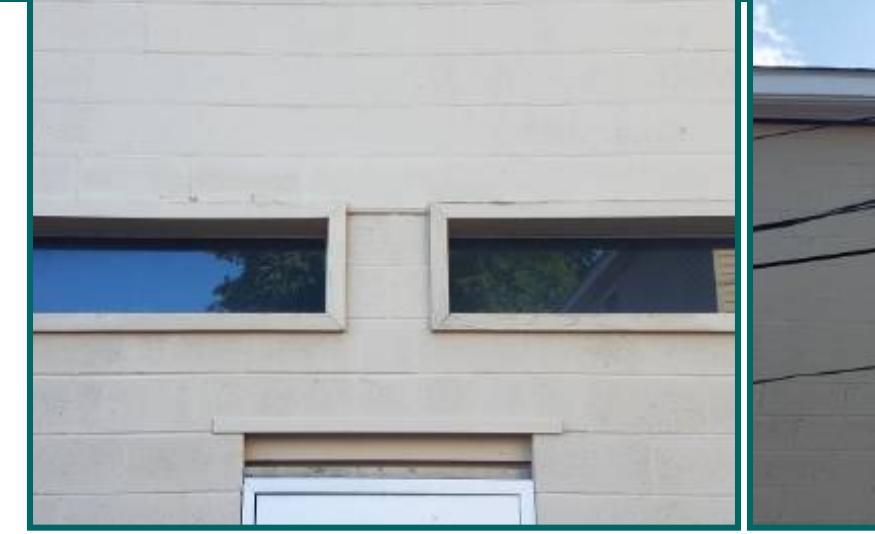
3.2. There is broken glass at one or more window, recommend repairs by a qualified tradesman.

Broken panes at left side above entry door

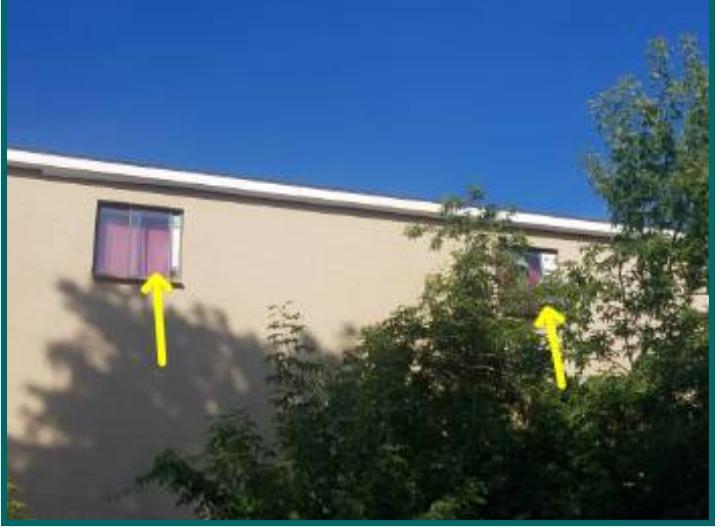
Fogged windows at right side

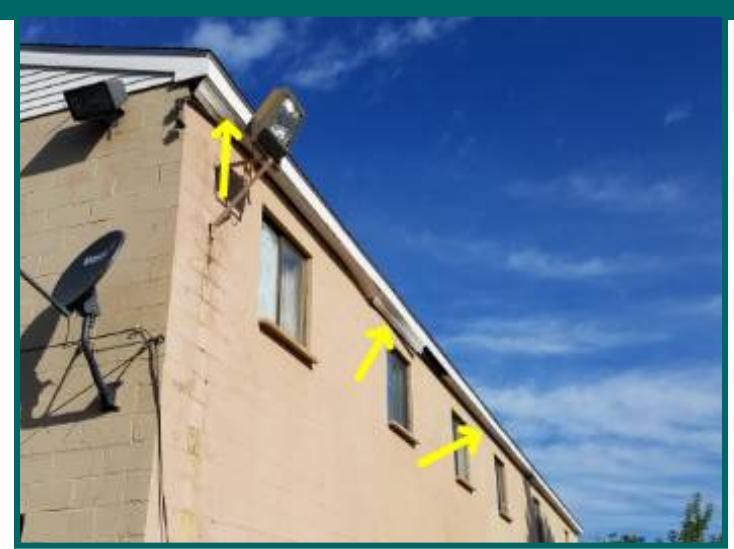
4.3. Soffit trim is gapped in one or more area, this is conducive to insect and animal intrusion, recommend repair by a qualified tradesman.

Missing and damaged soffit trim along right side

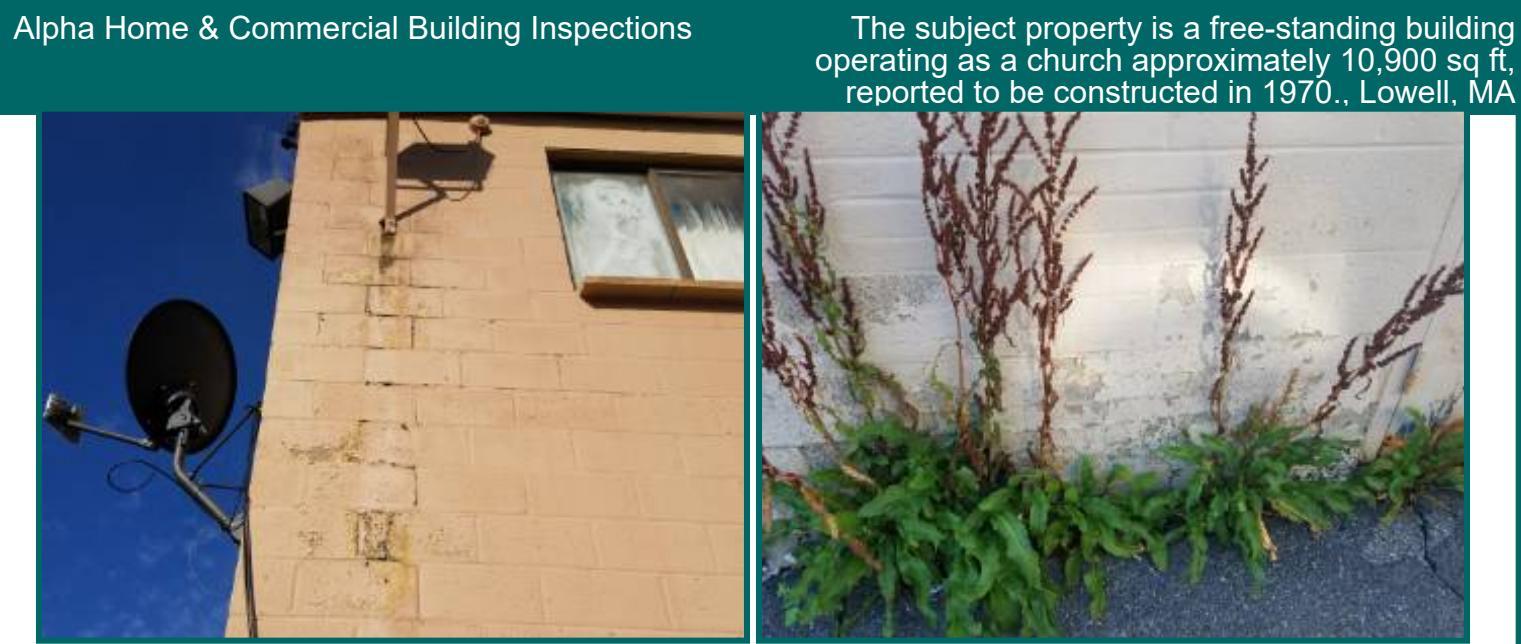
6.1. Peeling paint observed on siding and trim, suggest scraping and painting as necessary.

Peeling paint at front corner

Peeling paint at left side

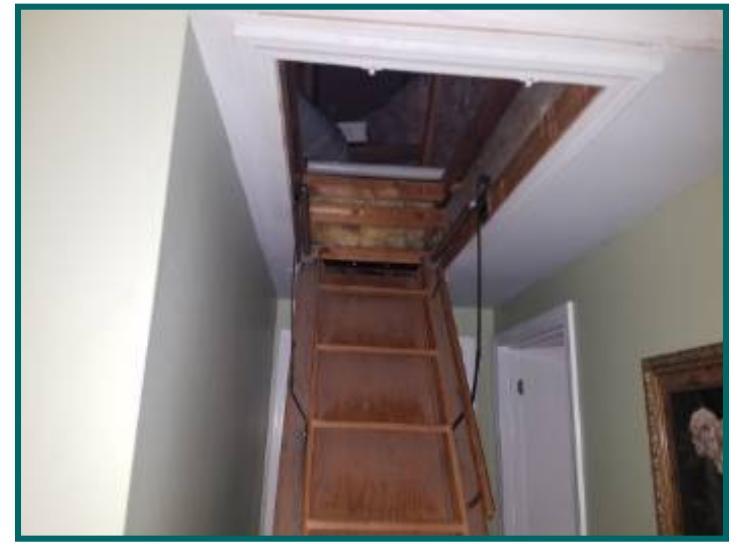
1.3. Recommend insulating the back of attic access cover to reduce condensation, ice damming, heating and cooling costs

Second floor hallway access, cover should be insulated

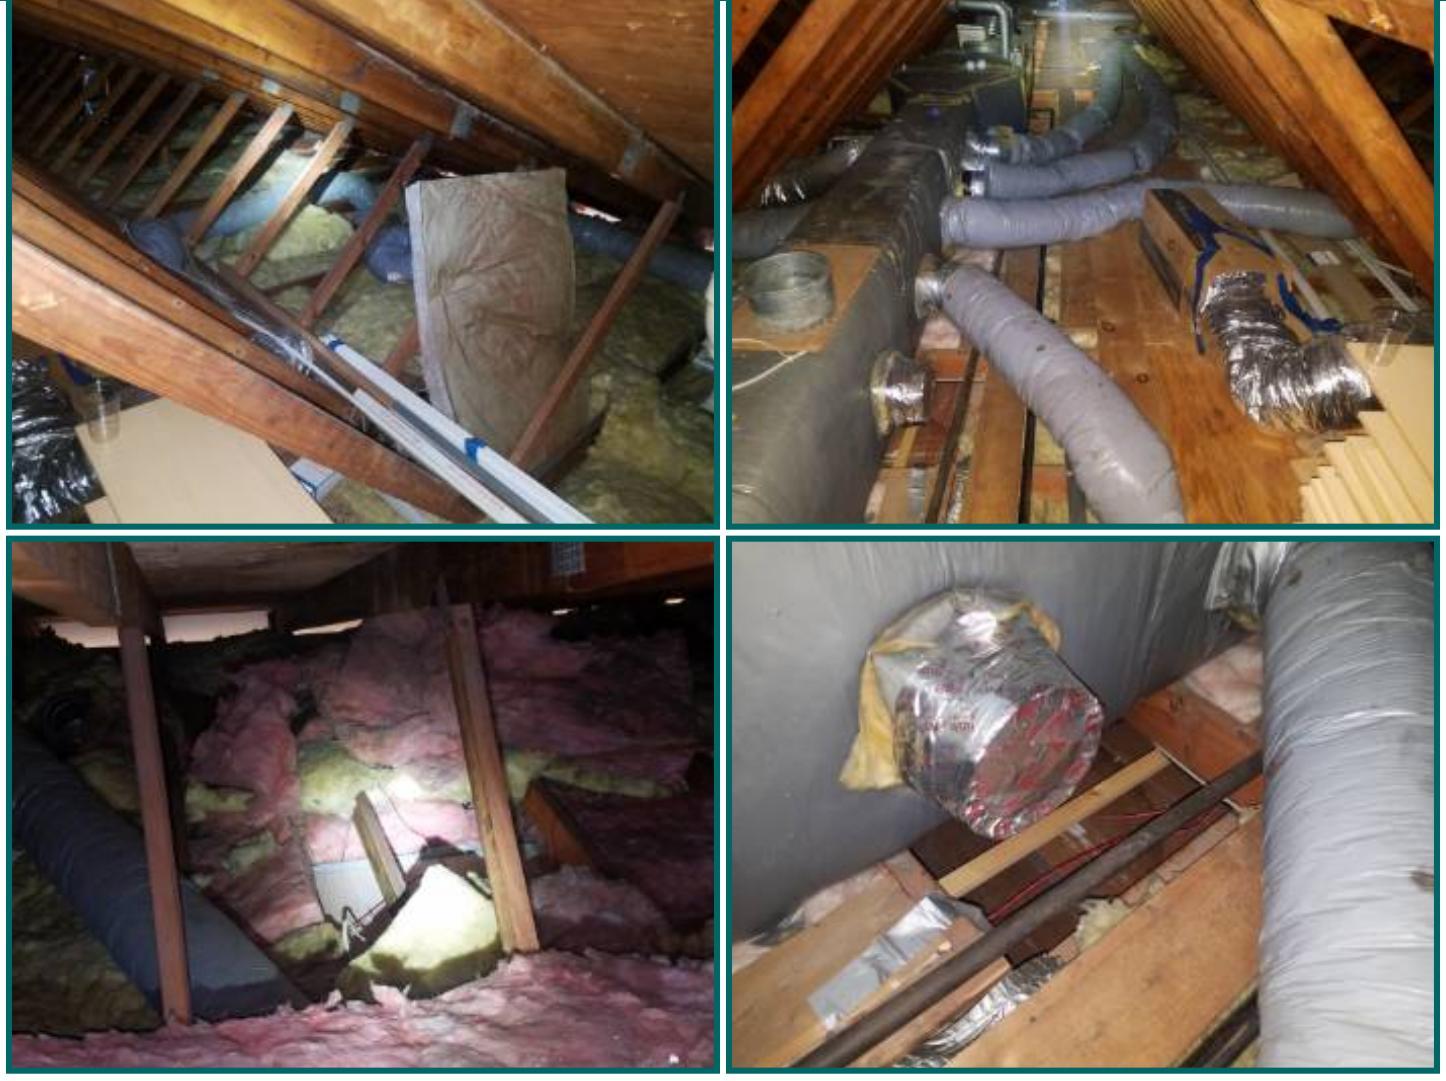
4.1. Areas of missing insulation. Missing insulation can be a contributing factor to condensation, fungal growth, ice damming, and energy loss. Recommend installing additional insulation where needed by a qualified tradesman.

Areas of missing insulation

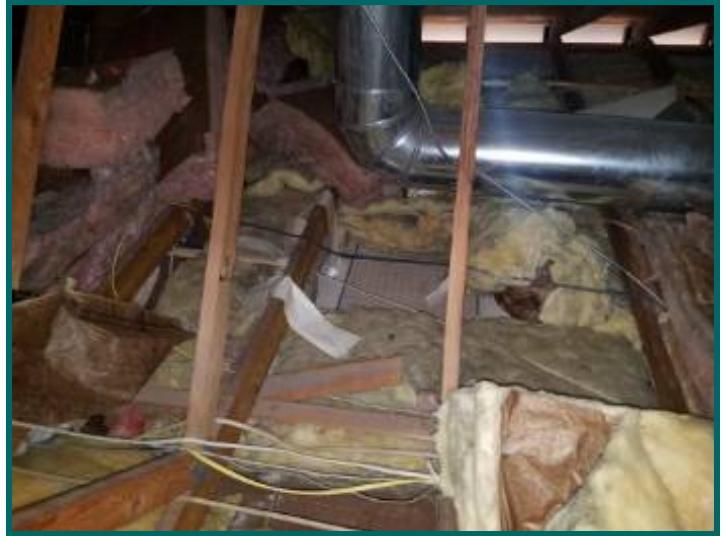
Areas of missing insulation

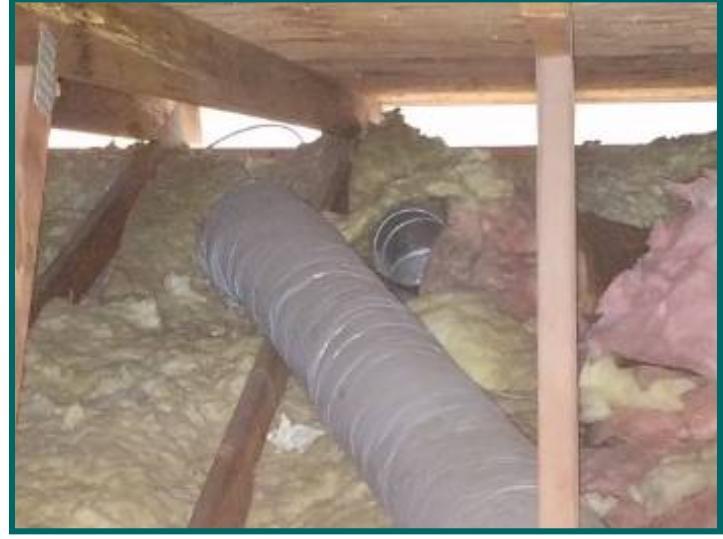
5.1. Ducts are loose or damaged at one or more area, this can contribute to energy loss, ice damming, moisture and mold growth, recommend assessment by a qualified HVAC contractor.

Disconnected ductwork at right rear corner, above living room

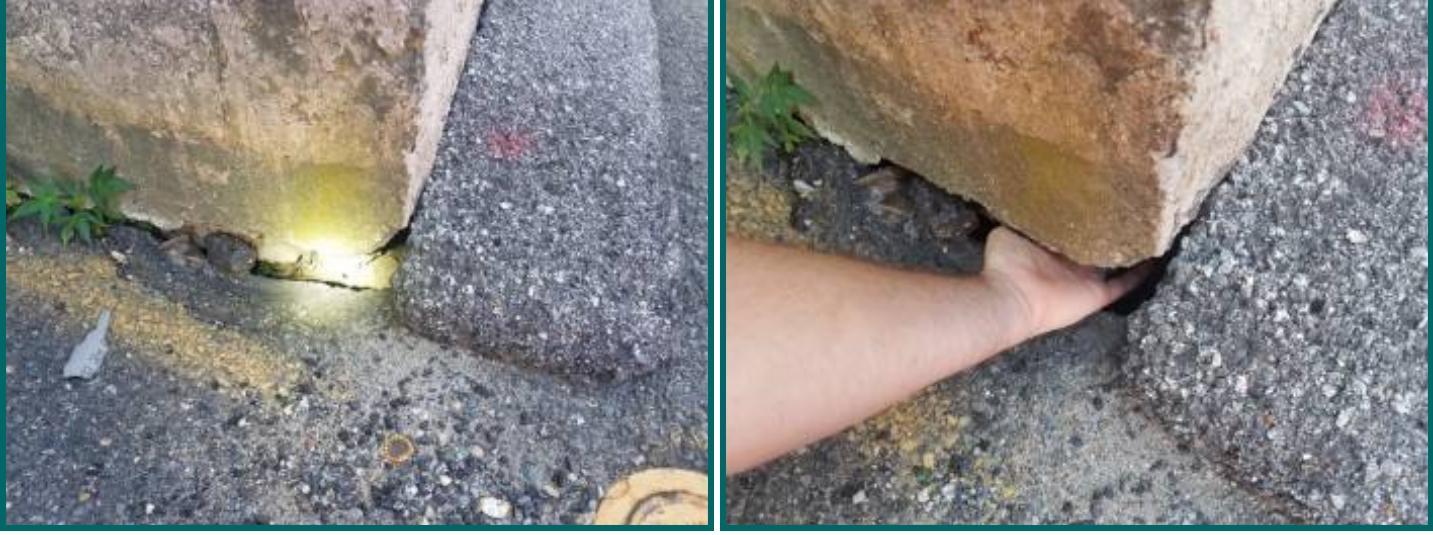
1.2. Foundation wall at the rear corner is deteriorated, recommend assessment and repairs as needed by a qualified contractor.

Deterioration to wall at rear corner

Undermined exterior wall

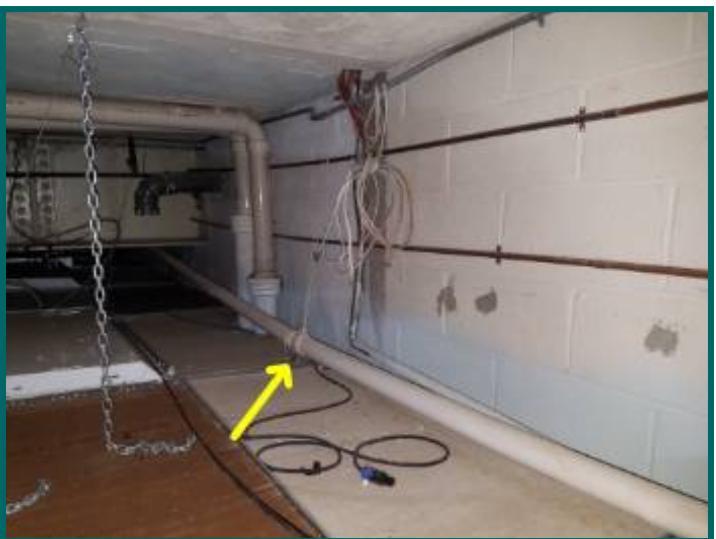
1.5. One or more drain line appears to be improperly pitched, should be 1/4" per foot towards drain, recommend review and repair by a licensed plumber.

1.6. Drain lines appear to lack proper support, recommend adding support hangers.

Sag in drain line and improperly secured at lower level mechanical chase

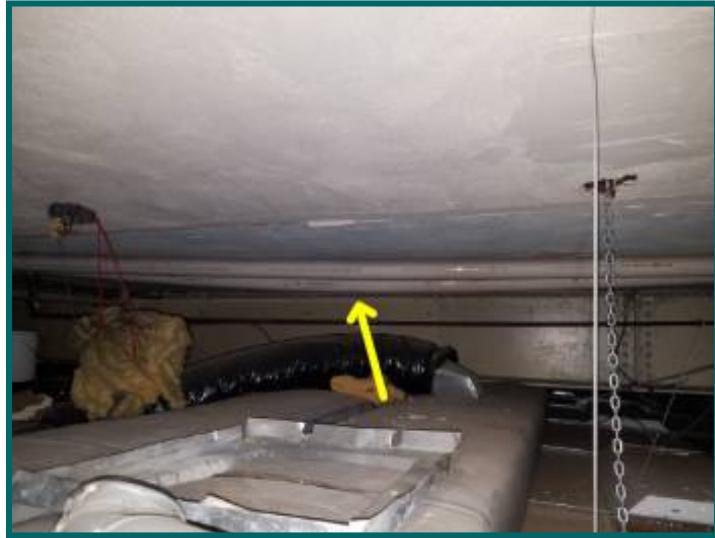
Sag in drain line at lower level mechanical chase

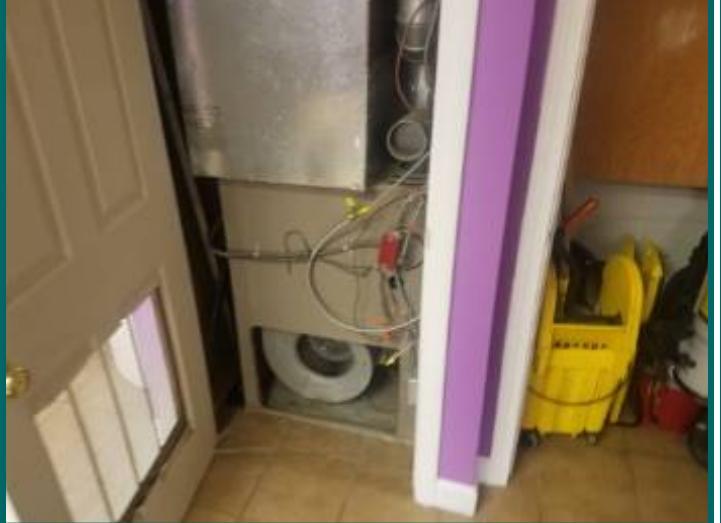
1.6. The front entry furnace was reported to be in need of repairs/replacement, does not operate. Recommend full inspection and repairs if needed by a qualified HVAC contractor.

Furnace at front entry closet, 21 years old. Reported to be not working and in need of repairs.

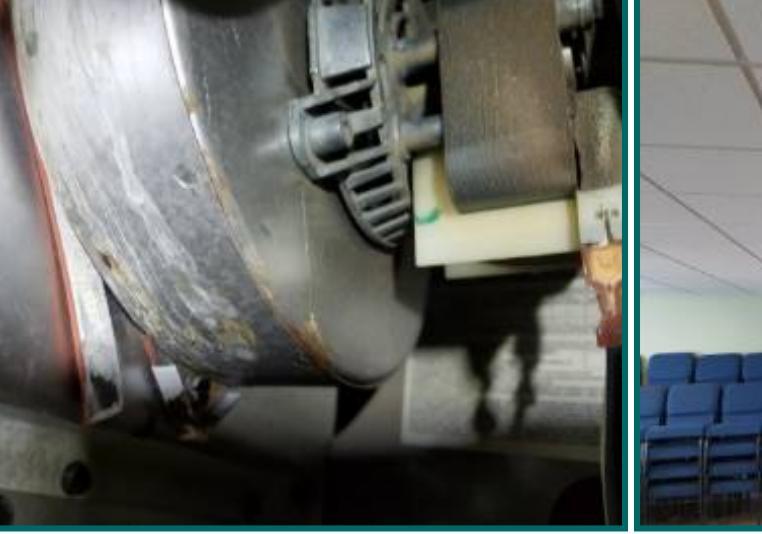
1.5. There is a corrosion inside cabinet on one or more furnace, Recommend full inspection, preventative maintenance and repairs as needed by a qualified HVAC contractor.

Corrosion/water staining in cabinet

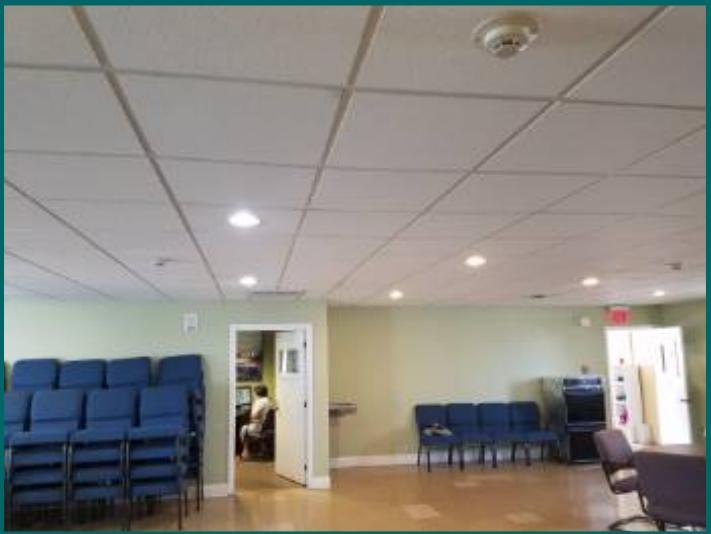
1.7. One or more air conditioner system did not operate properly. Recommend HVAC contractor evaluate the system.

Seller reported AC system is not working at function room area

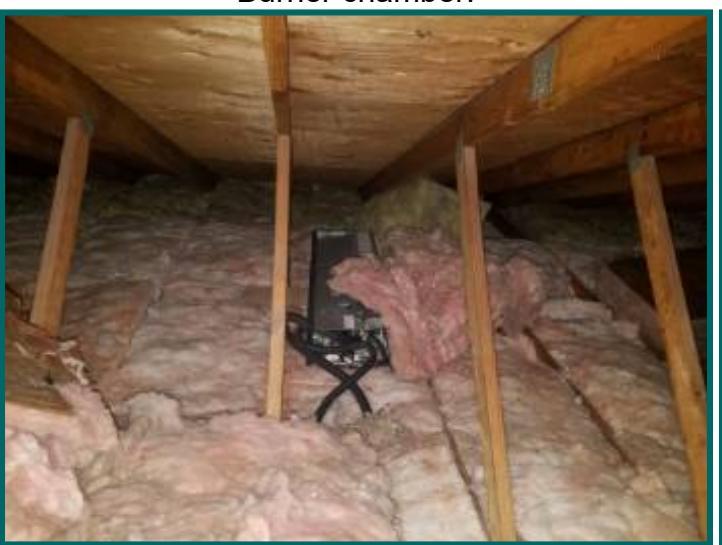
Ductless wall unit disconnected and laying in attic

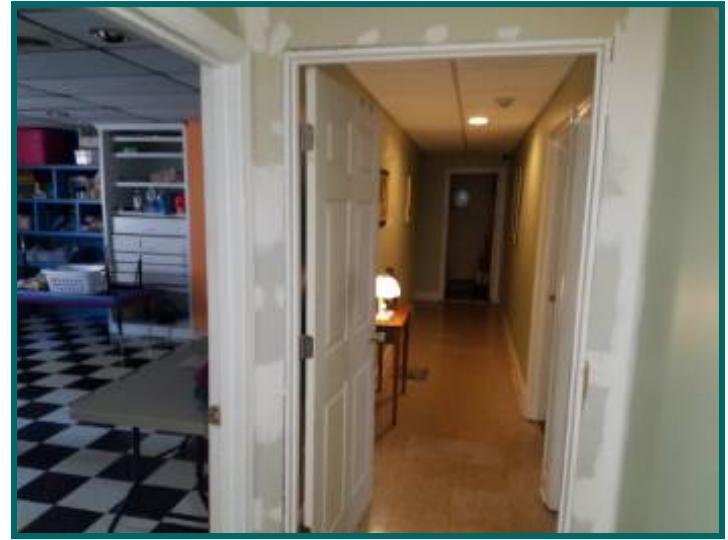
AC not working at second floor rear

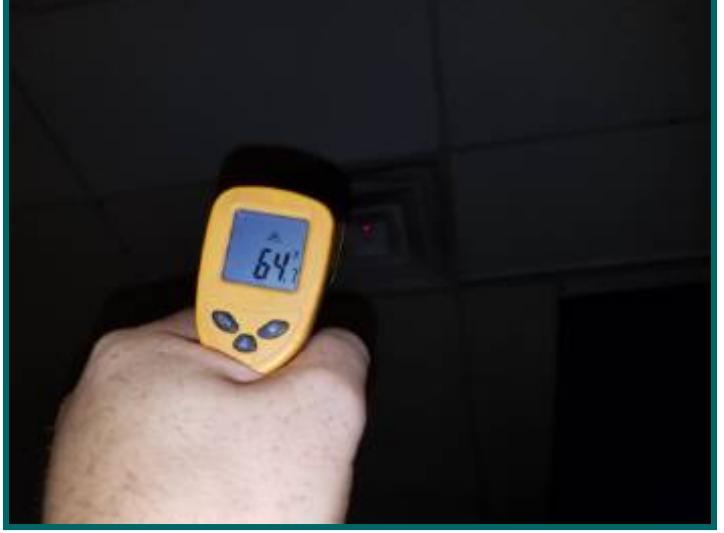
AC working at lower level but not blowing very cold

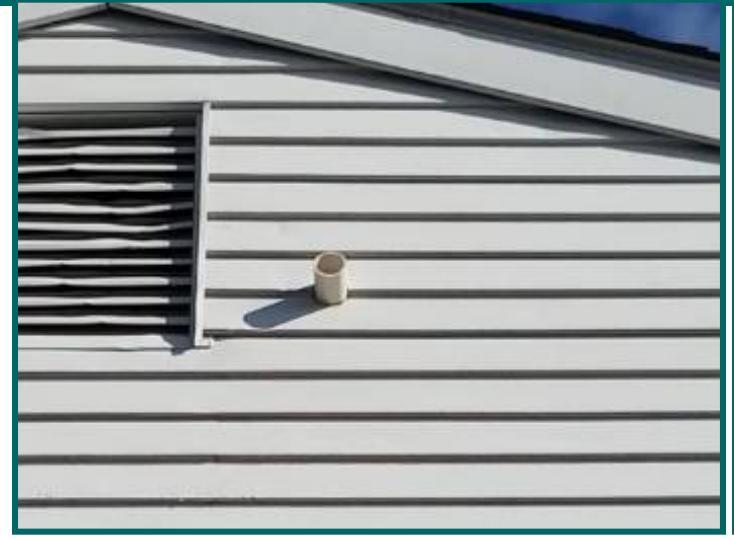
2.1. Plastic vent pipe termination for attic furnace is missing proper elbow, recommend repair by a qualified HVAC contractor.

Attic furnace vent termination, missing elbow

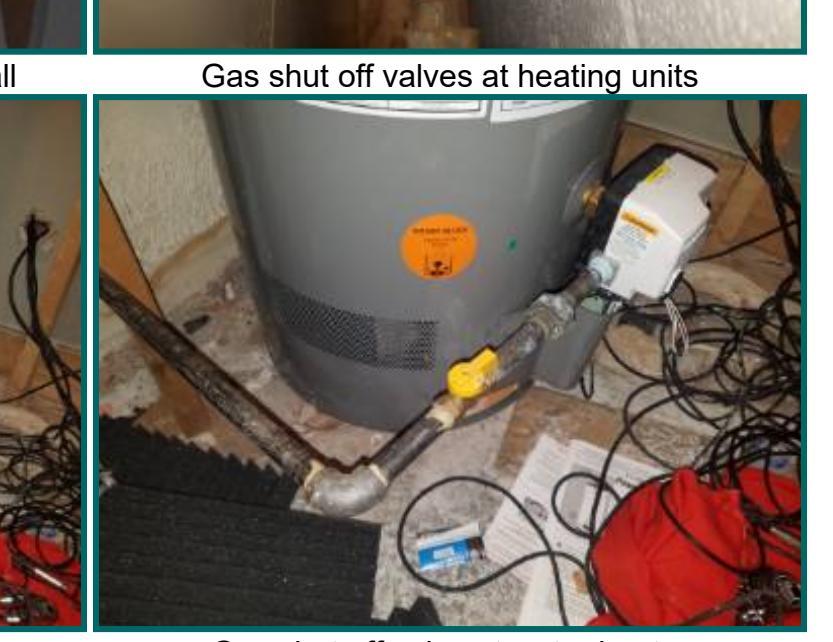
3.4. Gas line is missing sediment drip leg at one or more appliance connection, recommend repair by a qualified heating contractor.

Missing drip leg at water heater

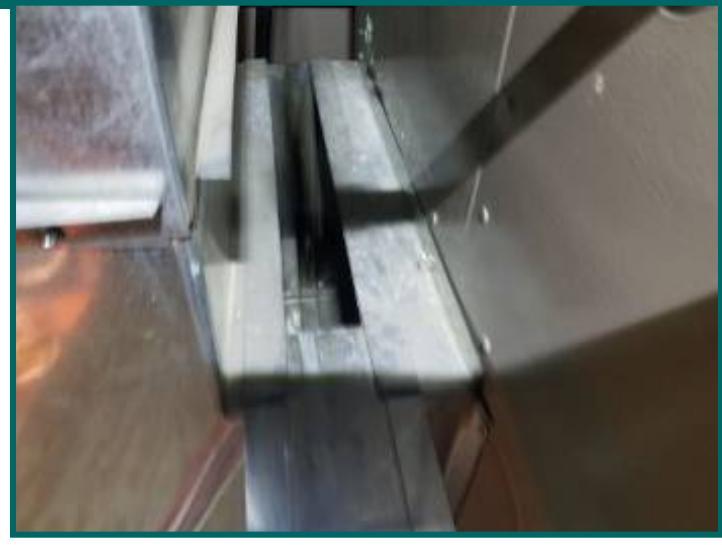
Missing filter at lower level furnace

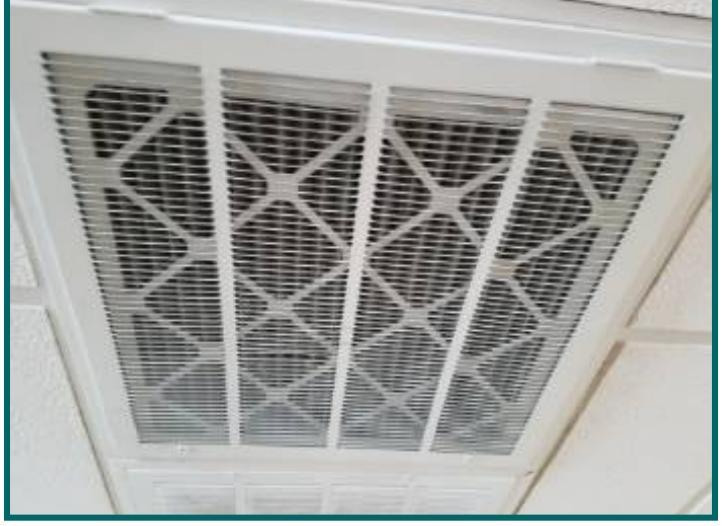
Filter is dirty needs cleaning or replacement at second floor function room

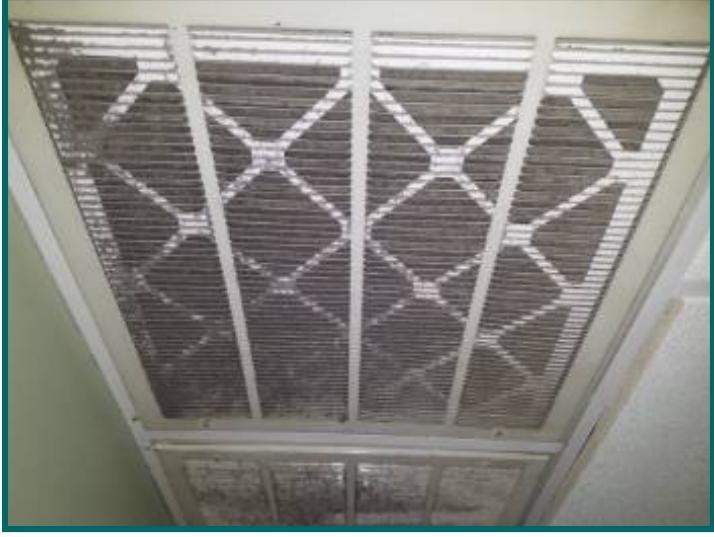
Filter is dirty needs cleaning or replacement at second floor hall

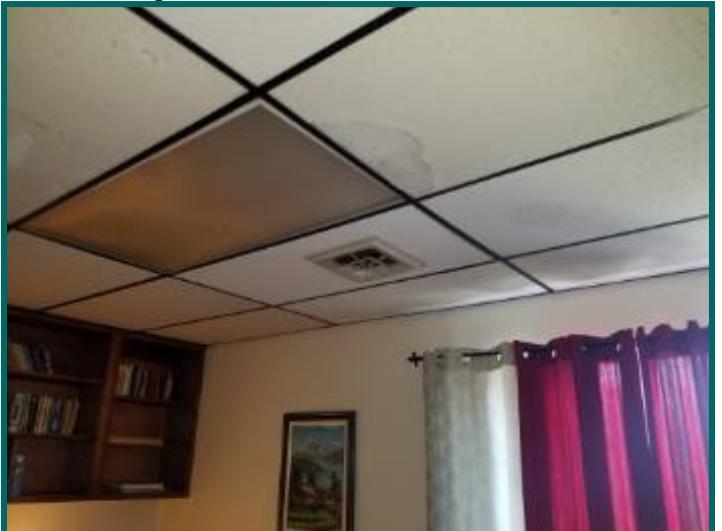
Presumbed disconnected attic ductwork at register in living room

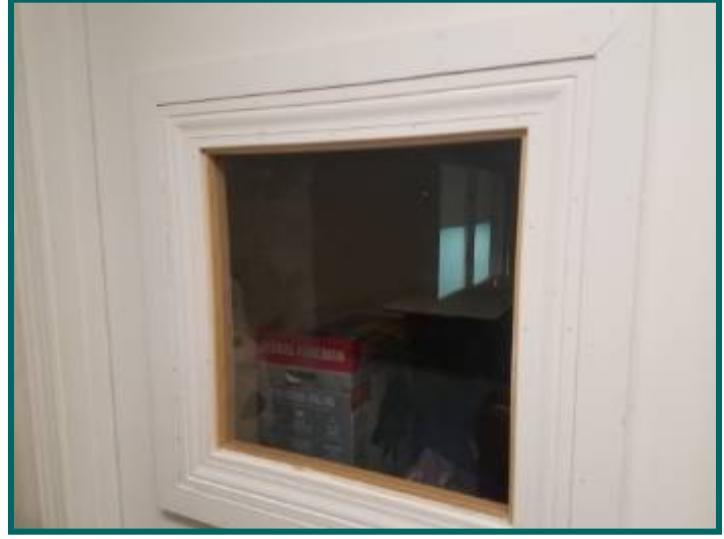
Broken glass on door at sound control room

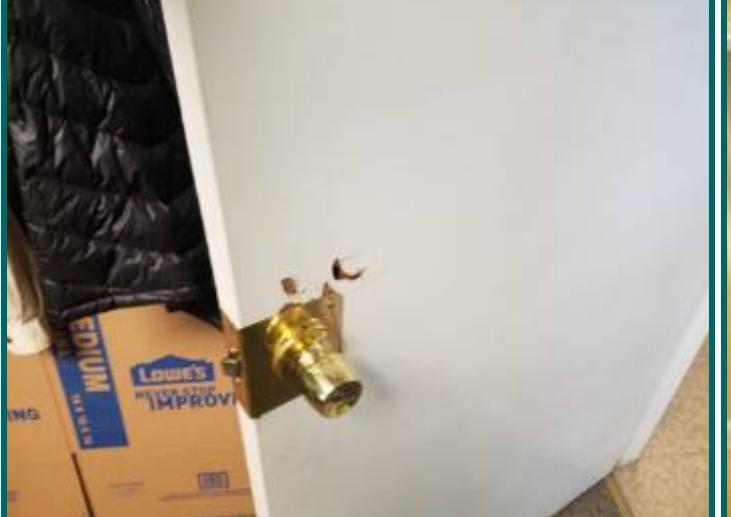
Impact damage to door at function room office

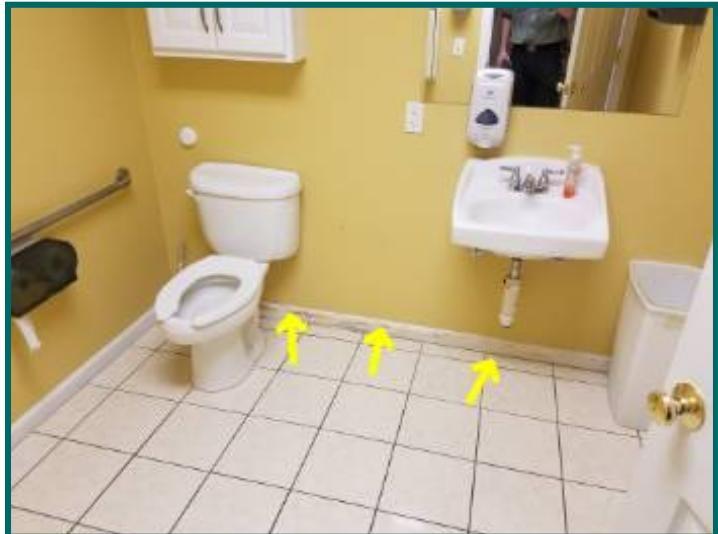
Elevated moisture levels on outside wall at front entry rear bathroom

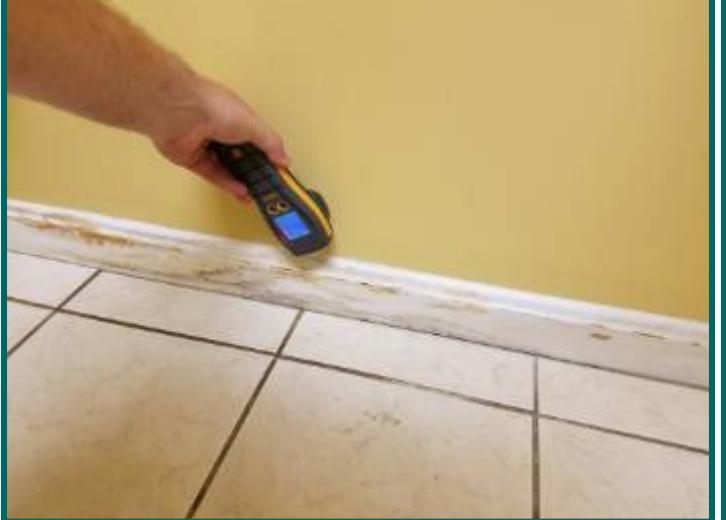
Elevated moisture levels on outside wall at front entry rear bathroom

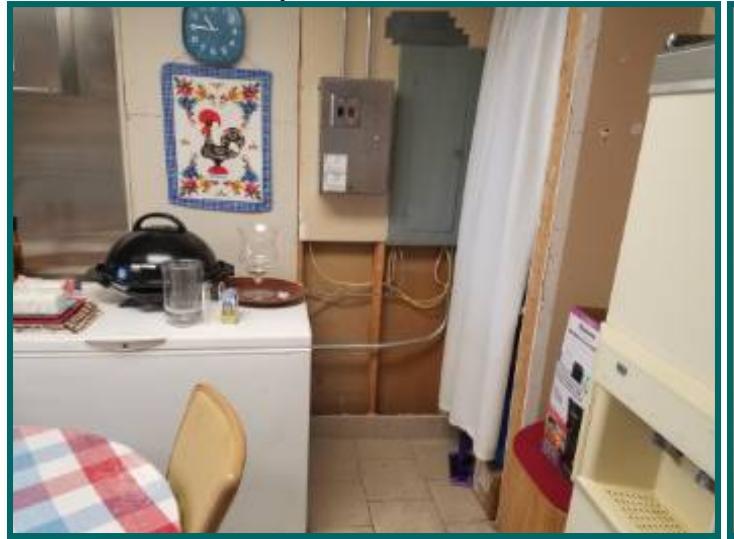
3.3. Damage to wall surfaces at one or more areas, recommend assessment of wall surfaces and repairs by a qualified tradesman.

Incomplete finish / missing sheet rock at kitchen Impact damage to wall at second floor living room

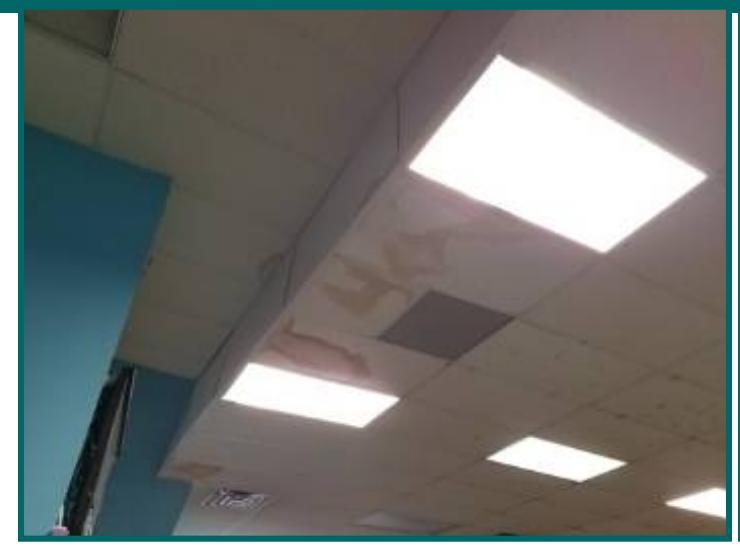
Stains on ceiling at lower level

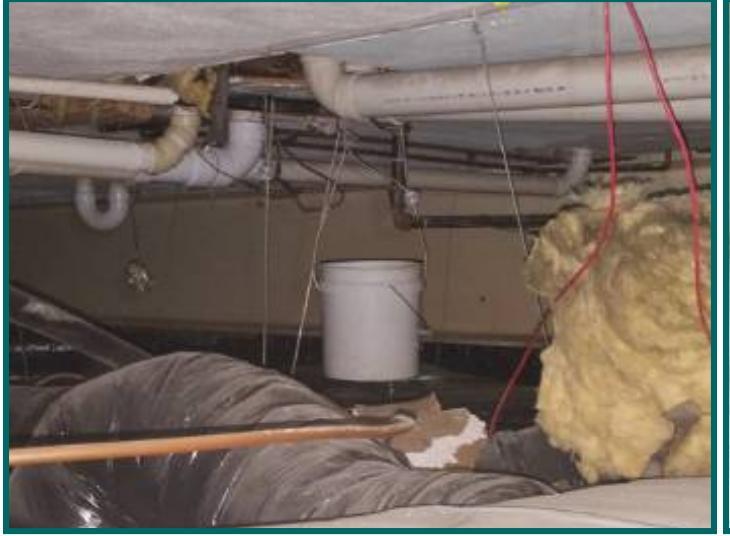
Bucket suspended from ceiling in lower level mechanical chase, client should check with seller for history of water leaks

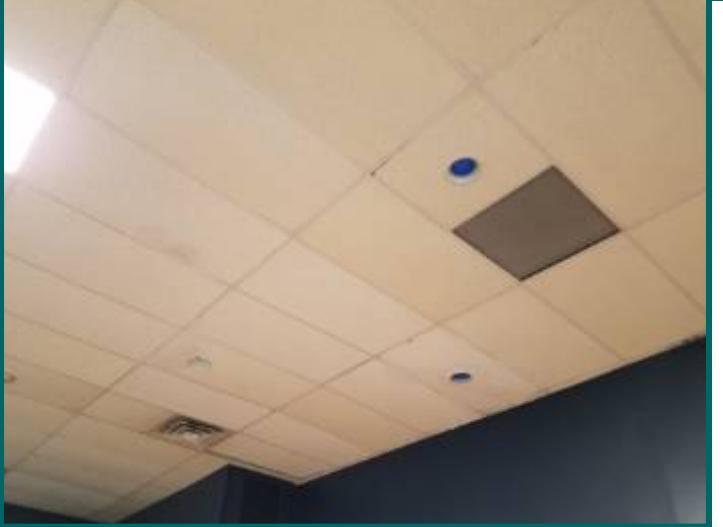
Stains on ceiling at lower level
