PROPERTY INSPECTION REPORT

Steve Mangekian License # 0054 Alpha Home & Commercial Building Inspections

Date of Inspection: 8/12/2020

The subject property is a free-standing building operating as a church approximately 10,900 sq ft, reported to be constructed in 1970., Lowell, MA

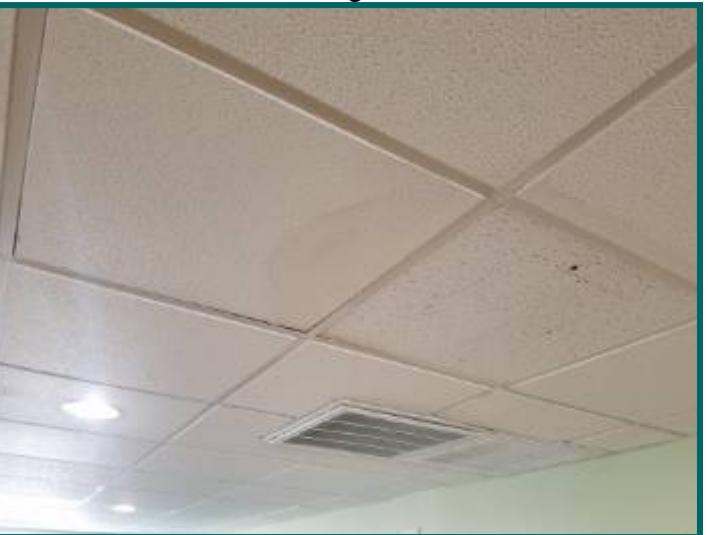
Stains on ceiling tested dry at second floor function room, below furnace area

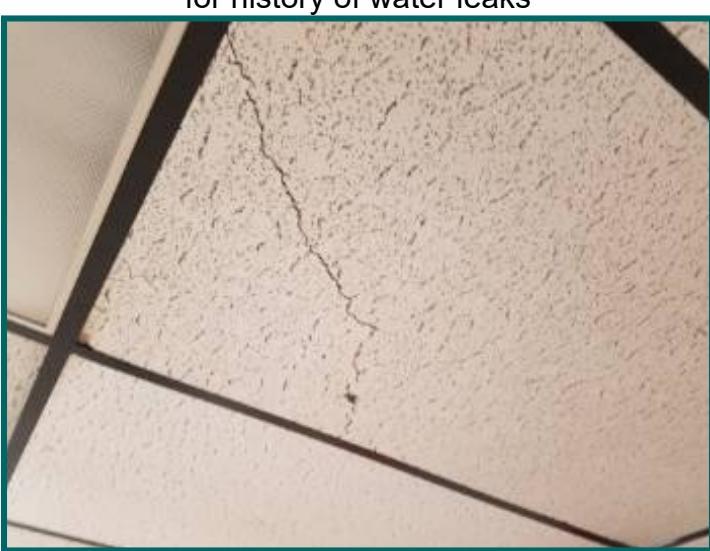
4.3. There are damaged or missing ceiling tiles present in one or more areas, recommend having repaired as needed.

Numerous damaged ceiling tiles

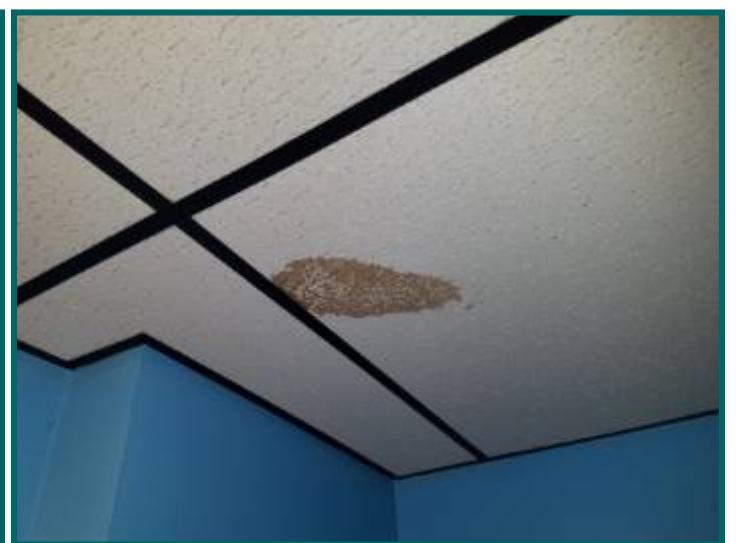
Stains on ceiling tested dry at second floor bathroom

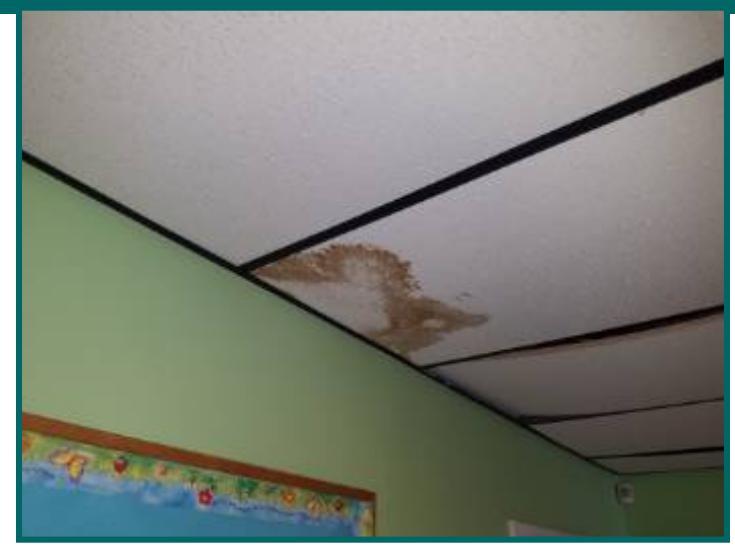
Stains on ceiling tested dry at second floor, outside of bathroom
