PROPERTY INSPECTION REPORT

Steve Mangekian License # 0054
Alpha Home & Commercial Building Inspections

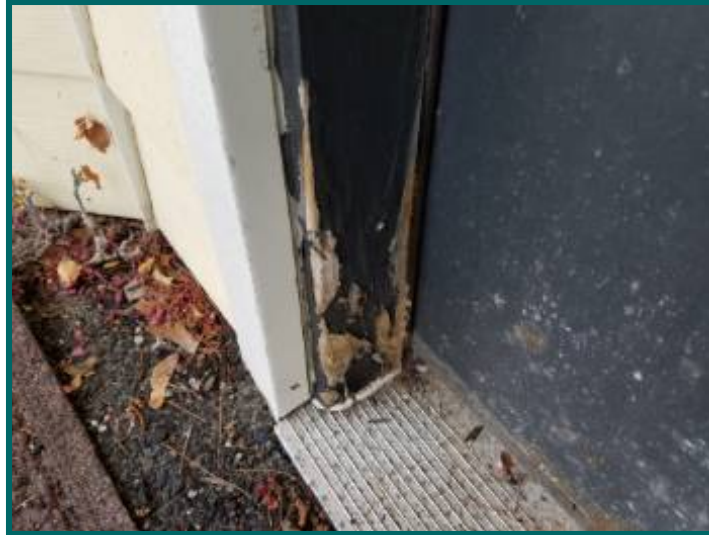
Peeling paint at front entry

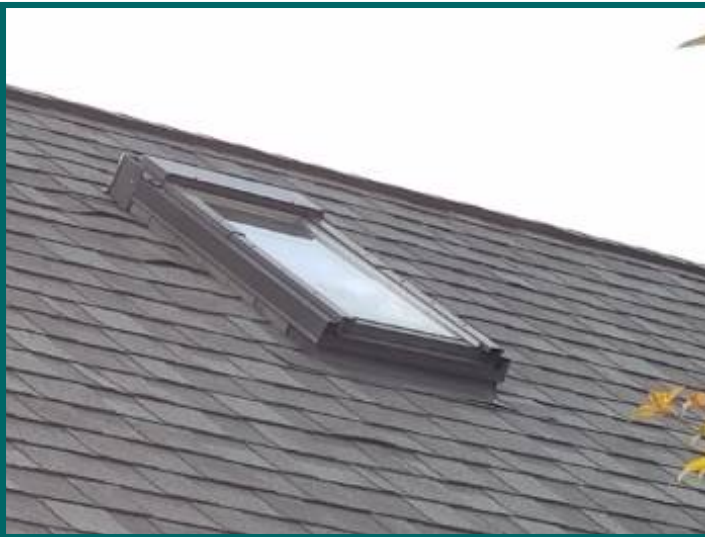
1.3. Sky lights have damage to interior trim, recommend repair or replacement as needed by a qualified contractor.

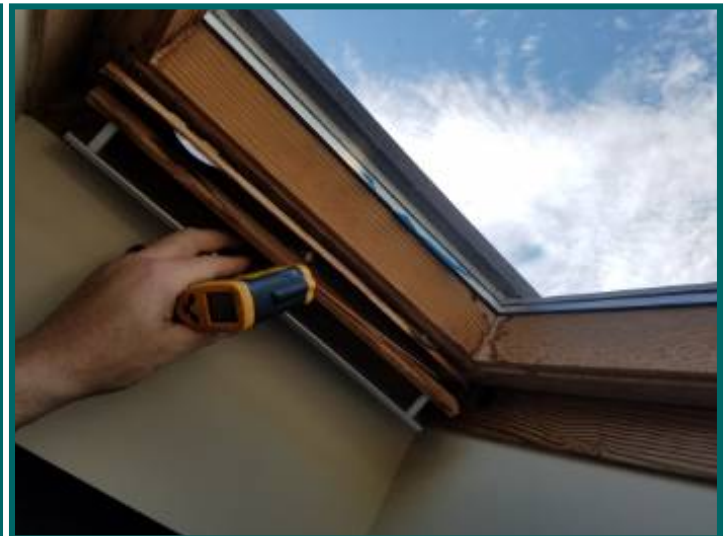
Damaged skylight trim at front

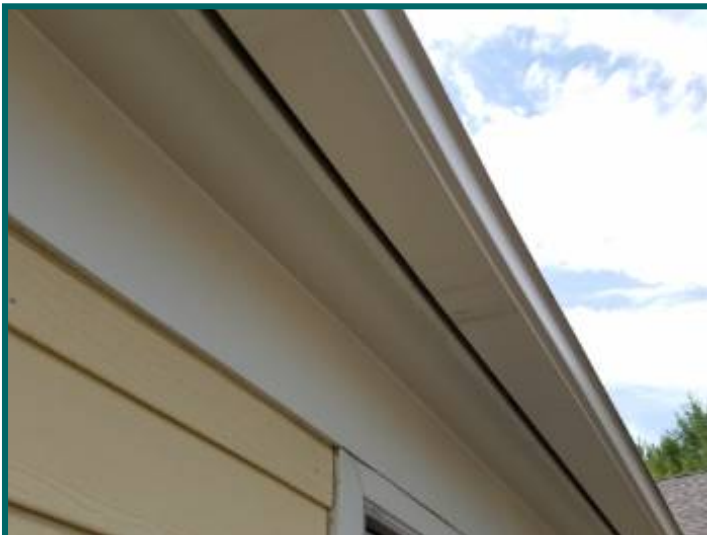
2.3. Gable and / or ridge vents present with no lower soffit vents. Inadequate ventilation can contribute to diminished roof life, condensation, higher energy costs, fungal growth and ice damming. Recommend assessment by a qualified attic ventilation contractor.

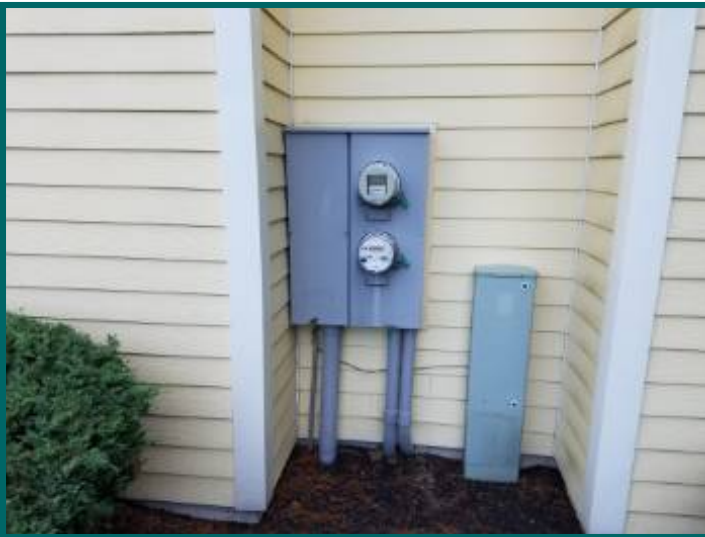
Common meter bank at front, individual meters and breakers are not labeled

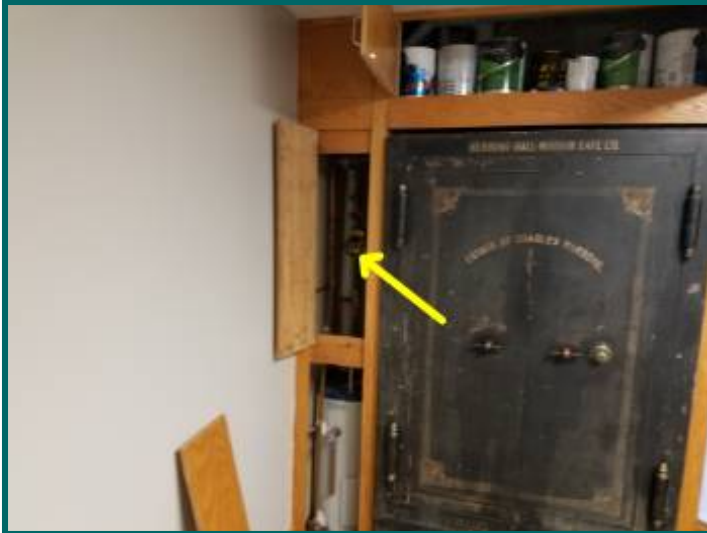
Water meter and shut off valve location

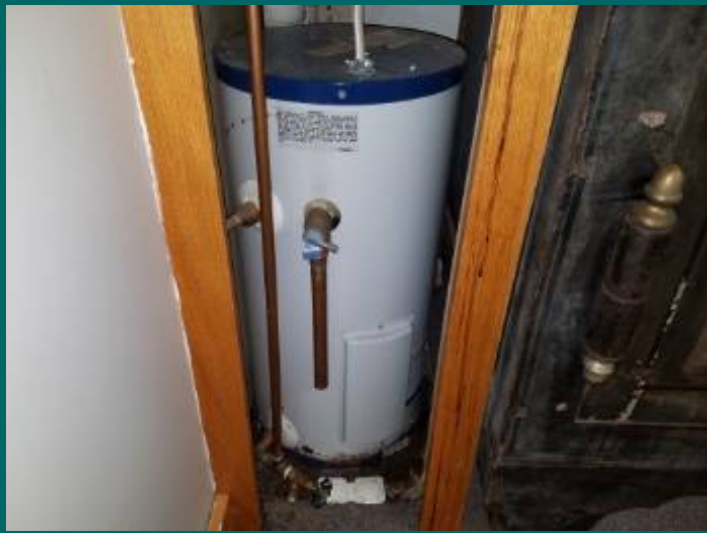
Electric water heater below water meter, 35 years old, 12 gallons

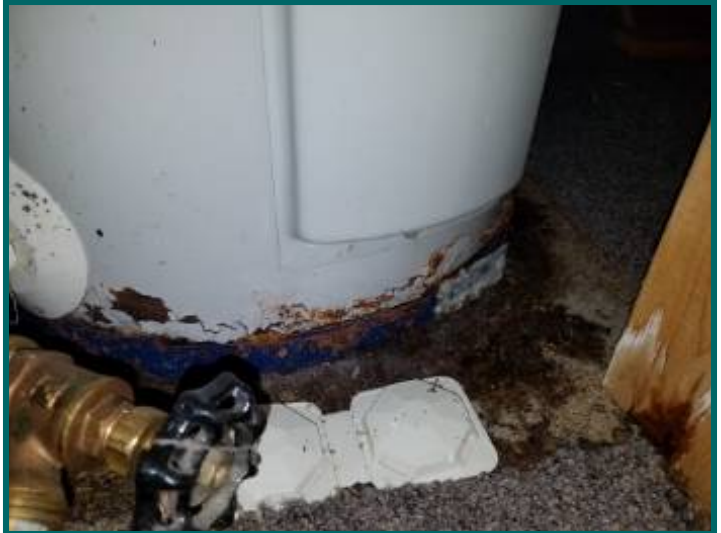
Corrosion on cabinet.

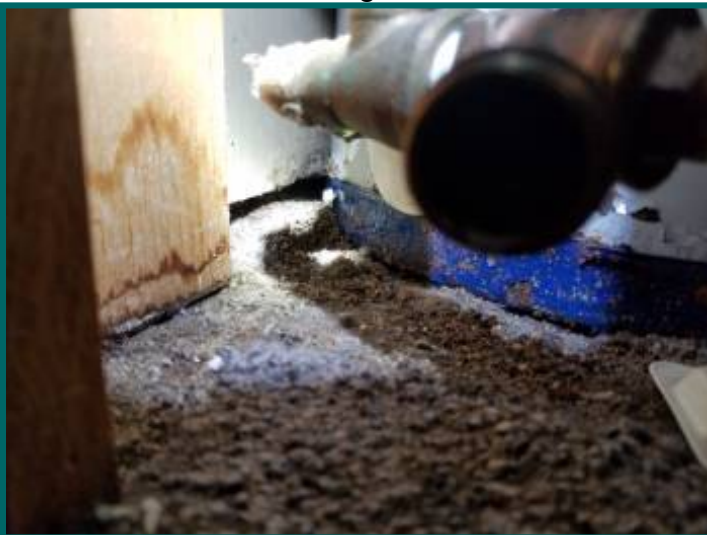
Wet/damp sand around water heater appears to be from condensate

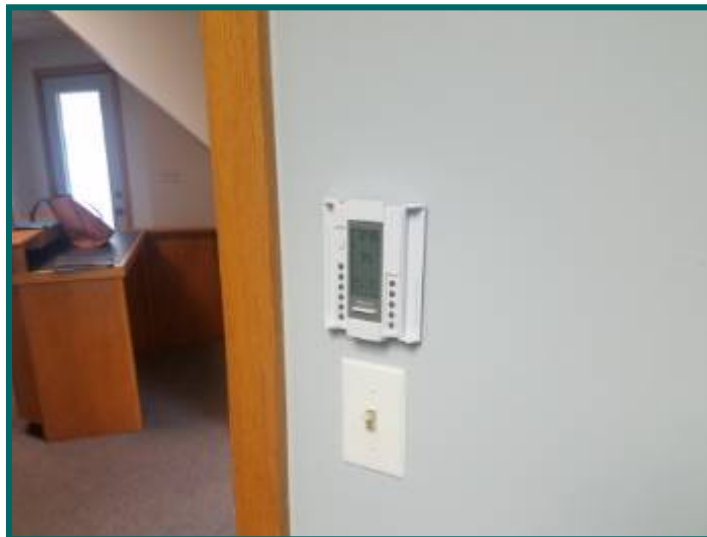
Individual electric heater thermostats

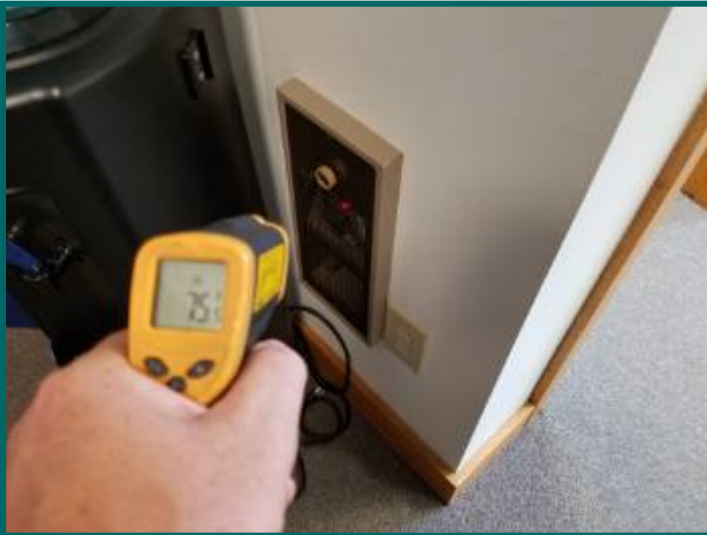
Electric wall heater not working at entry desk area

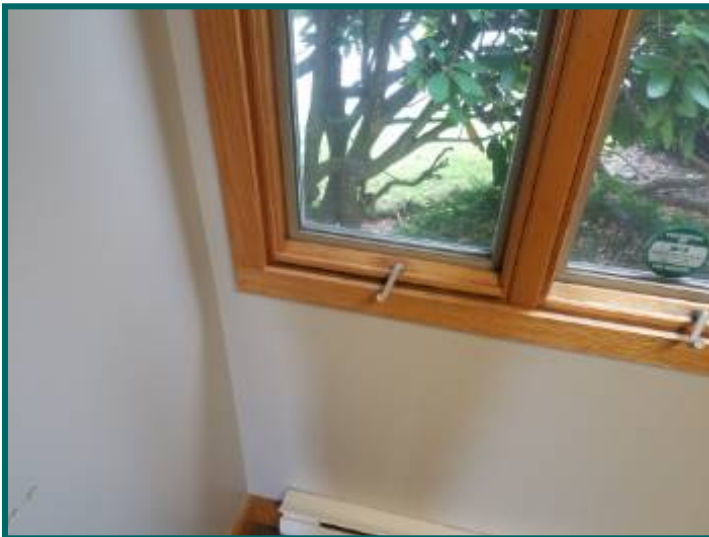
Damaged window crank at rear right corner office

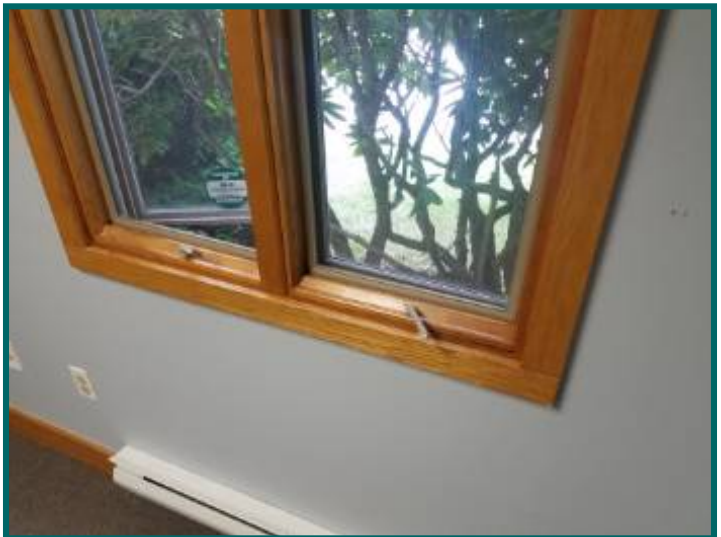
Damaged window crank and heavily corroded crank arm at rear left corner office

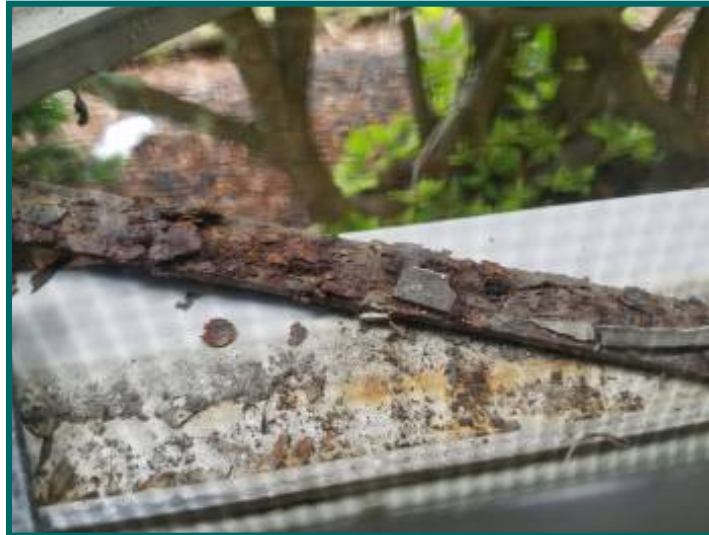
Heavy corrosion on crank arm

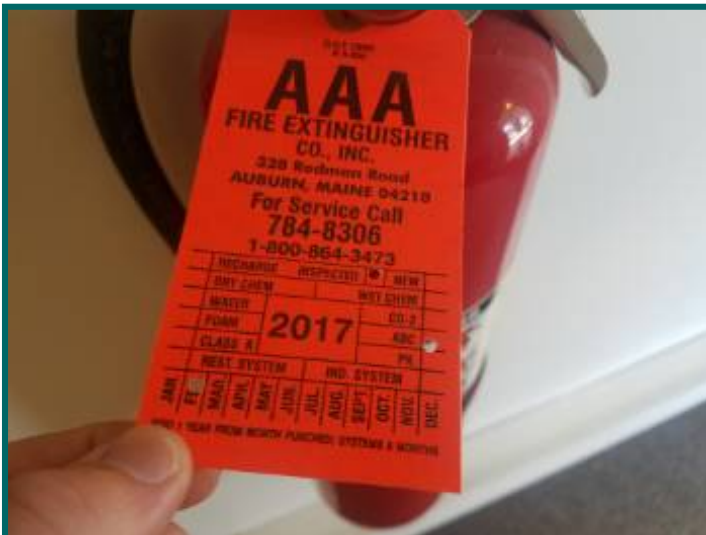
Fire extinguisher tags are expired, dated 2017

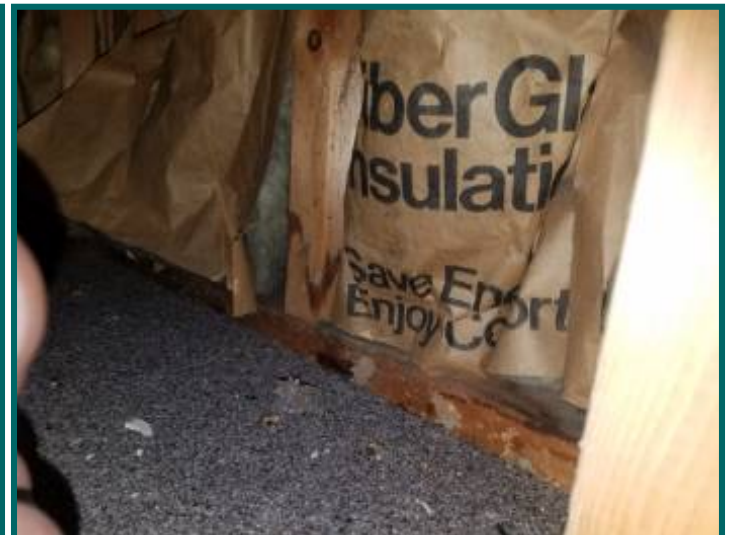
Minor staining on framing below front entry stairs

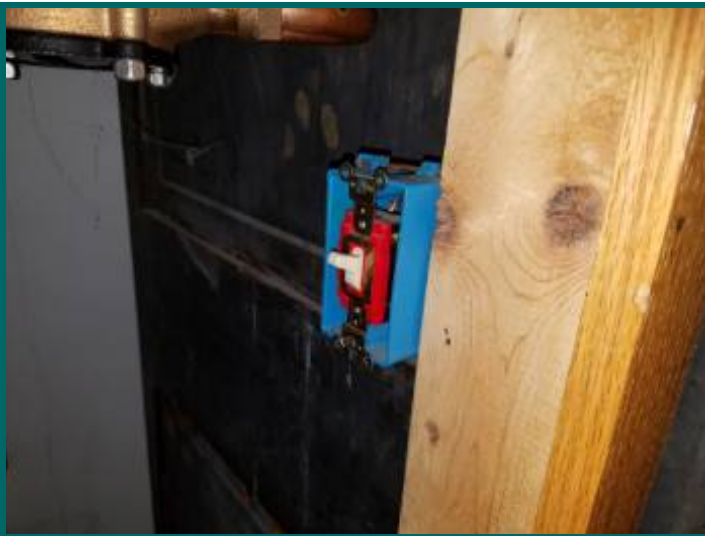
Plate cover missing above water heater

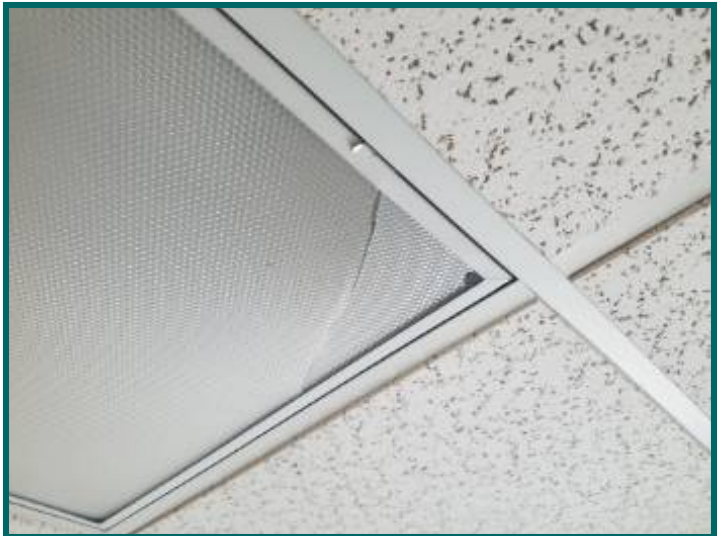
Damaged/cracked lense at first floor hall

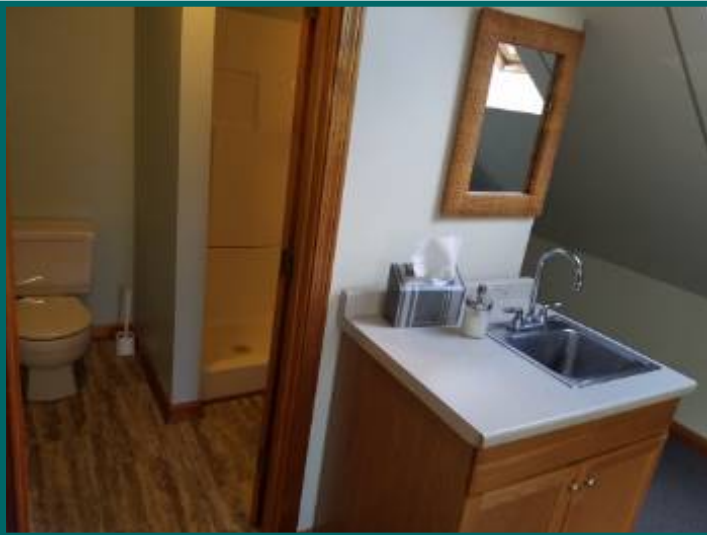
Second floor bathroom/sink

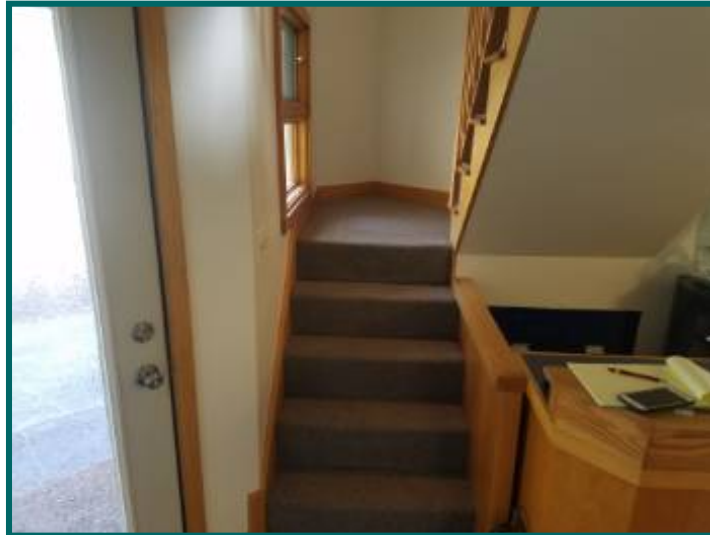
Missing hand rail at first floor
