Alpha Home & Commercial Building Inspections

Property Inspection Report

Sample Townhouse , Hooksett, NH 03106

Date of Inspection: 11/30/2017 Time: 1:00 PM

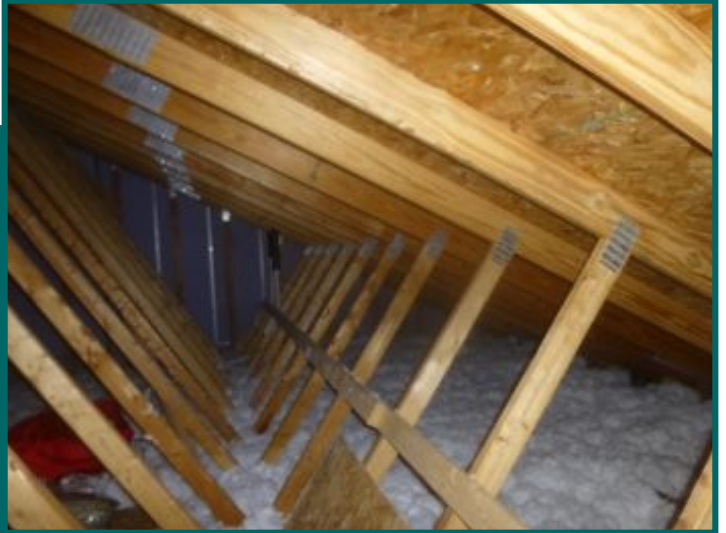
3.1. Rodent activity observed in the attic. Vermin can damage insulation & electrical wiring. Recommend a professional pest contractor evaluate for treatment.

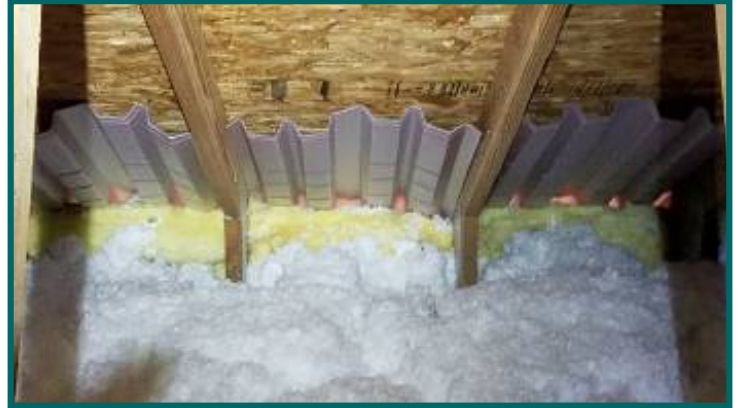
Soffit vents with propa vents

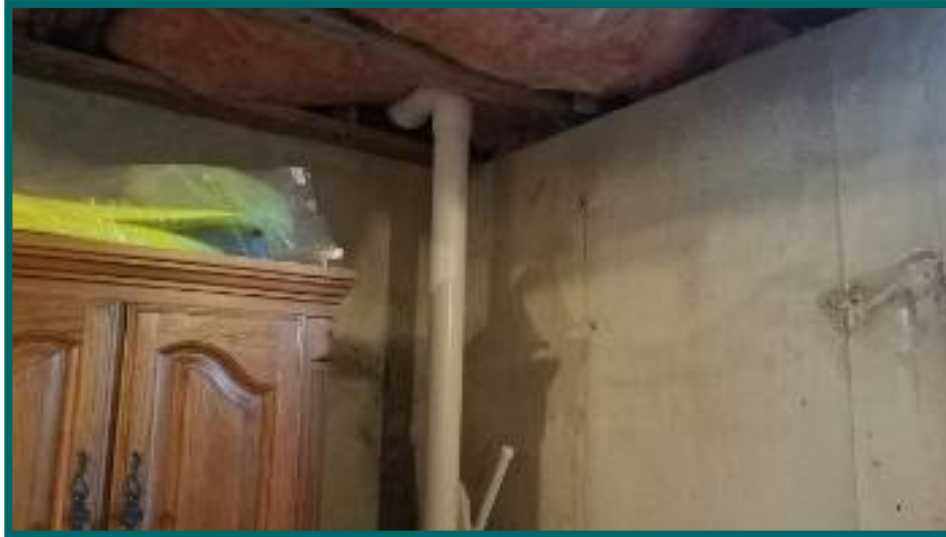
Radon Pipe

3.4. Passive radon mitigation pipe is present. A vent pipe is run from floor slab outside through roof. By adding an in line fan the system would become an active radon system and will further reduce radon levels in home.

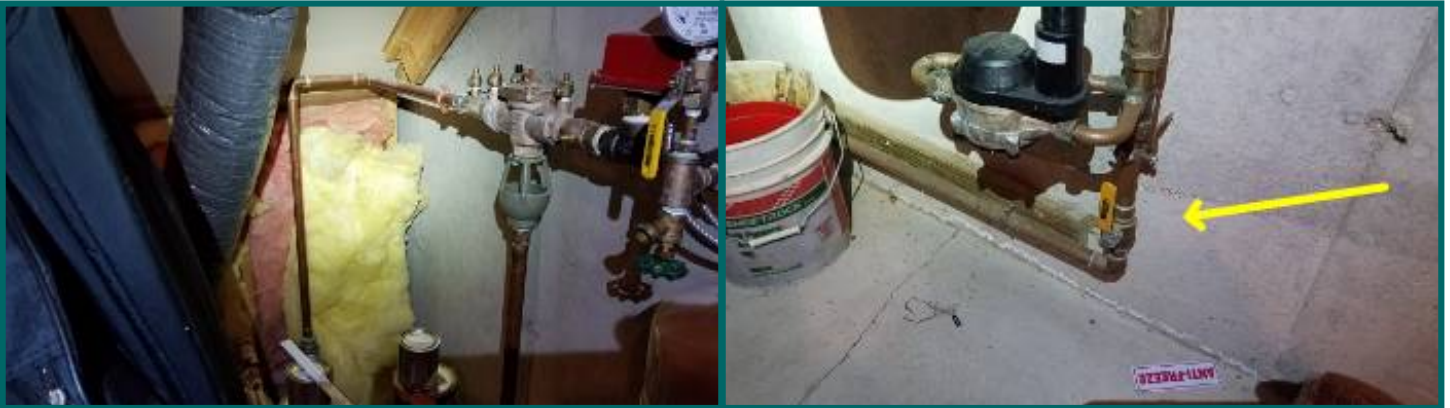
- 1.1. Main water shut off valve is located in basement
- 1.2. Copper water supply lines
- 1.3. "PVC" waste and vent pipes noted
- 1.4. There is a fire suppression wet sprinkler system in the house, not assessed in this report. This system will need to be inspected and serviced on a regular basis. Recommend contacting home owner for service history and continue proper service.

fire suppression riser

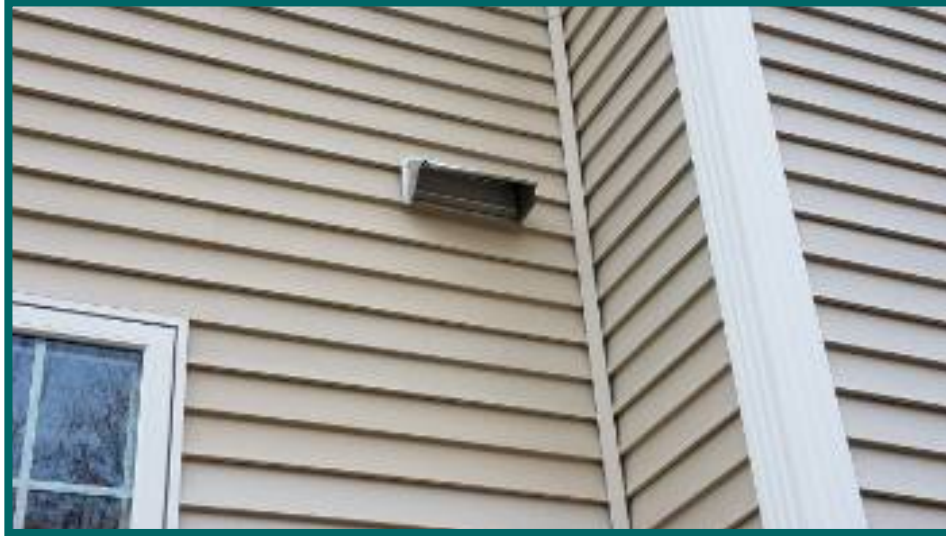
Kitchen vent termination at rear wall not in use.

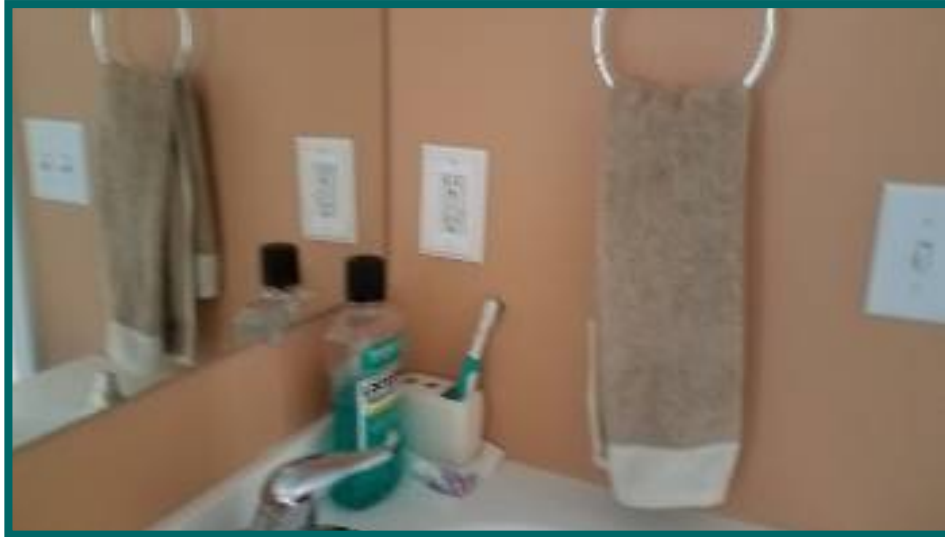
Master bath GFI outlet protects other bath outlets

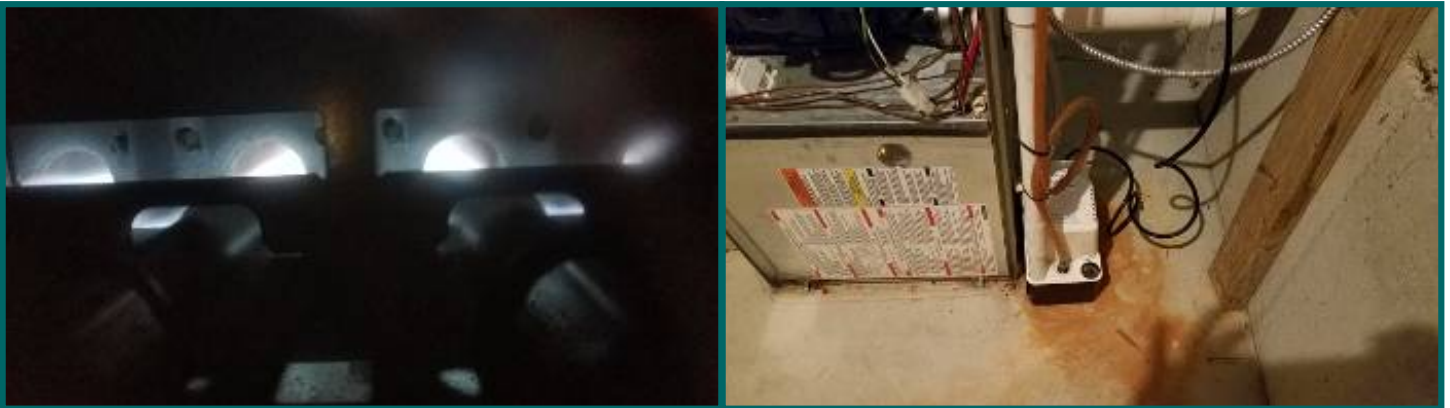
clean flame pattern

Condensation Pump and drain lines should be monitored for evidence of water leaks.

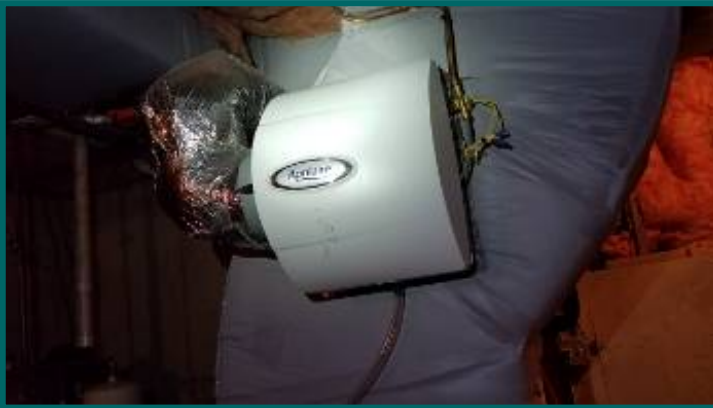
1.4. Whole house humidifier present. Humidifier is not operated or tested. Humidifiers require annual maintenance by a qualified hvac company to ensure proper operation, there is a baffle for winter and summer mode that must be switched with season.

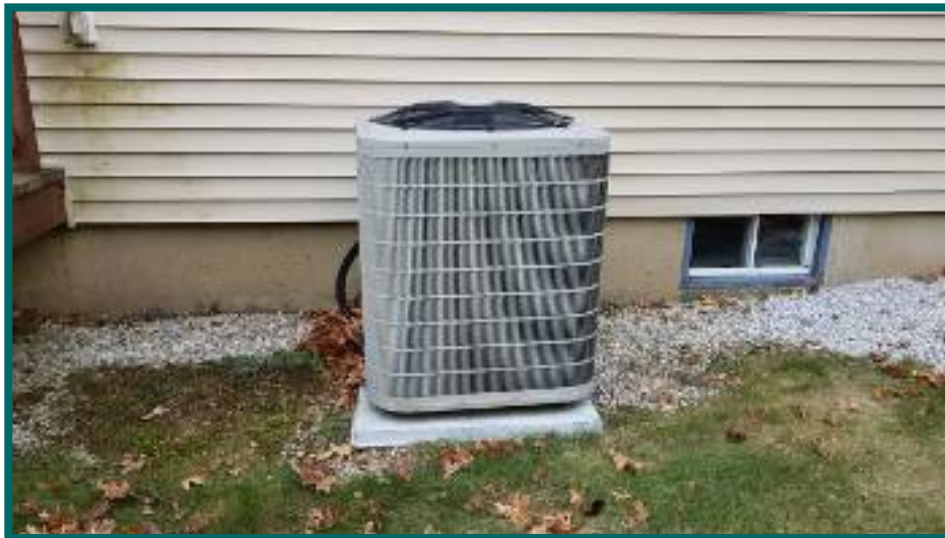
6.3. Compressor is approaching or beyond its design life, recommend monitor operation and full inspection and service by a qualified HVAC contractor as needed.

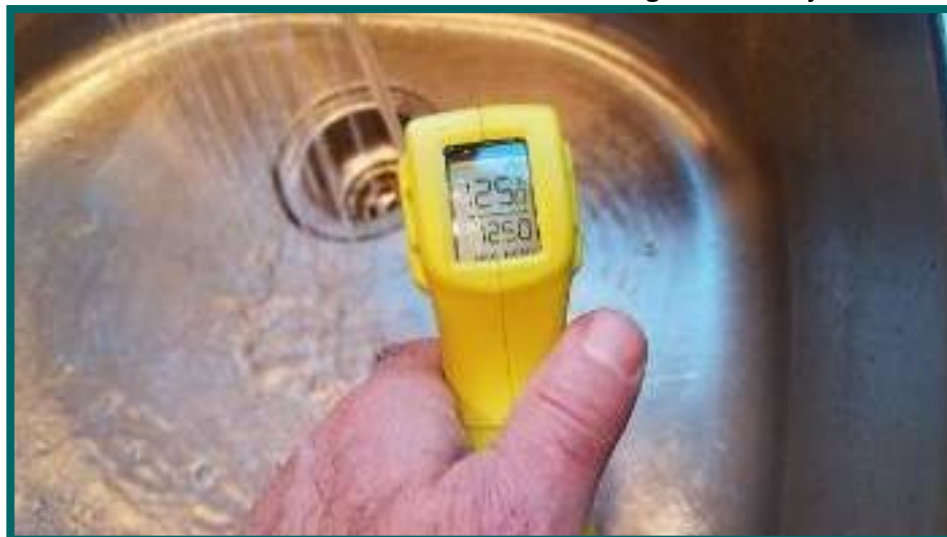
1.4. Water temperature is between 110 and 125 degrees, this is an acceptable temperature. Should be set minimum of 110 degrees for comfort and 125 degrees to prevent scalding hazard, particularly for very young and very old.

Water temperature
