Alpha Home & Commercial Building Inspections

Property Inspection Report

Date of Inspection: 11/4/2020 Time: 11:00 AM
Order ID: 11820

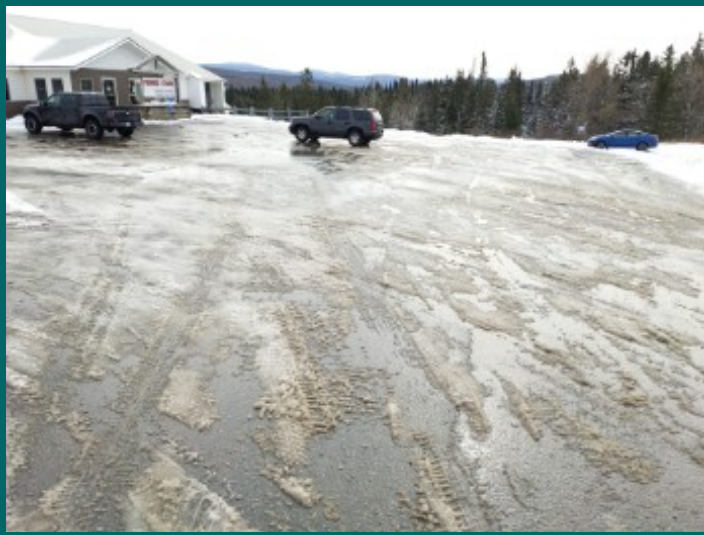
1.3. Some surfaces were snow covered; not fully inspected.

Limited visibility of parking area due to snow cover.

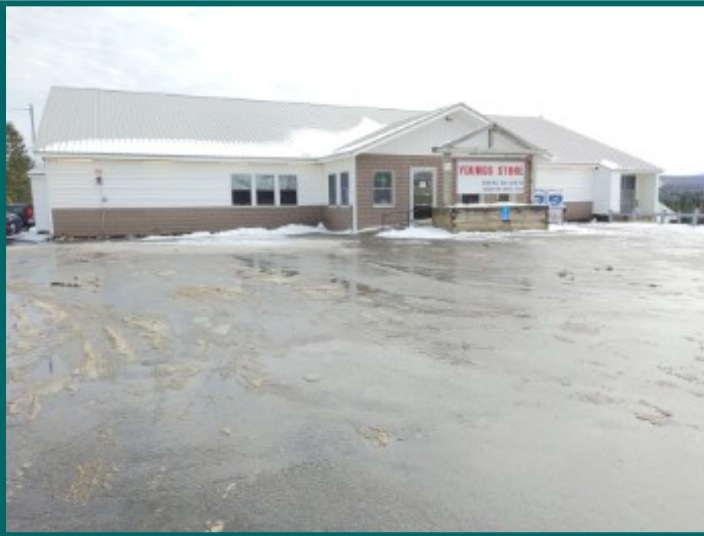
2.3. Grading at one or more area of property has neutral slope, this may be conducive to ponding of water against foundation, recommend monitoring condition and take measures to divert water away from this area as needed.

Neutral grading at front

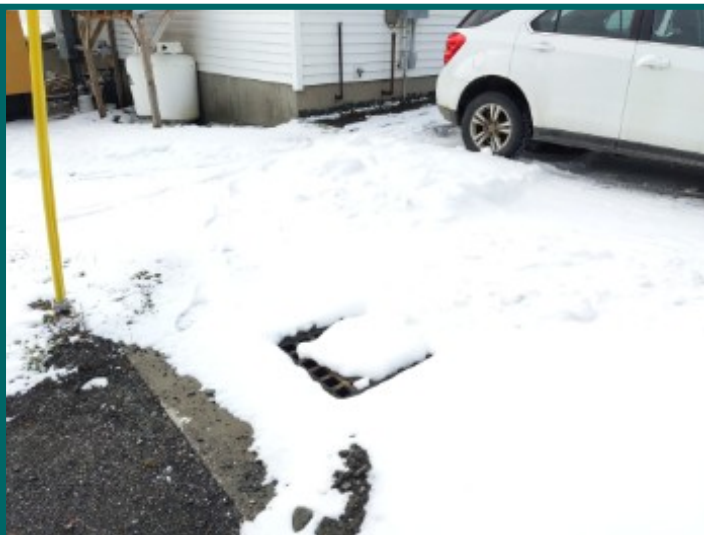
2.4. There is one or more surface drain at exterior of building, recommend monitor for proper drainage, keep clear of snow / ice / debris and have cleaned and serviced as needed.

Surface drain at left side of building

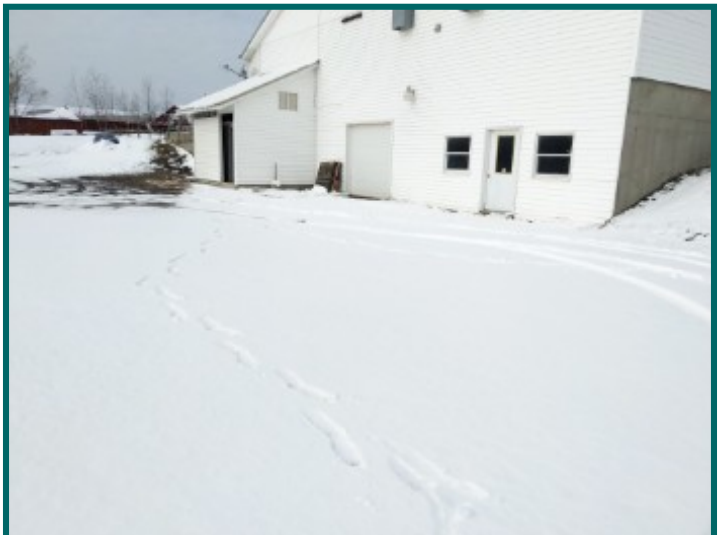
Neutral grading at right side of building

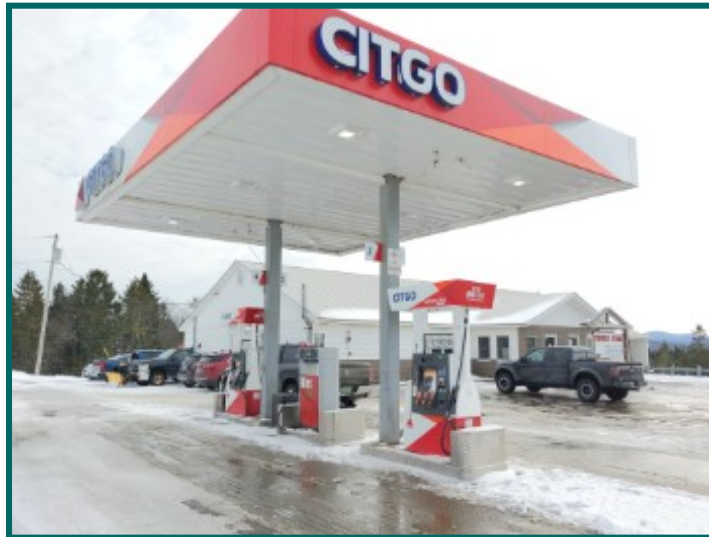
Gas pumps were not inspected

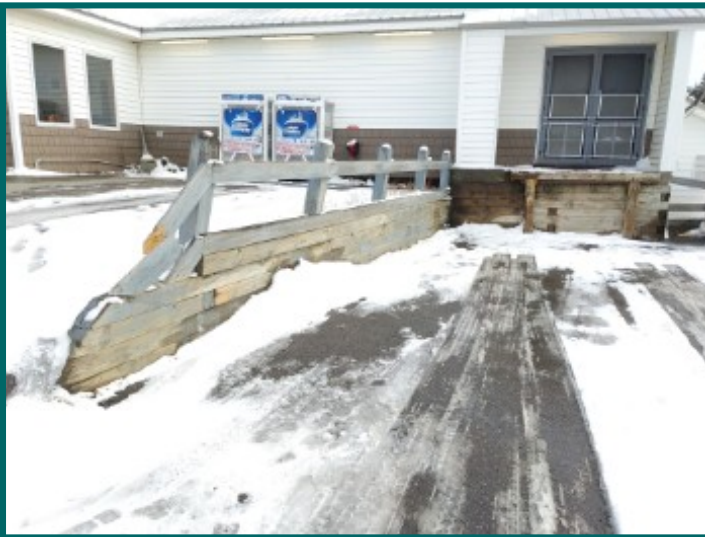
4.3. There are cracks, damage or evidence of movement in retaining walls. Recommend further investigation and repair as needed by a qualified masonry contractor.

Front retaining wall is damaged / leaning

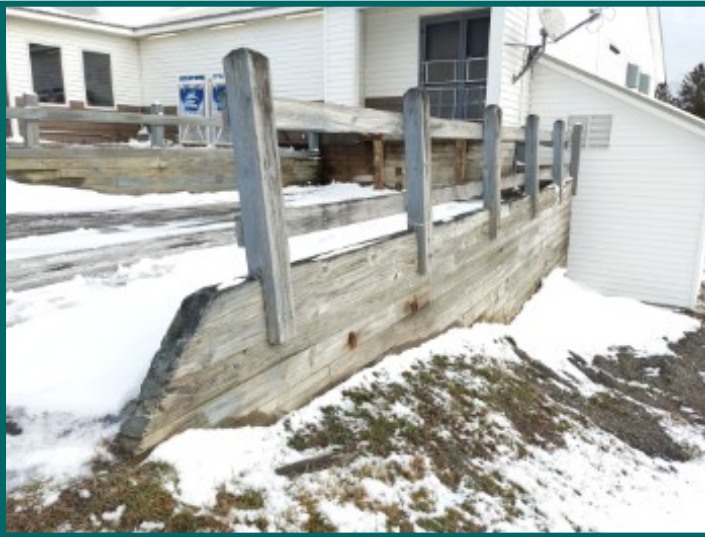
Loading dock wall is leaning

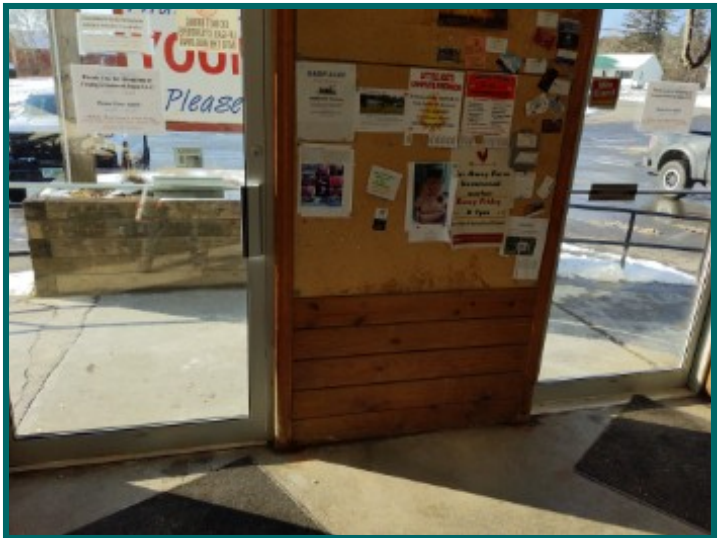
1.4. One or more exterior door does not seal well. This can be an energy drain and allow vermin into building. Recommend repair / adjustment by a qualified contractor.

Front door does not seal well

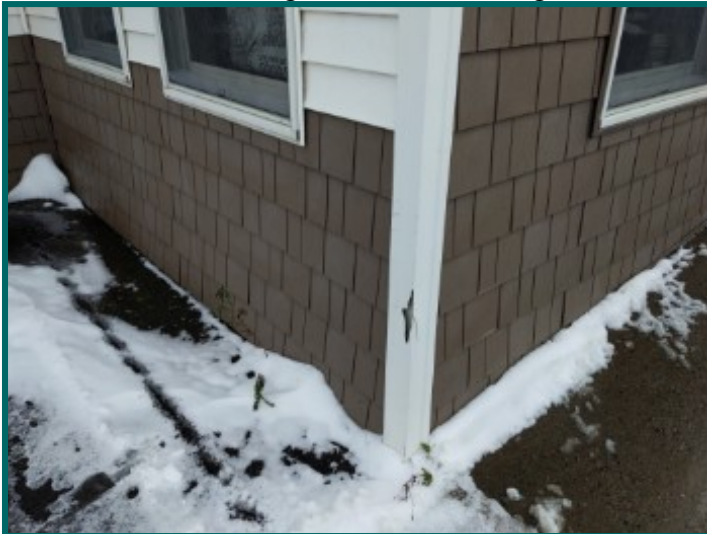
2.4. Siding is in contact with finish grade at one or more area of building, this is conducive to moisture and insect intrusion, recommend monitor area and have repaired as needed by a qualified contractor.

2.5. One or more areas of damage or deterioration to siding. This condition is conducive to water intrusion and further deterioration. There may be damage to structural components of the building that are not visible until further probing by a qualified professional are performed. Recommend further assessment and repair by a qualified tradesman.

Damaged siding is in contact with ground at front / left side

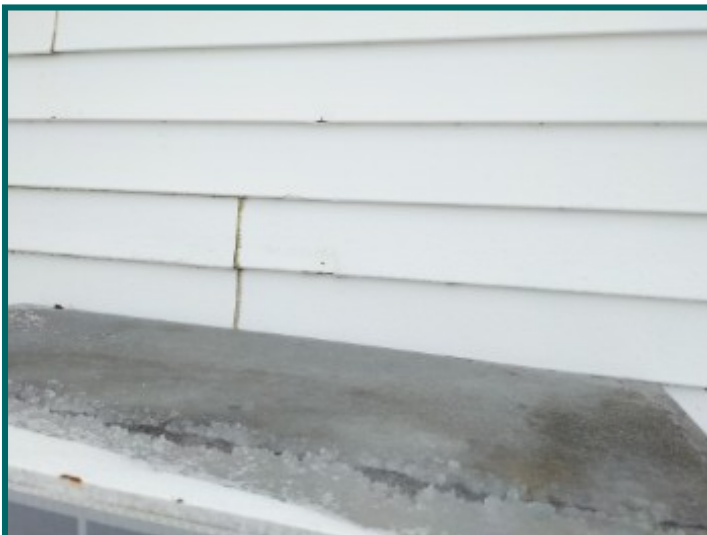
2.2. Noted stains/ discoloration / corrosion at wall surfaces. Recommend inspection, cleaning, repairs as needed and taking measures to divert stain causing water or moisture and monitoring area for further staining or damage.

Damaged siding and staining on siding in front of building.

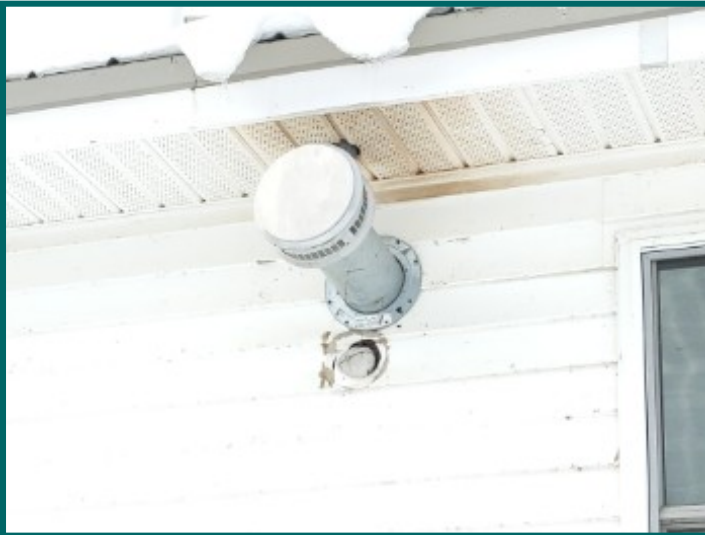
2.3. Penetrations at one or more exterior area of building are not properly sealed, this is conducive to water, insect and animal intrusion, recommend repair by a qualified tradesman.

Open penetration at rear of building

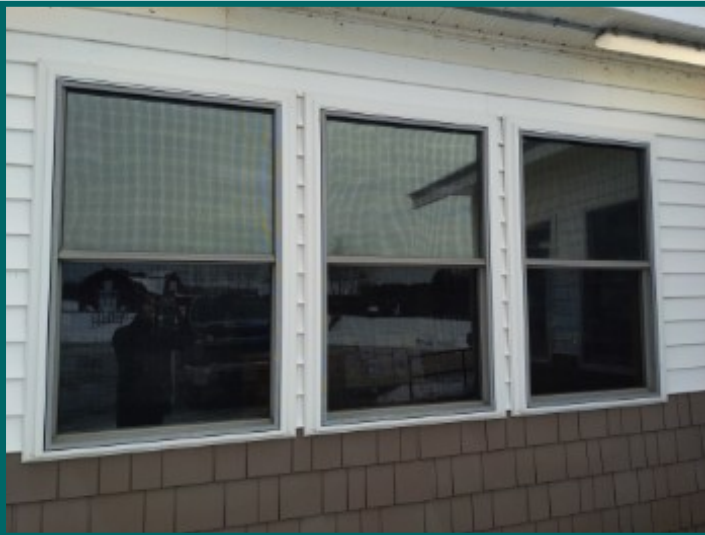
3.2. Peeling paint observed, suggest scraping and painting as necessary.

Peeling paint at right side windows.

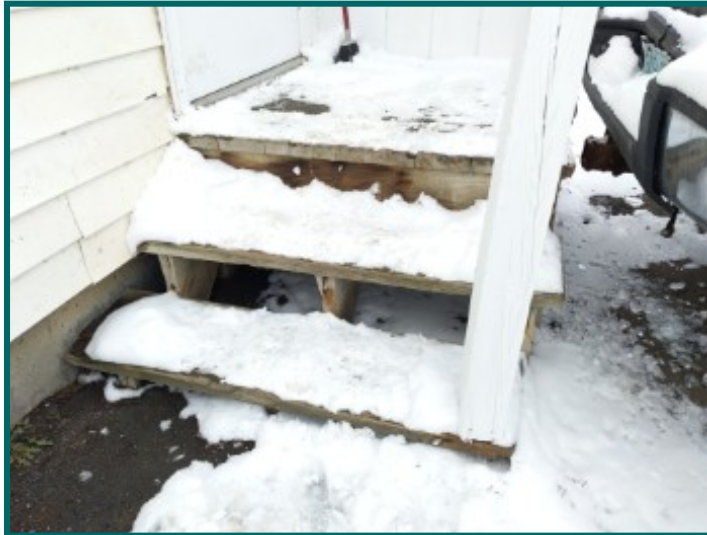
5.3. One or more stairways have uneven riser heights, this is considered a potential trip hazard. For new construction it is required for steps to have even risers with a maximum of 3/8 of an inch difference between the risers over the entire length of the stairs. When the risers are uneven, people tend to either trip at the higher riser when ascending the stairs or stomp down hard on the lower risers when descending the stairs.

5.4. There is damage or gaps in stair framing, recommend assessment and repairs by a qualified contractor.

Uneven riser height and damaged framing at left side stairs

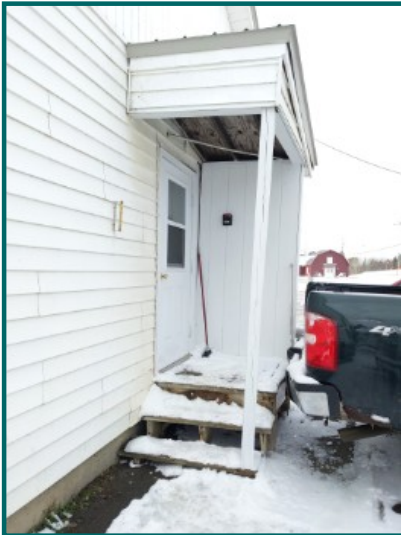
- 6.4. One or more footings for deck posts were not located, missing footings can be conducive to heaving and settlement of deck.
- 6.5. One or more support post is out of plumb, this is an indication of settlement or movement of the deck/porch, recommend assessment by a qualified contractor.

Left side porch/landing support post is not plumb.

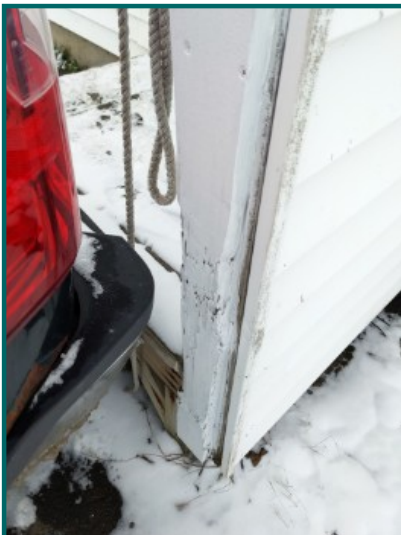
- 6.6. There are areas of settlement to decks and or porches, recommend assessment by a qualified tradesman and repairs as needed.
- 6.7. Areas of movement or damage at deck/porch framing, recommend assessment and repairs by a qualified contractor.

Damaged framing/post at left side landing

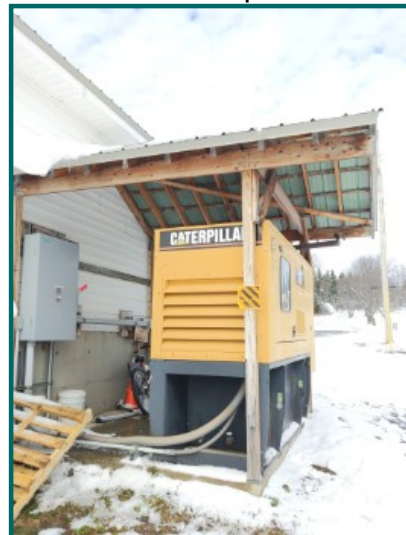
Support post at rear overhang is not plumb.

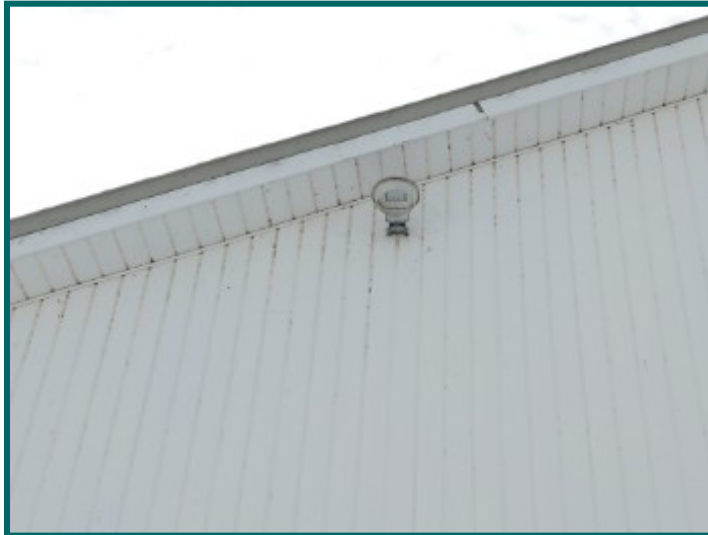
Exterior lighting was not observed illuminated

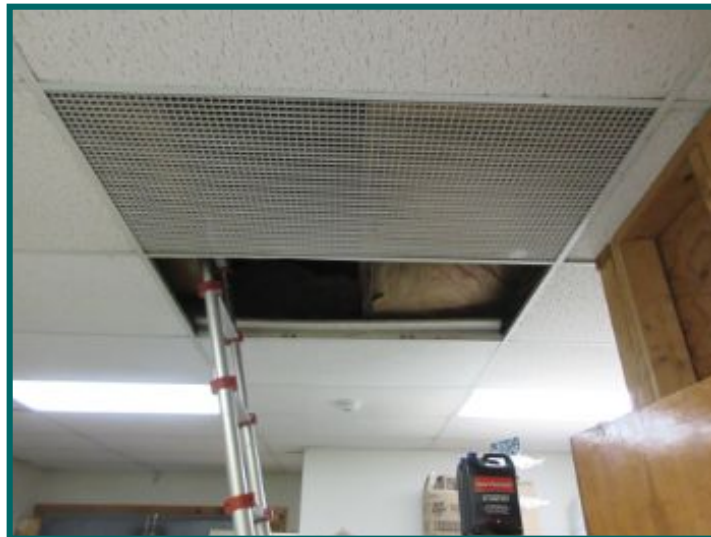
1.1. Some attic areas were inaccessible due to lack of permanently installed walkways, the possibility of damage to insulation, low height and/or stored items. These areas are excluded from this inspection.

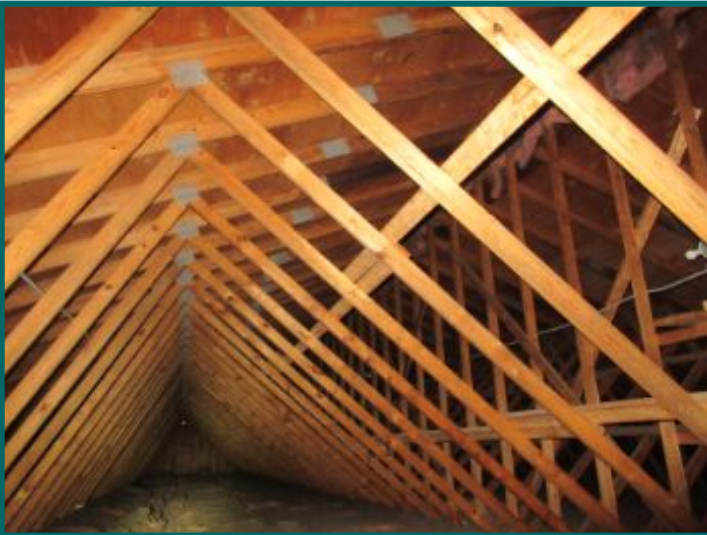
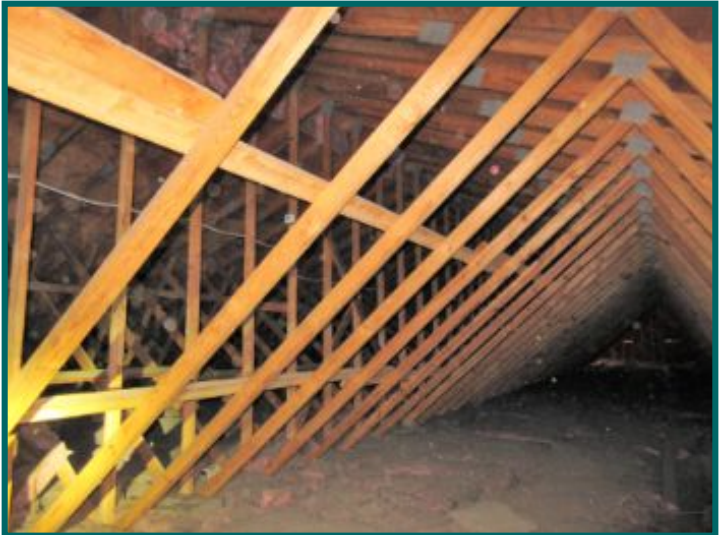
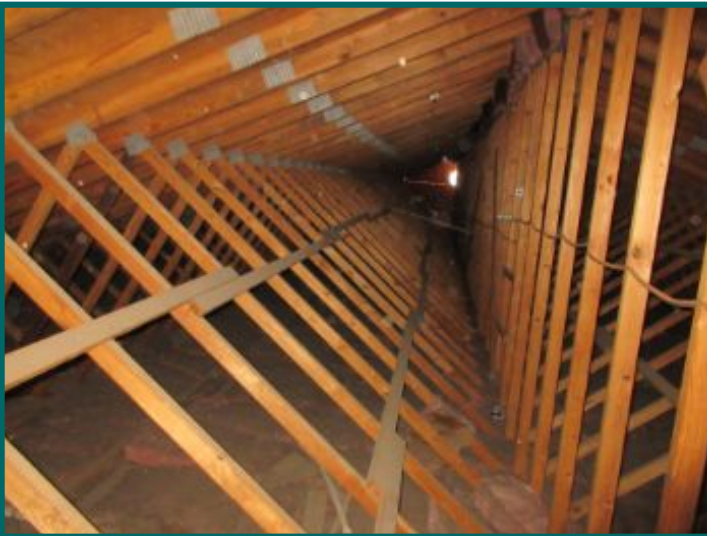
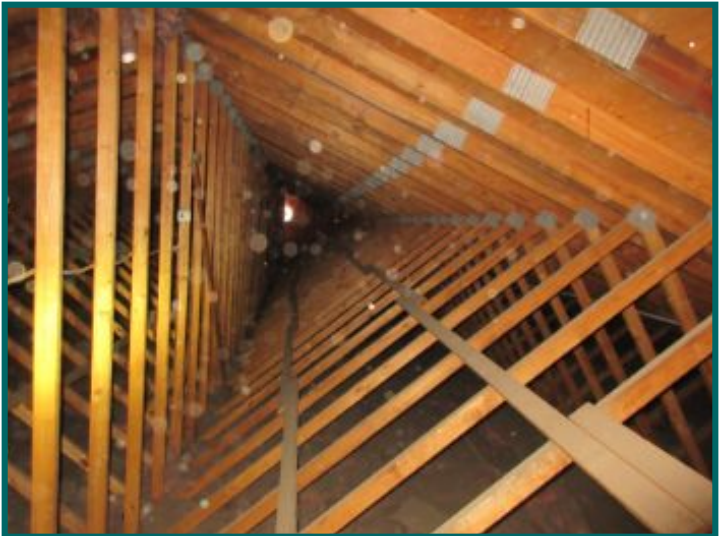
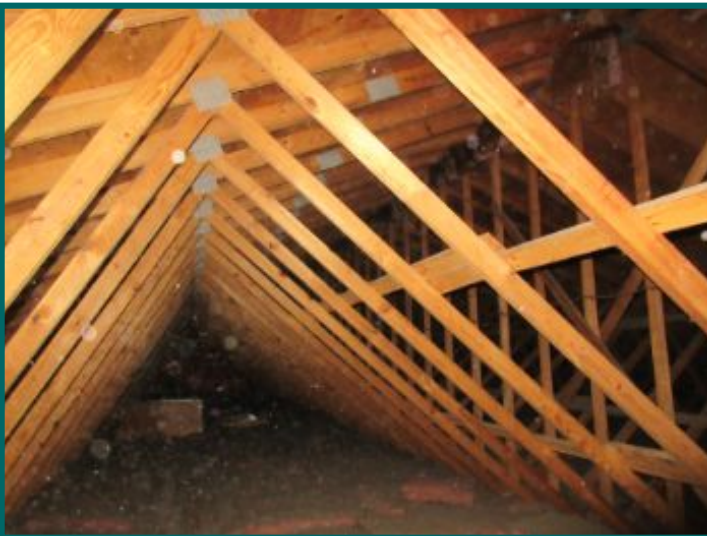
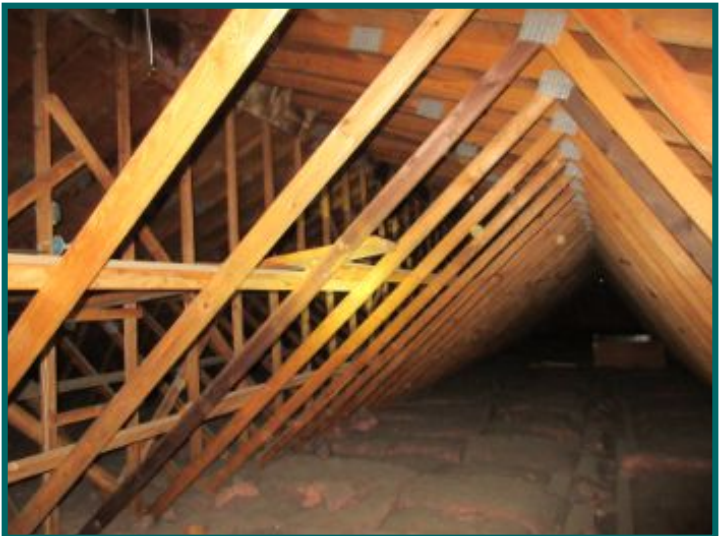
2.4. Stains were found in one or more attic surface areas, no elevated levels of moisture were found. The stain(s) may be due to past or present roof and/or plumbing leaks. Recommend asking the property owner about history of water intrusion and or assessment of any affected areas by a qualified contractor and repairs as necessary.

Stains tested dry

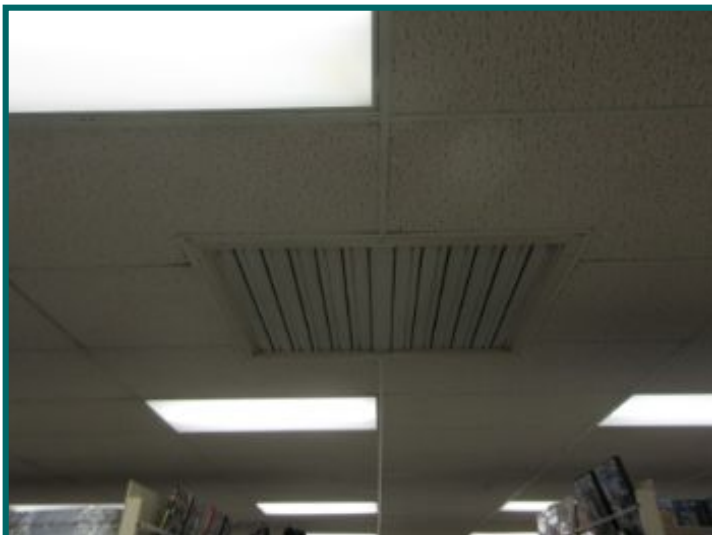
3.5. Whole building fan present, it is important to cover and insulate fan during heating season to control heating cost. Need to uncover prior to using in the summer.

Whole building fan not tested / control not located

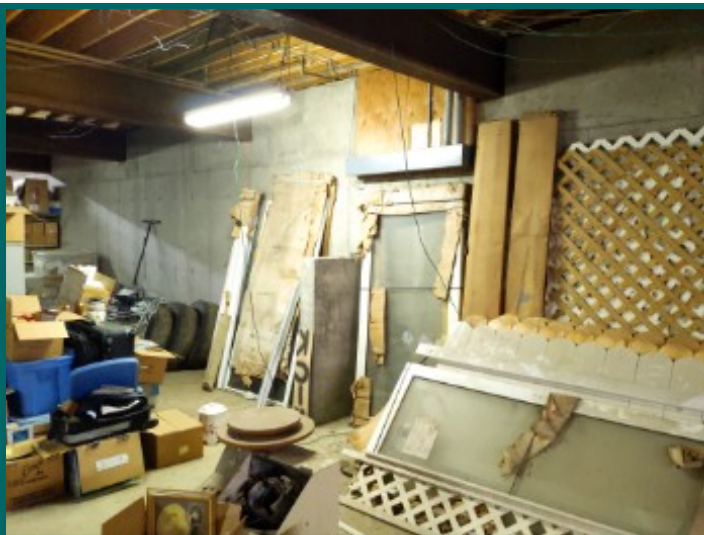
1.6. Vertical cracks noted on foundation wall at one or more location, recommend monitor for further movement and or water intrusion and sealing / repairs as needed.

Cracking at left side wall

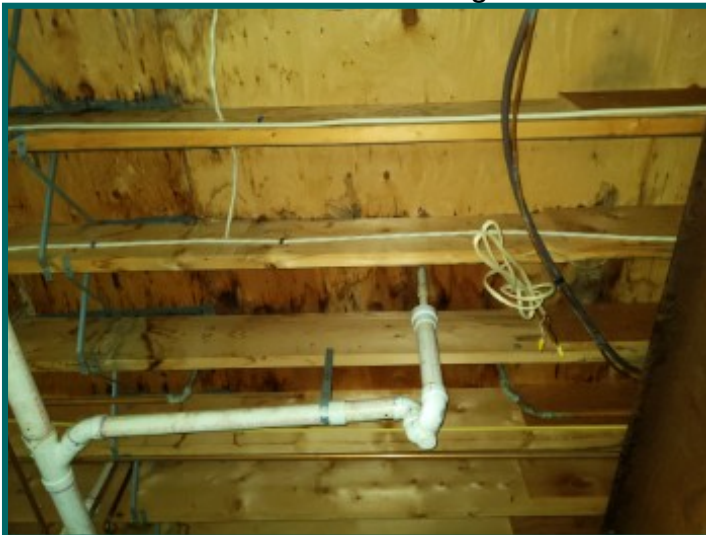
Water staining at rear / left side of basement

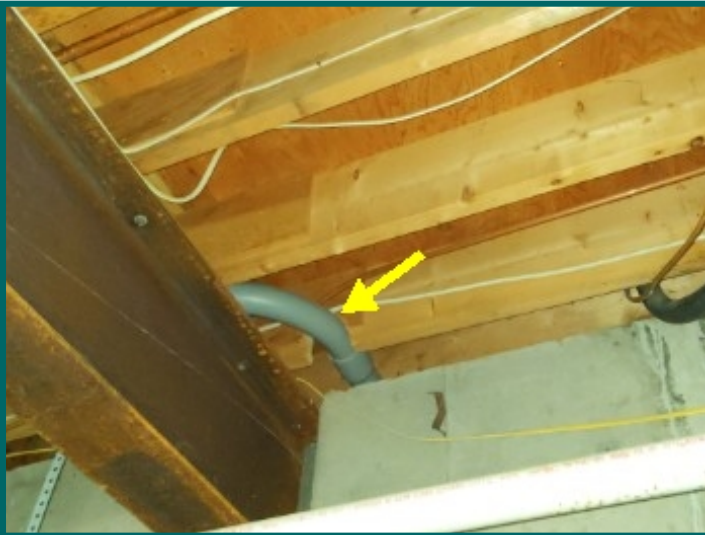
Improperly notched joist at rear / left side of basement

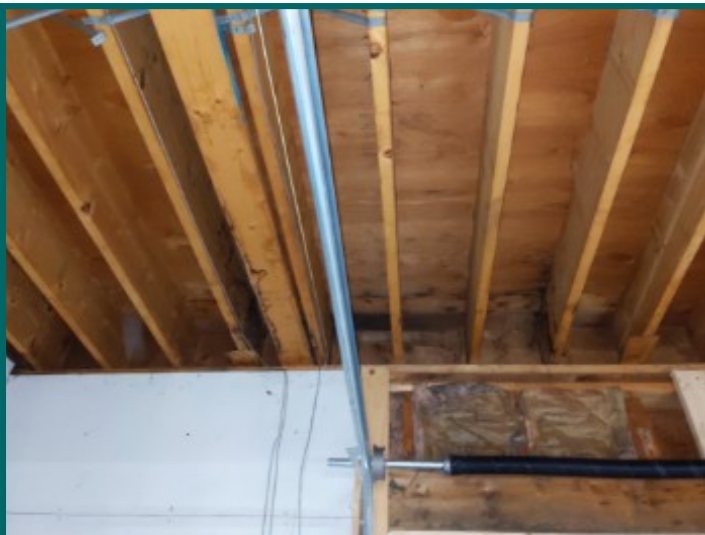
Water staining at right side of basement

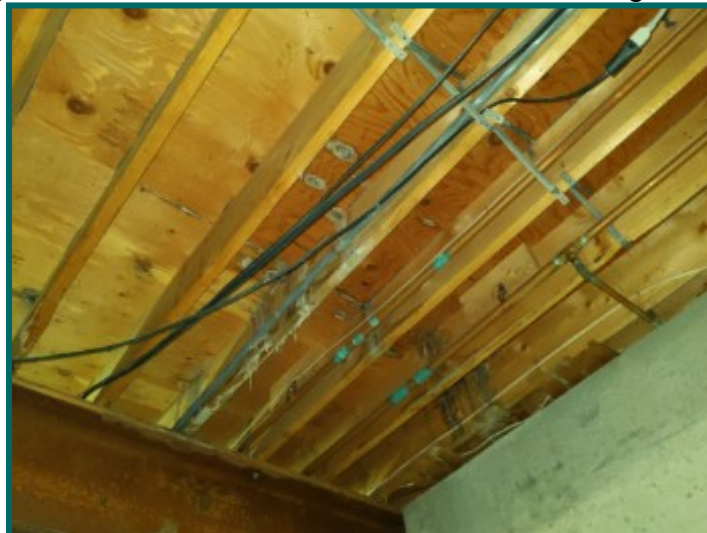
Water staining on framing below front entry.

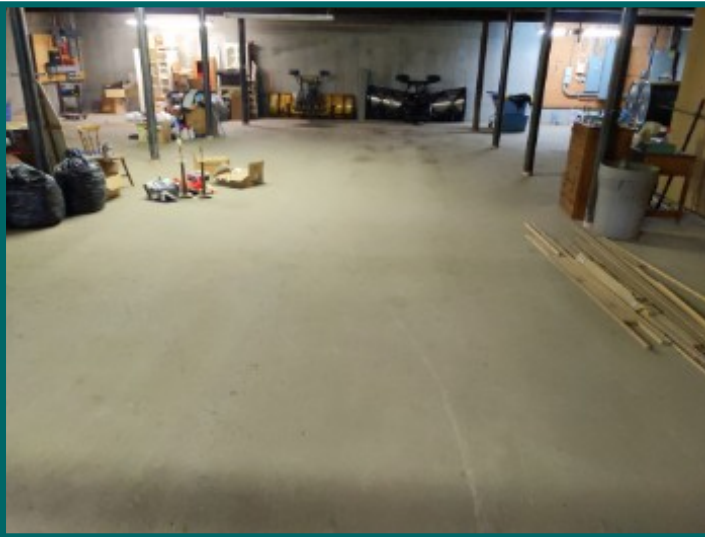
3.3. Typical settlement cracks, recommend monitor for further movement and water intrusion and repairs by a qualified contractor as needed.

Typical cracks

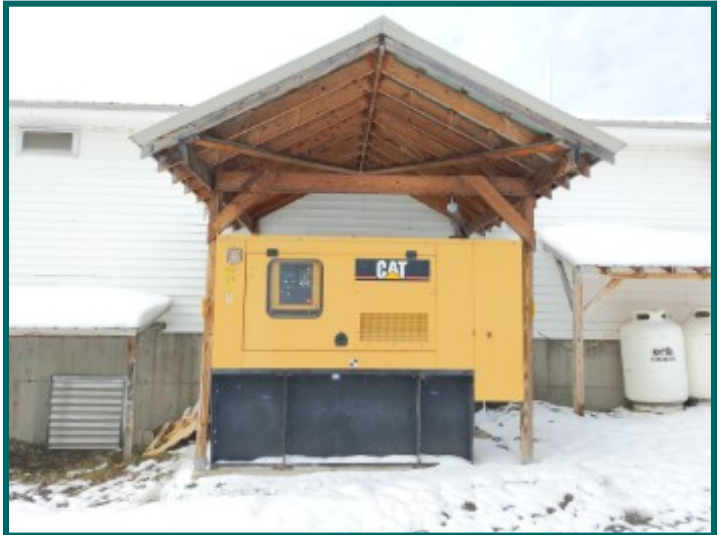
Generator at rear of building. Enclosure was locked, unable to test.

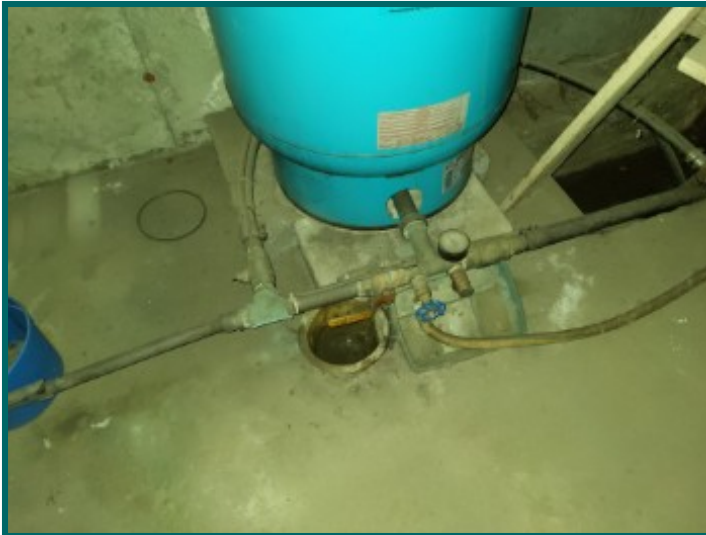
1.8. One or more plumbing line or fitting is leaking. Recommend further investigation and repair by a qualified plumber.

Main water shut off valve is located at well tank.
Valve is leaking.

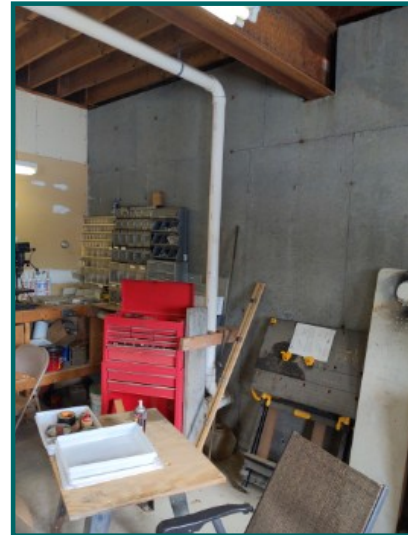
1.7. There appears to be a separate dry well that services drain lines for laundry and refrigeration condensate lines, not inspected. Client may wish to have further investigation into condition and check with seller for history of back ups.

Drain line termination at rear / right side of basement appears to be going to a separate dry well.

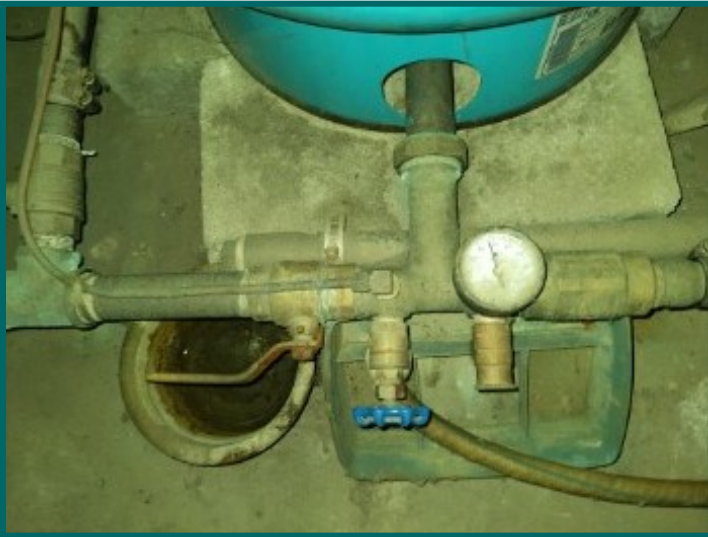
- Pump pressure gage is damaged, could not determine water pressure levels at the tank, recommend repairs and assessment by a qualified well company.

Well guage is not operating properly.

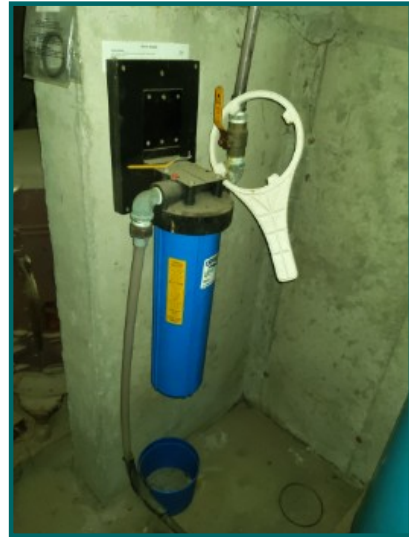
Sediment Filter, recommend changing to clear cover to observe when filter needs changing.

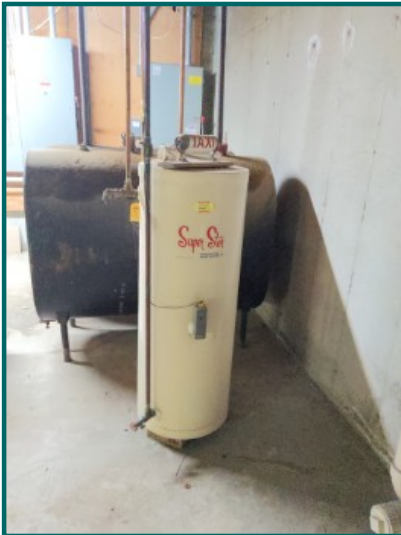
1.2. One or more water heater is approaching or at the end of its typical service life. Client should monitor condition and have replaced as needed.

Single water heater integrated with boiler, exact age not determined but appears to be approaching design life.

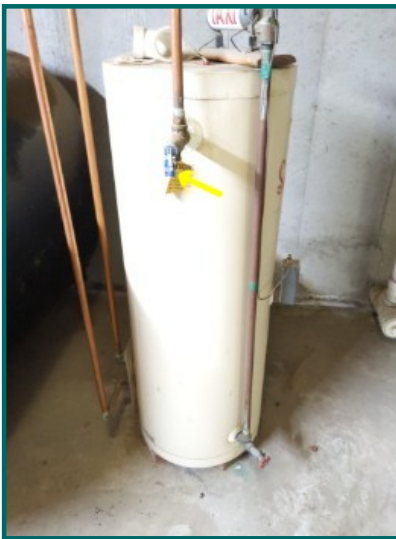
2.2. T/P relief valve extension is missing. Recommend installing of extension pipe that exits within 6" of floor. This is a safety item to prevent scalding in the event the temperature pressure relief valve releases hot water and or steam.

Missing downpipe at TPR valve.

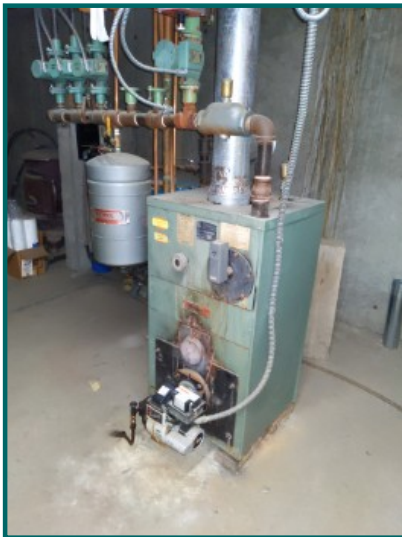
1.4. There is corrosion on plumbing fixtures and or outside cabinet surface, this is an indication of leaks, of age or improper combustion. Recommend full inspection and repairs if needed by a qualified heating contractor.

Oil fired boiler in basement, 32 years old.
Corrosion on boiler / boiler plumbing.

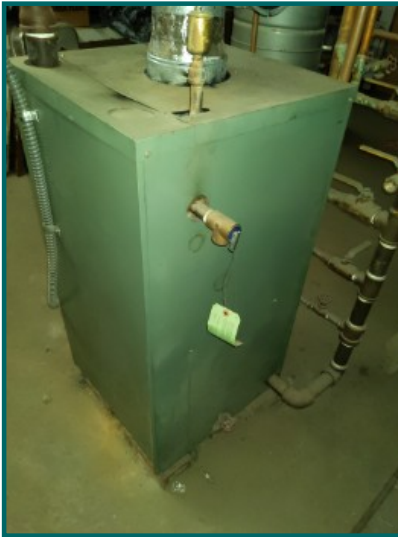
1.5. T/P relief valve extension is missing at one or more boiler. Recommend installing of extension pipe that exits within 6" of floor. This is a safety item to prevent scalding in the event the temperature pressure relief valve releases hot water and or steam.

Missing down pipe on boiler TP valve

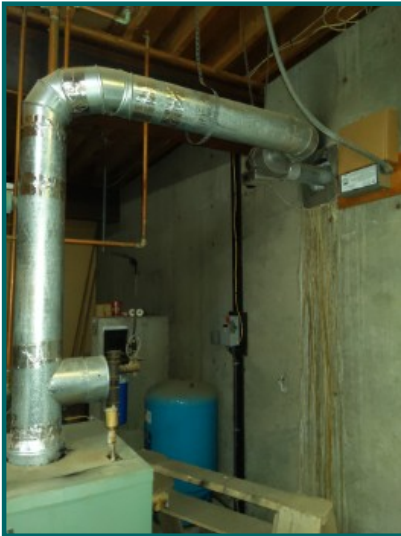
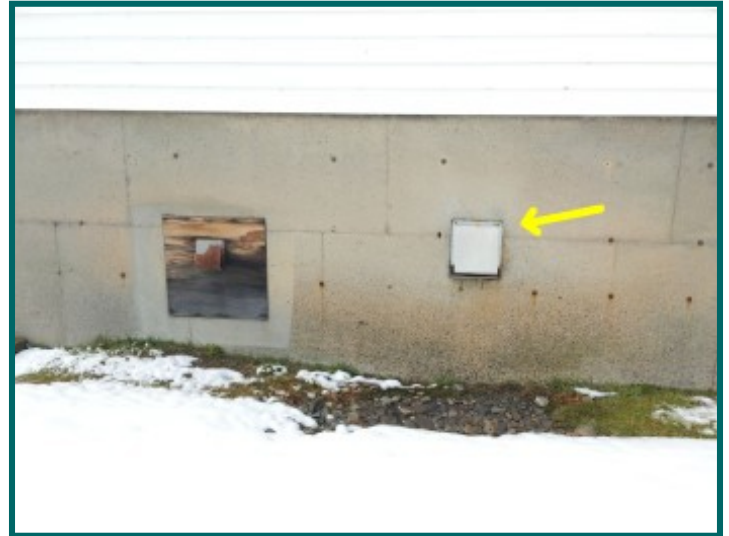
Boiler vent termination

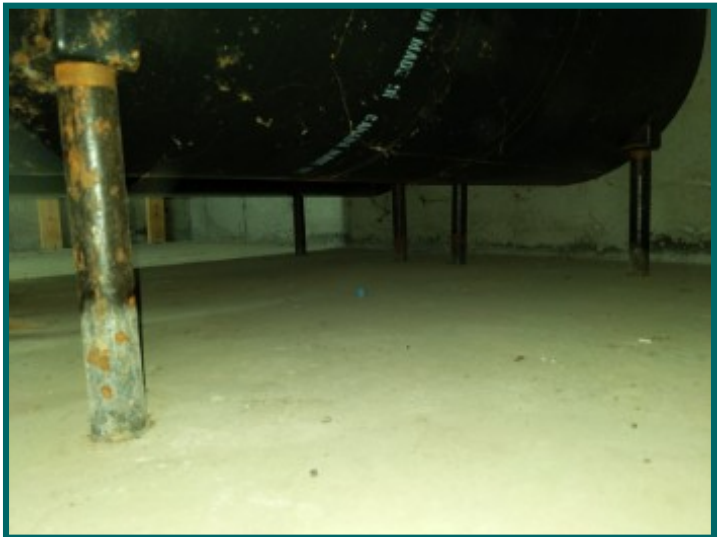
3.6. There is oil staining, wet oil on tank, oil lines / fittings, and or floor. Oil tank should be fully inspected by a qualified oil burner company and replaced or repaired as needed.

Underside of oil tanks

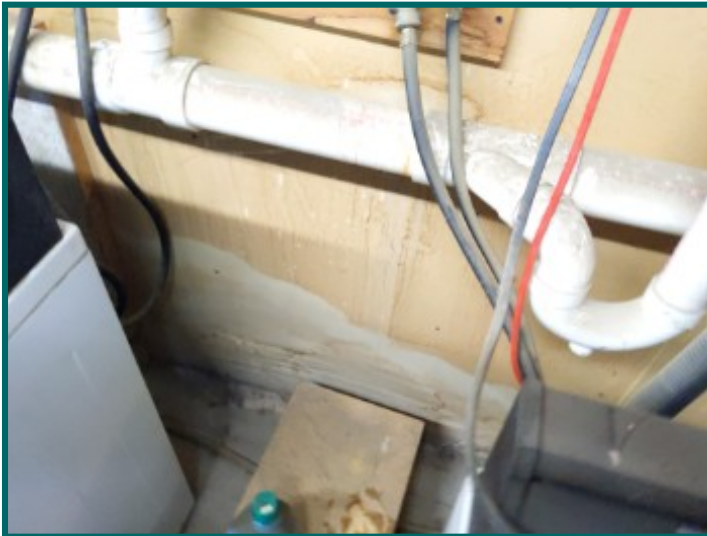
3.2. Stains on walls at one or more area of building, tested dry at time of inspection, recommend checking with current property owner about history of water intrusion or leaks, repairs by a qualified contractor and monitor for future water intrusion.

Water staining and damage to wall behind basement laundry. Area tested dry.

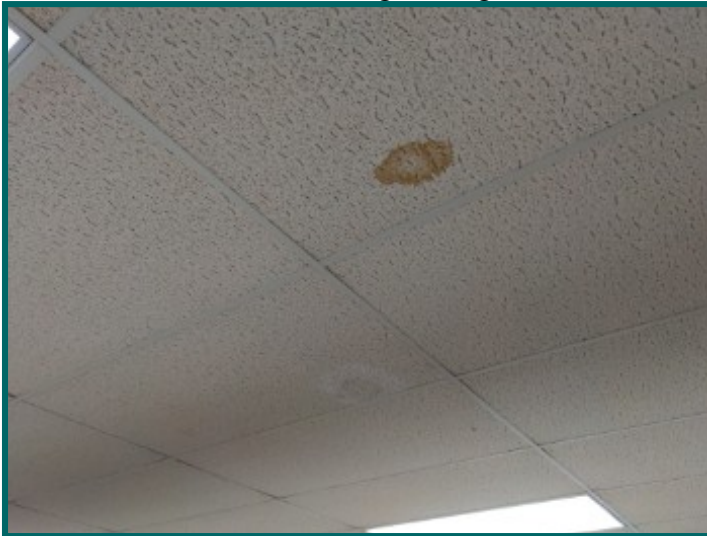
Water staining on ceiling throughout retail space.

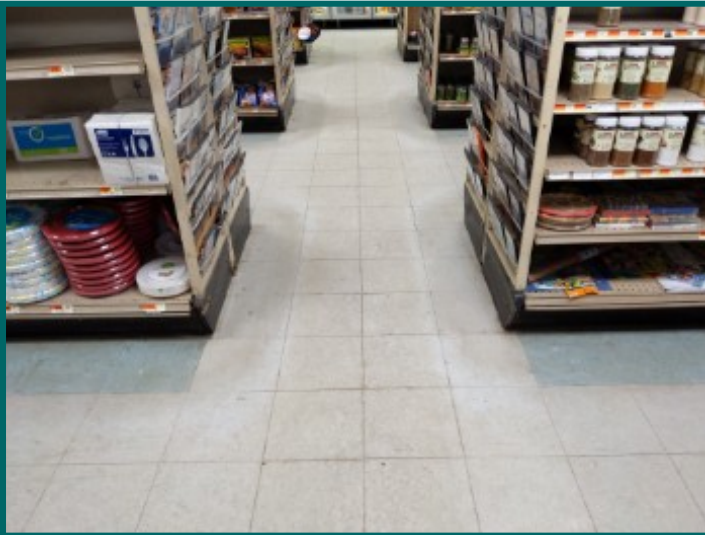
5.2. Damage or excessive wear to flooring in one or more area, recommend assessment and repairs by a qualified flooring contractor.

Worn flooring throughout

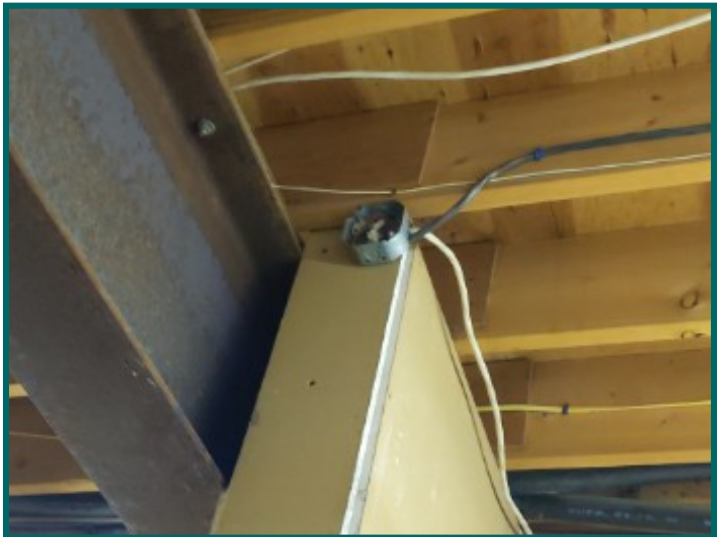
- 6.5. Improper use of extension cord observed. Extension cords should not be permanently installed or be routed through walls, floors or partitions.
- 6.6. Open junction boxes were observed, which is a safety concern. Recommend installing proper covers, as needed, for safety.

Open junction boxes in basement

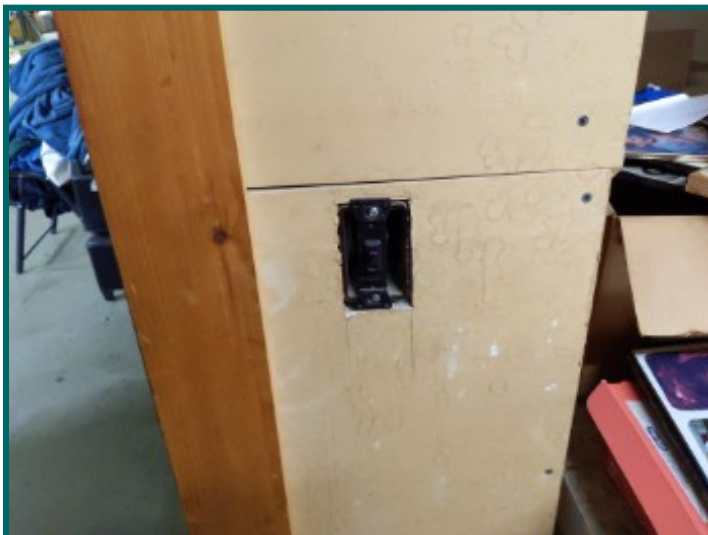
- 6.2. One or more outlet / switch cover plates missing. Recommend repairs for safety.
- 6.3. One or more ceiling light fixtures not working at time of inspection. Recommend changing bulb and repair/ replacement by a qualified electrician as needed.

Several missing outlet covers / switch covers throughout.

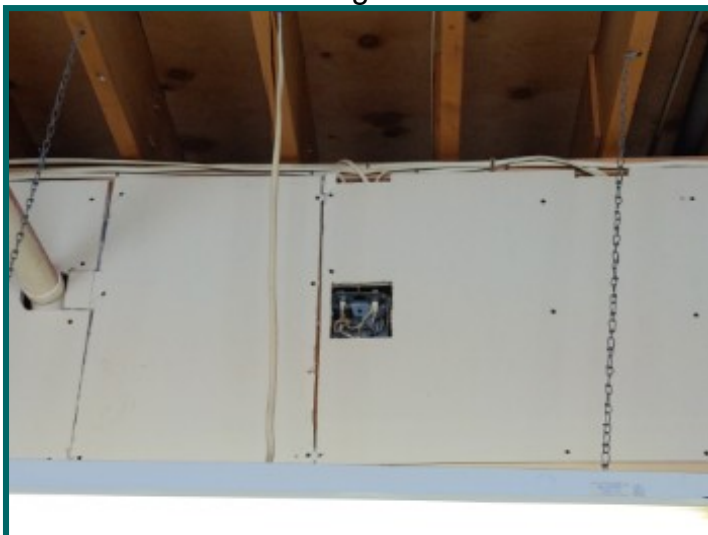
Open junction boxes in basement

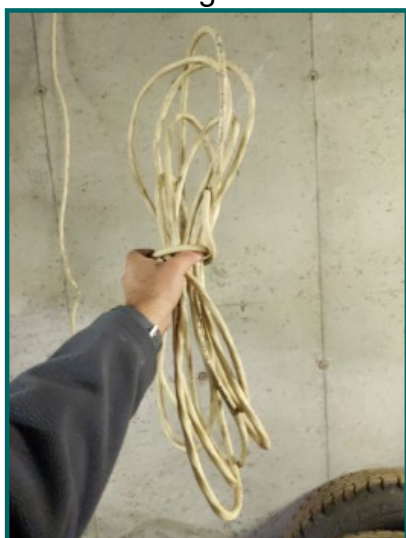
- 6.4. Improperly terminated wires present, this is a potential shock hazard, recommend proper termination of any exposed wires by a licensed electrician.

Improperly terminated wires at front basement wall.

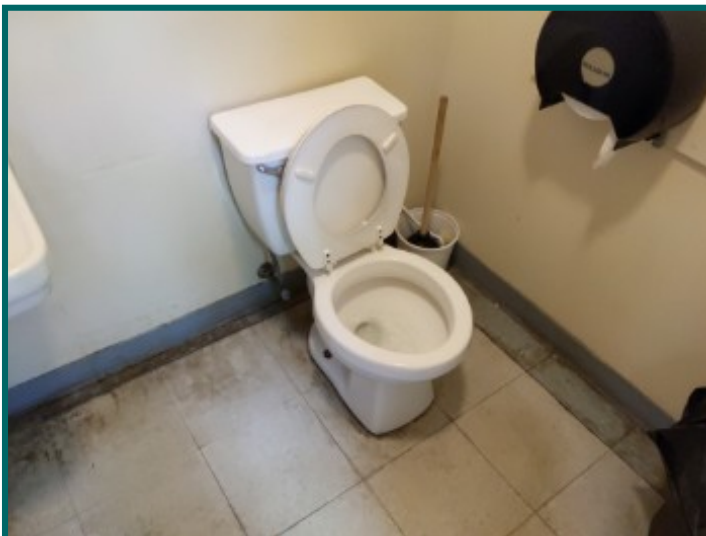
7.2. The toilet bowl at one or more location is loose at floor anchor bolts. The wax ring inside the unit must have a snug, secure fit in order to keep from leaking. Properly resealing and re-securing this unit is suggested to prevent water leakage and damage to the sub-floor area. This type of damage is not always visible or accessible to the inspector at time of inspection.

7.3. Toilet at one or more location continues to run after flushing; recommend have contractor evaluate and repair.

Toilet is loose and is running at customer bathroom

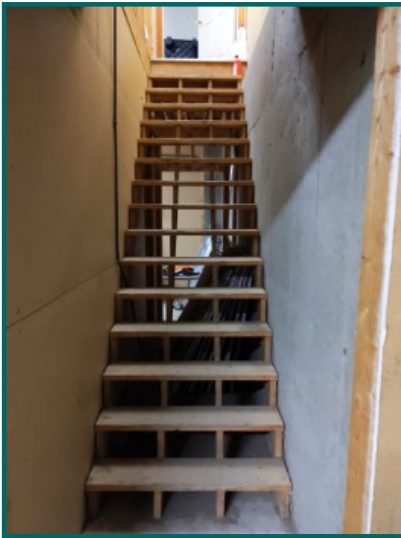
8.3. Stairs have one or more area of handrail missing. Recommend installing proper hand rail and balusters by a qualified contractor for safety.

Missing handrail at basement stairs

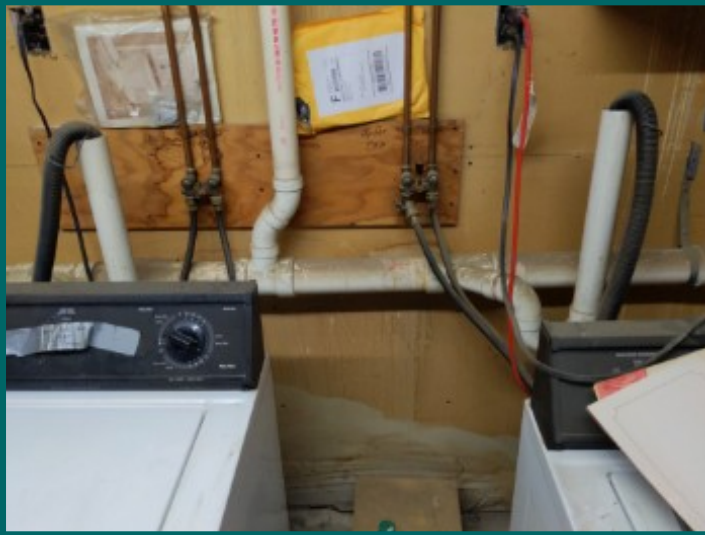
- Recommend regular inspection and cleaning of dryer vent to help prevent fire hazard.
- Laundry supply lines are rubber or plastic, recommend installing metal mesh burst proof hoses to help prevent water intrusion / damage from laundry leaks.

Recommend replacing rubber with steel mesh burst proof water hoses.
