Property Inspection Report

85 Year Old Single Family Victorian, NH
Inspection prepared for: Sample Client
Real Estate Agent: -

Date of Inspection: 10/9/2015 Time: 1:00 PM
Age of Home: 115 years Size: 2738 sf
Order ID: 2977

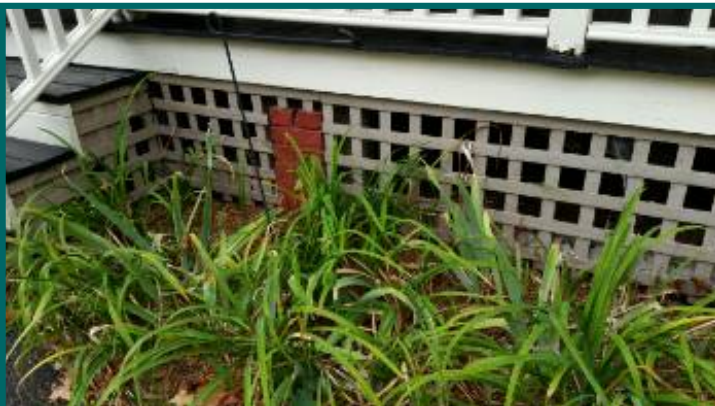
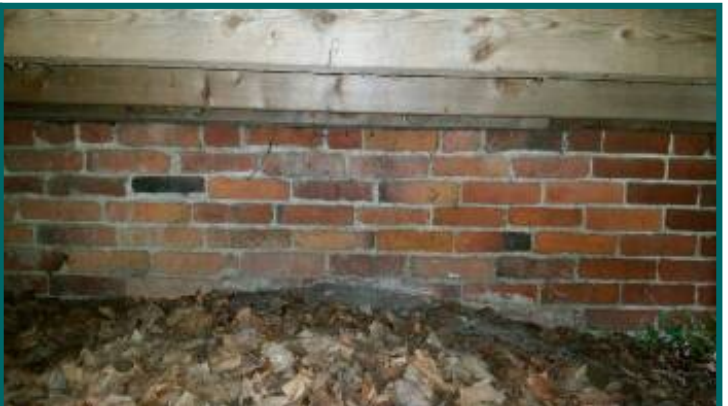
6.2. Limited visibility under deck due to skirting or low clearance.

Deck framing side

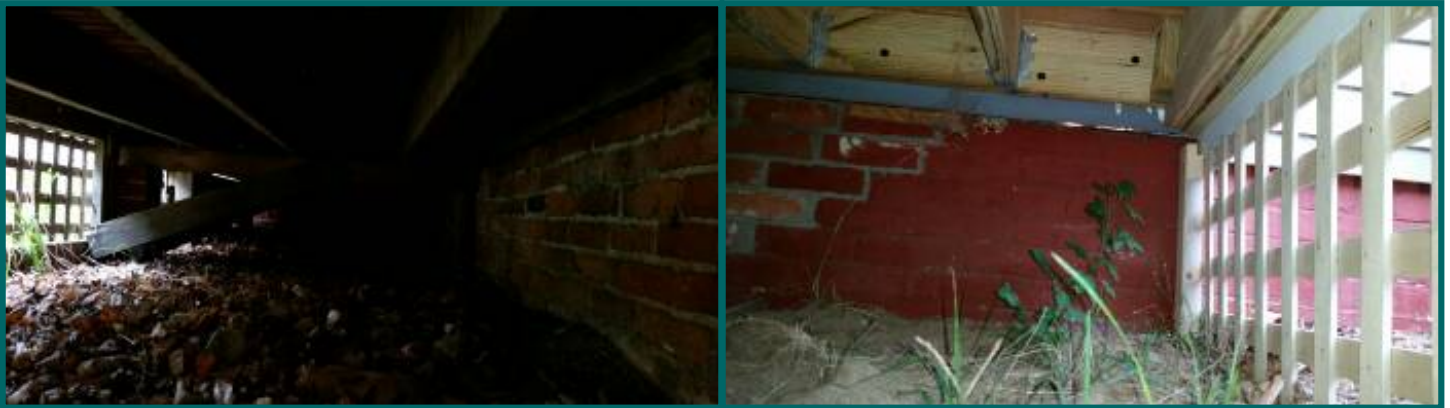
Deck framing front

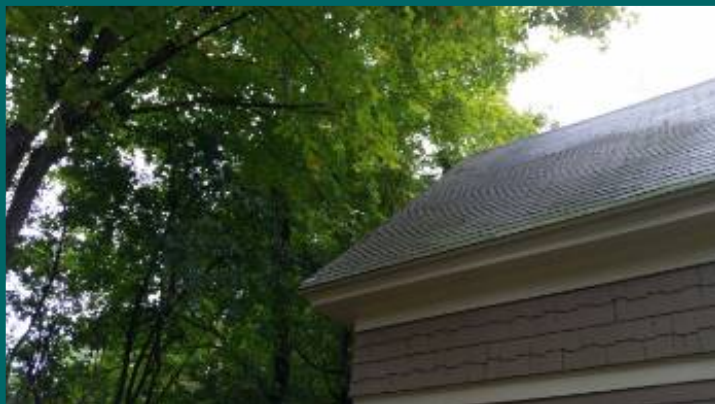
trees should be cut

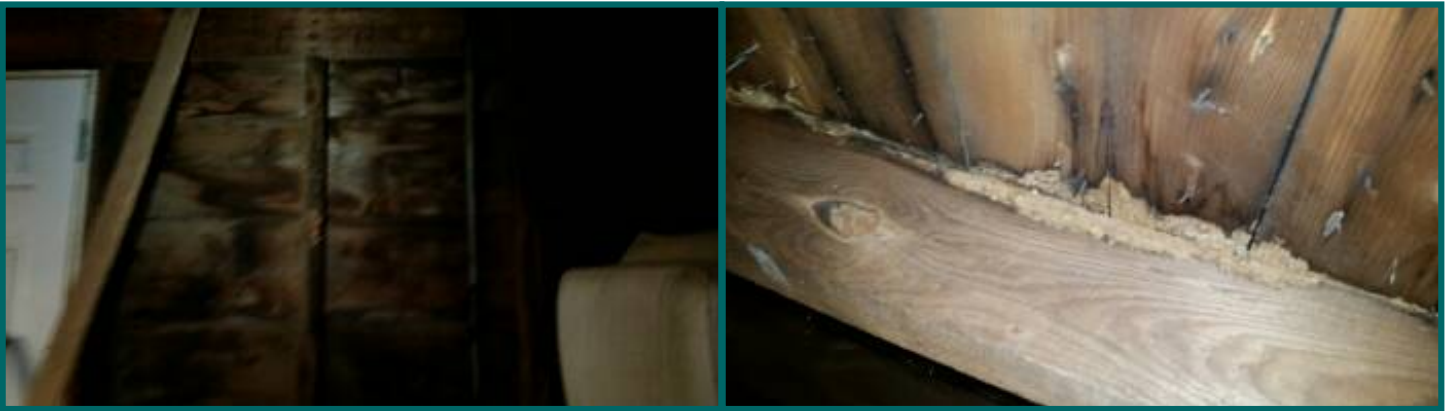
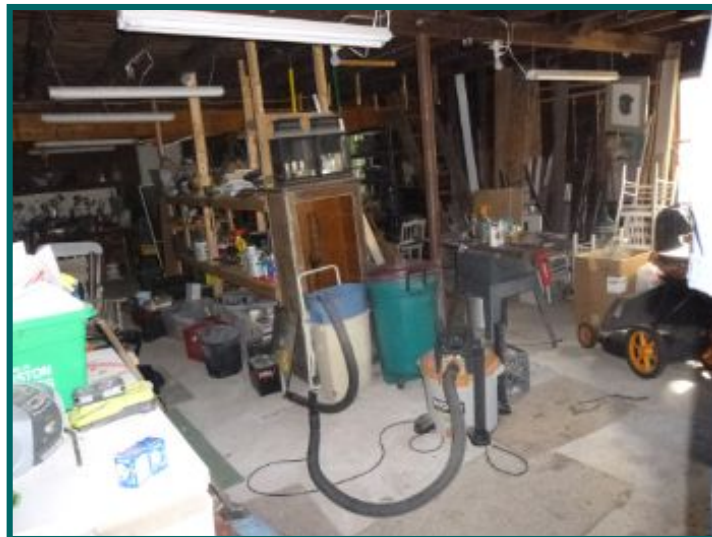
- 1.1. Interior ceiling and wall surfaces were checked for visible evidence of staining, damage, settlement cracks and improper installation.
- 1.2. Limited visibility due to stored items.
- 1.3. Stains noted at one or more area of the garage walls and or ceilings. This is evidence of past or present leaks. They tested dry at the time of the inspection. Recommend repairs and monitor for further water staining.
- 1.4. There are areas of deterioration or damage to roof framing present - recommend monitoring condition closely for further deterioration and having repaired as needed.

Cluttered conditions limited visibility.

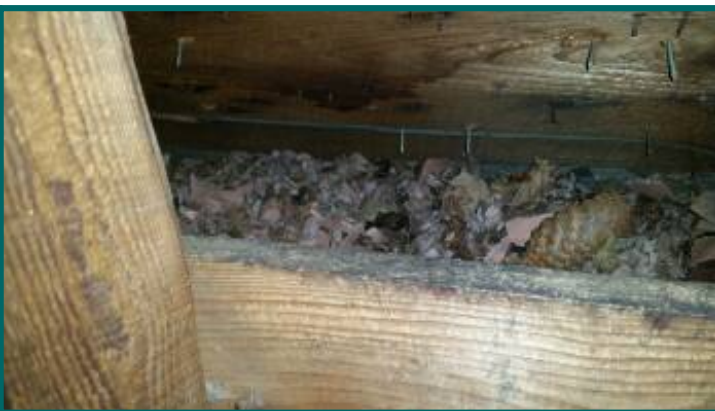
rodent nesting

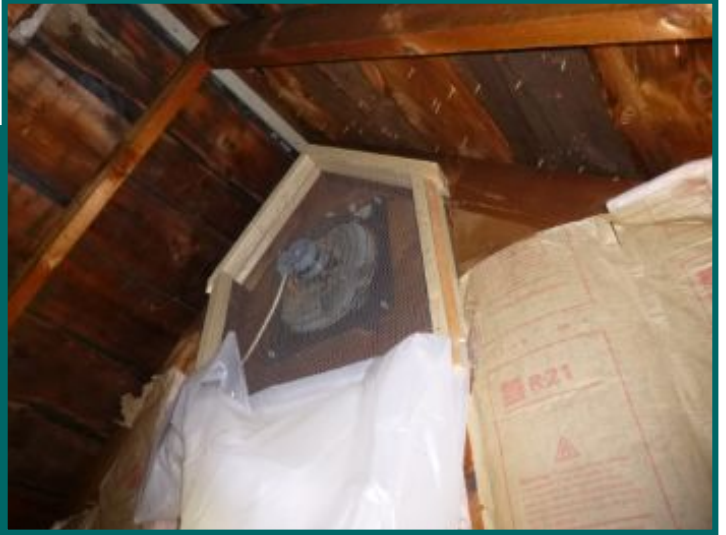
Thermostatically controlled fans are not operated.

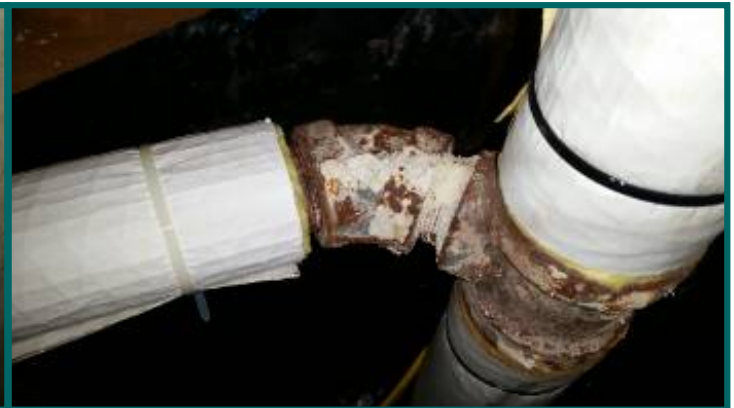
Page 23 Item: 4	Ducting / Heat Pipes	4.1. Insulation on heat pipes in basement may contain asbestos . Recommend further investigation and encapsulation or proper removal if needed by a qualified asbestos remediation company.
Plumbing		
Page 26 Item: 1	Plumbing	1.6. There are two main sewer line terminations exiting the basement presumably one is for gray water that goes into a separate dry well independent of the main septic system. Existence of second dry well was not verified.
Page 27 Item: 2	Well System	2.2. A visual assessment of the well equipment and operation of the well was conducted, no gages or special testing equipment were used. This report makes no comment or prediction as to the future production or operation of the well system. Operation of multiple plumbing fixtures at the same time may not be advisable to help prevent over loading the well system. The client may wish to have additional testing done by a qualified well company. The system is presumed to be a drilled well with submerged pump and well tank located in the basement. The well head was presumably located at the rear of the property. The well riser was not visible, is below finish grade recommend excavating wellhead and installing a riser for safe and easy access to inspect and repair as needed. Water flow was observed after running tub system for a minimum of 30 minutes and was providing a minimum of 3 gallons per minute. Pump had an acceptable pressure range of 30 psi to 55 psi. Pump had an acceptable operating cycle of approximately three minutes, Water quality test report will be delivered in a separate report.

Remnants of older suspected asbestos insulation.

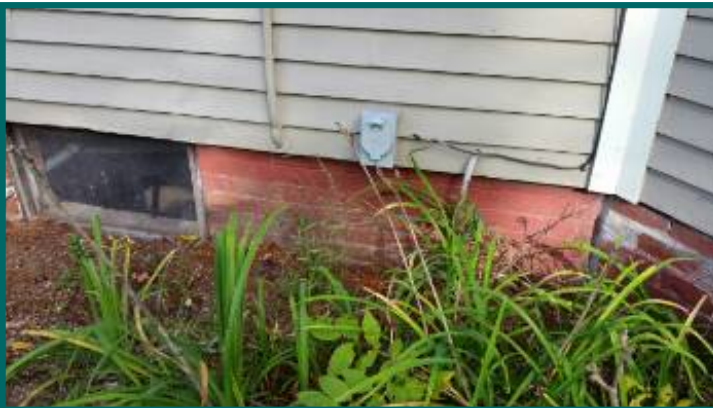
2.2. There is a portable gen tran switch with outlet at exterior wall, not tested or inspected. Recommend contacting home owner for proper operation information, recommend never running generator near open doors , windows or vents.

Generator transfer switch connection next to electric meter

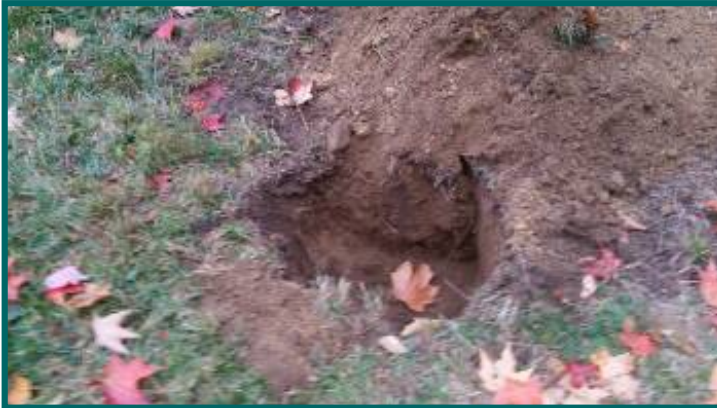
client dug access hole to view top of well access

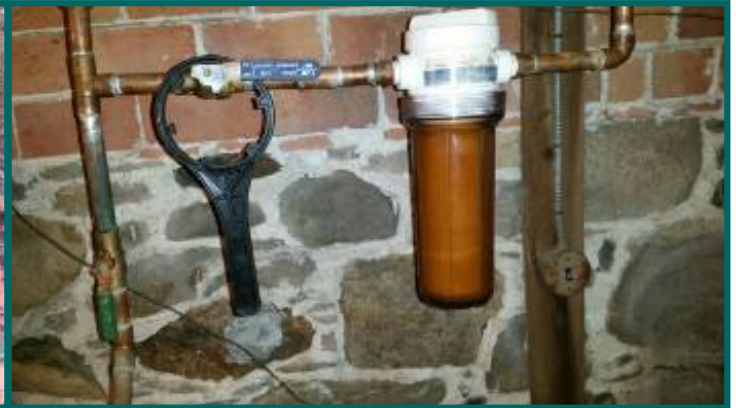
Sediment Filter

- 2.1. There is a sediment filter that should be monitored and changed on a regular basis. A dirty sediment filter can significantly diminish water flow and pressure.

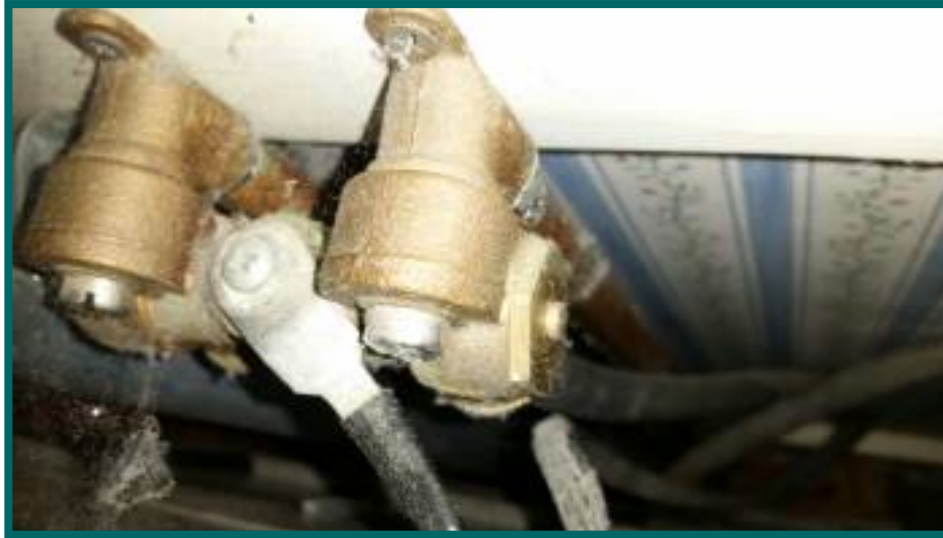
1.1. Laundry supply lines are rubber or plastic, recommend installing metal mesh burst proof hoses to help prevent water intrusion / damage from laundry leaks.

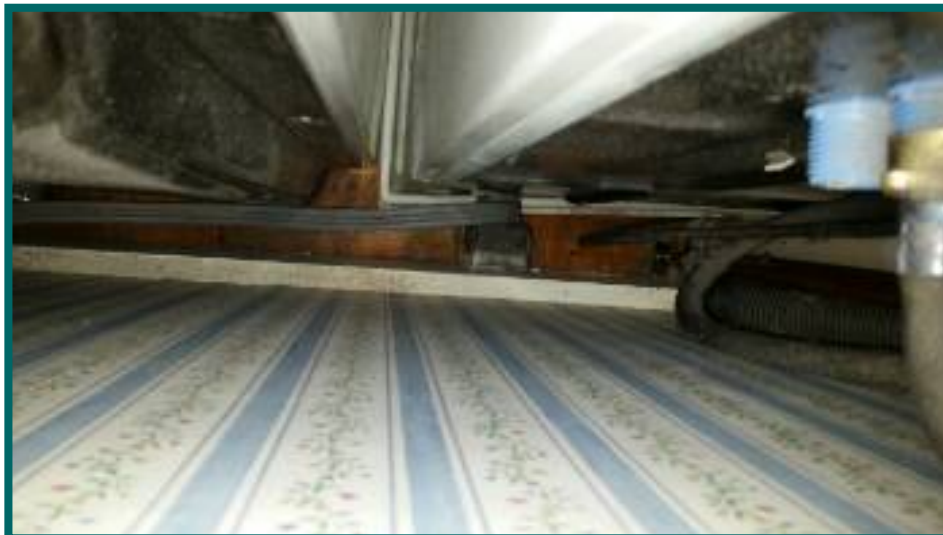
2.1. Electric dryer outlet is three prong, when buying appliances dryer will come with either 3 or 4 prong chord. You can buy three prong chord or upgrade outlet to a four prong receptacle to bring circuit up to current building standards.

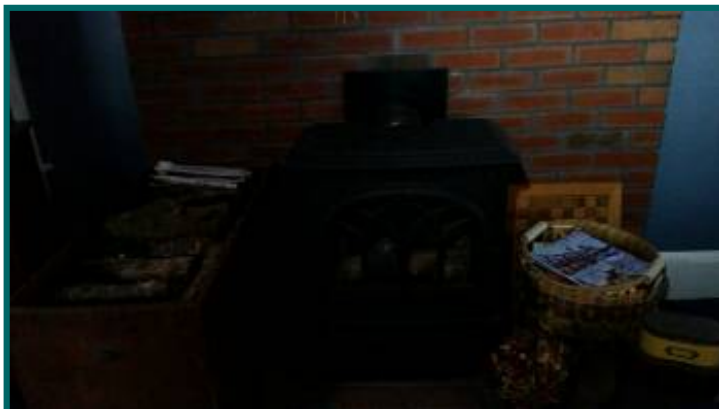
gas stove is only source of heat in family room

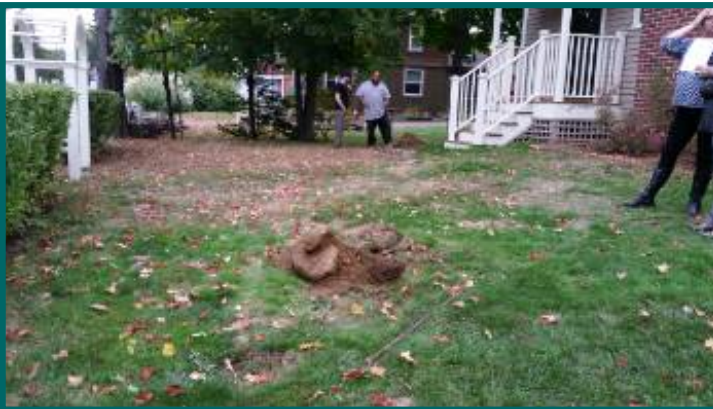
Concrete tank approximately 500 gallons in good condition, is at operational level, does not need a pumping at this time. Outlet and inlet baffle are not in place. Dry well leaching system, is too deep to fully inspect by hand, a small excavator is needed to expose cover on dry well. Stone material on outside of well was observed in good condition, clean sand and stone, no water present.

Dry well in foreground, septic tank in background

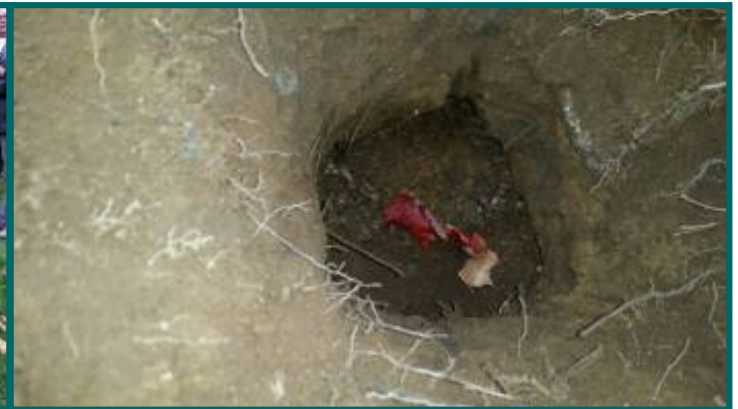
Dry well fill

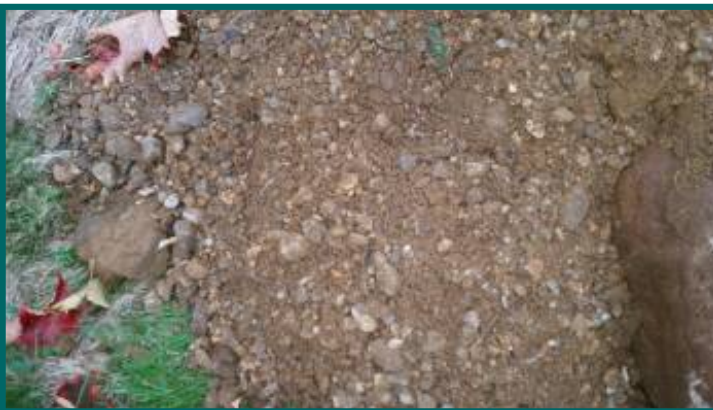
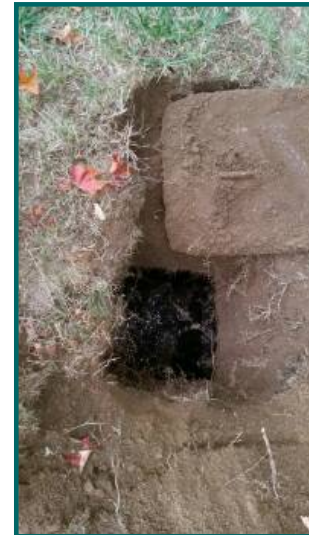
Septic tank Center cover

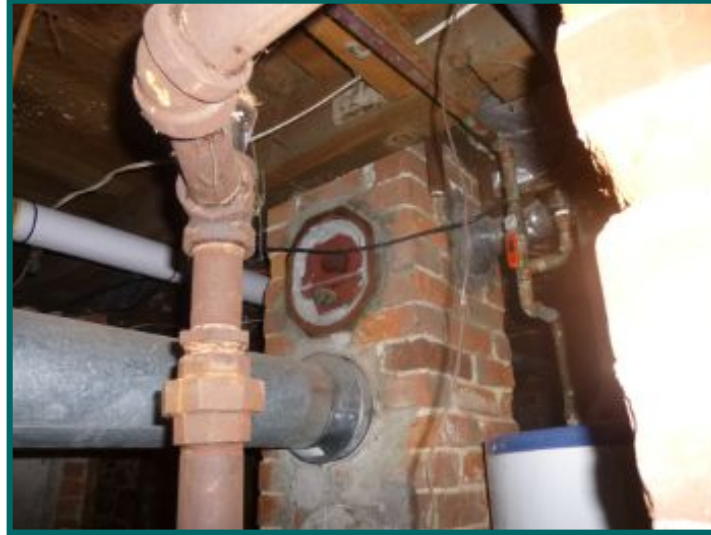
2.1. Metal single wall chimney vent pipe terminating into masonry chimney,

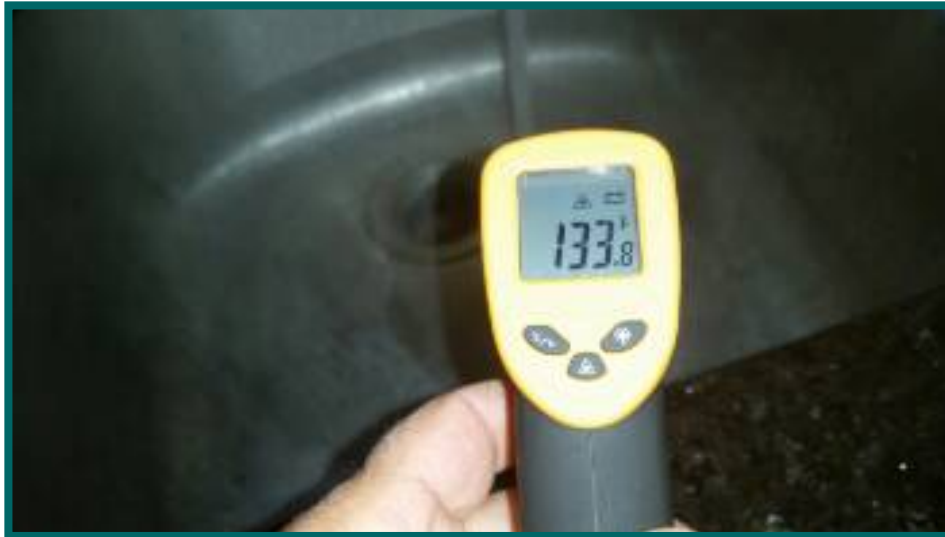
1.3. Water temperature is above 120 degrees, should be set minimum 110 degrees for comfort and maximum 120 degrees to prevent scalding particularly for very young and very old persons.

Water Temperature
