# Alpha Home & Commercial Building Inspections

## Property Inspection Report

Sample 85 year old 2 Family, NH 03064  
Inspection prepared for: Sample Client  
Real Estate Agent: -

Date of Inspection: 9/30/2015 Time: 1:00 PM  
Age of Home: 85 years Size: 2090 sf  
Order ID: 2941

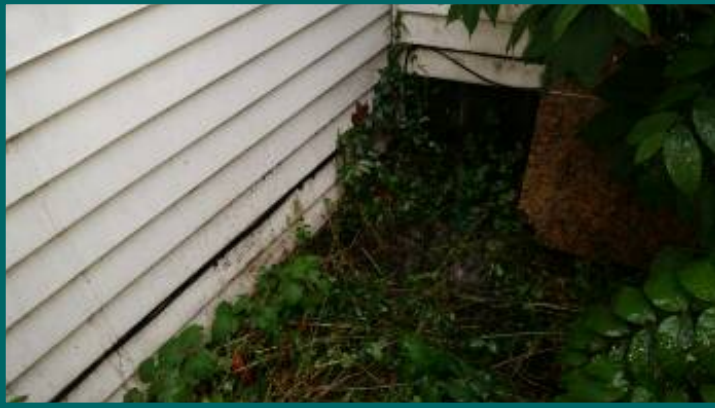
2.2. There is a depression in grading at one or more exterior area of foundation wall. This is conducive to ponding and possible water intrusion into house, recommend filling or re grading any depressions and taking measures to divert water away from this area and monitor for proper drainage.

rain water ponding at left side of house

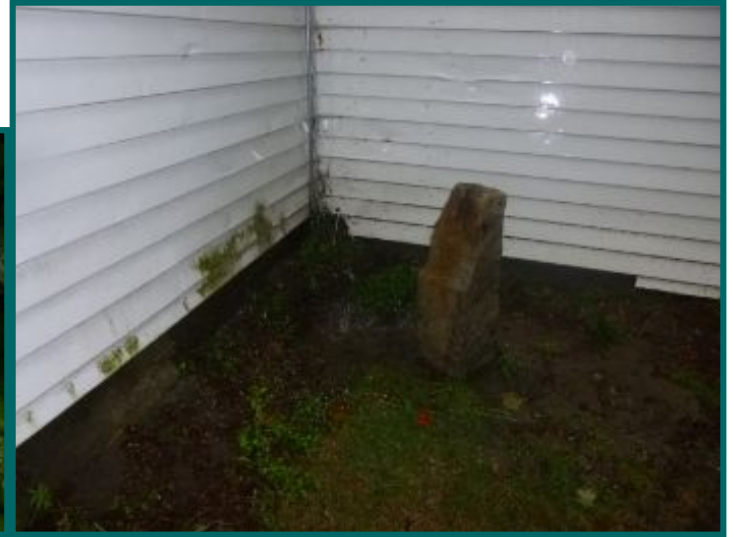
Rain water ponding at rear of house

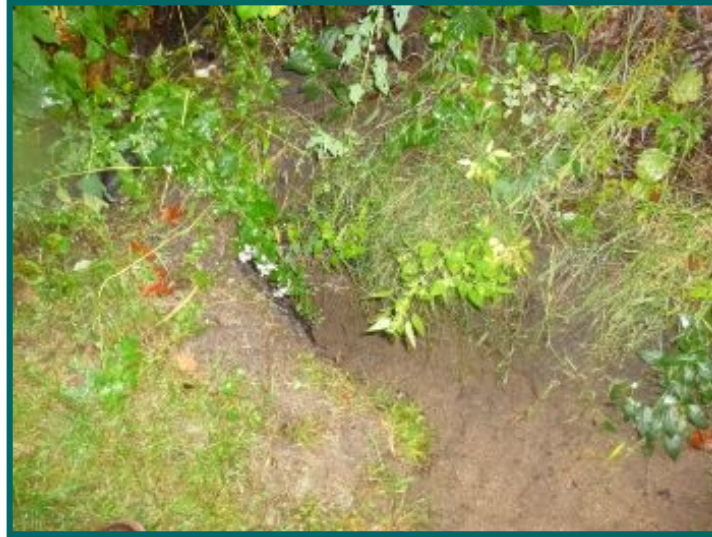
2.3. Areas of erosion to grounds , recommend repairs, re grading if needed and adding plantings as needed to maintain integrity of grounds,

Sink hole in back yard

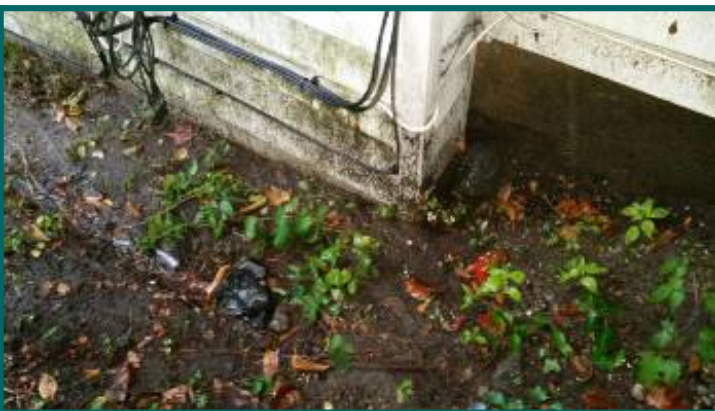
contact with finish grade side of house

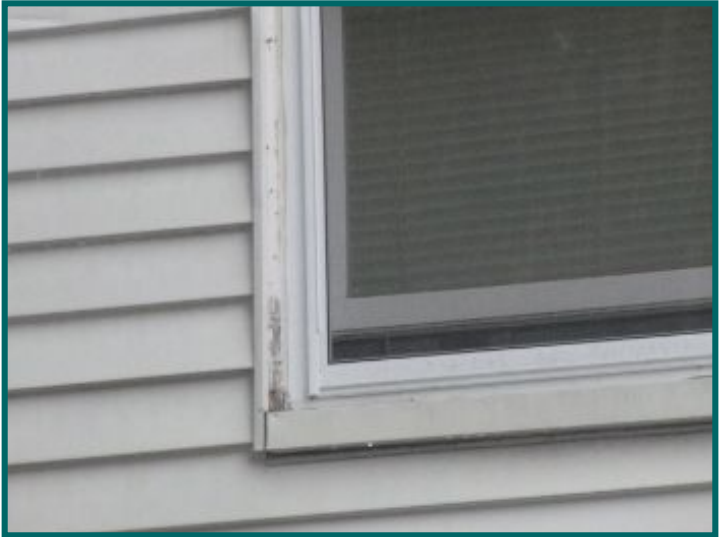
Peeling paint.

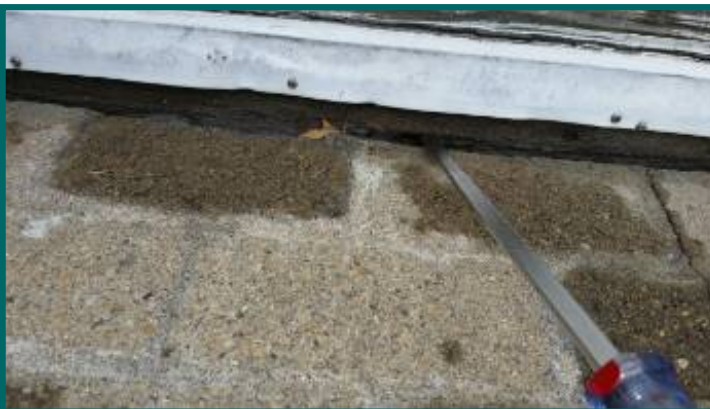
4.2. Trim boards have areas of damage and or deterioration, recommend assessment and repair by a qualified contractor.

deterioration to trim below front door

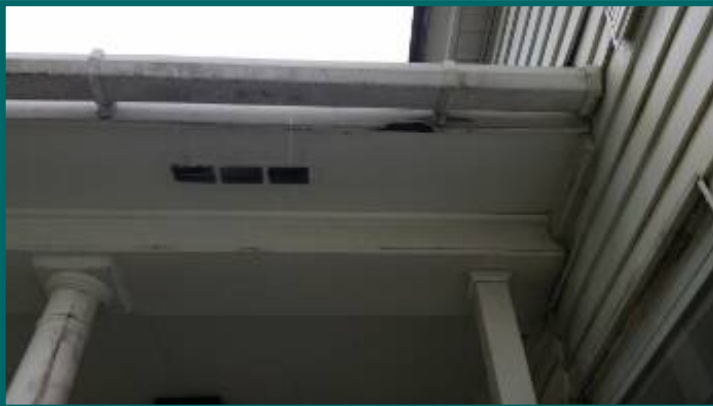
damage fascia board and trim above front porch

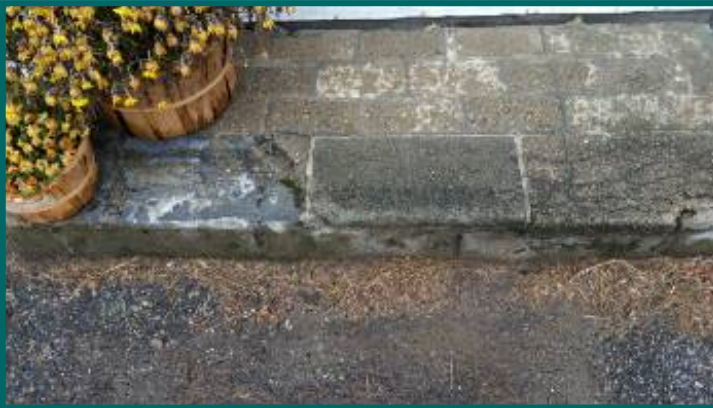
Front of house.

6.2. Front steps have damage to brick or mortar. Recommend further investigation and repair by a qualified masonry contractor.

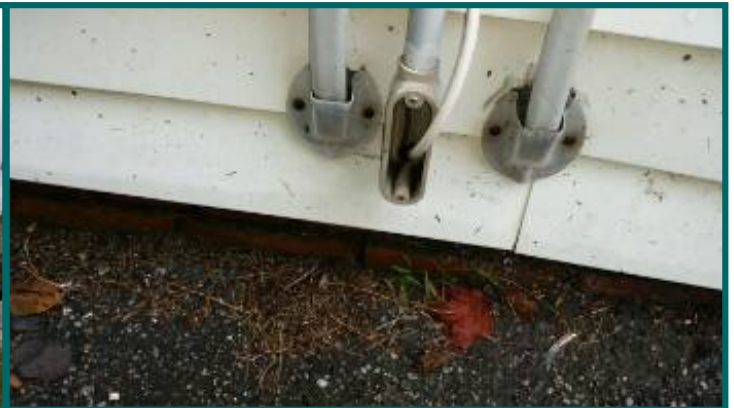
8.2. Open conduit for data lines near electric meter should be sealed to prevent water intrusion.

open conduit below meters

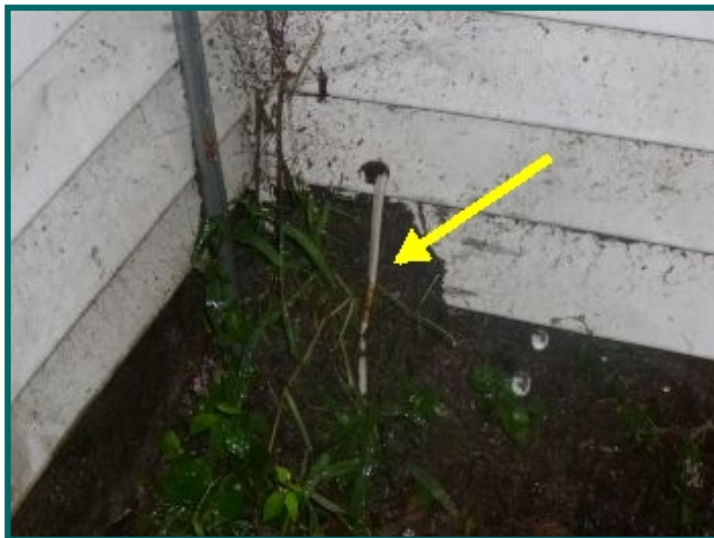
8.3. There are improperly protected electric wires at one or more area, this is a potential safety hazard, recommend further investigation and repair by a licensed electrician. Wire should be protected by conduit or pipe.

Exposed wires at rear of house

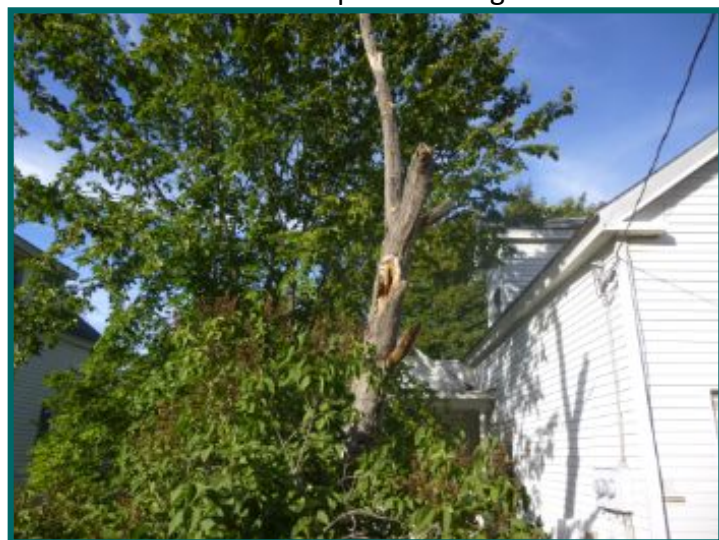
Trees overhanging roof should be cut back or removed.

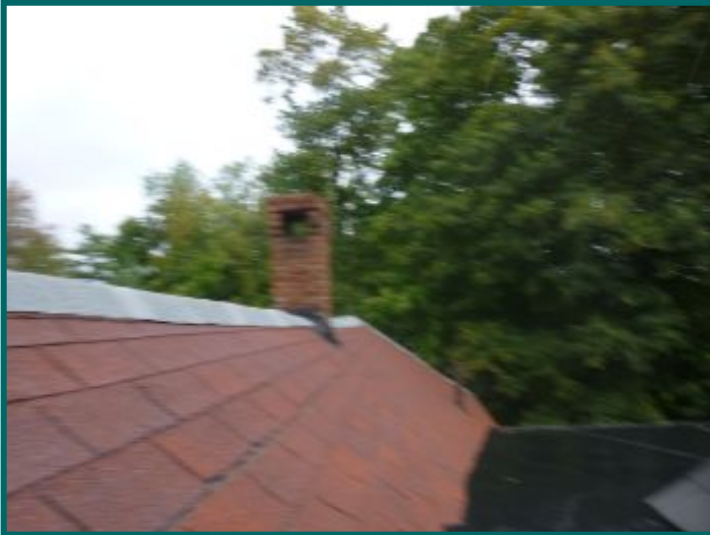
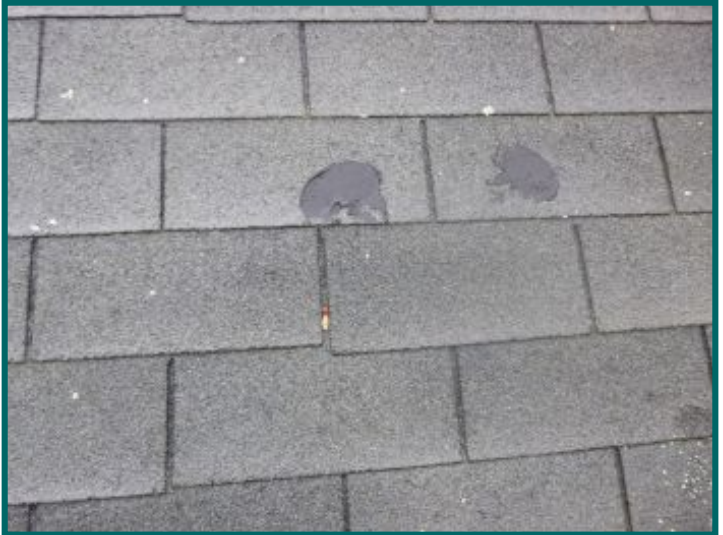
Repaired shingles

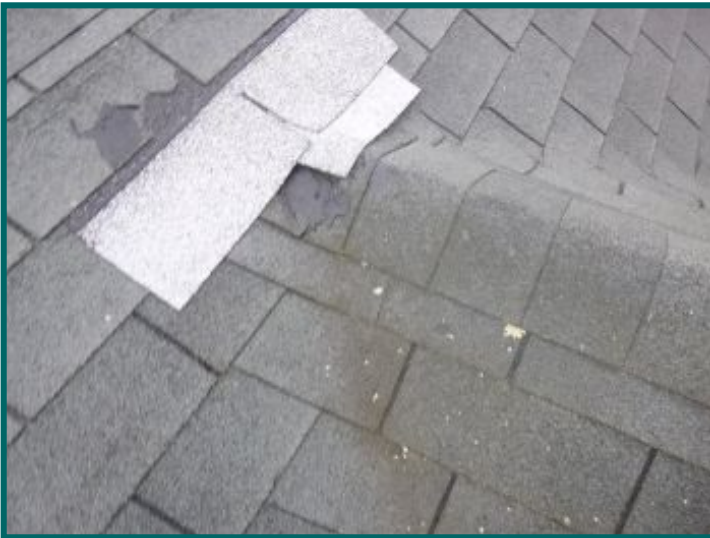
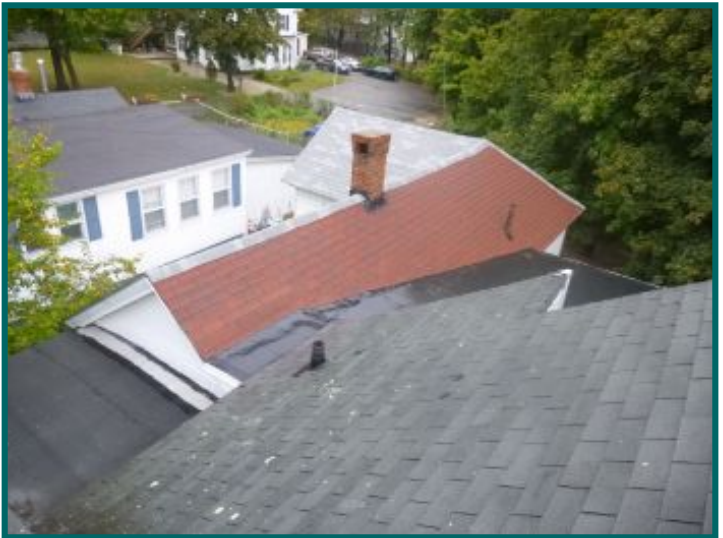
Repaired shingles

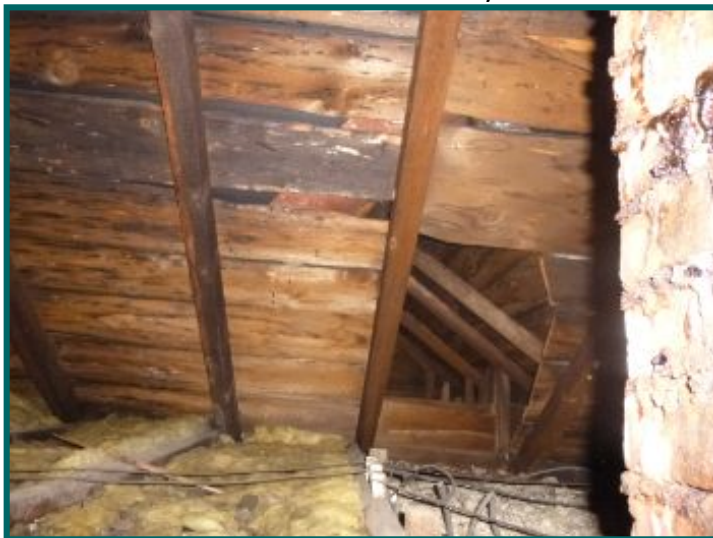
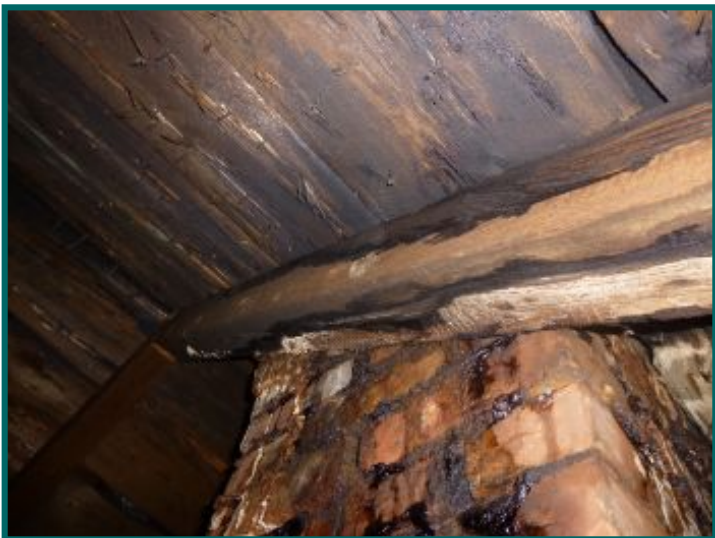
Leak around chimney.

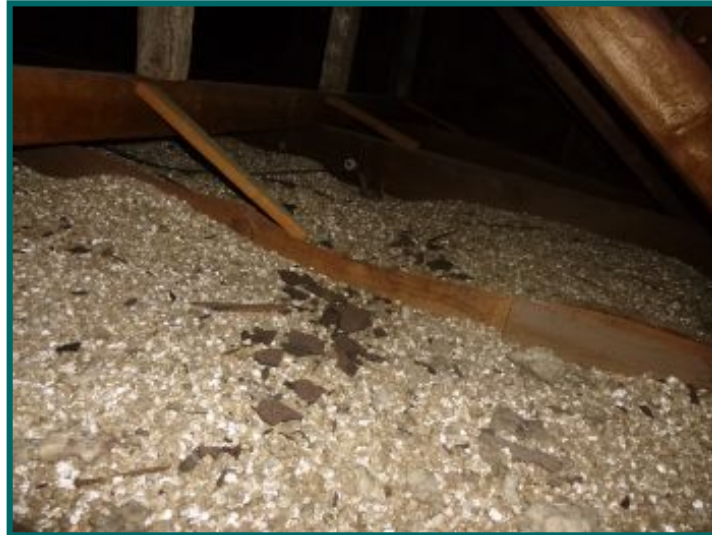
If you plan to remodel or conduct renovations that would disturb the vermiculite, hire professionals trained and certified to handle asbestos to safely remove the material.

You should never attempt to remove the insulation yourself. Hire professionals trained and certified to safely remove the material."

Vermiculite insulation

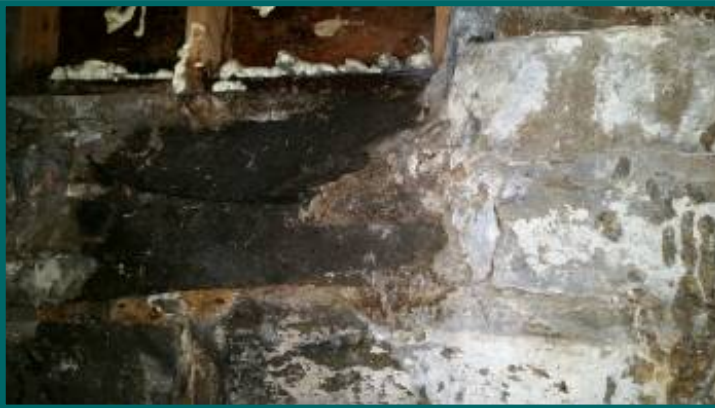
Wet wall right side window

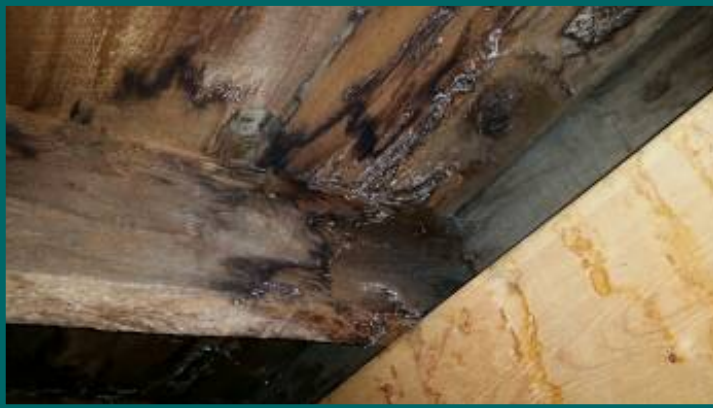
2.8. Water staining and damaged wood at one or more area of under floor framing, dry at time of inspection recommend monitor area and repairs as needed by a qualified tradesman.

stains below kitchen

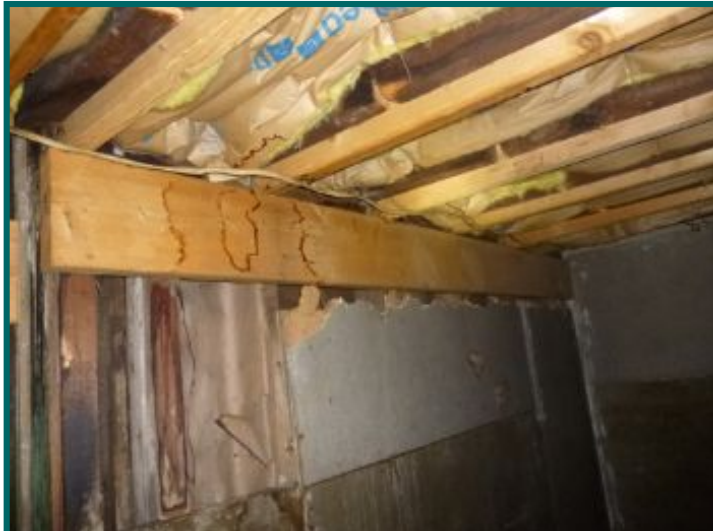
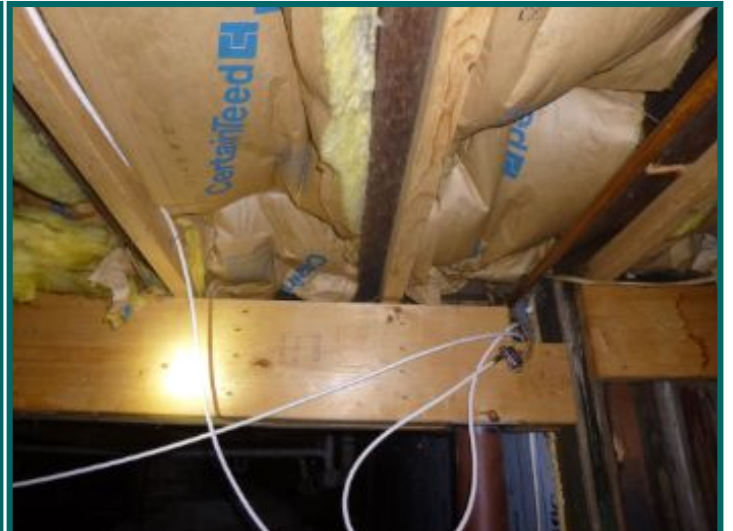
Damaged wood next to left side window

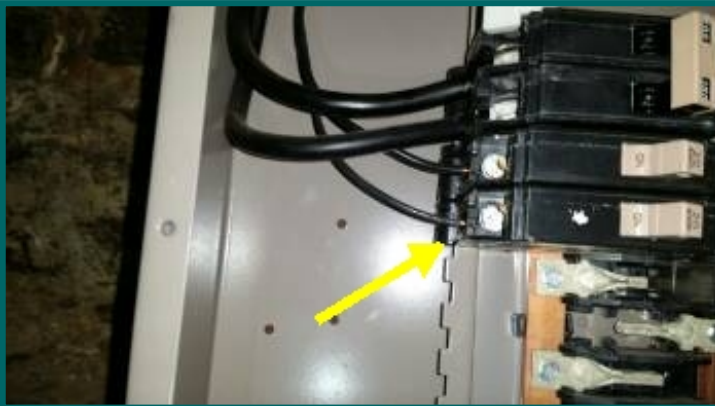
14 gage wire on 20 amp breaker left side apartment panel.

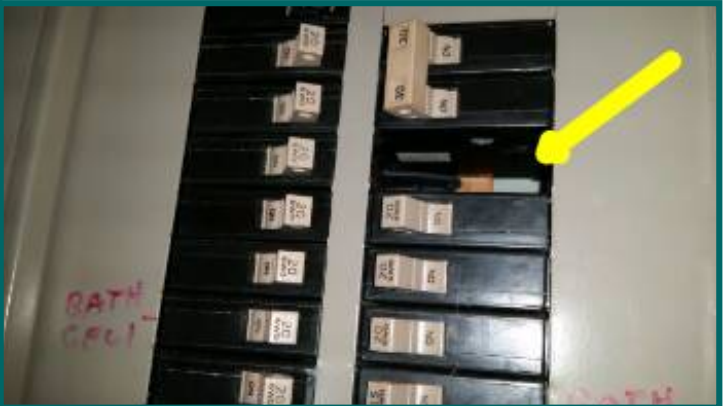
Open breaker space

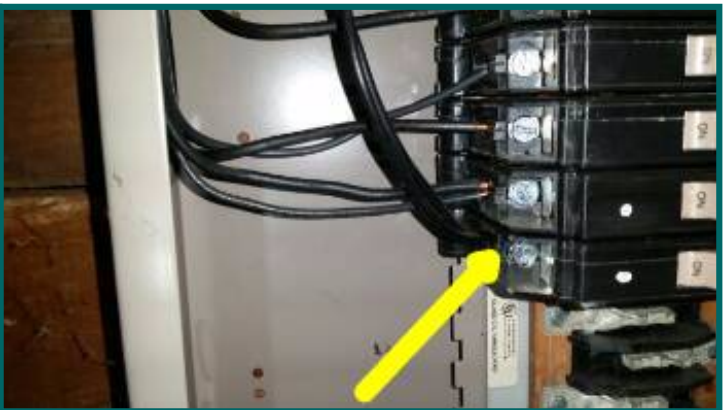
double tapped circuit.

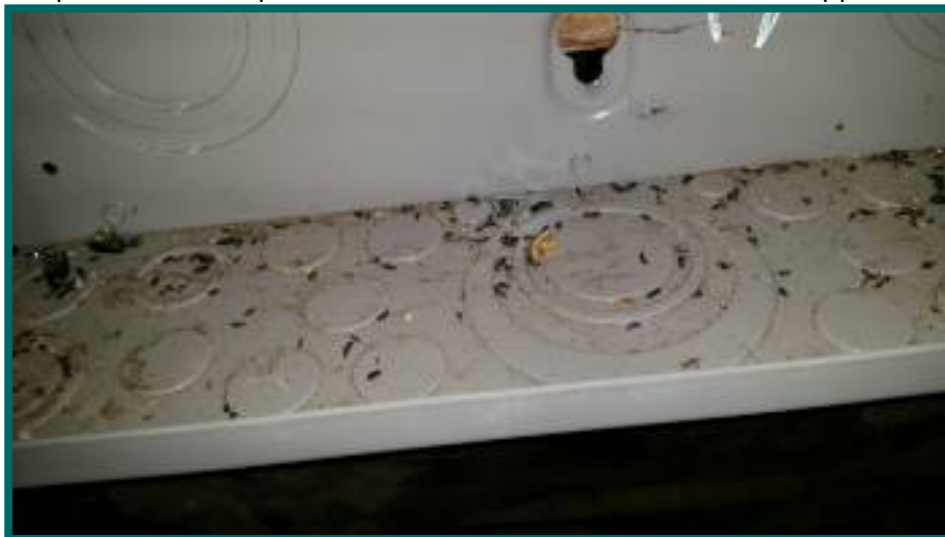
rodent droppings

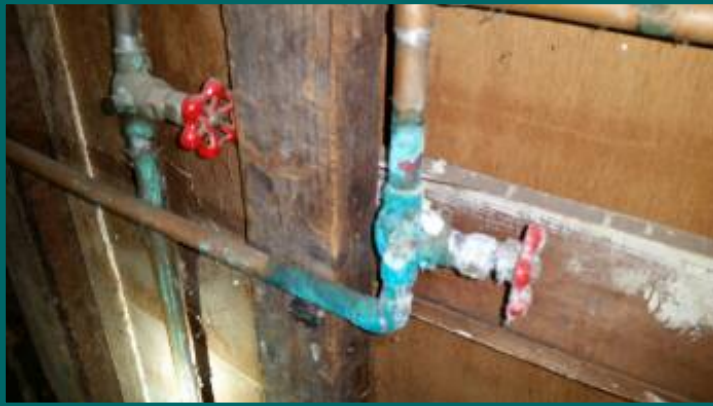
Leak on plumbing line in basement.

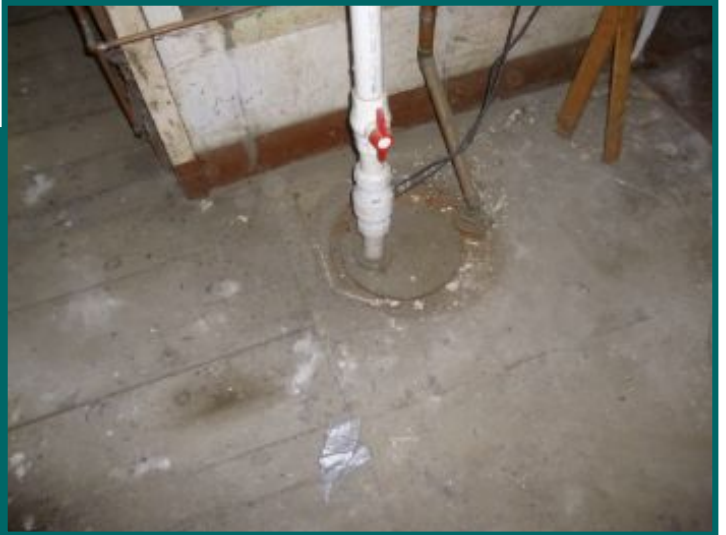
Expulsion pump for basement plumbing fixtures.

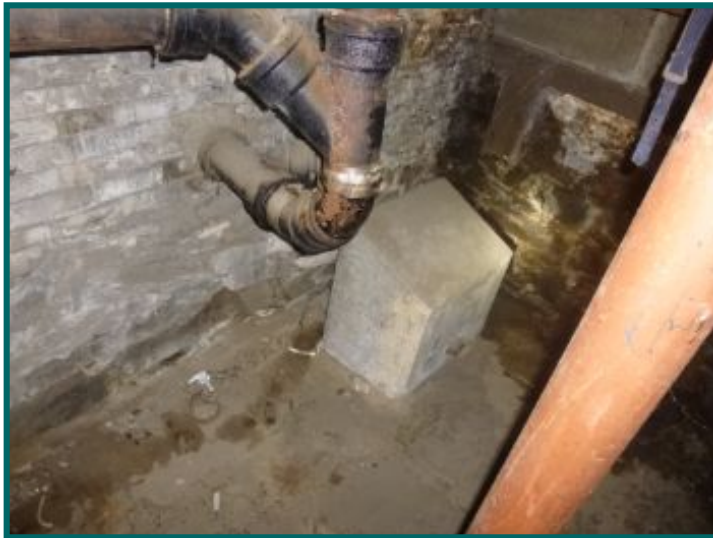
Main drain line termination.

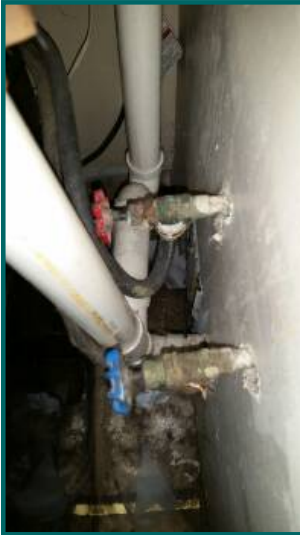
right side

2.2. Corrosion staining around water supply and drain lines, recommend monitor for leaking and repairs as needed by a licensed plumber.

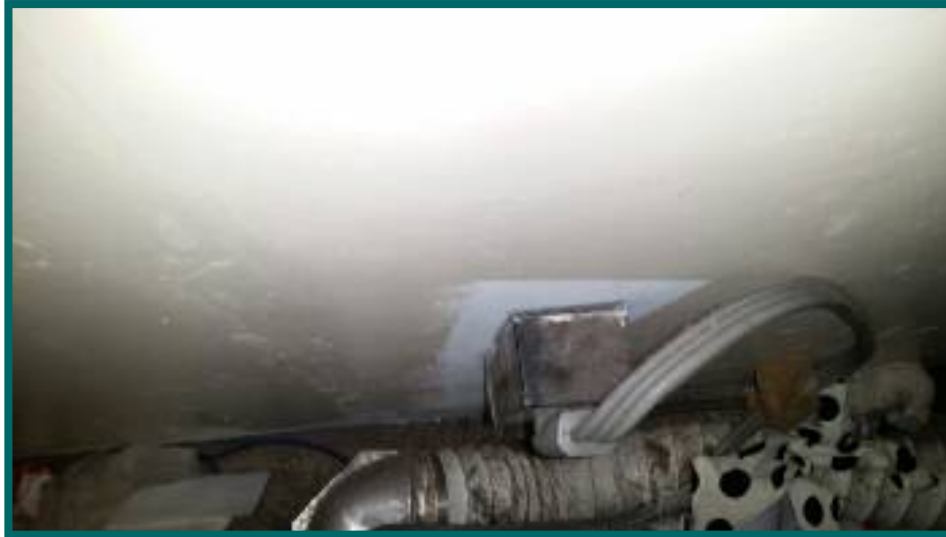
3.1. Electric dryer outlet is three prong, when buying appliances dryer will come with either 3 or 4 prong chord. You can buy three prong chord or upgrade outlet to a four prong receptacle to bring circuit up to current building standards.

right side dryer connection is 3 prong electric

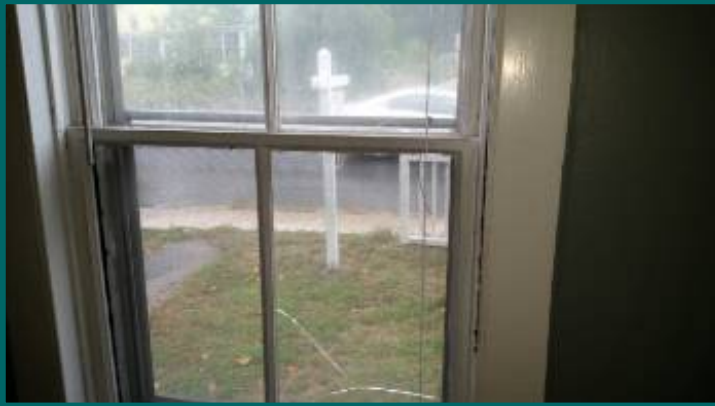
2.2. Window has broken pane in one or more area of home. Recommend assessment of windows and repair by a qualified tradesman.

First floor front wall broken panes

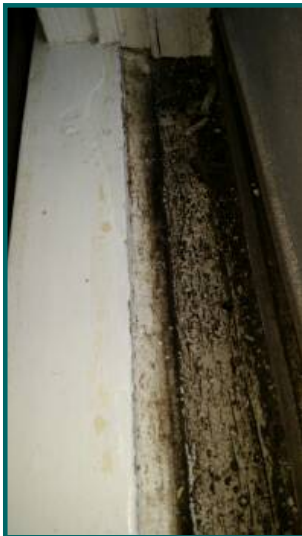
2.3. Peeling paint on and inside windows at one or more areas of building, due to the age of the building lead paint may be present, this is a potential health hazard recommend keeping windows clean of all paint chips and dust.

peeling paint first floor

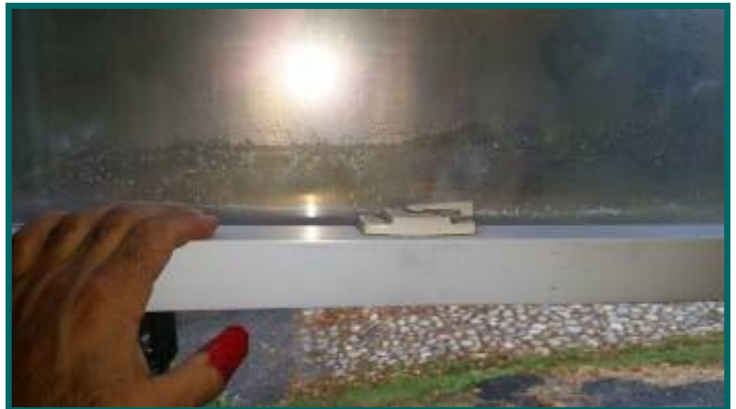
2.4. Windows at one or more area did not lock/latch properly, recommend repairs for enhanced security/safety to occupants.

right side apartment dining room window is fogged  
will not lock.

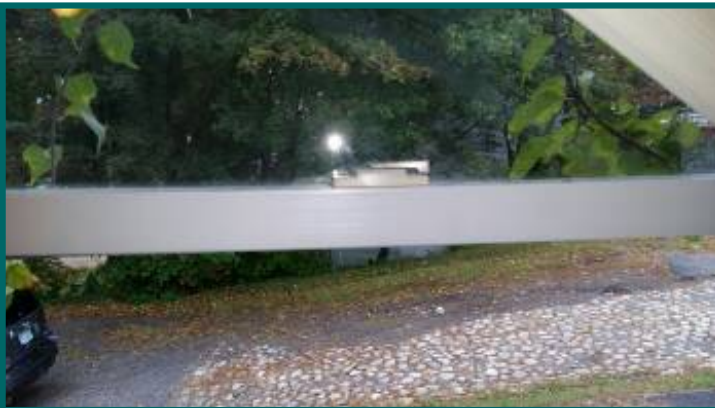
2 dining room windows will not lock

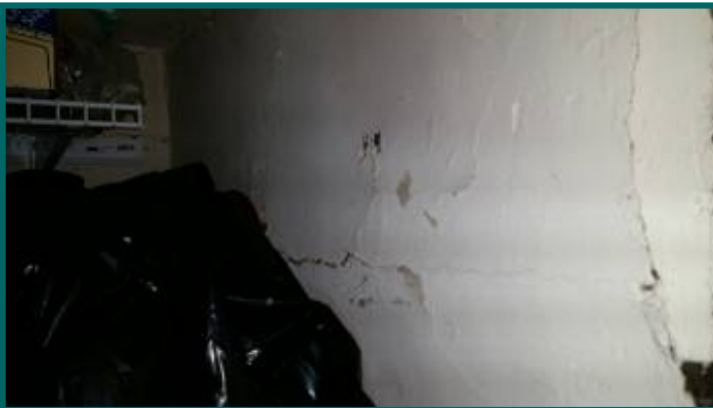
3.3. There is peeling paint on walls at one or more area of home. The areas tested dry at the time of the inspection, but should be monitored for further damage or possibly water intrusion. Recommend scraping, prepping and repainting as needed.

peeling paint 2nd floor rear bedroom

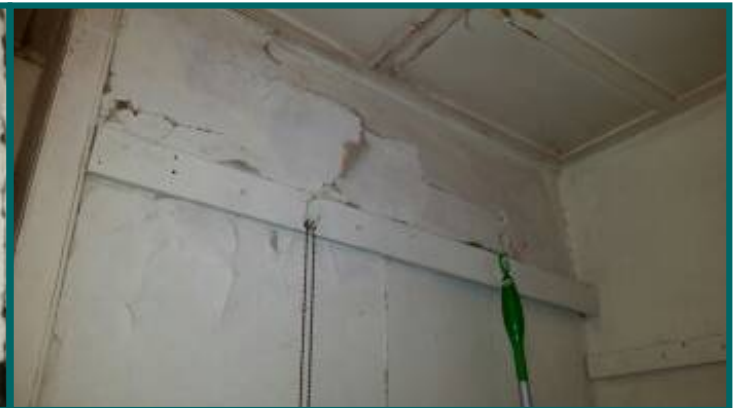
basement stairway

3.2. Damage to surface of wall in one or more area of home, recommend assessment of wall surfaces and repairs by a qualified tradesman as needed.

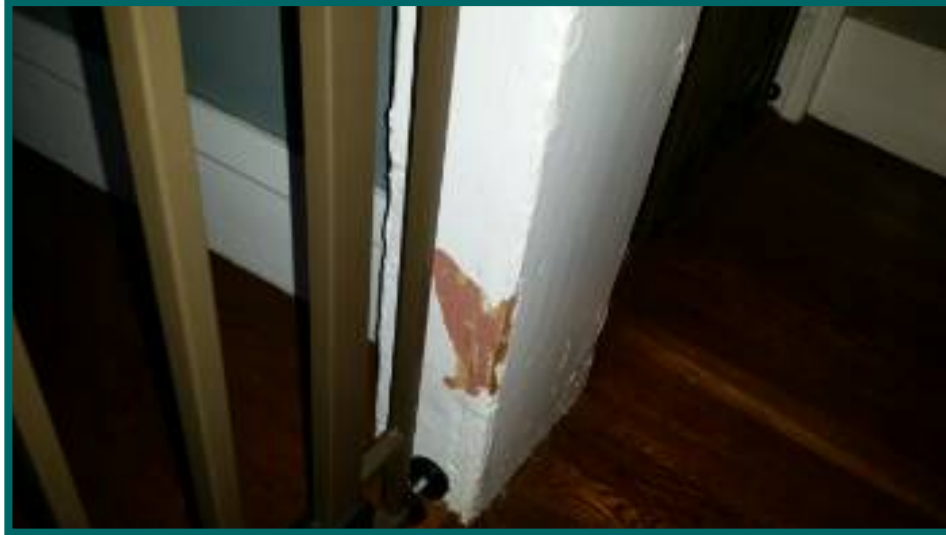
peeling paint right side living room.

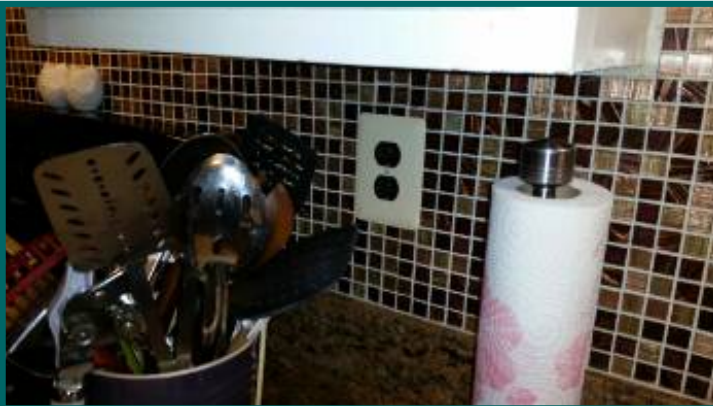
- 6.3. One or more electrical outlet at wet location is not **GFC** protected. Current building practices require GFI protection at all wet locations; kitchen and bath counters, outdoor and garage outlets, unfinished basement outlets, any outlet providing power to a wet appliance such as hot tub or pool, and any outlet within 6' of the rim of a sink. Recommend assessment and installation of GFI outlets where needed by a licensed electrician for safety.

No GFI protection at kitchen outlets.

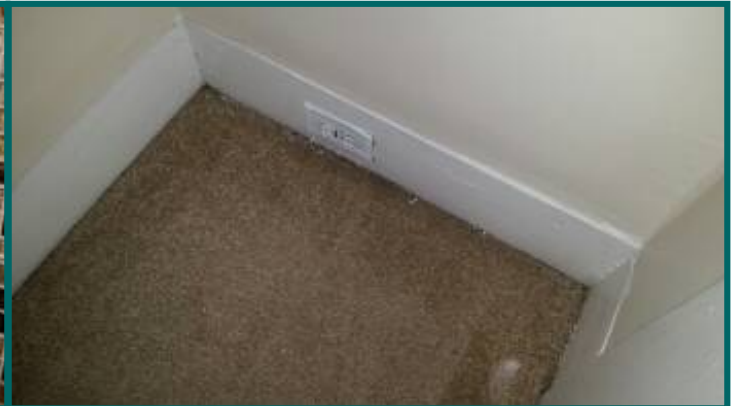
- 6.2. Ungrounded outlets present. Ungrounded outlets do not offer current standard of protection for equipment, especially for sensitive electronics. Recommend installing three prong grounded outlets where any sensitive electronics are being used, ( Entertainment center, TV, computer etc.)

the house has a mix of three prong grounded and two-prong ungrounded outlets

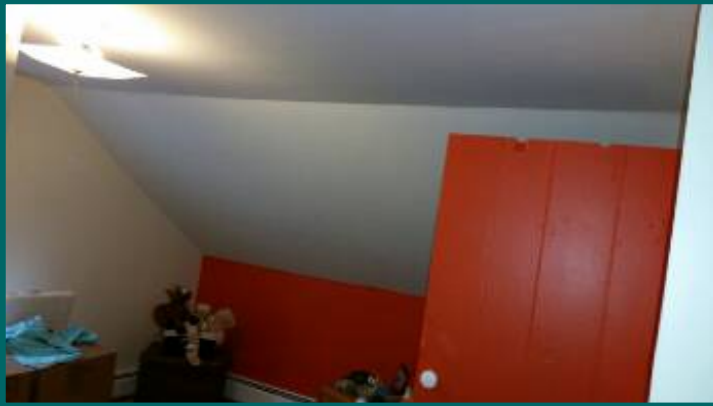
- 6.8. There are no switched outlets or lights at one or more area of the home, recommend having a switched outlet or switched light fixture for illumination in every room for safety.

Second floor bedrooms are missing wall switches to turn lights on and off

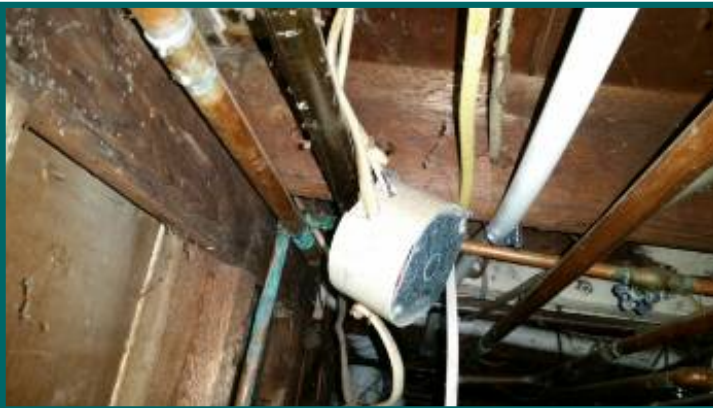
- 6.4. Open junction boxes were observed, which is a safety concern. Recommend installing proper covers, as needed, for safety.
- 6.5. Improperly secured wires present, all wiring should be properly secured to the framing. recommend assessment by a licensed electrician.

- 6.6. Electric wires in contact with plumbing or heating lines, this is a potential safety hazard, causing damage to wires and potential energizing of pipes / duct. Recommend repairs by a licensed electrician.

improperly secured junction box, wires in contact with pipes

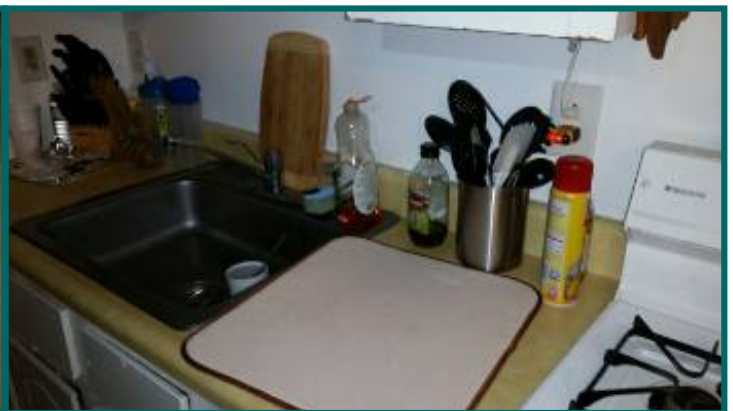
No GFI protection at kitchen outlets.

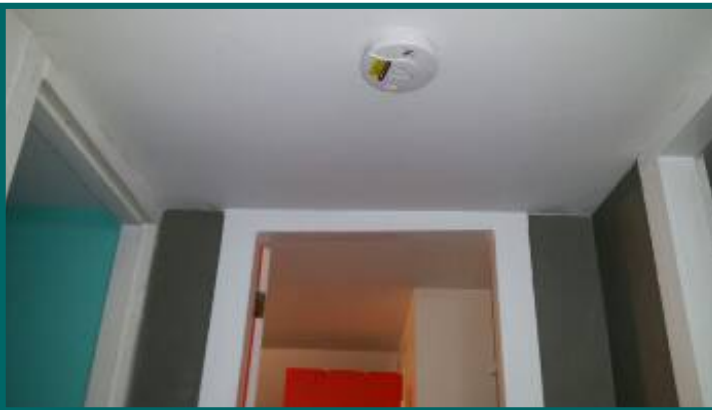
7.2. Smoke and or CO detectors are missing at one or more bedrooms, recommend assessment and installation of smoke / CO detectors at the correct locations by a licensed electrician.

There is one smoke detector in bedroom hallway area, no smoke or CO detectors in bedrooms.

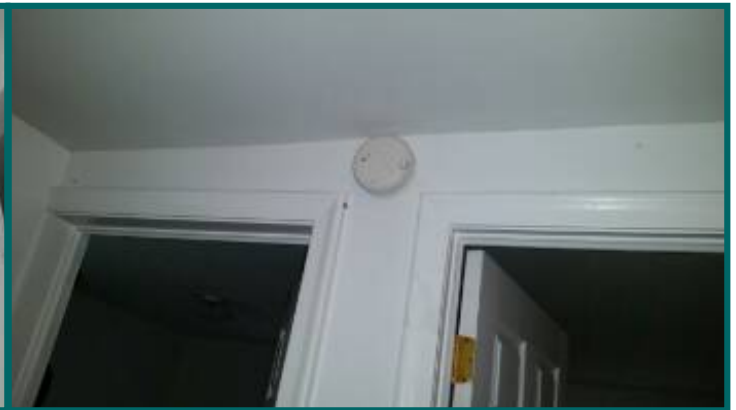
left side apartment smoke detector outside of bedrooms

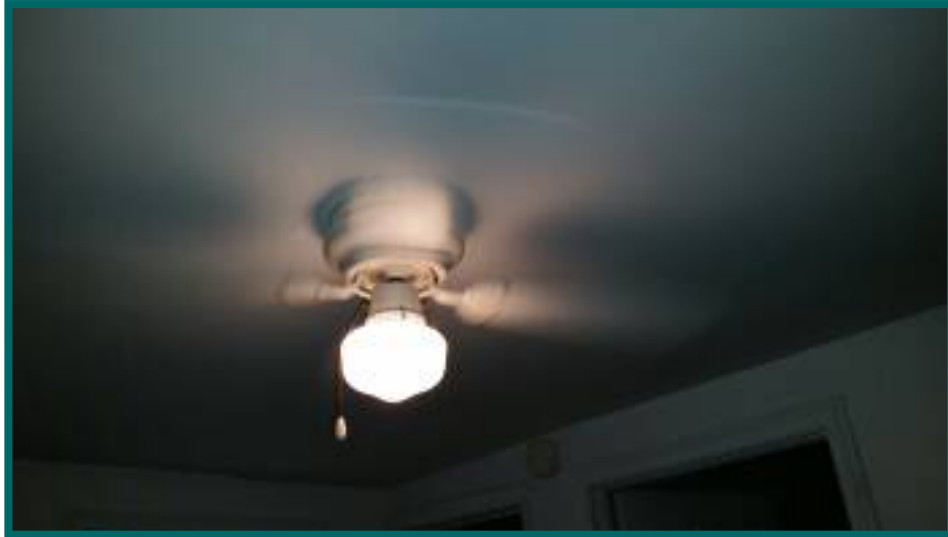
10.1. The fan unit at one or more area of the home makes an irregular noise. This may be a sign that it has reached the end of its useful life.

left side apartment ceiling fan clanging

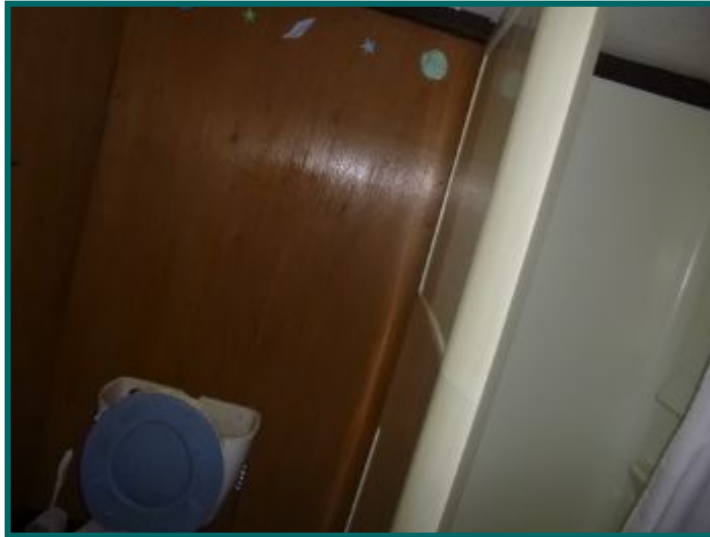
Basement bathroom is not in service plumbing fixtures not tested.

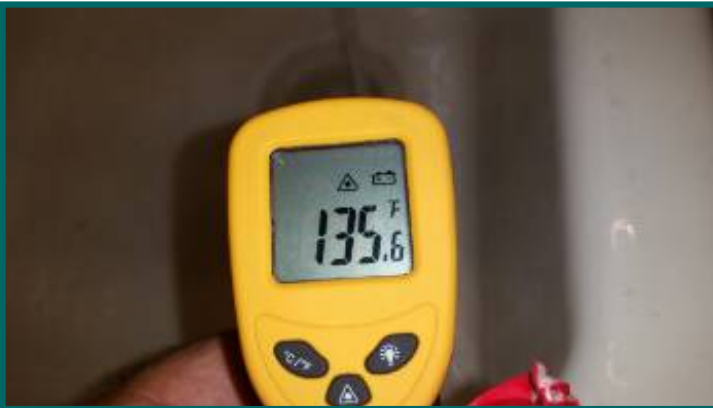
Water Temperature

1.3. Water temperature is above 120 degrees, should be set minimum 110 degrees for comfort and maximum 120 degrees to prevent scalding particularly for very young and very old persons.

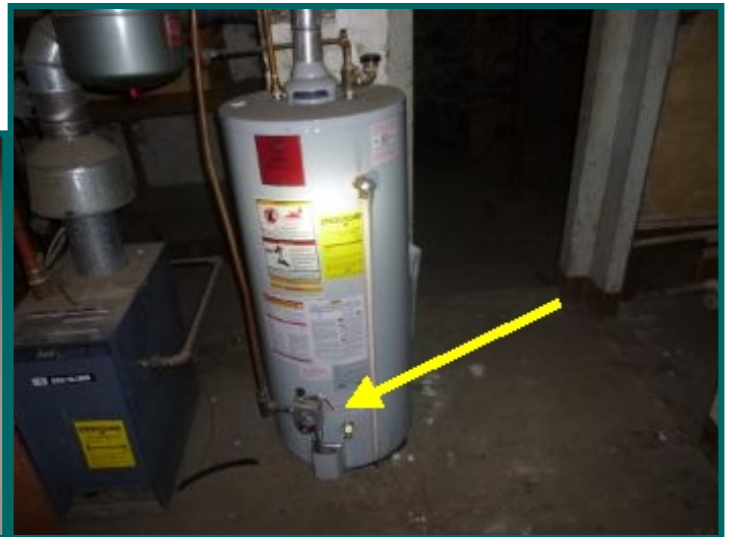
Mixing valve / burner control to adjust water temperature.

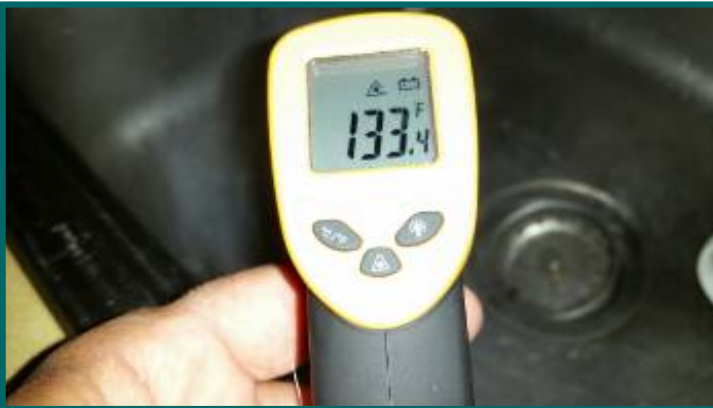
Water Temperature

1.3. Water temperature is above 120 degrees, should be set minimum 110 degrees for comfort and maximum 120 degrees to prevent scalding particularly for very young and very old persons.

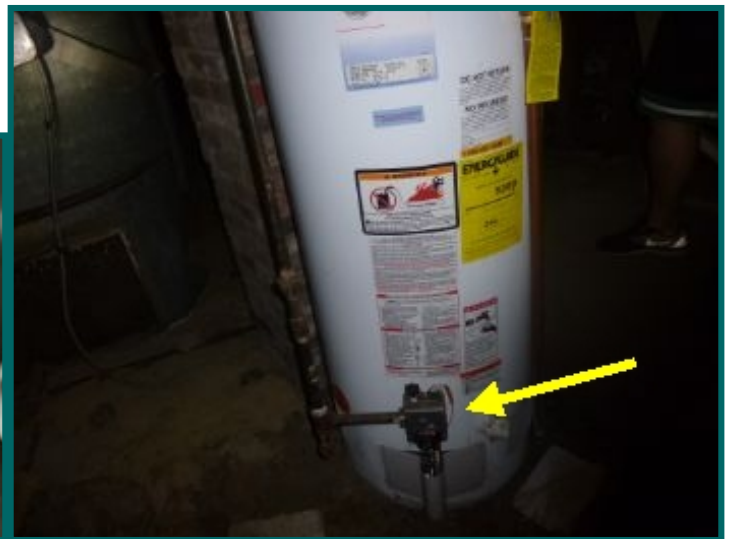
Mixing valve / burner control to adjust water temperature.
