# *Alpha Home & Commercial Building Inspections*

## Property Inspection Report

Date of Inspection: 8/13/2015 Time: 9:00 AM  
Order ID: 2748

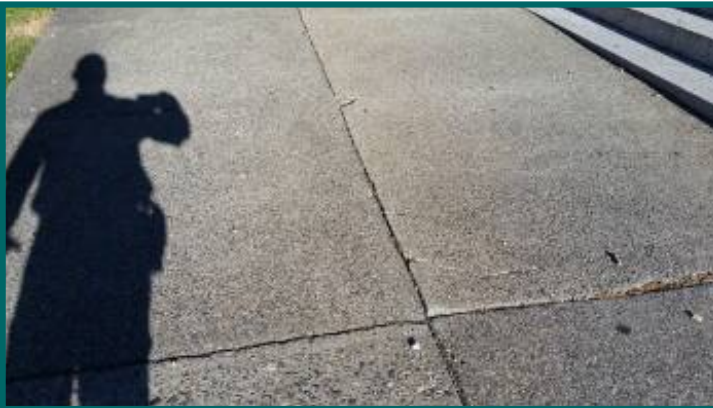
1.3. One or more area of damaged concrete surfaces, may be causing water intrusion into building. Recommend assessment by a qualified concrete flat work contractor and repairs as needed.

cracks and settlement in concrete surfaces front of building

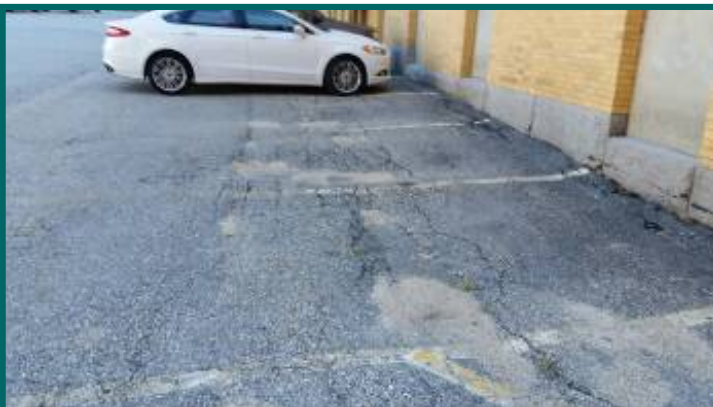
1.2. Typical deterioration was observed at the lot surfaces. Further deterioration will occur as water expands and contracts from freeze and thaw cycles. Recommend assessment by a qualified asphalt surfacing contractor.

deterioration to surfaces rear of building

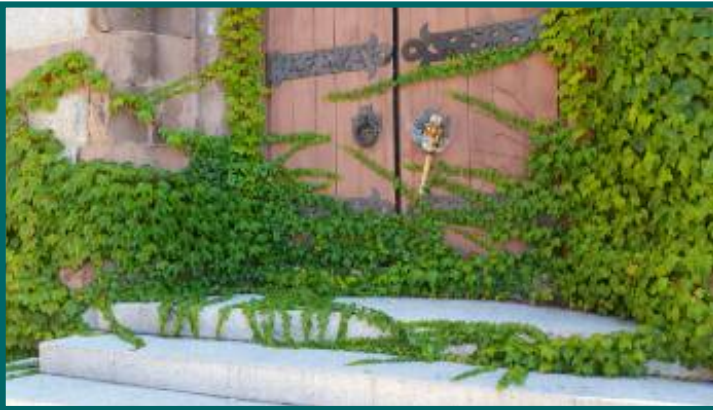
vegetation over door was not opened

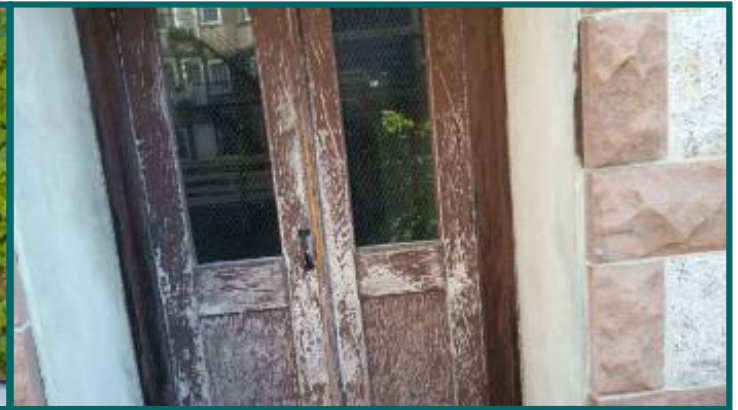
peeling paint at side door

- 1.1. There is peeling paint at one or more door and framing, recommend scraping, caulking and painting by a qualified contractor as needed.
- 1.2. Unable to operate one or more door, locked / sealed shut at the time of inspection.

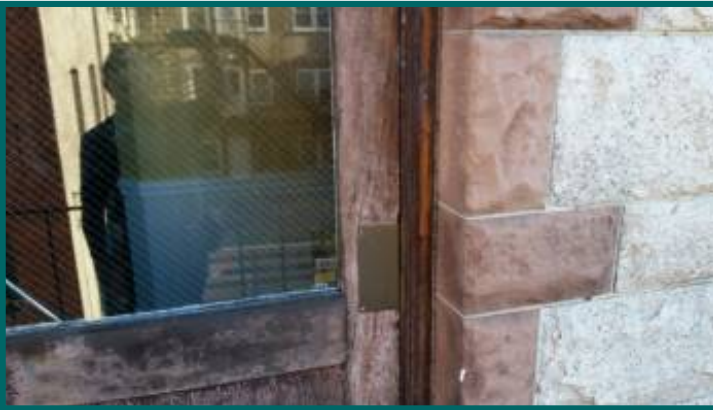
peeling paint at upper side door

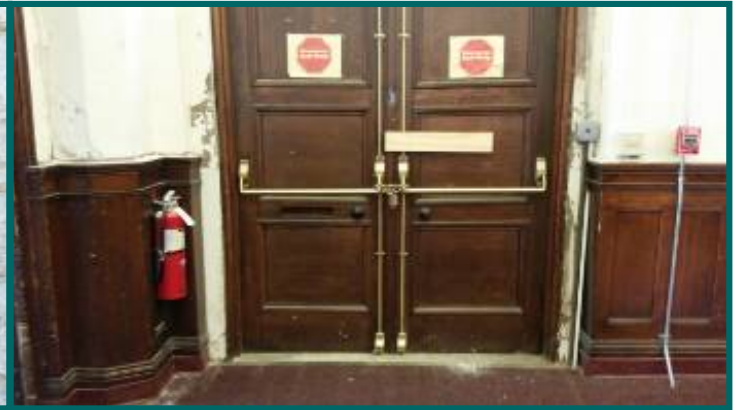
one or more doors bolted shut

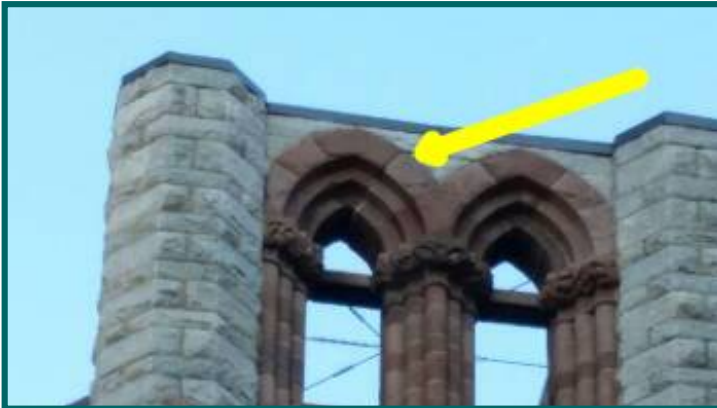
damage grout line right side tower arch

- 2.1. The exterior brick and stone masonry walls are in fair condition. There are many areas of loose and receding grout, there are several vertical and step cracks walls, some loose bricks at upper corners, some areas of prior repair. Front surface basement wall has elevated levels of moisture, outside surface should be assessed immediately in this area. Recommend full inspection and repairs by a qualified masonry contractor.

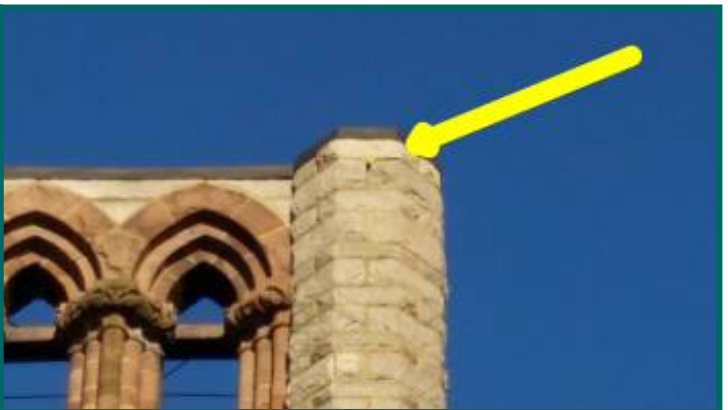
missing grout front left tower

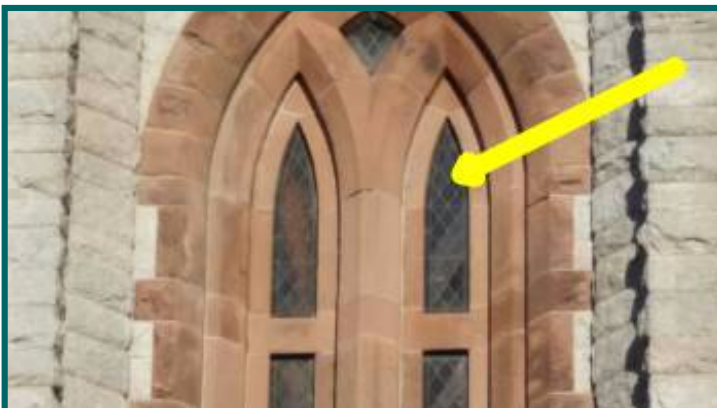
missing grout front left tower window

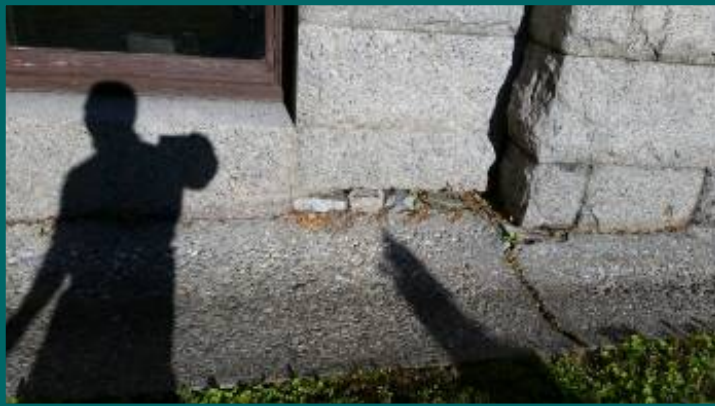
damage surface front of building this area appears to be letting rain run off into the building .

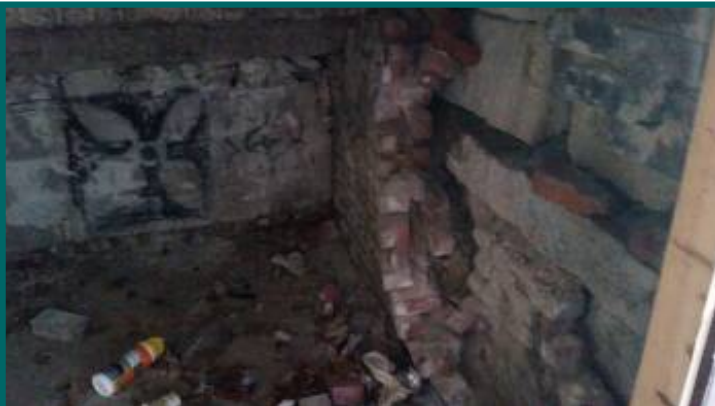
damaged wall surfaces under left side stairway

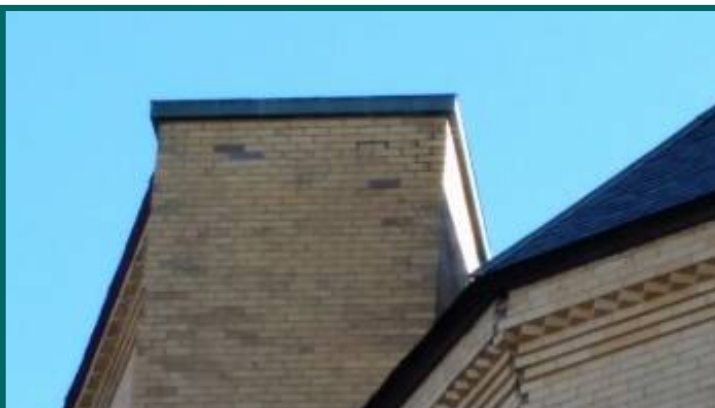
deteriorated grout rear brick surface

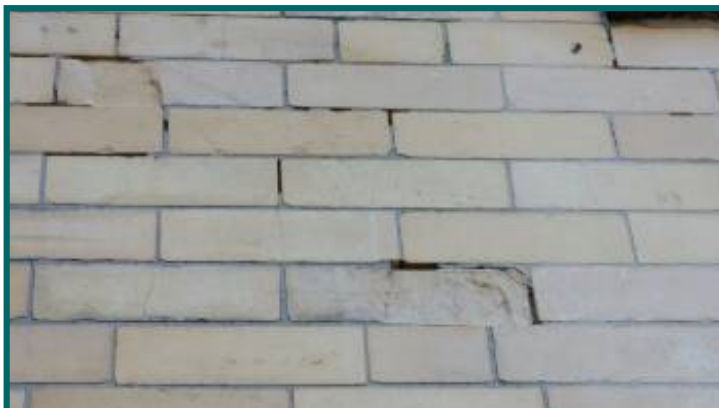
damage brick rear surface

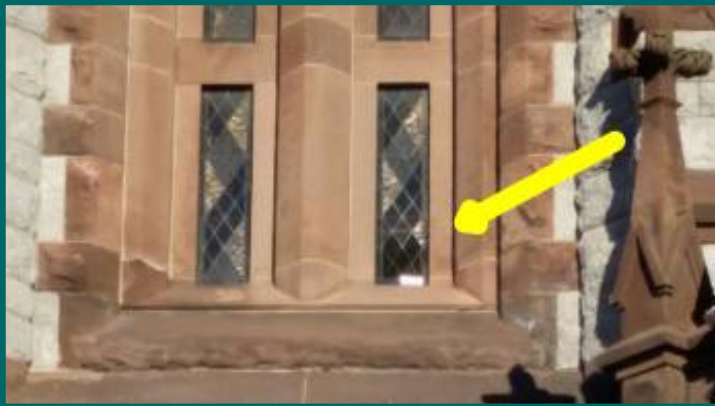
missing glass front left tower

4.1. There are damaged window panes or broken glass at one or more area of building, recommend repair by a qualified tradesman.

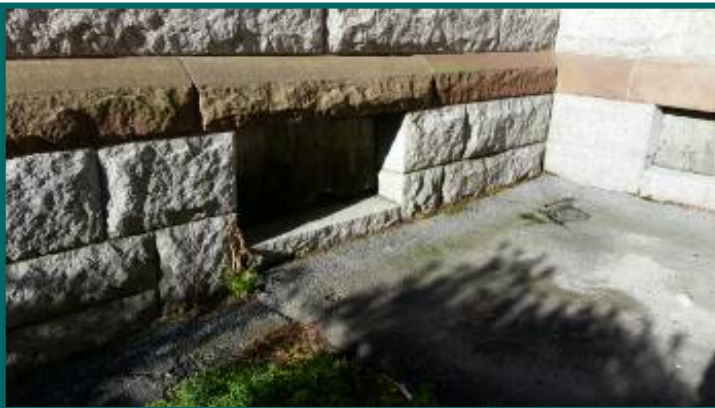
boarded up basement windows

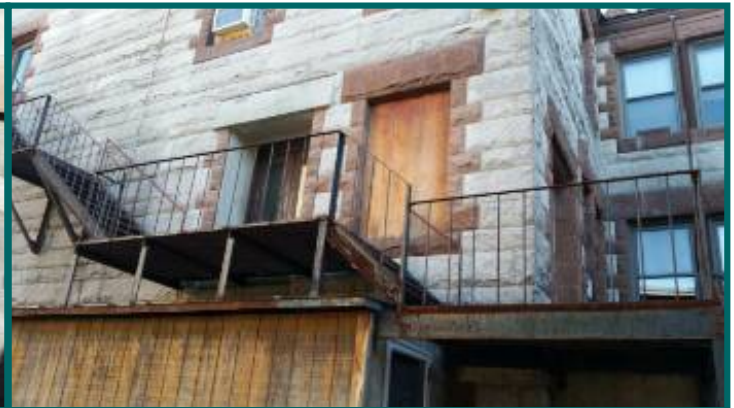
boarded up windows side of building

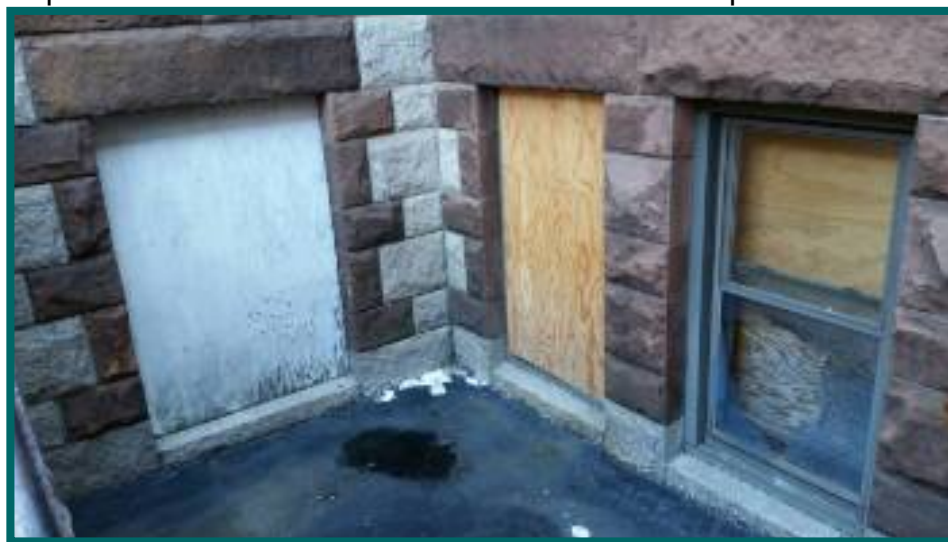
boarded up windows side of building

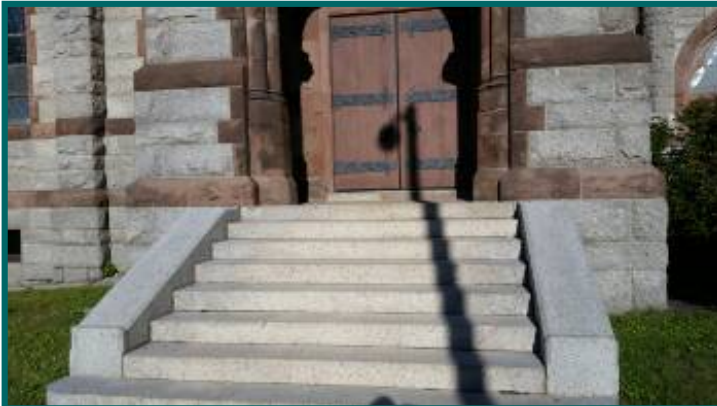
missing handrails front of building

- No handrail present at at one or more stair way. Where four or more stairs are present it is recommended to have installation of hand rail by a qualified tradesman for safety.

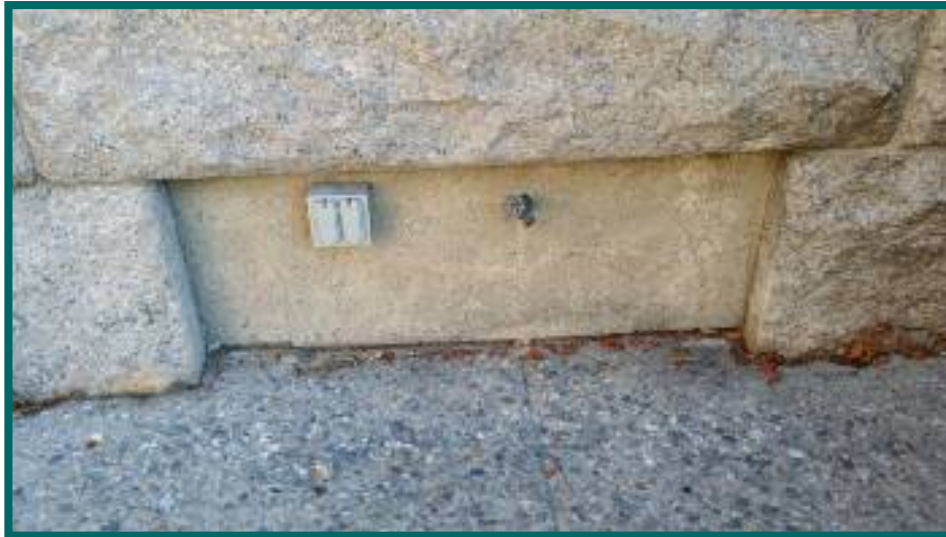
front faucet is off

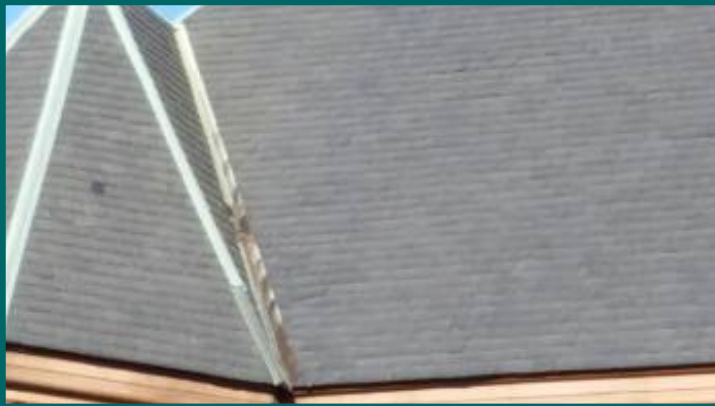
loose shingles front roof surface

1.1. Several missing or damaged shingles. Recommend further investigation and repairs by a qualified roofing contractor.

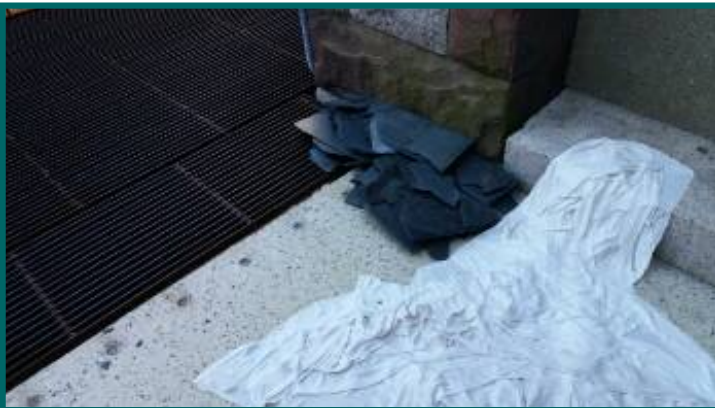
fallen shingles around building

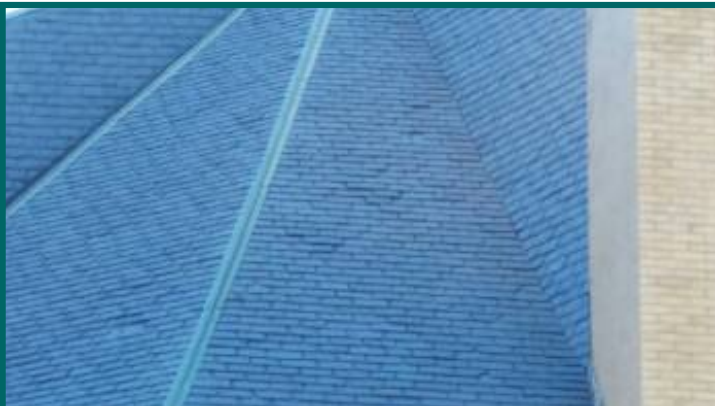
Front of building missing shingles.

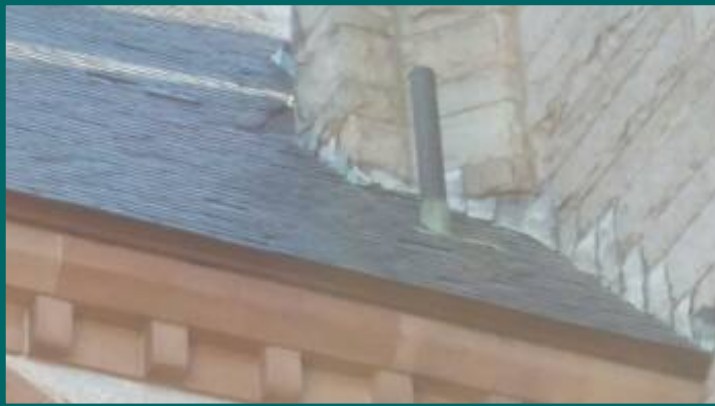
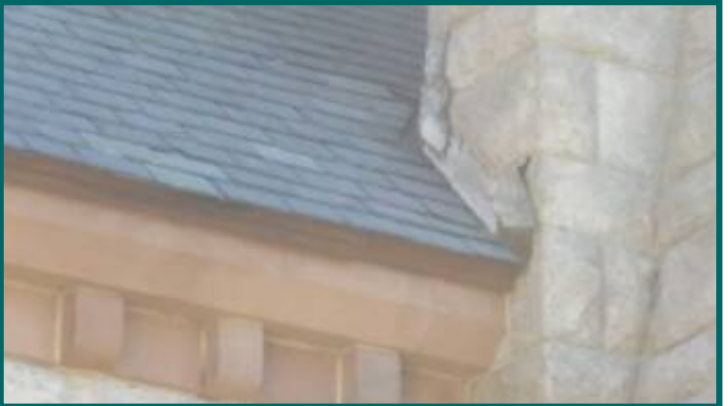
Front roof surface.

2.1. Damaged flashing at **drip edge** and transitions at one or more area of building, areas of suspected leaks. Recommend assessment and repairs by a qualified roofing contractor.

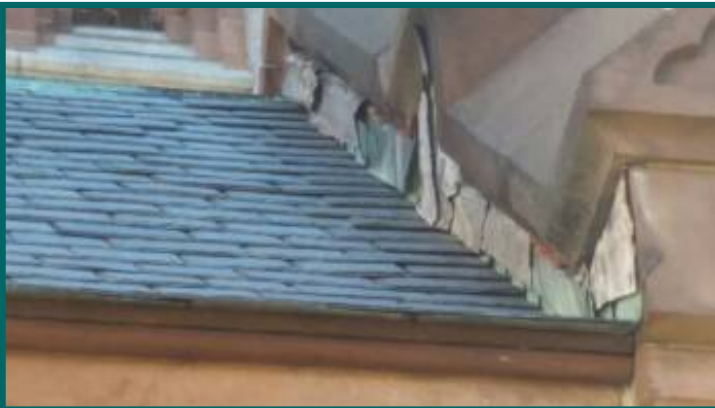
tar covered flashings will need to be monitored  
and serviced from time to time

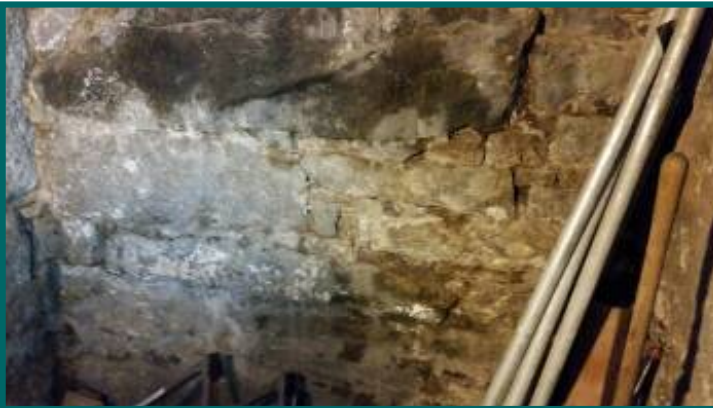
1.7. It was reported that bulkhead area has a history of leaking, current owner has installed a sump pump and dehumidifier. There is still active water intrusion in that area.

water staining near bulkhead

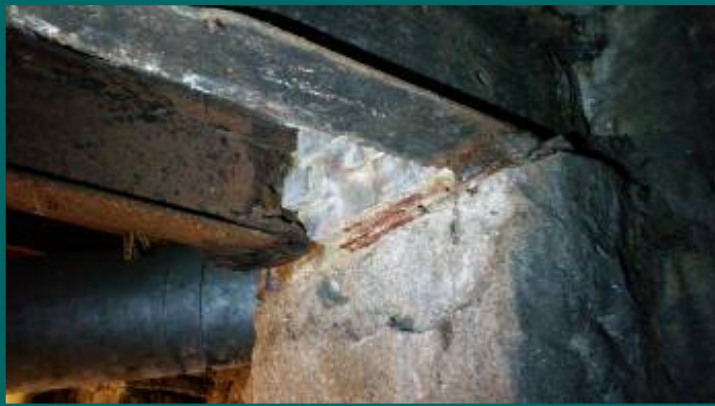
Corrosion on steel beams at bulkhead area

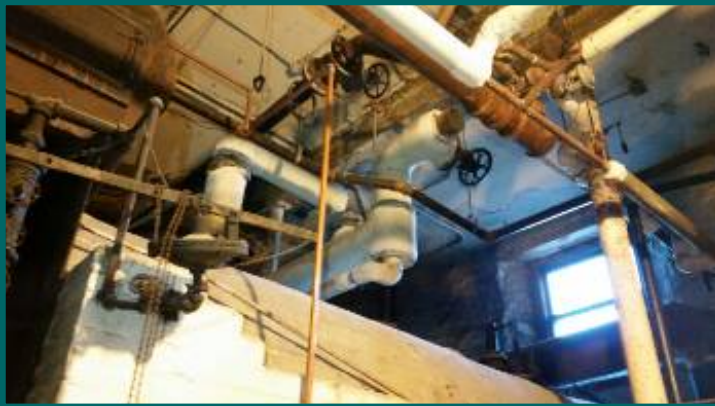
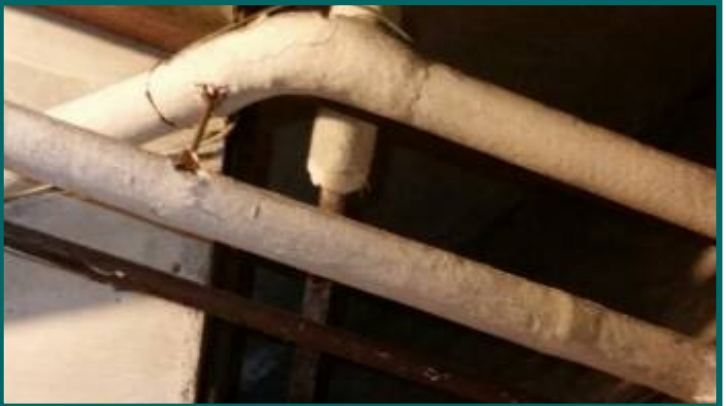
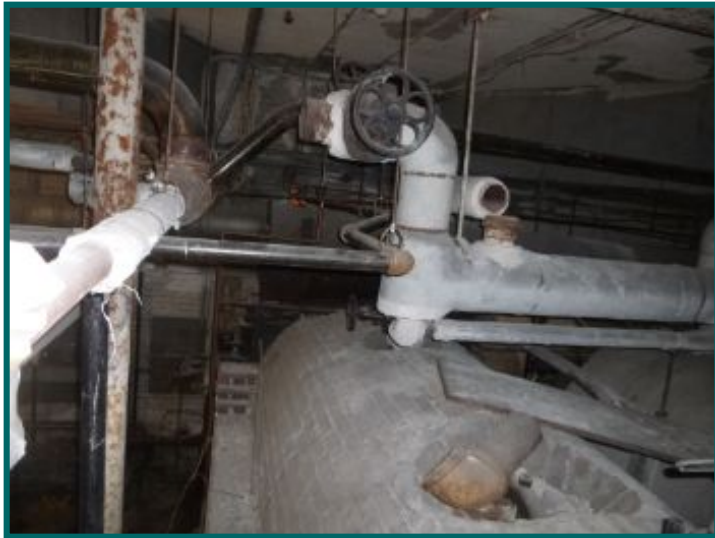
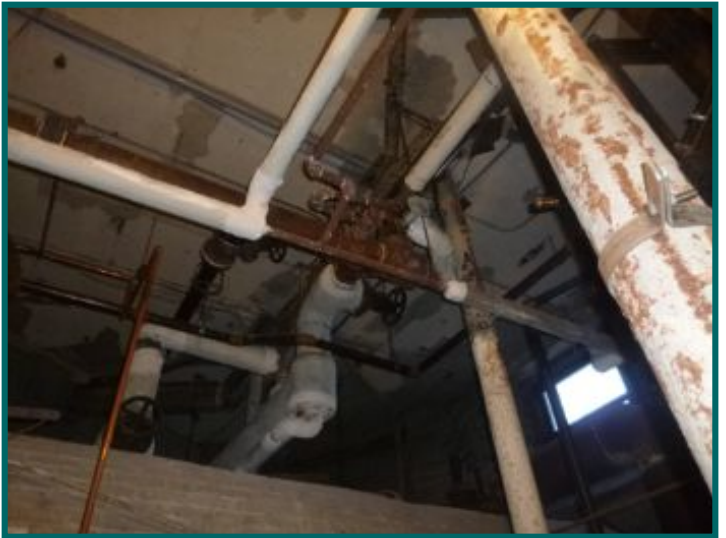
Suspected asbestos insulation.

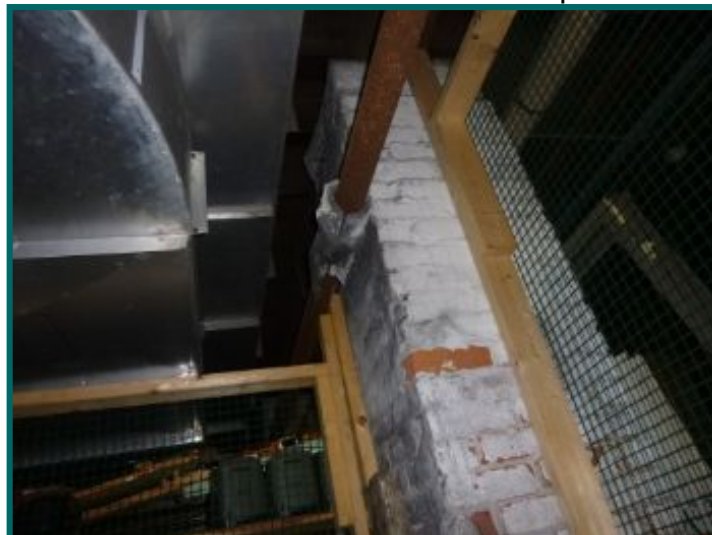
Suspected asbestos insulation.

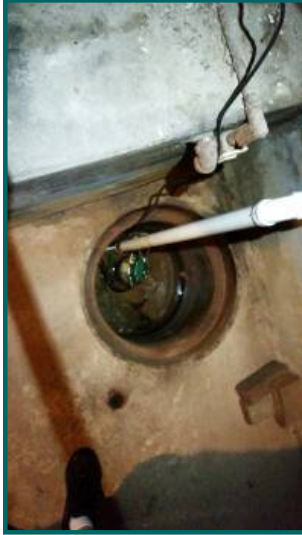
sump pump in boiler room

5.1. Sump pump and drain line should be monitored for proper operation particularly during wet conditions to help prevent water intrusion.

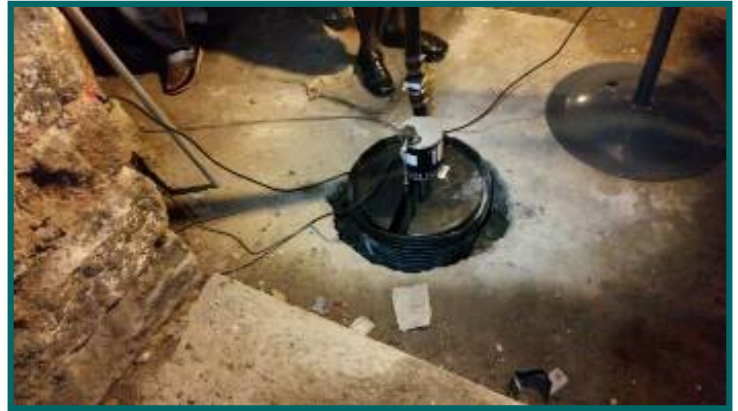
sump pump at bulkhead

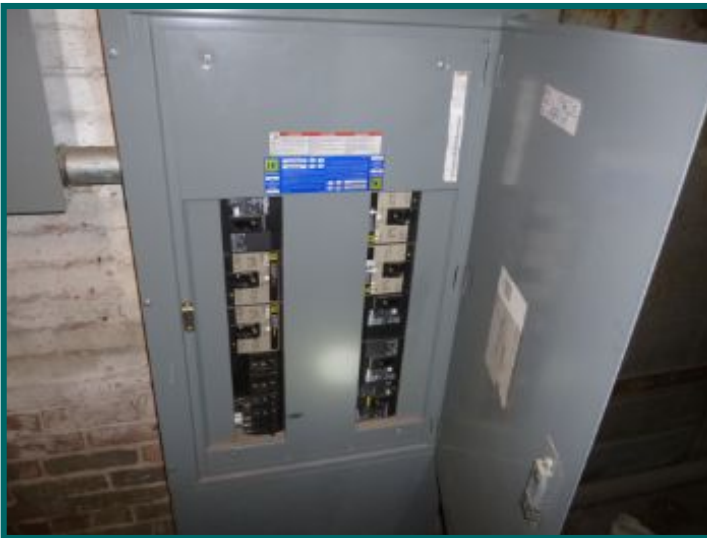
Numerous electric panels through out building ,  
reported to be 10 years old.

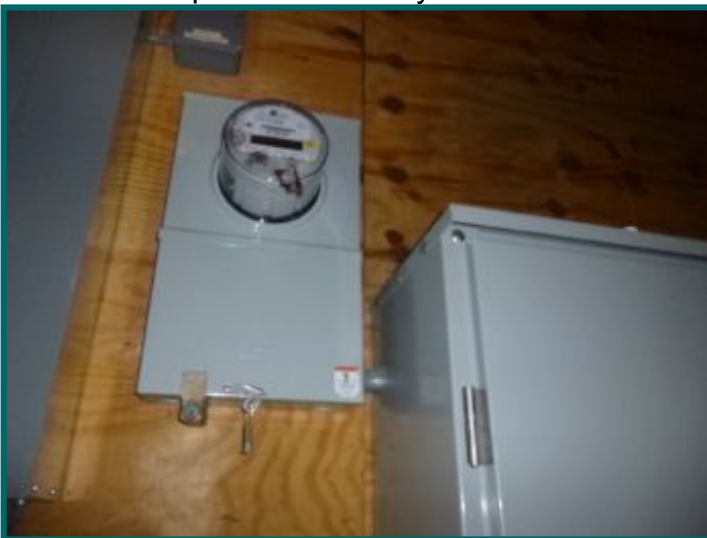
One electric meter in basement.

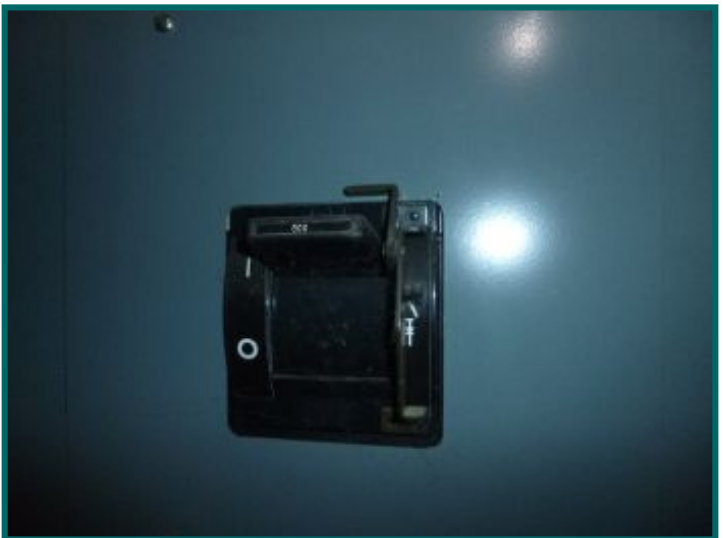
Main breaker disconnect 600 amp three phase.

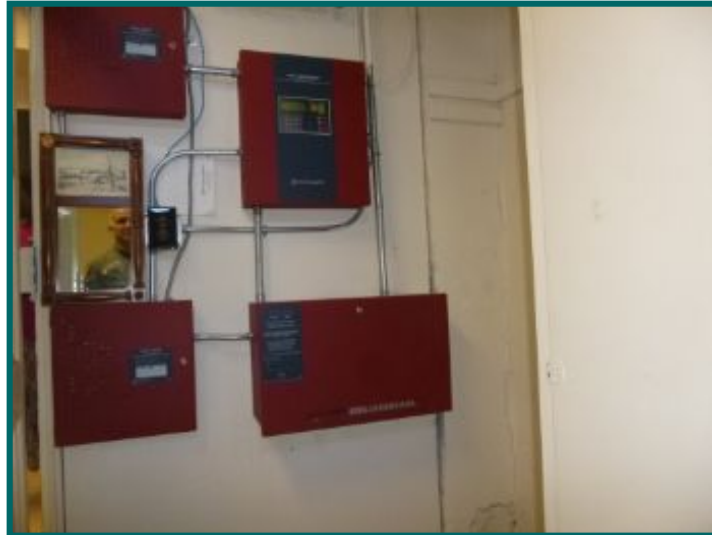
Alarm controls were not assessed.

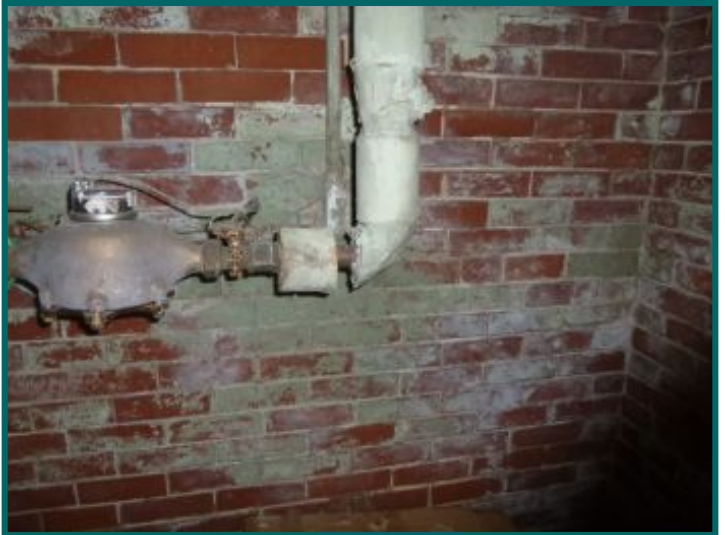
Main water shut off valve is located at water meter.

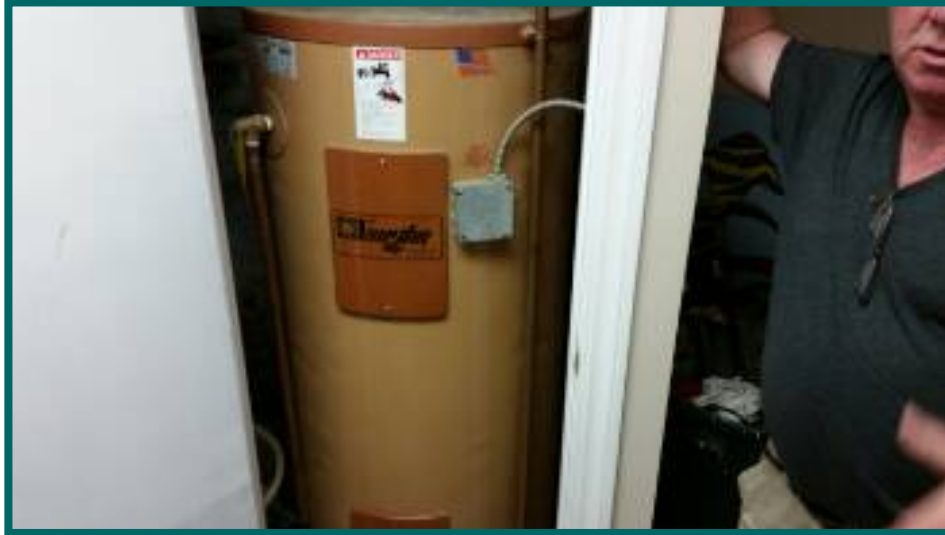
Water heater shut off not tested.

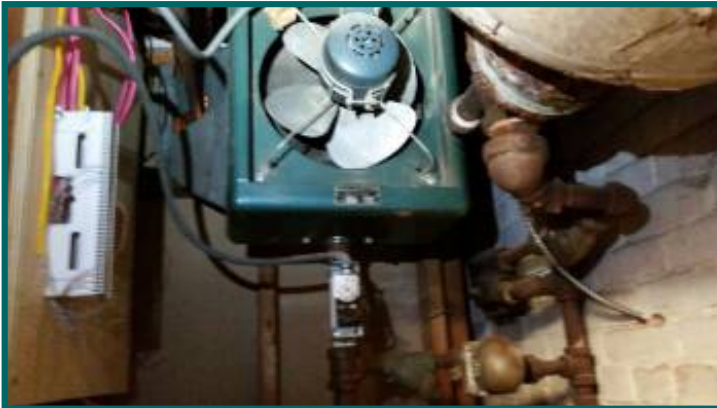
Heater near water heater is not in use

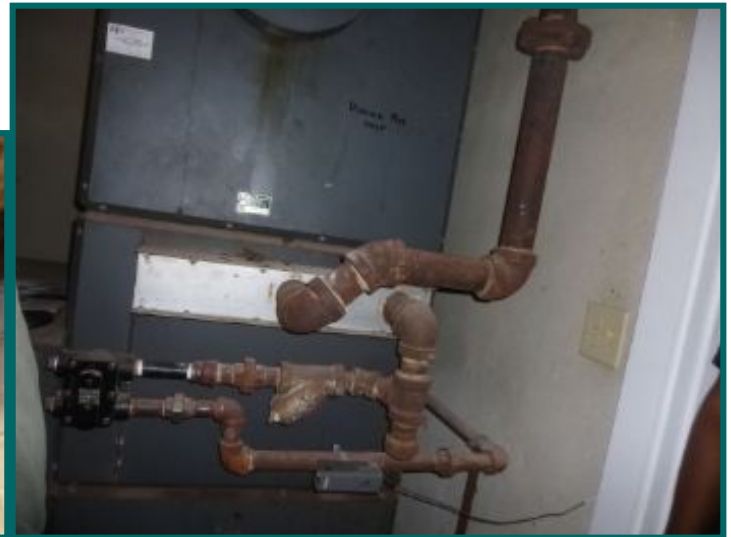
Hydronic air handlers.

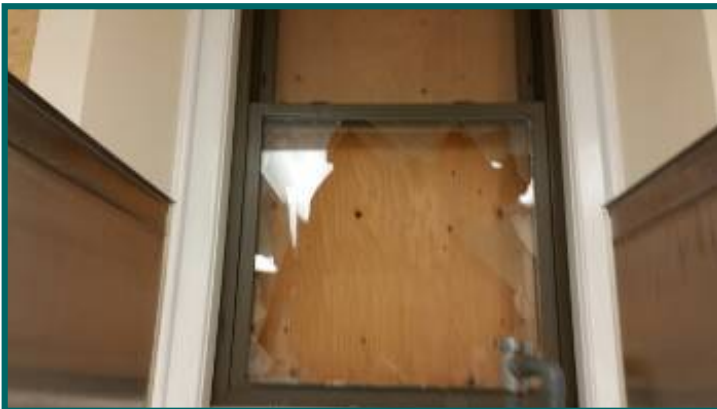
3.1. Window has broken pane in one or more area of building. Recommend assessment of windows and repair by a qualified tradesman.

Broken basement window

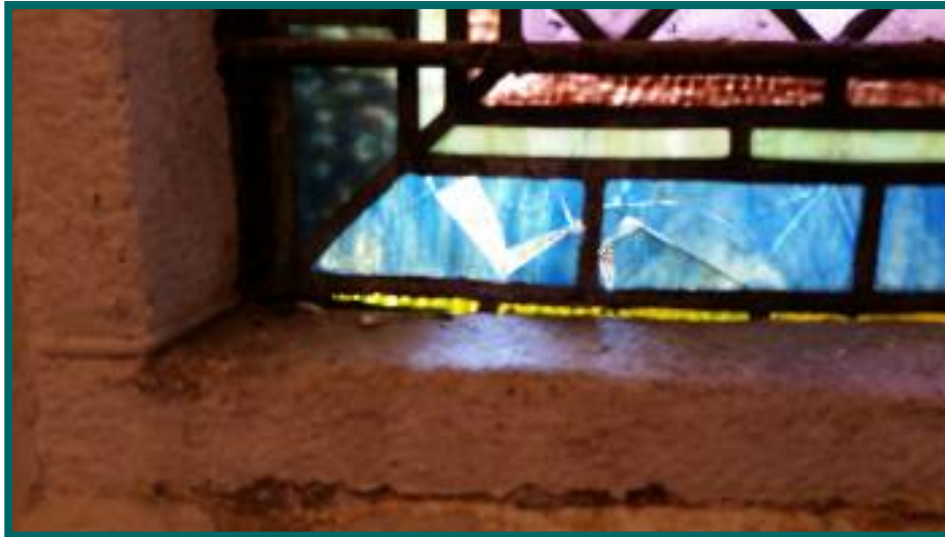
broken glass front foyer stained window

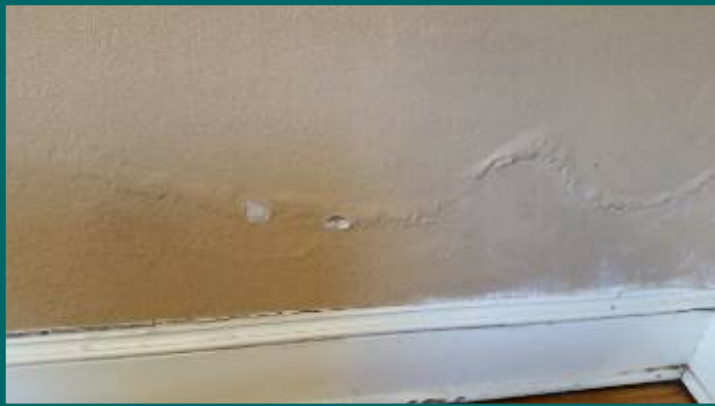
blistering paint at rear sanctuary office

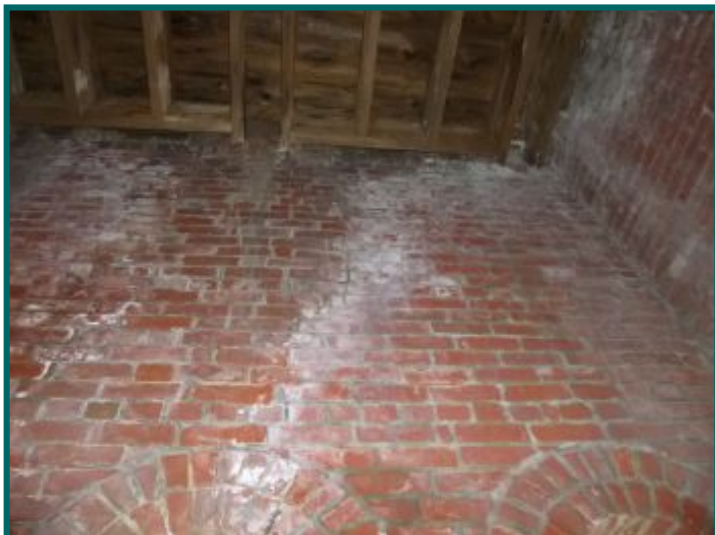
Efflorescence on right side tower walls, evidence of water intrusion.

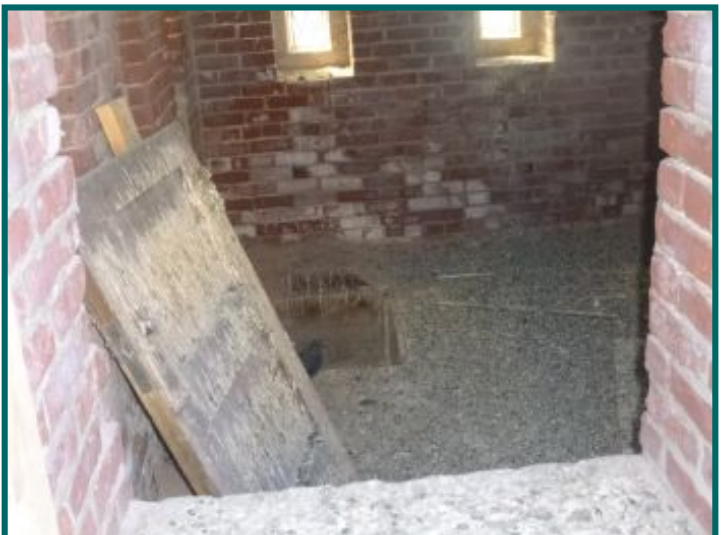
- 4.8. There are unsanitary conditions in left side front tower due to pigeon roosting. This area should be cleaned, repaired as needed and sealed to prevent further pest infestation.

Inside upper left tower has pigeons roosting.

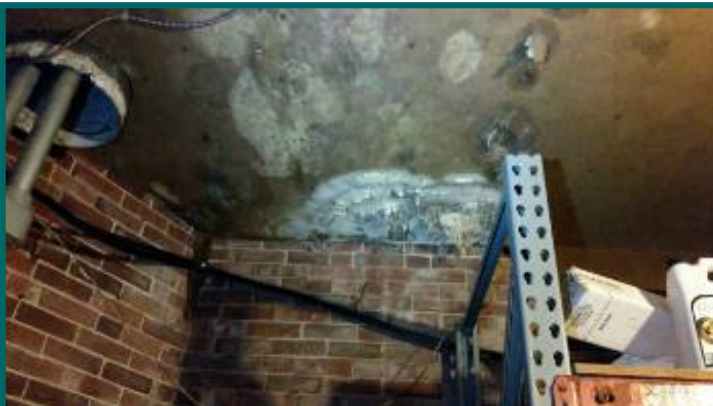
5.3. There is significant cracking or damage to ceiling surfaces in one or more locations, recommend repairs by a qualified contractor.

damaged ceiling in paint storage room

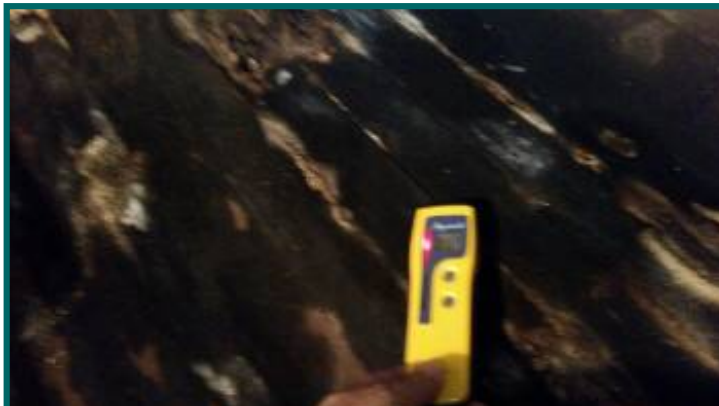
elevated moisture levels in fan motor room

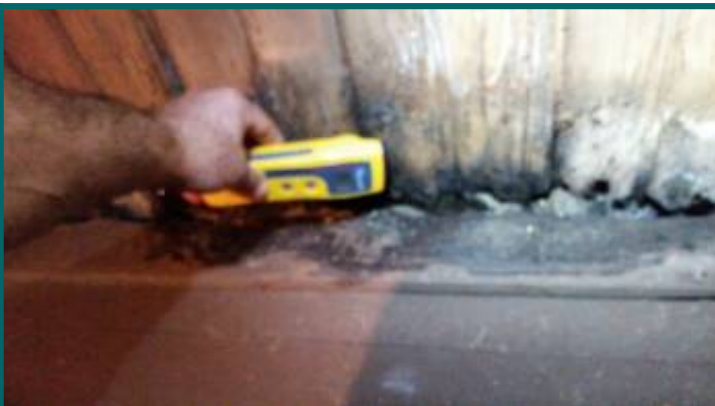
Elevated moisture levels on floor and wall in basement.

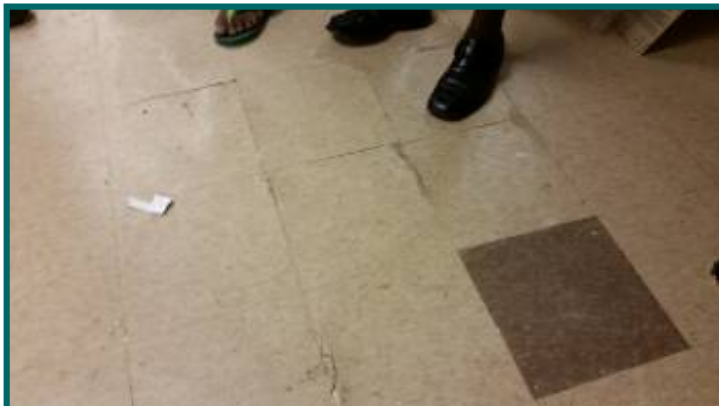
basement damaged floor tiles.

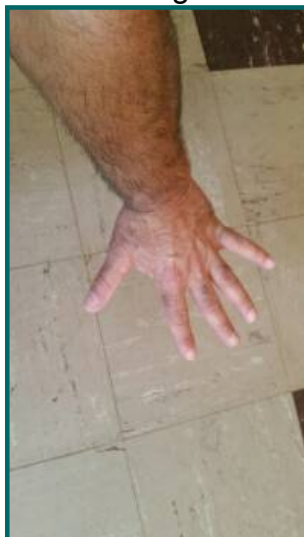
6.3. Some of the floors in this building are a vintage 9x9 size; be advised that these tiles may be the type that contain and have an adhesive containing asbestos. Asbestos is a health risk when it is made friable - in other words, when its fibres and dust can be breathed in by the lungs. To be safe, please refrain from removal and damaging these tiles until it is certain they are not asbestos containing material.

9 by 9 tiles at many areas of building.

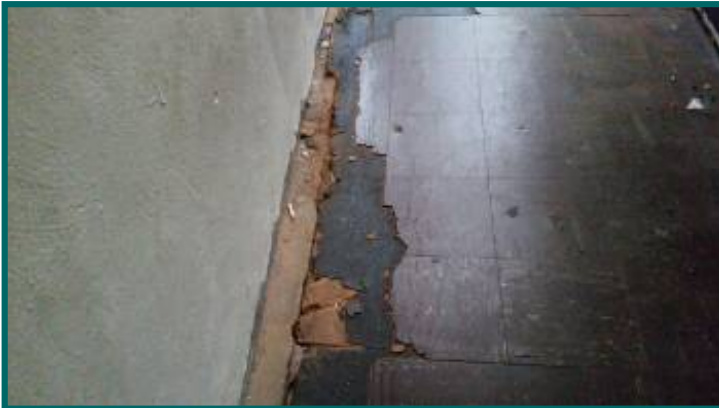
Damaged flooring sanctuary side hall.

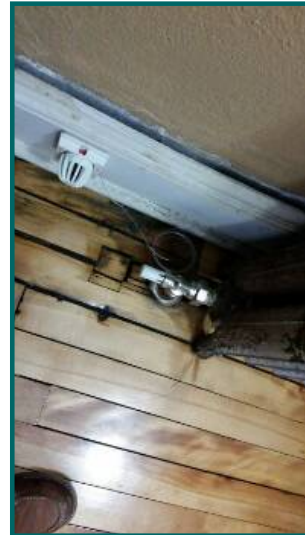
damage floor rear sanctuary office below heat register

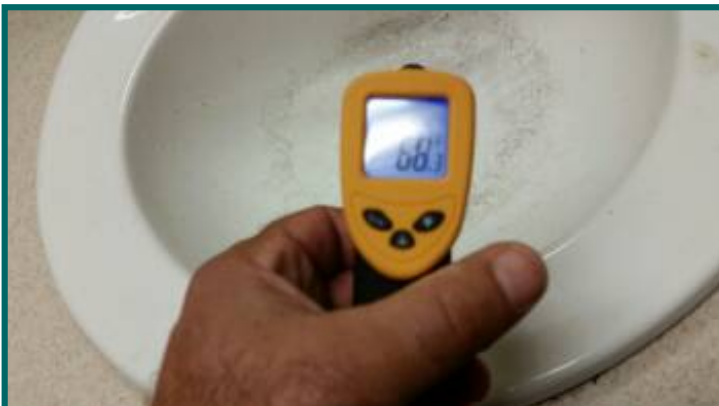
7.2. Hot water is shut off or not working to one or more sinks. recommend assessment and repairs by a licensed plumber.

No hot water.

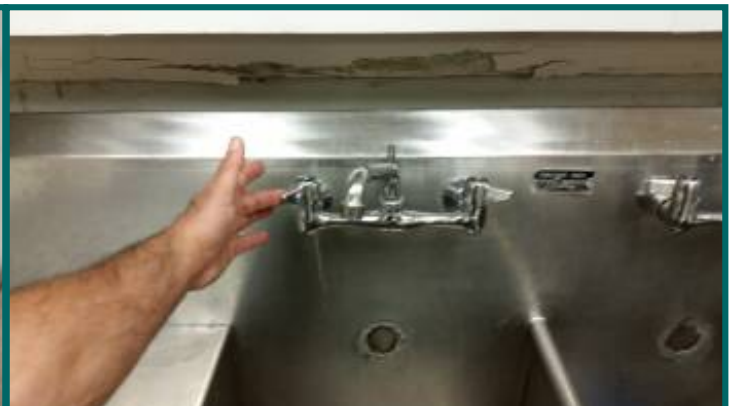
Water shut off to many sinks

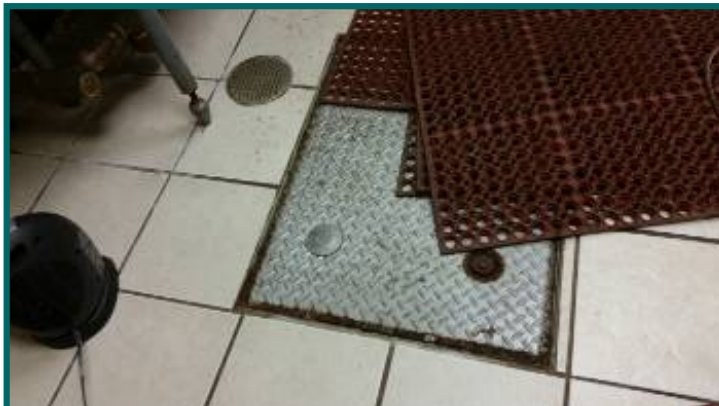
grease trap in kitchen

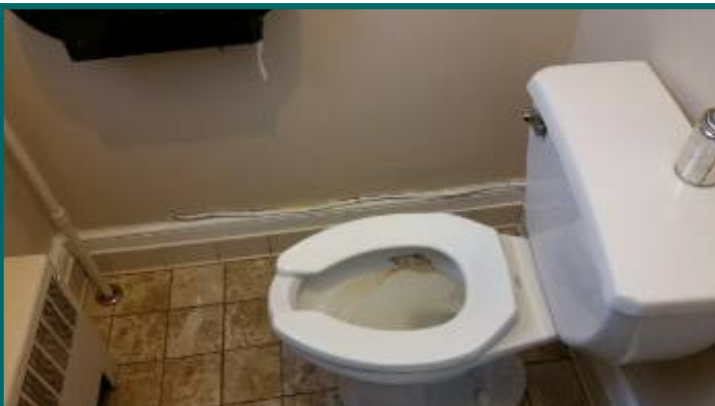
toilet clog 1st floor rear bath
