Alpha Home & Commercial Building Inspections

Property Inspection Report

Sample 11 family apartment 100 years old, Manchester, NH 03103
Inspection prepared for: Sample Report
Real Estate Agent: -

Date of Inspection: 1/8/2016 Time: 9:00 AM
Order ID: 3168

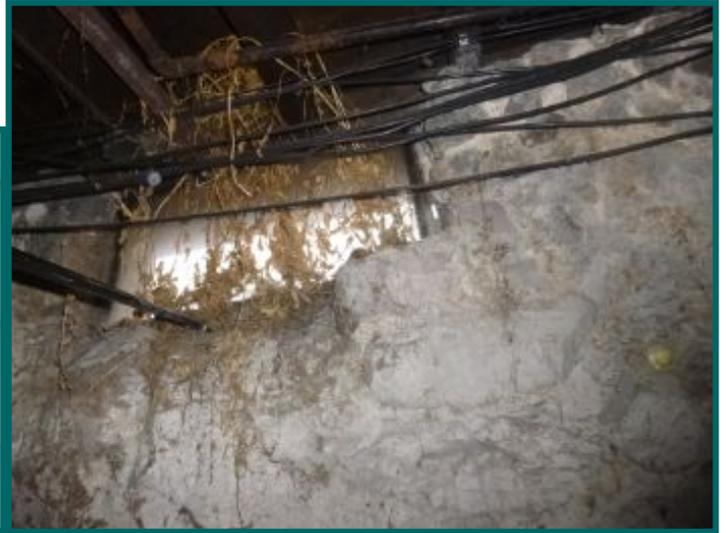
Vines growing into basement walls should be removed.

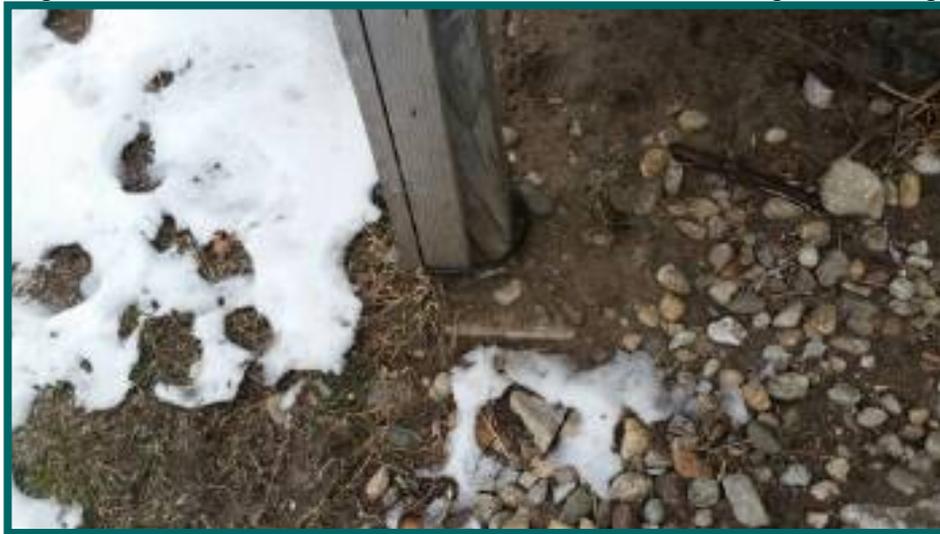
Poured footings present

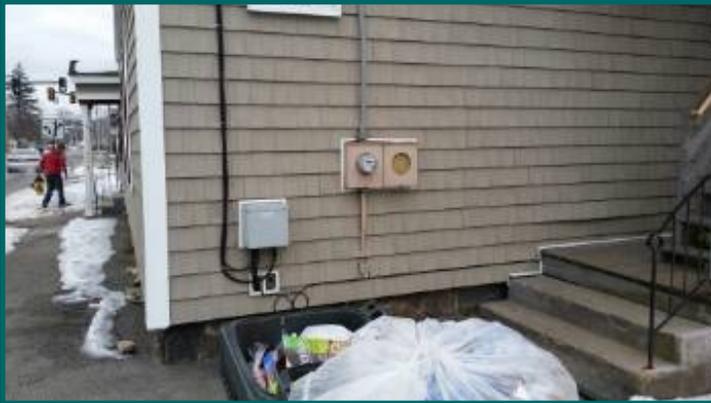
building is has one electric meter

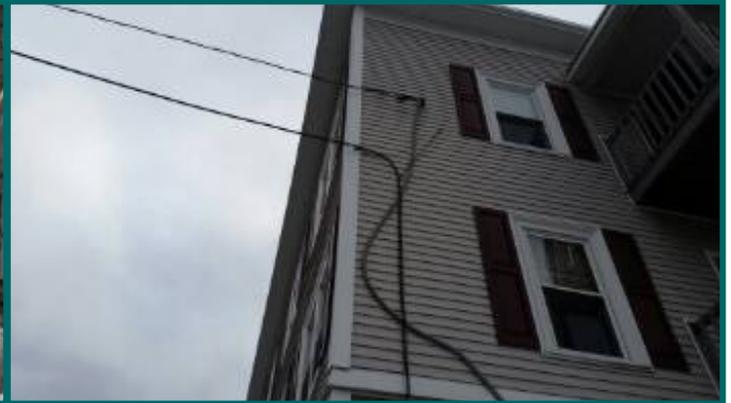
service wire attachment

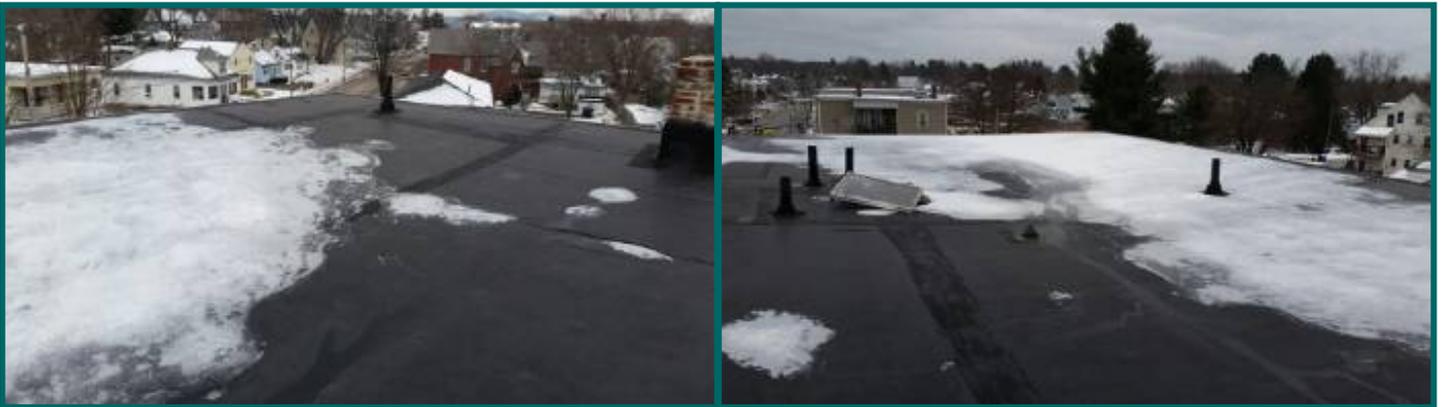
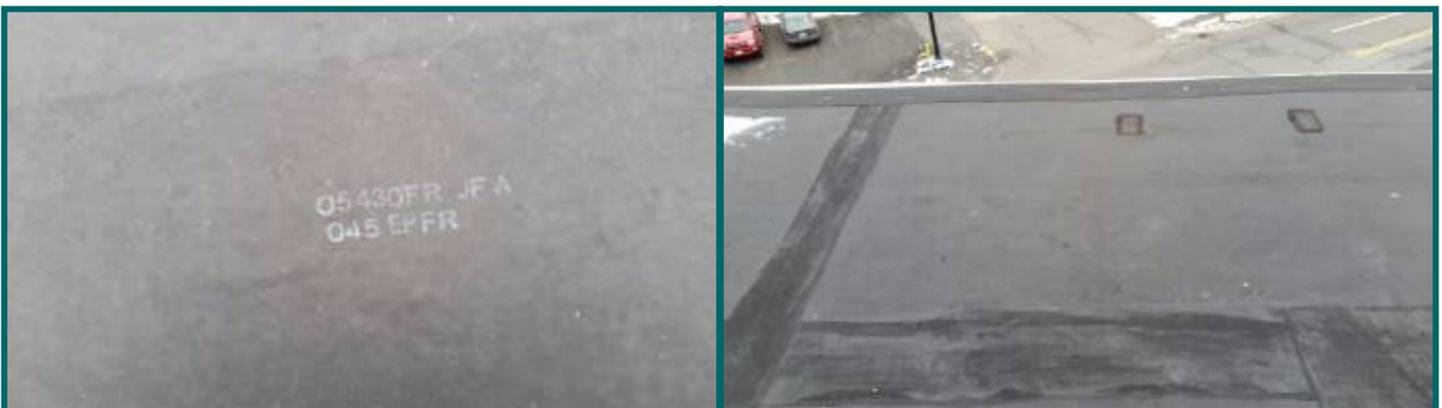
1.1. The roofing system consist of roofing trusses, roof decking, fastened insulation panels and glued down 45 ml. EPDM rubber membrane sheets. (Ethylene propylene diene terpolymer, EPDM) This type of rubber roof system can provide 20-30 years of service. Regular maintenance will help to extend the life of roof. The roof age appears to be within its intended design life and in acceptable condition. Recommend regular inspection of all seams and roof penetrations and maintenance by a qualified roofing contractor, to prolong life of roof and protect against leaks.

45 mil EPDM

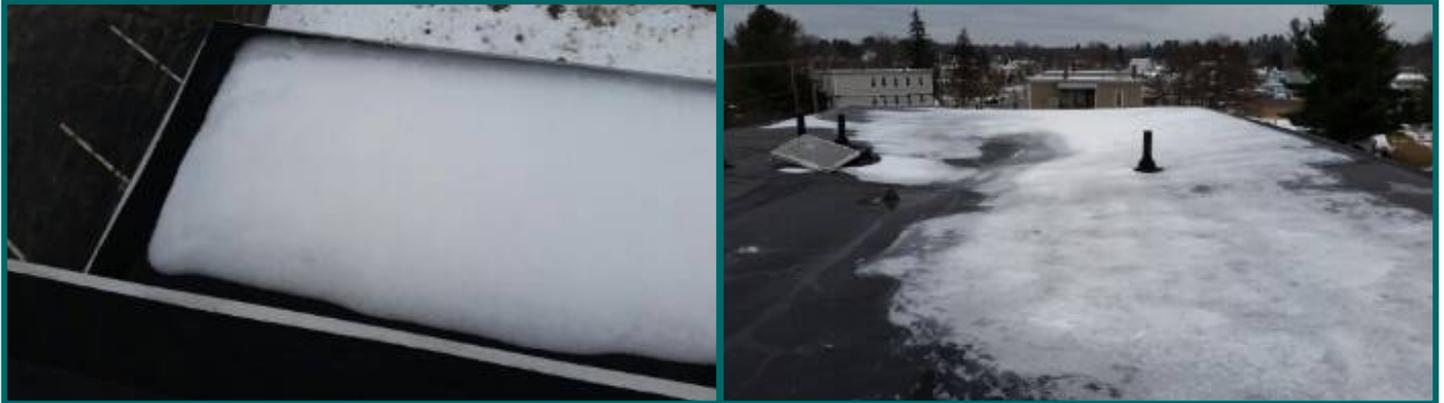
lower deck roofing

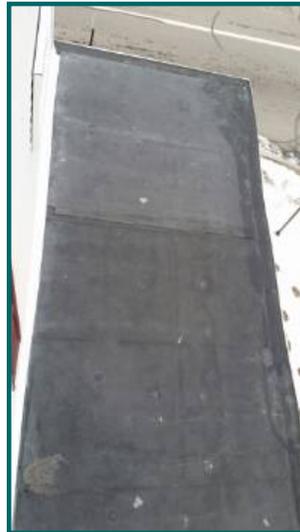
lower roof

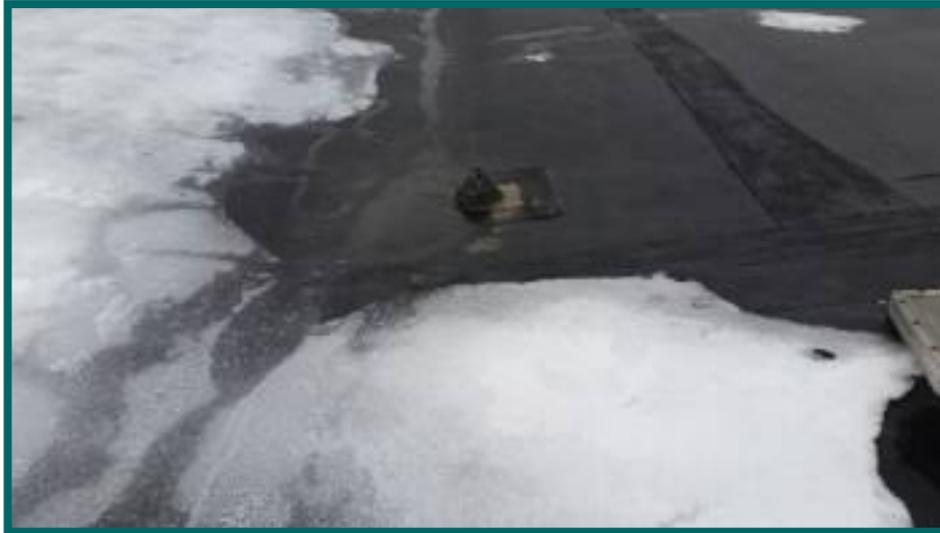
one internal roof drain presents is clean appears to be well maintained

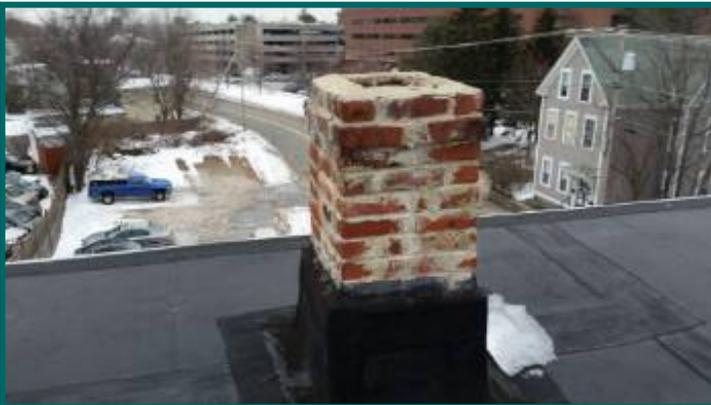
chimney appears in acceptable condition

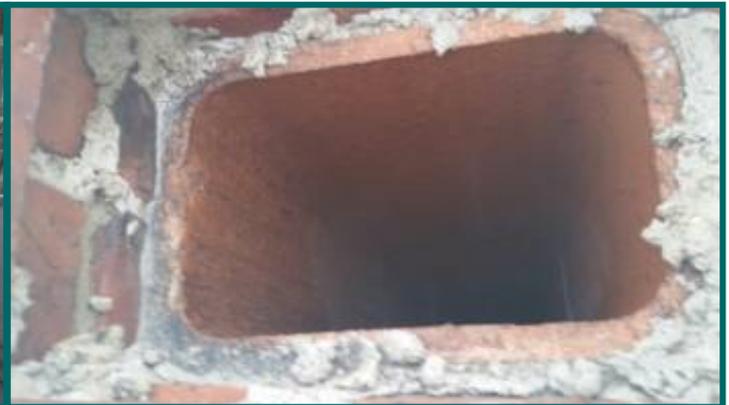
chimney is lined

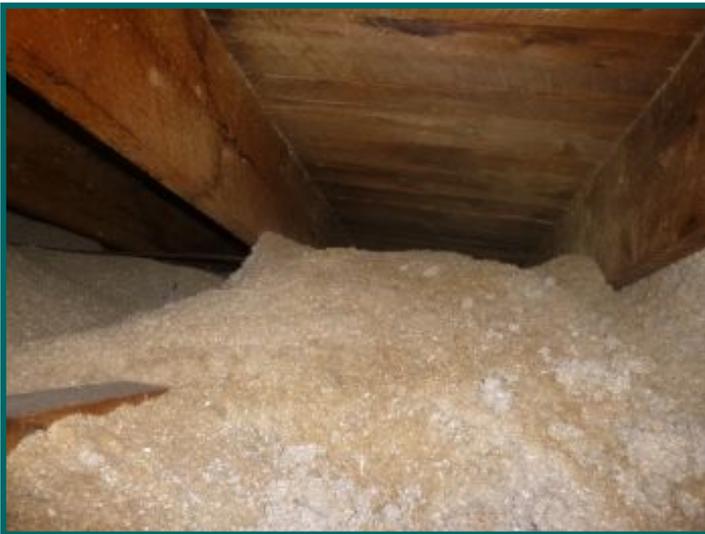
Mechanical chase viewed from roof hatch area.

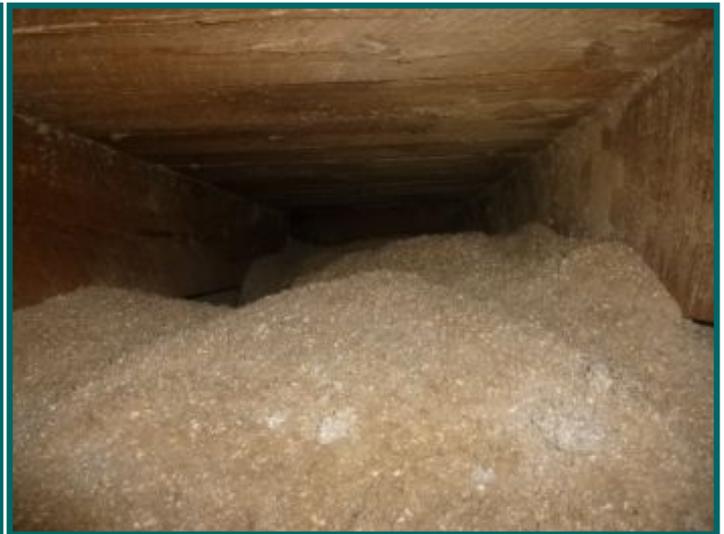
Mechanical chase viewed from roof hatch area.

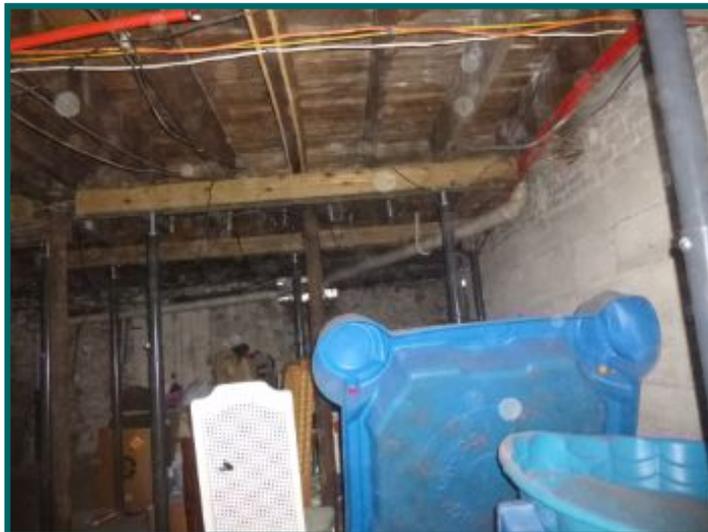
2.4. Foundation framing is very old, there are areas where framing components have been repaired or replaced, condition should be monitored closely and repaired as needed.

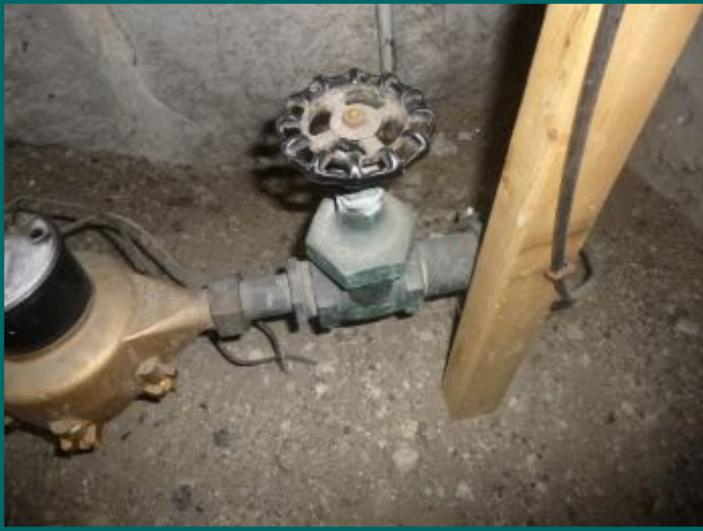
Main water shut off valve is located at water meter.

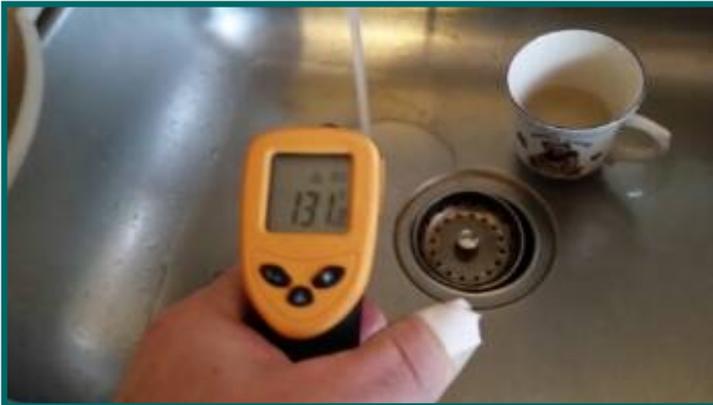
- Building is serviced by a single gas fired, 75 gallon water heater one year old, typical design life for water heater is 10-15 years. Water heater appears to be in acceptable condition and working except where noted.
- Water temperature is above 120 degrees, should be set minimum 110 degrees for comfort and maximum 120 degrees to prevent scalding particularly for very young and very old persons.

Water Temperature third floor

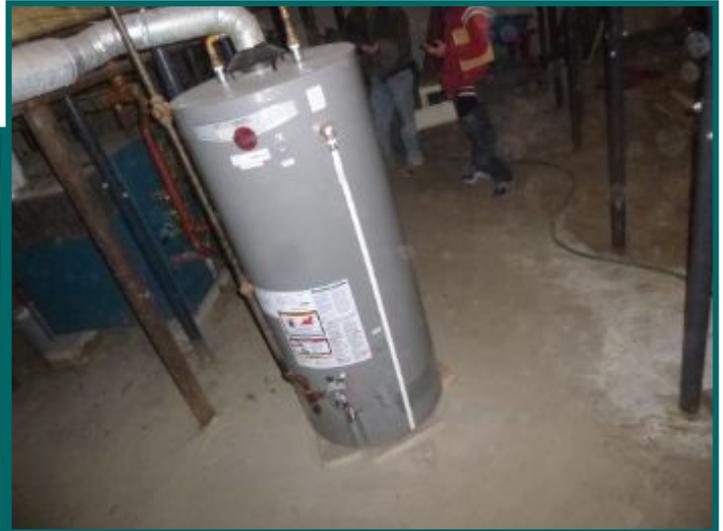
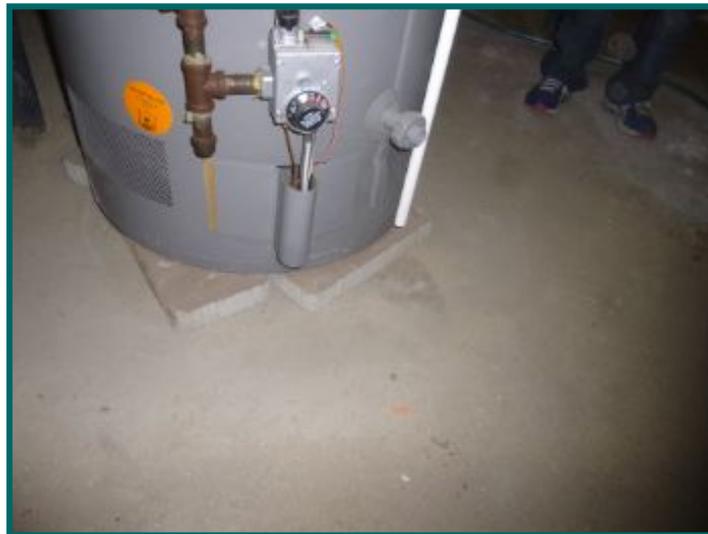
Mixing valve / burner control to adjust water temperature.

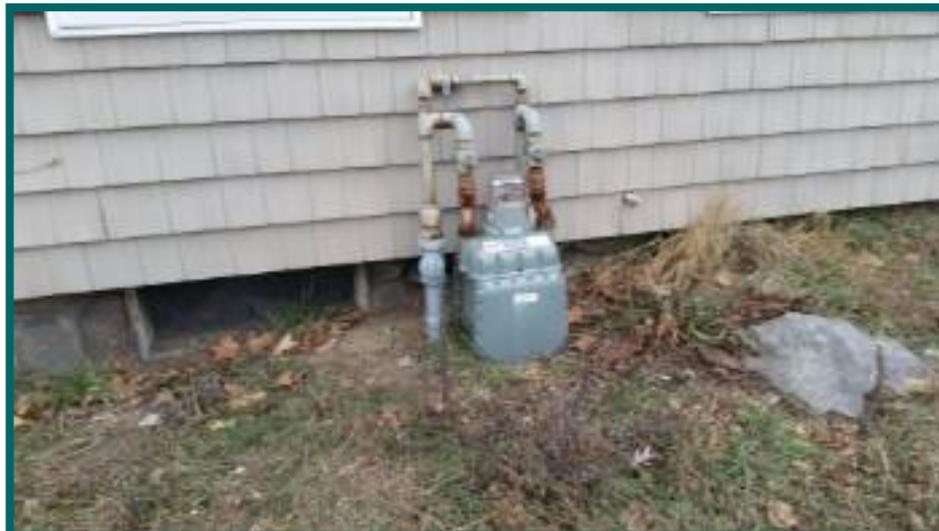
Gas Meter at rear of building

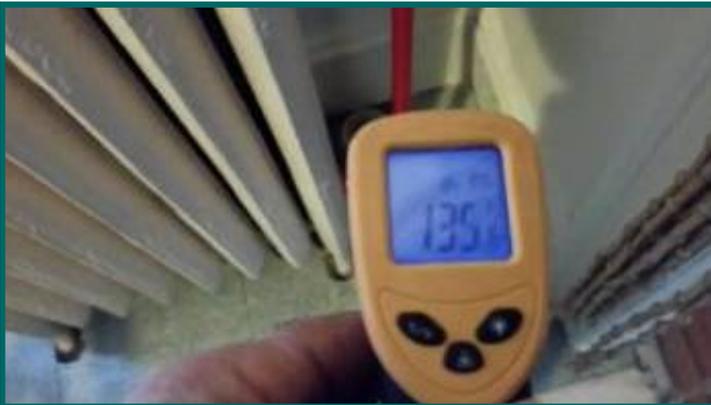
3rd floor heat

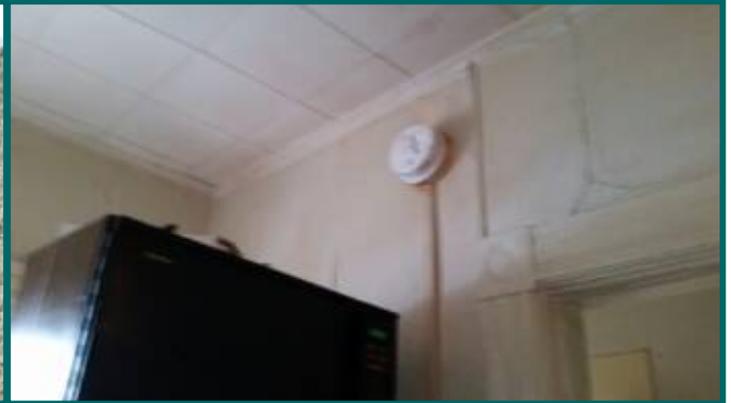
smoke detectors present were not tested

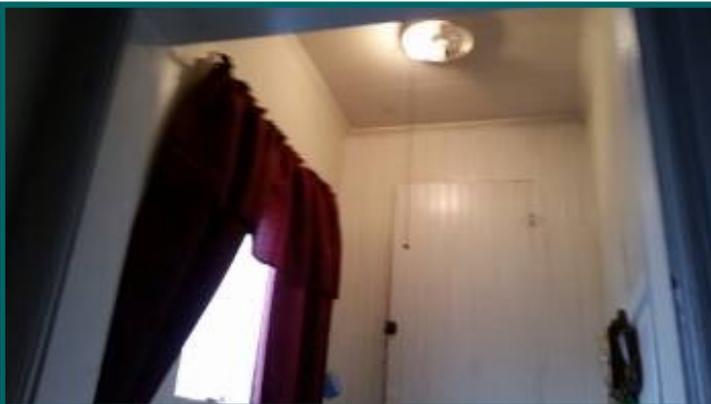
unit 11 pantry light will not shut off

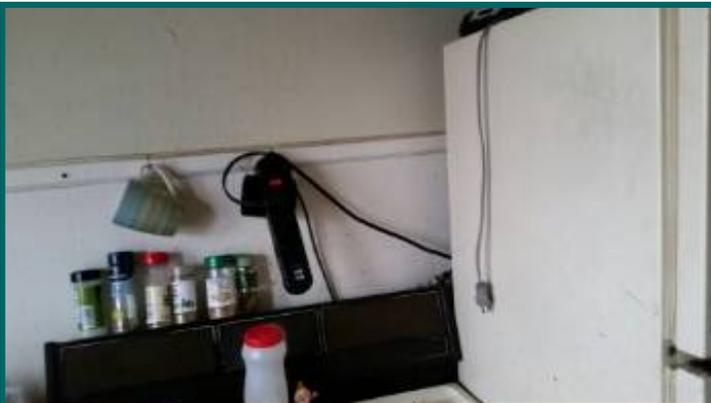
unit 11 reported repeated kitchen breaker tripping

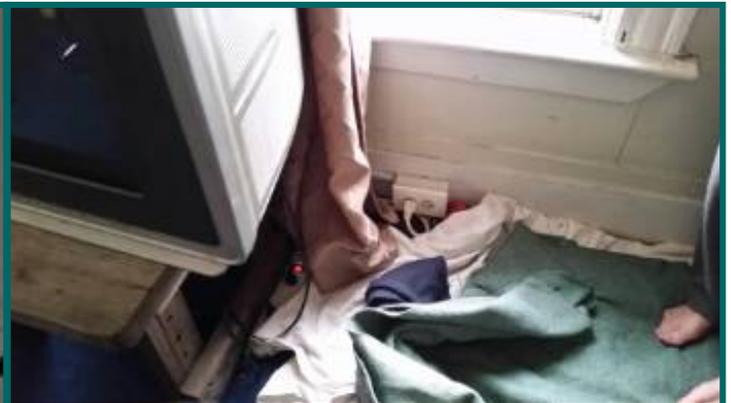
unit 11 bedroom reported no power, tripping breakers, electrical smell when in use

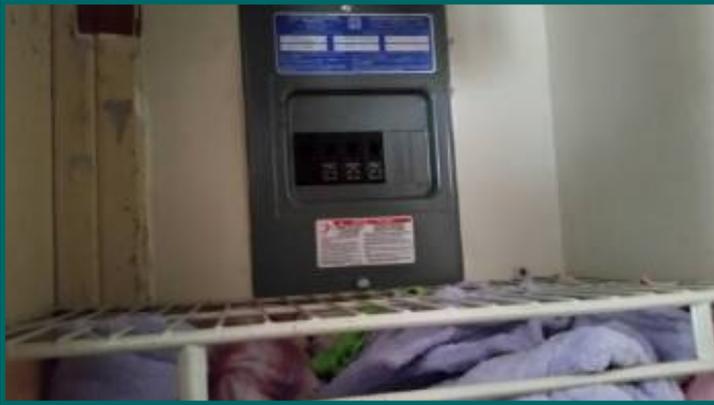
sub panel in closet unit 10

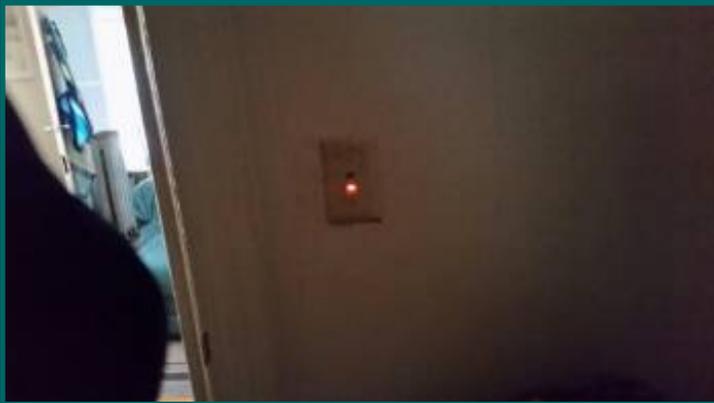
unit 7 bedroom wall switch not working

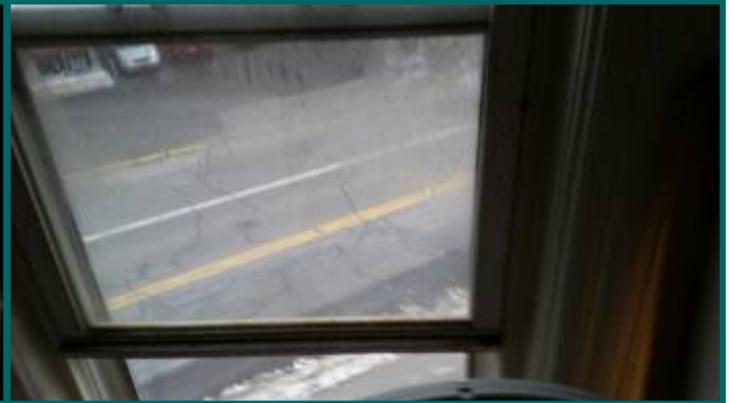
4.2. One or more windows have broken seals (fogged) this condition can diminish the energy efficiency of the window and cause permanent hazing to the glass, recommend repair by a qualified window contractor.

fog window unit 9

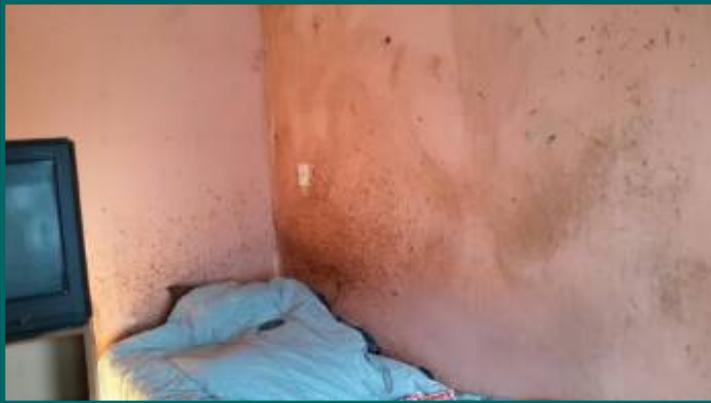
dirty conditions staining unit 6

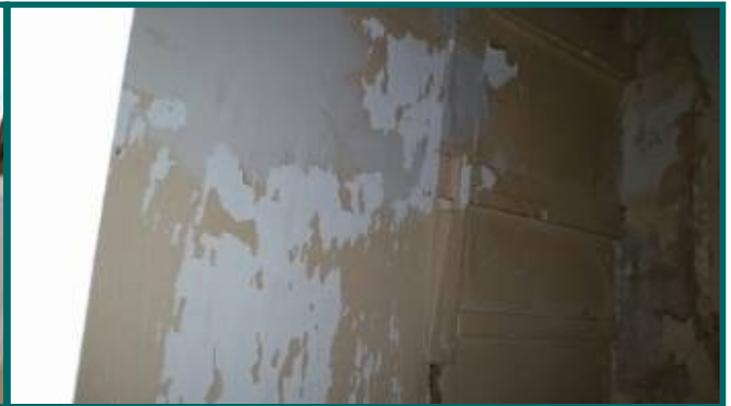
5.4. Areas of excessive peeling paint, caution should be taken to prevent any lead paint hazards, recommend assessment and repairs by a qualified contractor.

peeling paint unit 3 bedroom

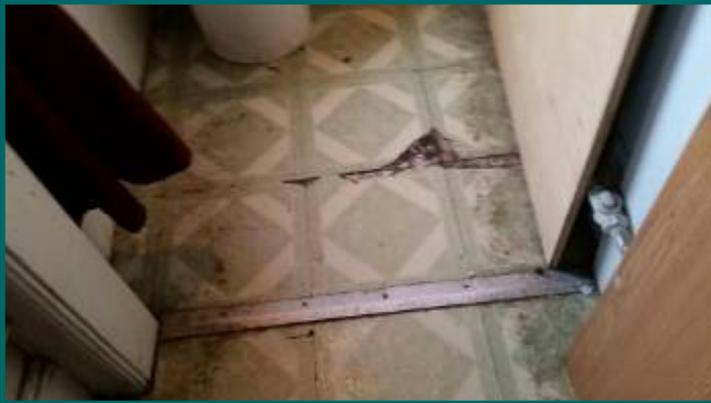
7.2. Damage or excessive wear to flooring in one or more area, recommend assessment and repairs by a qualified flooring contractor.

damage tiles unit 11

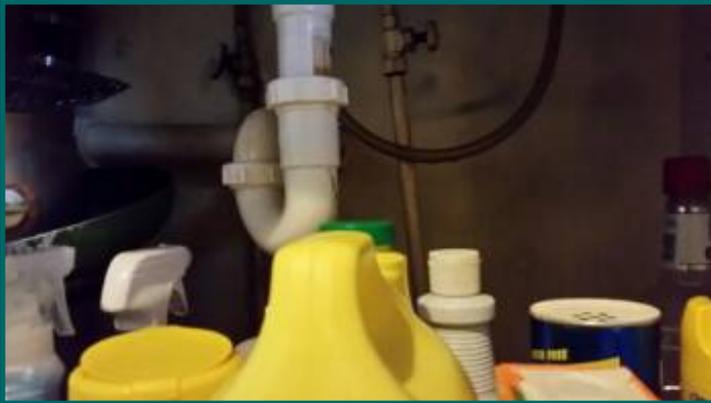
8.5. Sink supply line or fitting leaks in one or more location. Recommend repair/ replacement by a qualified plumber.

unit 8 kitchen sink is leaking

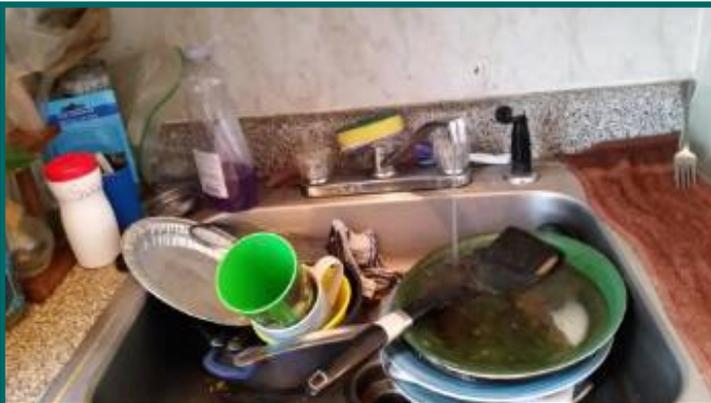
8.6. Poor pressure flow at one or more sink fixture, recommend assessment by a licensed plumber.

8.8. kitchen sink spray nozzle is damage at one or more unit. Recommend repairs by licensed plumber.

unit 11 kitchen sink has low water pressure and
damaged spray wand

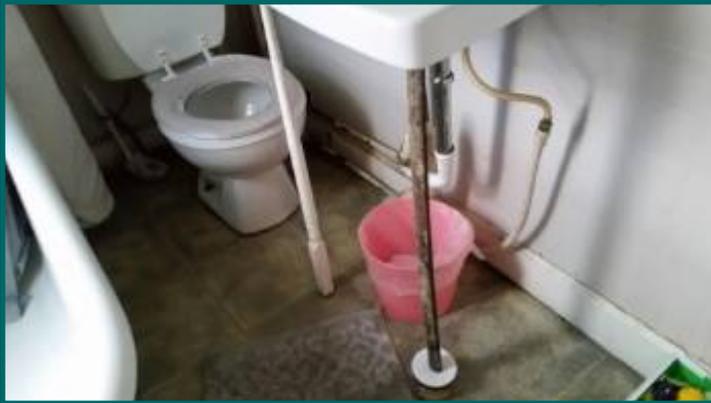
unit 7 bathroom sink leaking damage support post

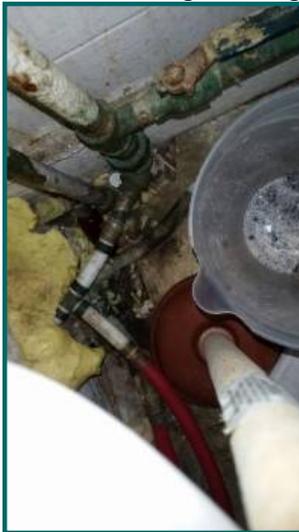
plumbing leak behind unit 7 toilet

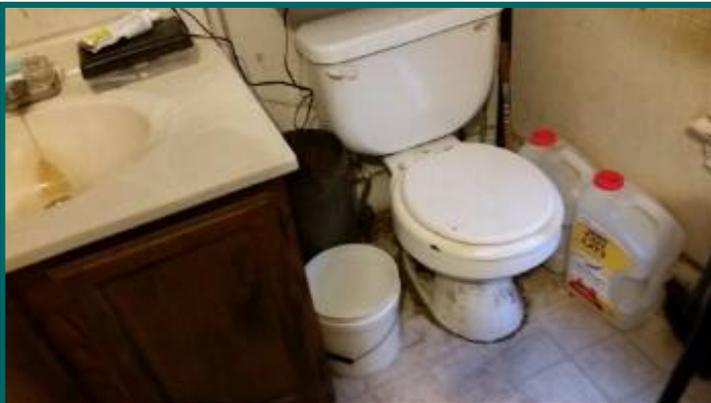
8.2. The toilet bowl at one or more location is loose at floor anchor bolts. The wax ring inside the unit must have a snug, secure fit in order to keep from leaking. Properly resealing and re-securing this unit is suggested to prevent water leakage and damage to the sub-floor area. This type of damage is not always visible or accessible to the inspector at time of inspection.

loose toilet unit 1

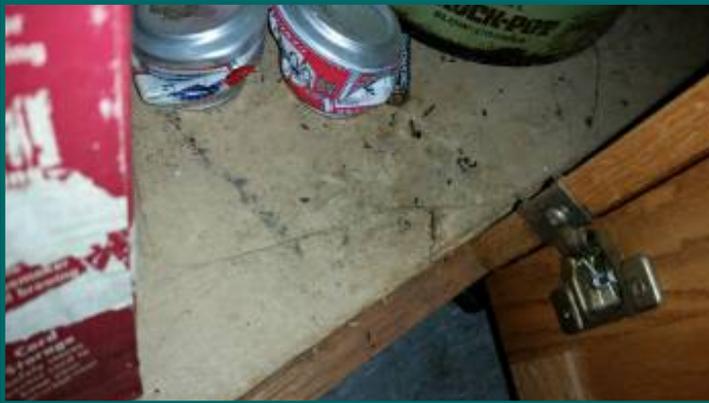
9.2. Evidence of past or present rodents under kitchen sink. Recommend assessment by a qualified pest control company.

rodent droppings unit 9 kitchen cabinet

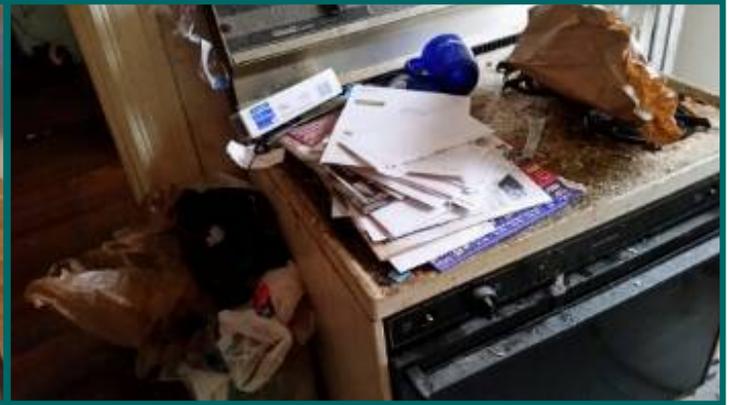
unit 9 oven was not operated
