Alpha Home & Commercial Building Inspections

Property Inspection Report

Sample 25,000 SF Bed & Breakfast, NH 03846
Inspection prepared for: Sample Client
Real Estate Agent: -

Date of Inspection: 1/8/2015 Time: 9:00 AM
Age of Home: 2002 Size: 24500
Order ID: 1920

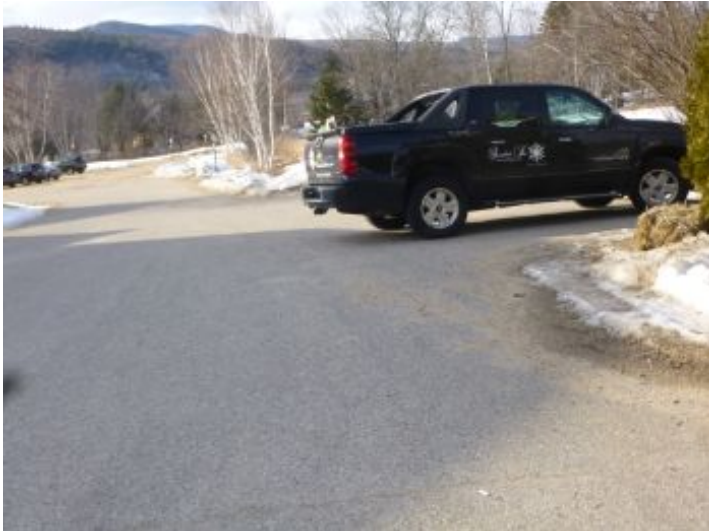
1.1. Snow covered; not fully inspected.

Side lot and entrance to rear lot.

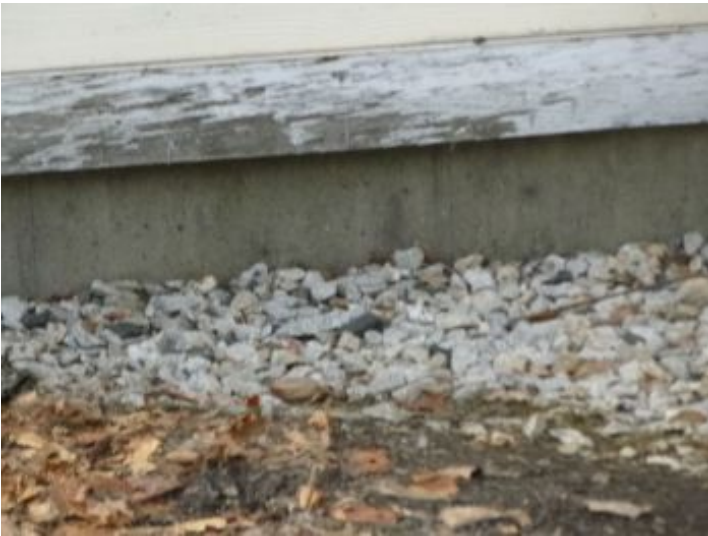
3.1. Peeling paint observed on siding and trim, suggest scraping and painting as necessary.

Peeling paint at front surfaces.

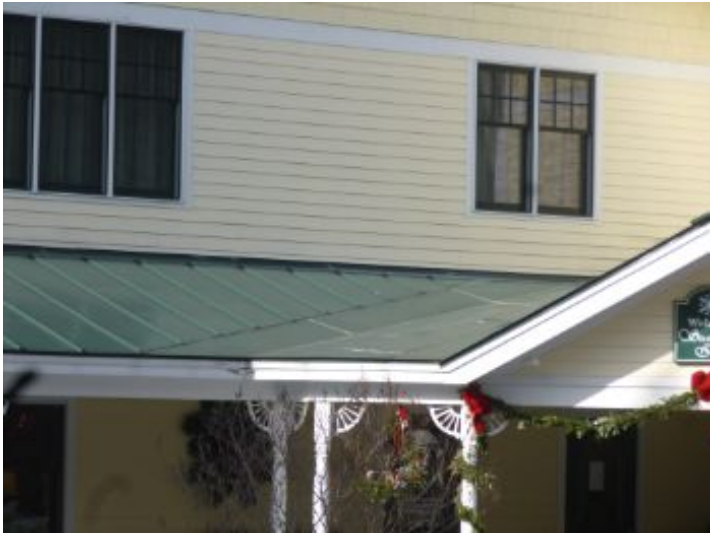
Front porch roof metal seam.

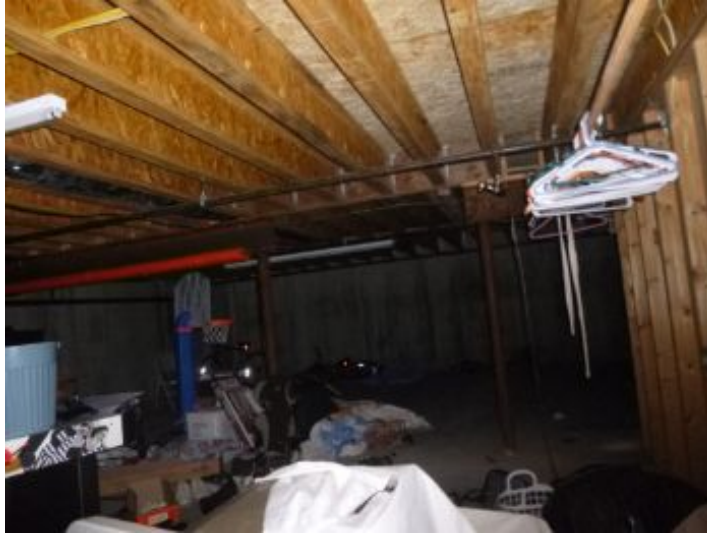
Framing, steel wood beams. engineered I beam joists.

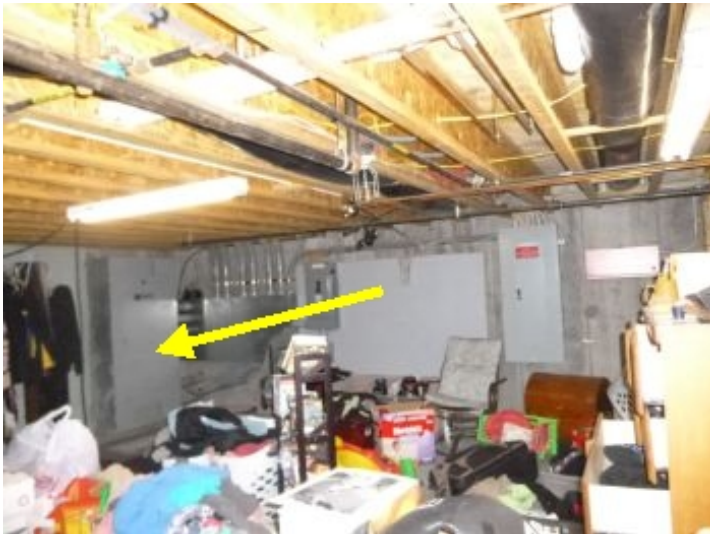
Main service 800 amp disconnect.

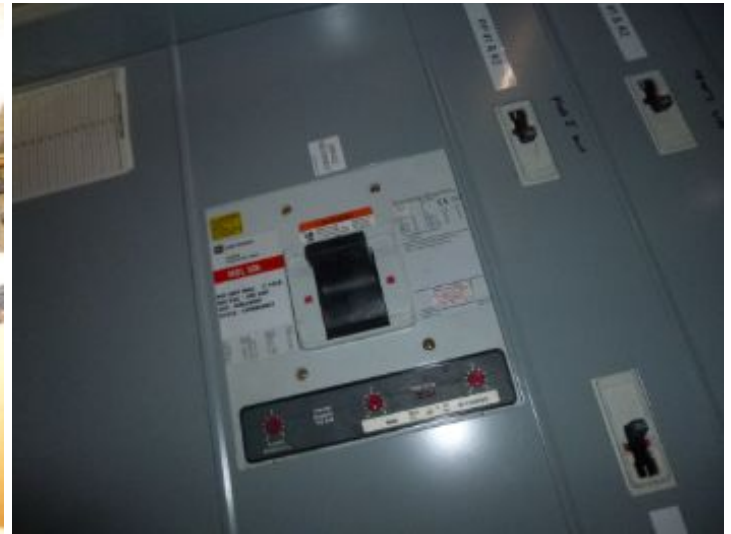
Main service 800 amp disconnect.

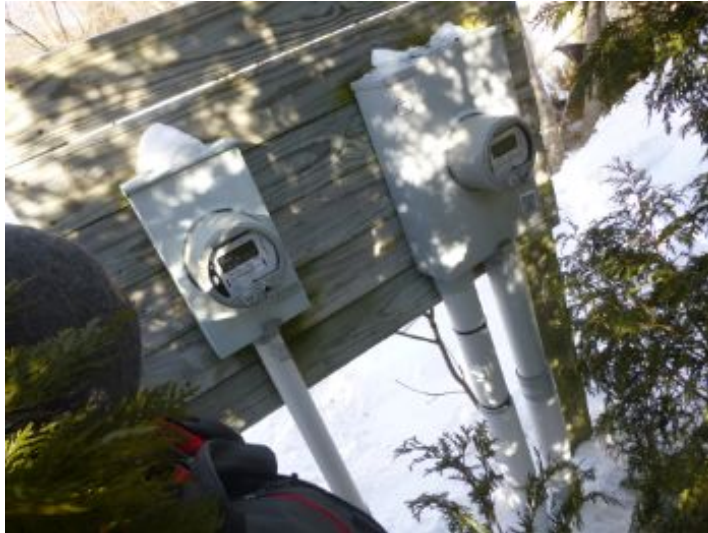
Electric meters on post in parking lot area.

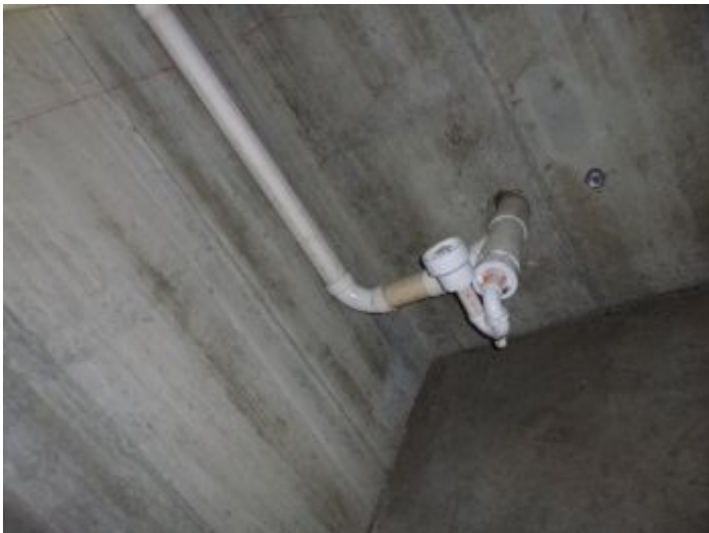
Main drain line to septic system.

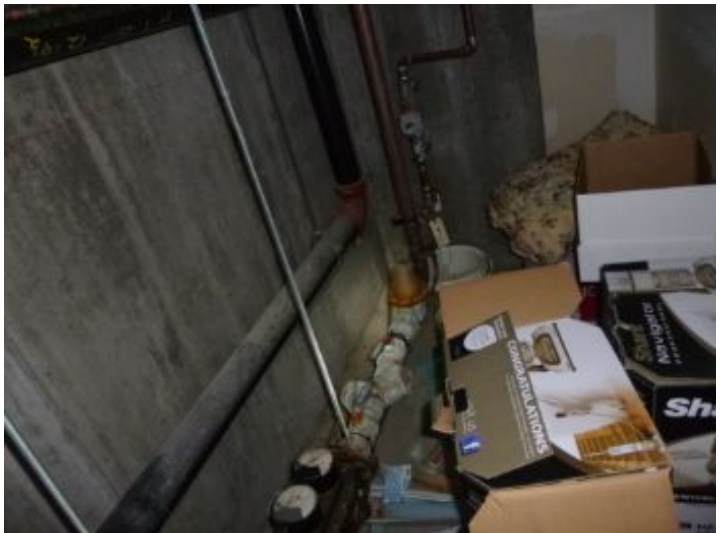
Main water entrance.

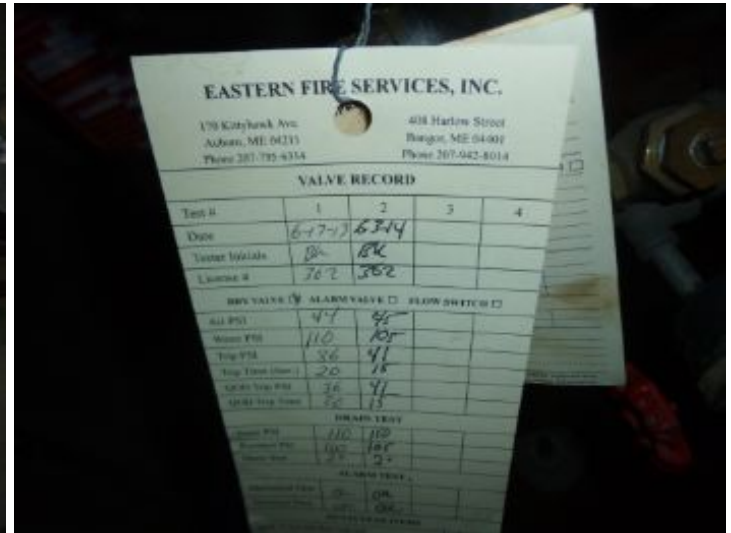
1.2. There is a fire suppression system present, not assessed. The system requires annual maintenance and inspection by a qualified contractor. Last maintenance service was performed June 4th 2014 by Eastern Fire Protection.

Most recent service tag for fire suppression.

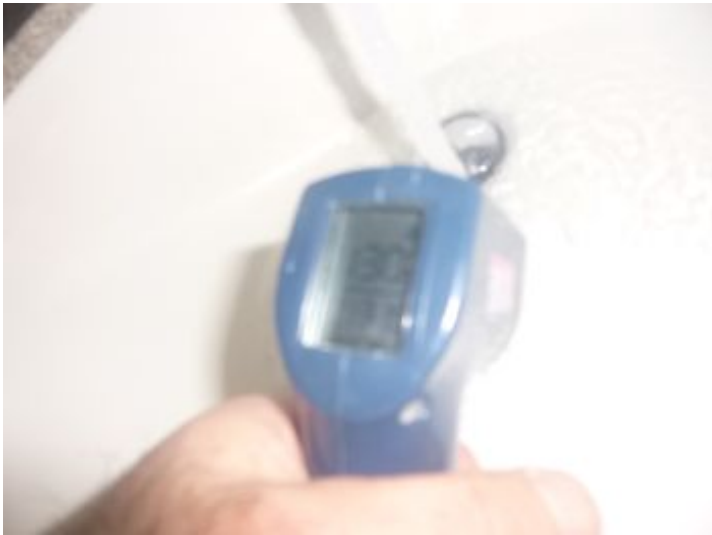
1.2. Water temperature is above 120 degrees, should be set minimum 110 degrees for comfort and maximum 120 degrees to prevent scalding particularly for very young and very old persons.

Water Temperature

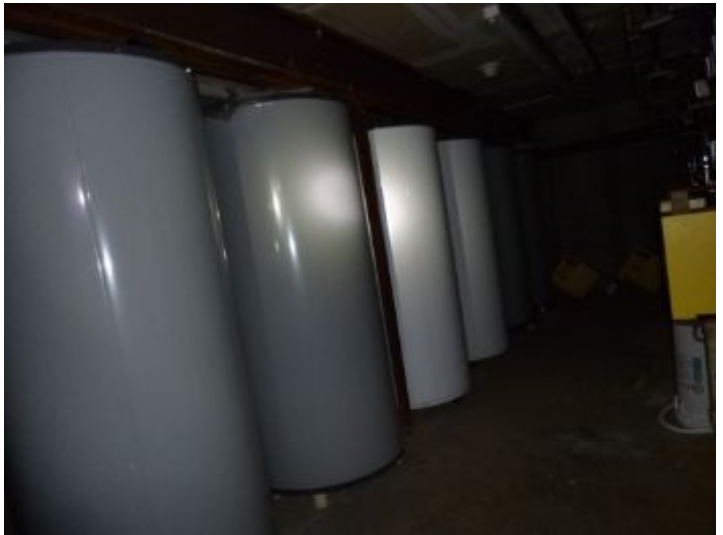
1.3. Corrosion on water heater fittings and cabinets noted, recommend monitor for further signs of water and repair by a licensed plumber as needed.

Six water heaters.

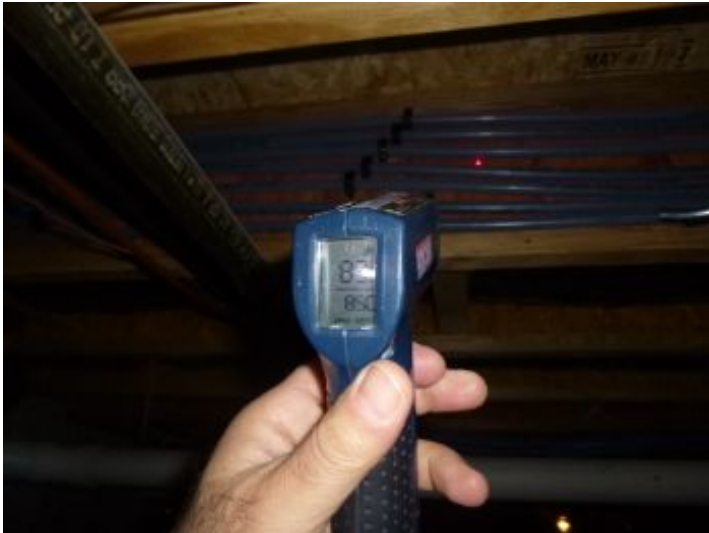
Radiant heat distribution lines.

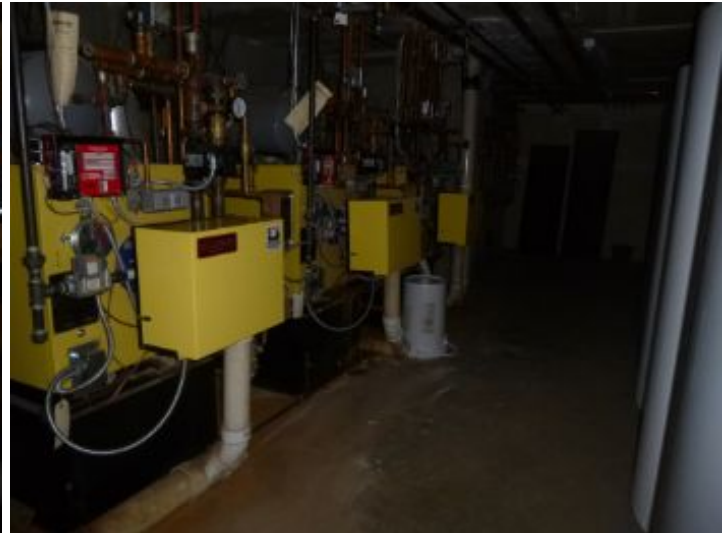
1.1. Heat for the building is provided by three system 2000 boilers with radiant floor heating distribution lines. All three boilers were built in 2002. Typical design life for hydronic boilers is 20 years. Commercial heating systems should have regular preventative maintenance, it was reported that regular maintenance has not been performed rather, system is serviced and repaired as needed when problems arrive. Recommend regular cleaning and preventative maintenance by a qualified heating contractor be performed annually. It was reported that service is performed by White Mountain Oil and Propane, numerous phone calls were made to the service manager to review maintenance history with no contact made.

Three main boilers.

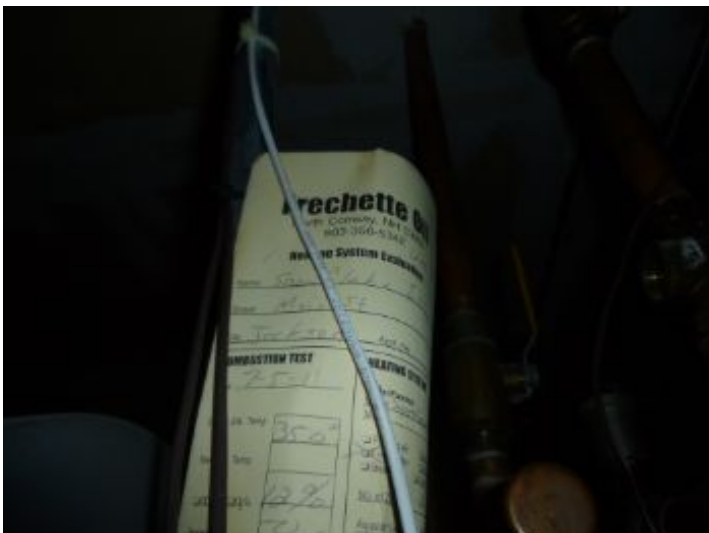
Last service tag.

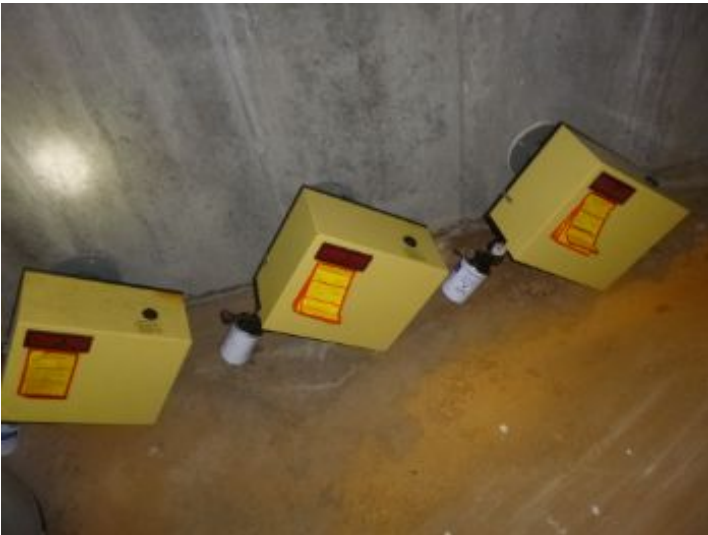
Burners to convert boilers to oil if warranted.

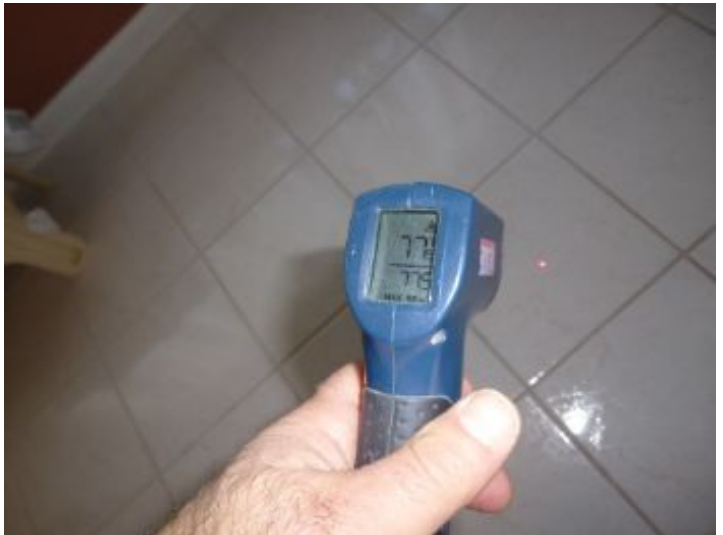
Radiant floor heat in guest room bath floor.

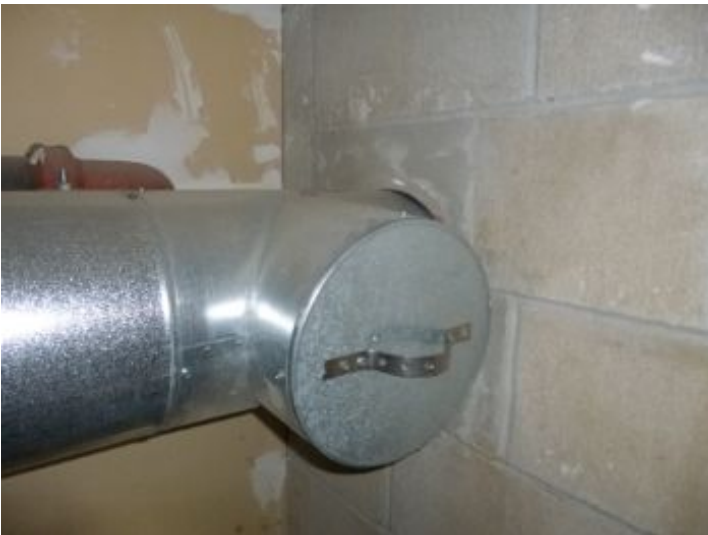
2.1. Metal single wall chimney vent pipe terminating into masonry chimney,

Boilers vent to chimney.

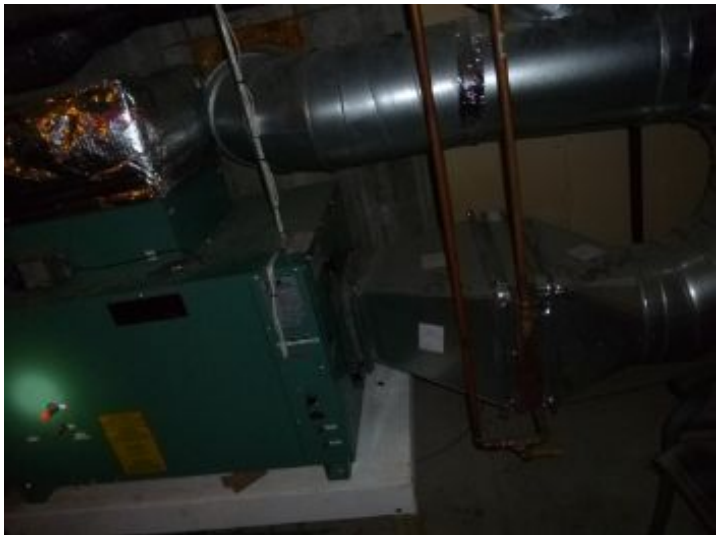
2.2. A pool room room dehumidifier air ventilator is noted. This device is installed for dehumidification to pool room. This is considered a specialized HVAC device, therefore it is excluded from this inspection. Due to the excessive moisture in pool room, it is unclear if it is operating properly or properly sized for the application. This device was installed and is maintained by Dom's Radiant Heating. I spoke to Dom, he stated the system was installed about 5-6 years ago, is sized properly and was serviced in the last two years. He also stated the high moisture problem in the pool room may be from keeping the pool water temperature at 90 degrees and or structural and or insulation issues with the pool room construction. Recommend assessment of the pool room and dehumidification system by a contractor experienced with construction and repairs of indoor pool facilities.

Pool room dehumidifier.

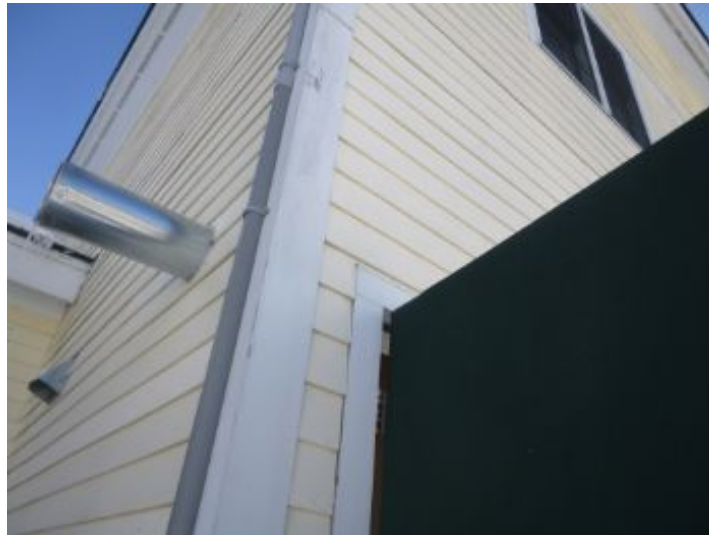
Return air and negative pressure fan vent for pool room.

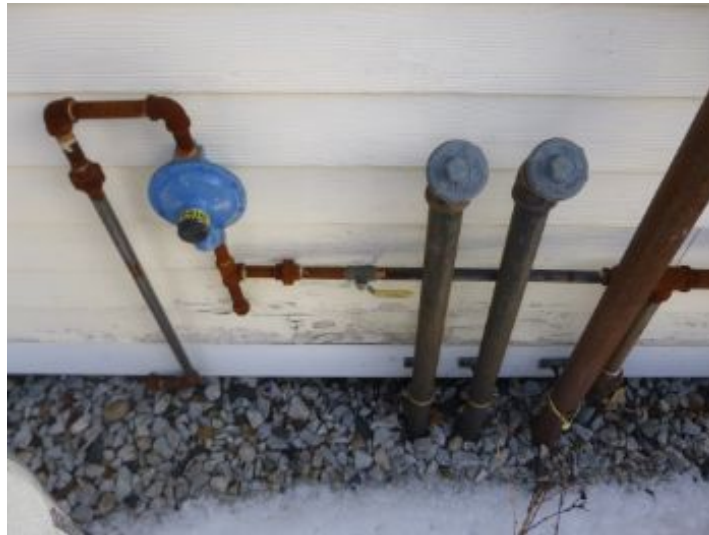
Propane gas piping entrance at rear of building.

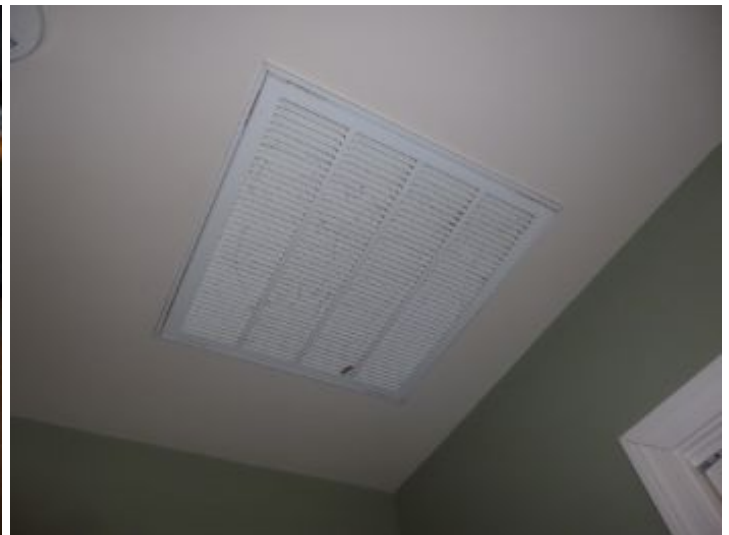
Filter access on ceiling in owners quarters.

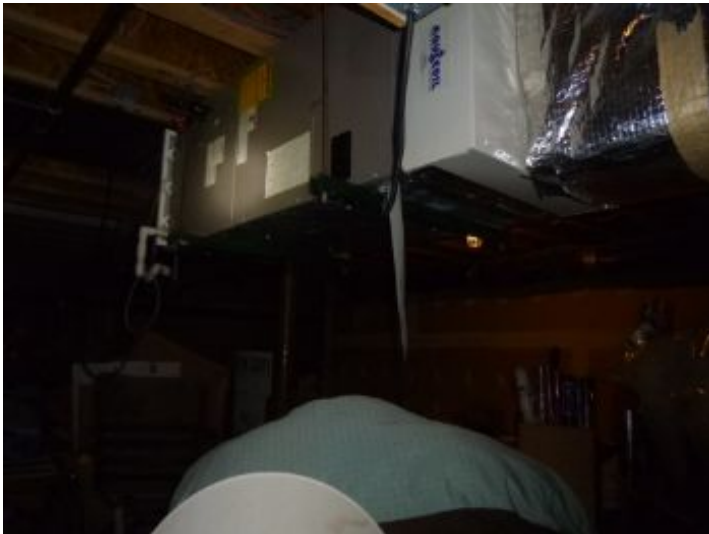
Basement air handler.

I spoke with the service manager at Jesse Lyman HVAC. He reported that no preventative maintenance or cleaning on AC systems is performed. They have performed a few repairs when called only. Proper maintenance can extend the life of systems. Recommend regular annual maintenance by a qualified HVAC contractor.

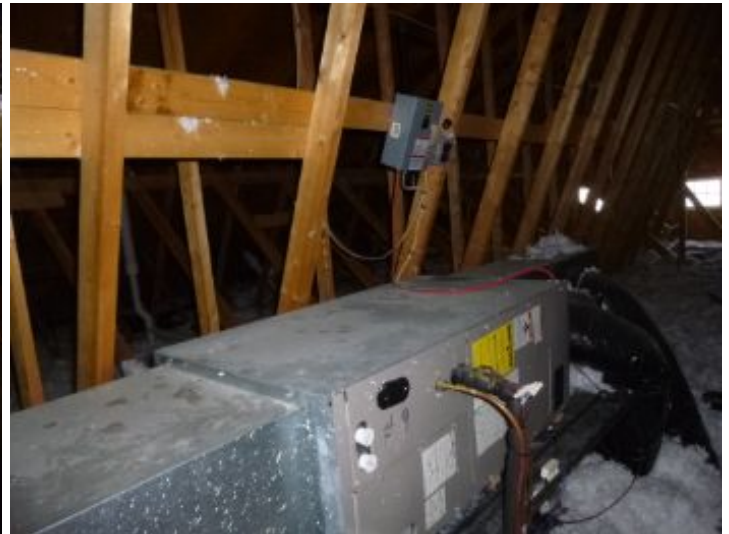
Air handler over owners quarters.

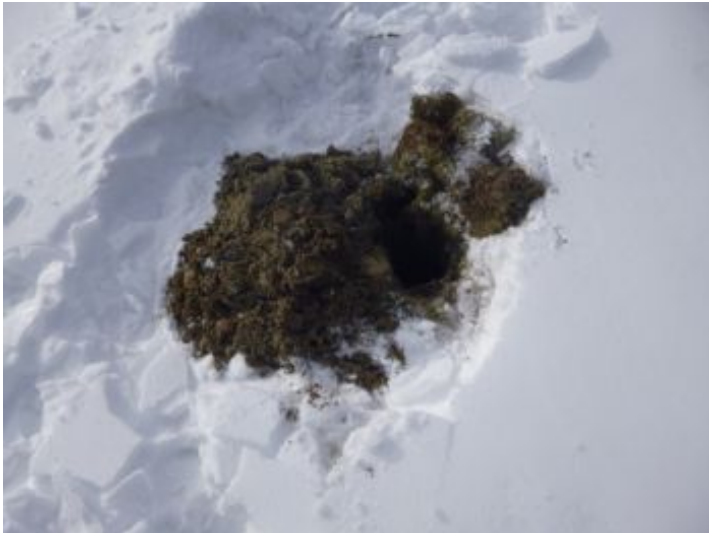
Leach Field

1.2. Tank needs to be pumped.

Recommend client obtain pumping record to determine if correct septic tank was pumped.

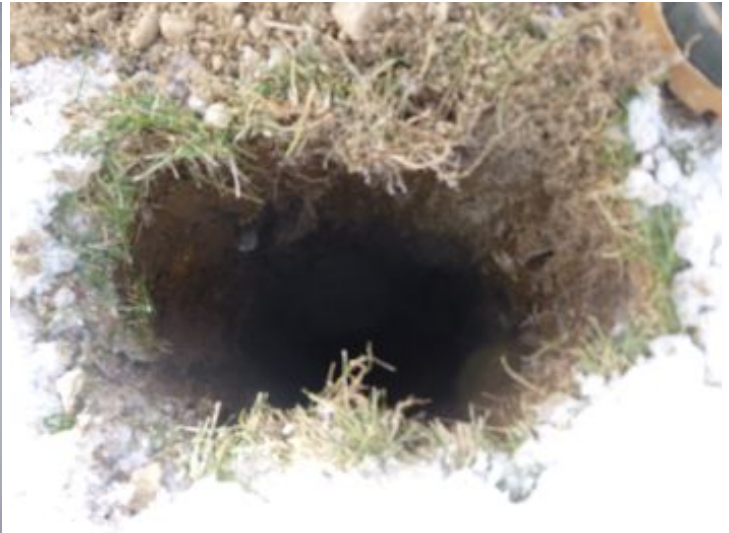
Leach Field water.

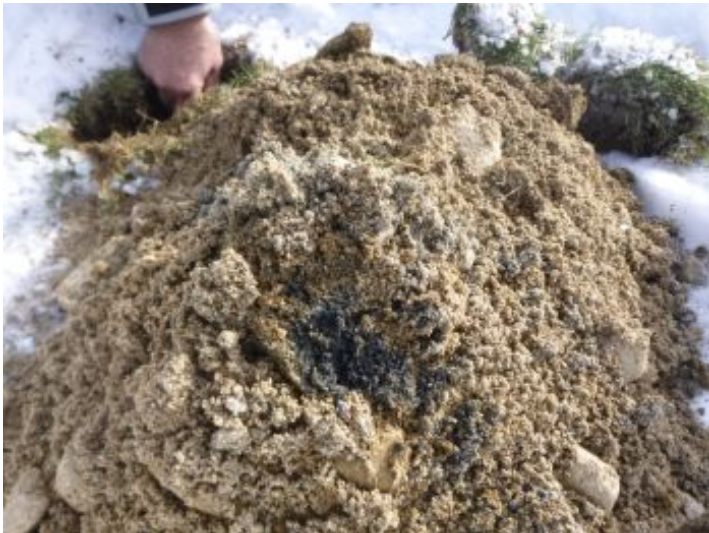
Leach Field stained sand.

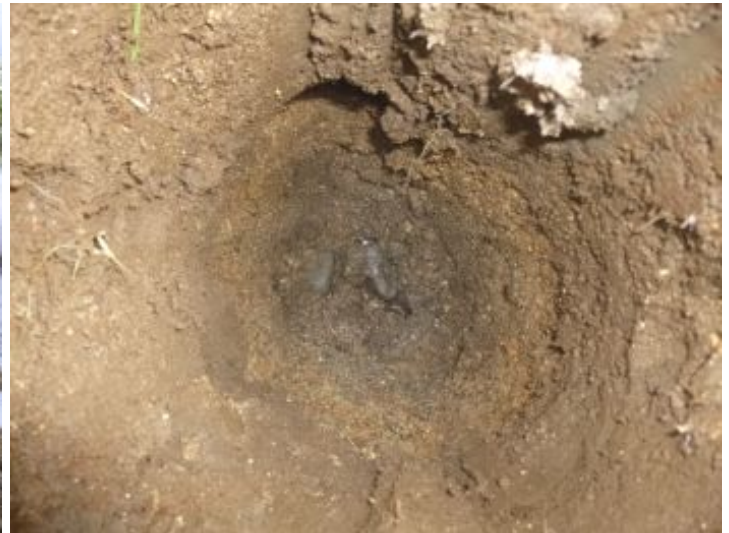
Leach field moisture.

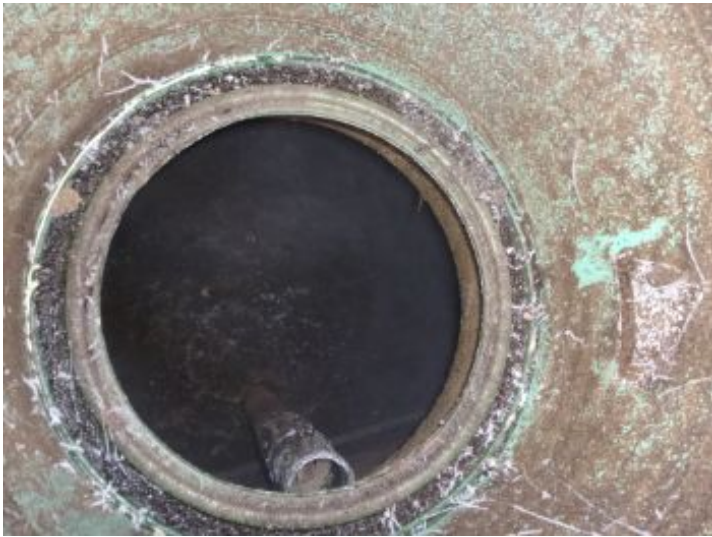
Septic tank.

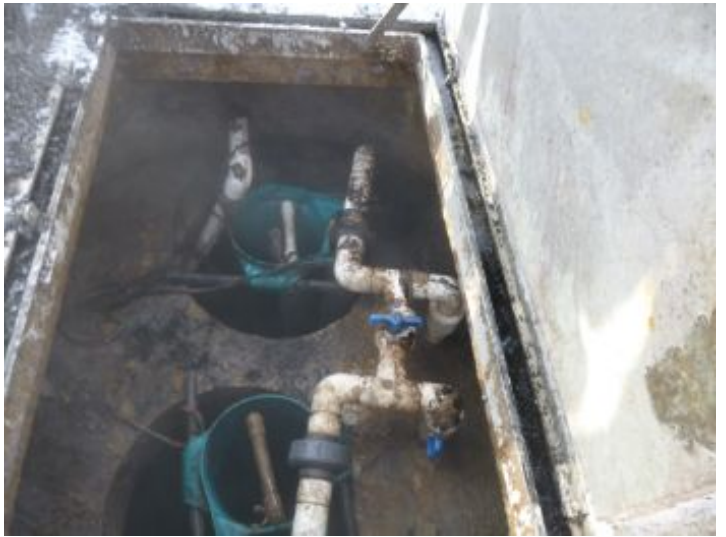
Pump chambers.
