PROPERTY INSPECTION REPORT

Steve Mangekian License # 0054 Alpha Home & Commercial Building Inspections

Date of Inspection: 8/12/2020

The subject property is a free-standing building operating as a church approximately 10,900 sq ft, reported to be constructed in 1970., Lowell, MA

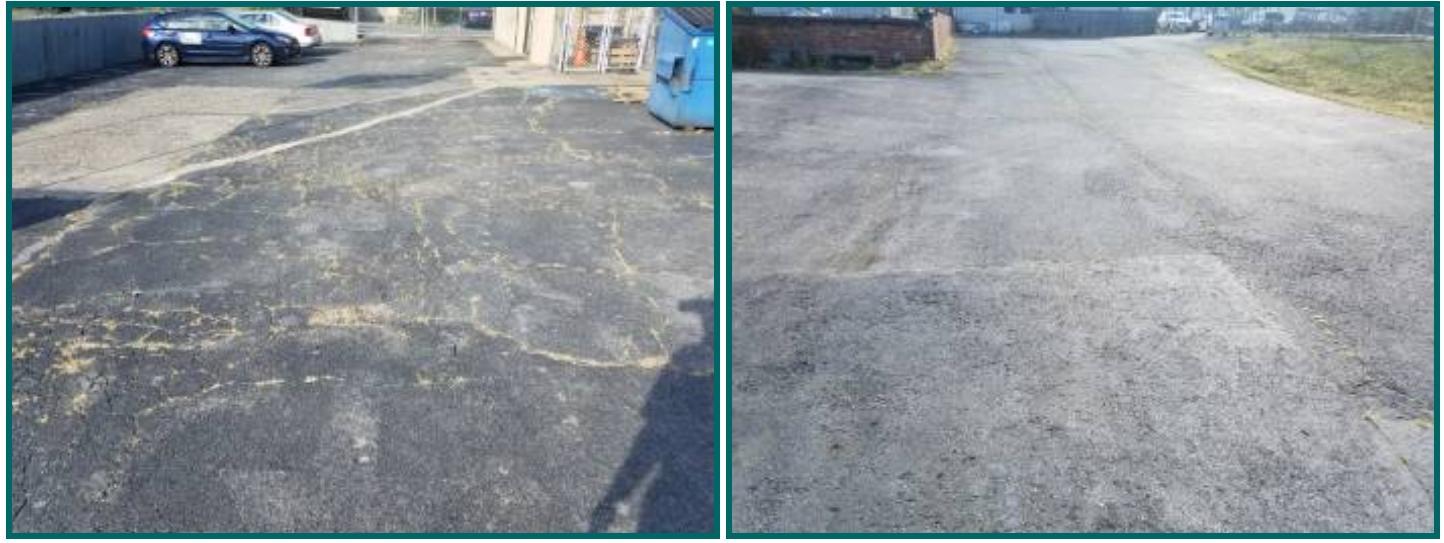
1.2. Excessive deterioration and cracking was observed at the asphalt surfaces. Recommend assessment and repairs by a qualified asphalt contractor.

Cracking in surfaces

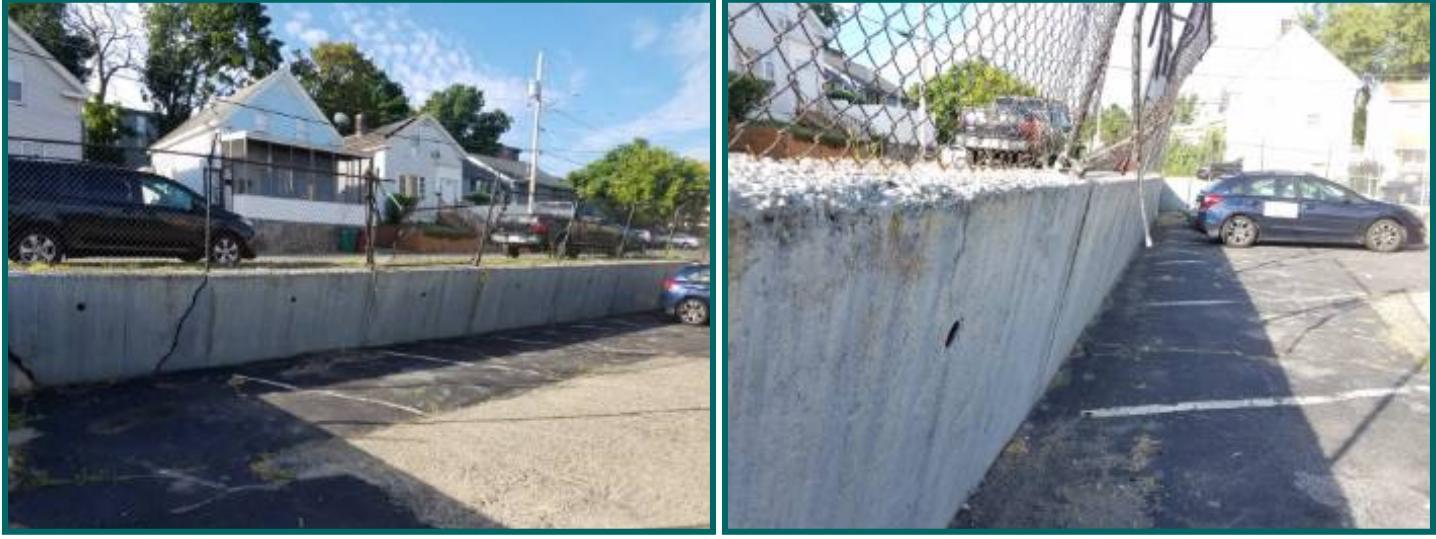
4.2. There are cracks, damage or evidence of movement in retaining walls. Recommend further investigation and repair as needed by a qualified masonry contractor.

4.3. One or more areas of fencing have damage to post or panels. Recommend assessment and repairs by a qualified fence contractor.

Leaning

Large cracks

Damaged fence sections

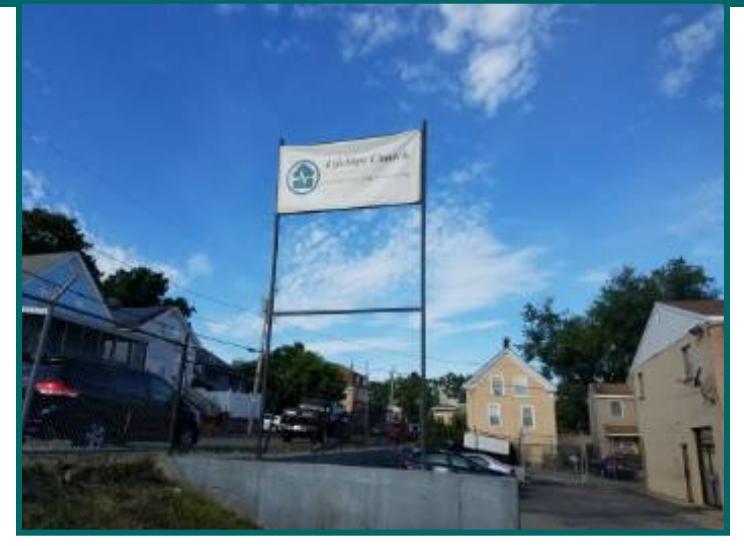
5.1. Sign does not appear to be illuminated.

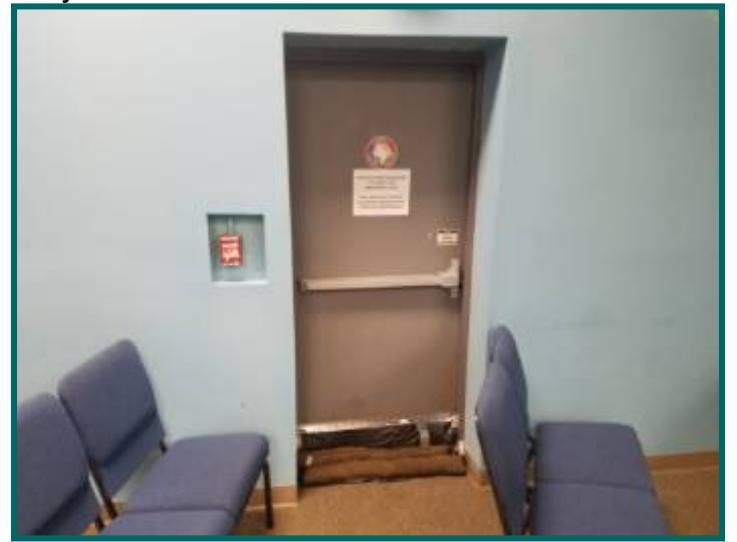
Lower level emergency exit door was not operated, sealed with plastic on bottom

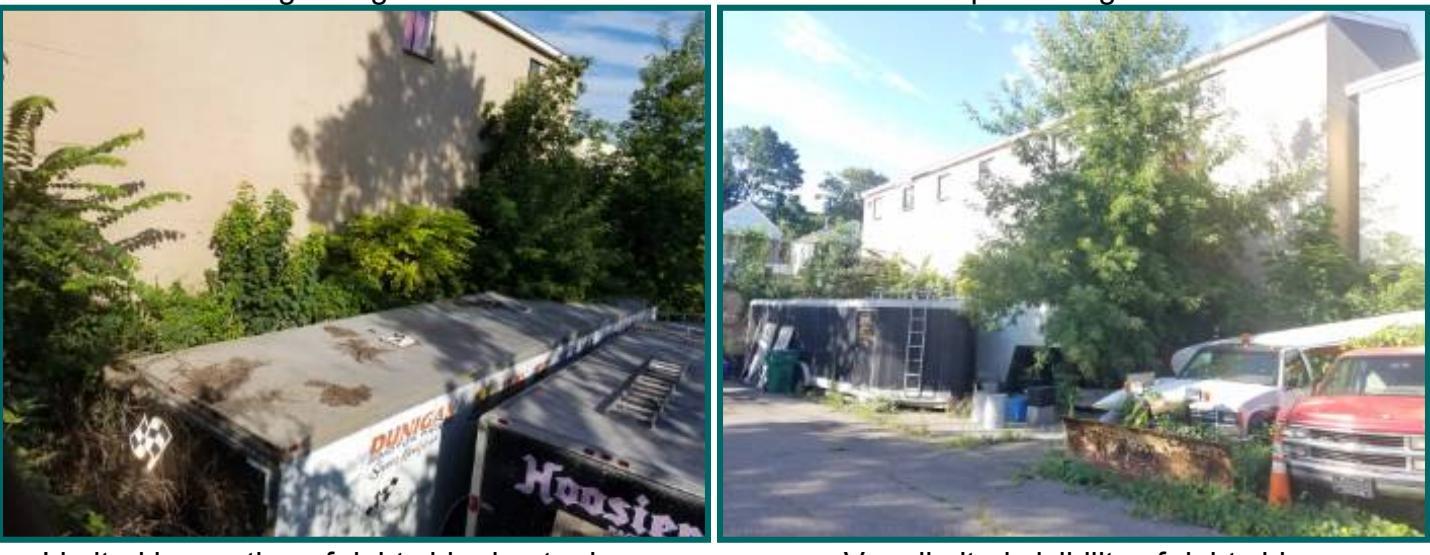
Limited inspection of right side due to dense vegetation

Very limited visibility of right side

Several small vertical and step cracks at left side

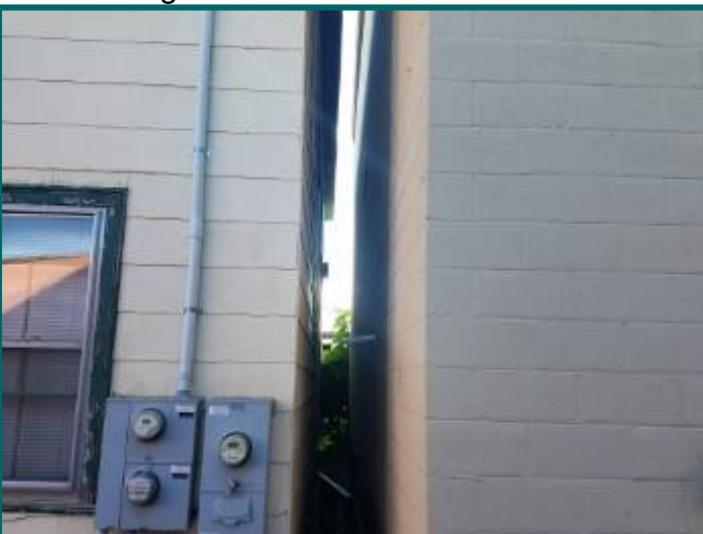
Limited visibility of rear wall

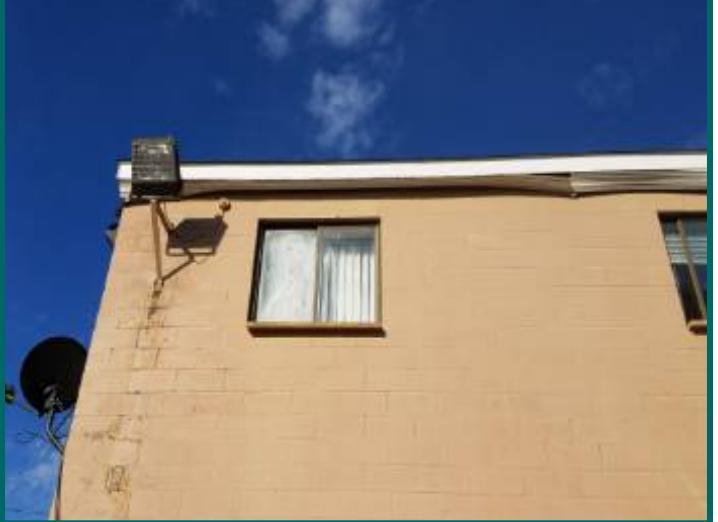
Broken pane and fogged window at front right corner

3.2. There is broken glass at one or more window, recommend repairs by a qualified tradesman.

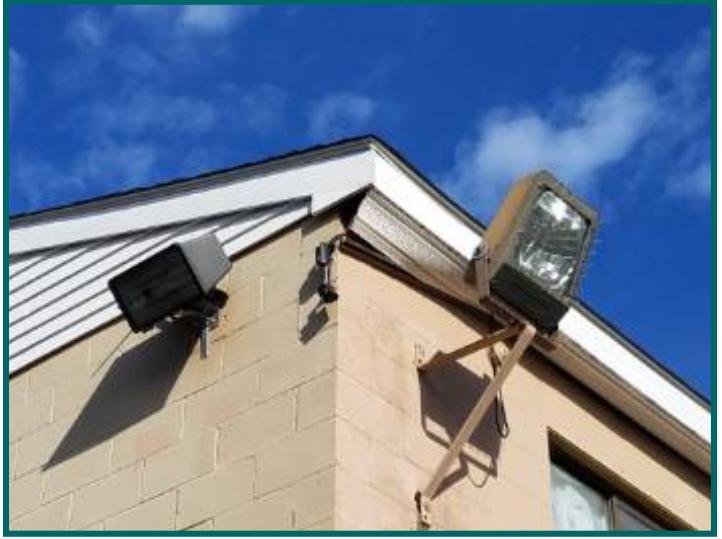
Outside lights were not viewed on

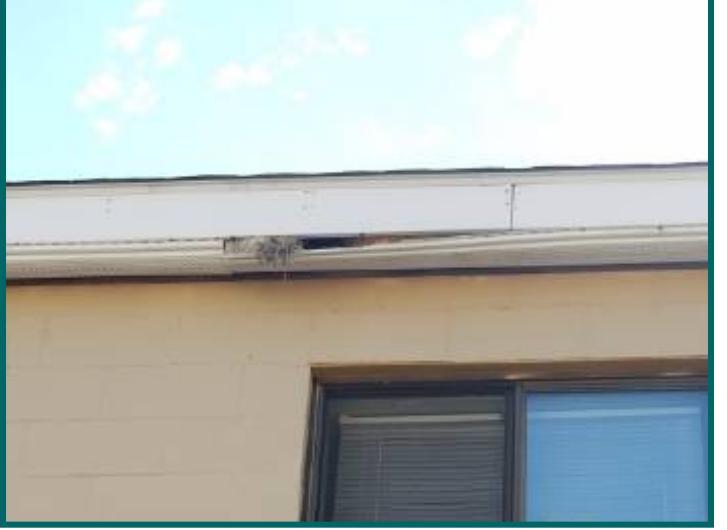
Gap in soffit trim at left side

4.2. Trim boards have areas of damage and or deterioration, recommend full assessment of trim boards and repairs by a qualified contractor.

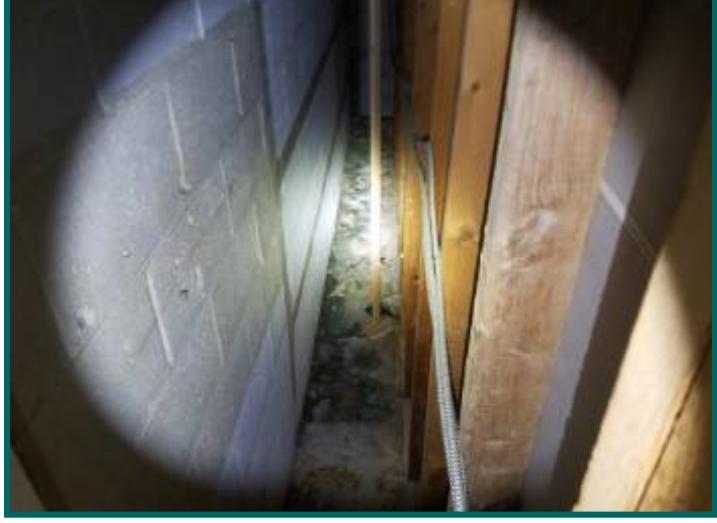
- 2.1. Concrete Floor Slab
- 2.2. Concrete slab not fully visible due to floor covering.
- 2.3. Water staining on floor, recommend monitor for water intrusion and repairs as needed.

Water staining at rear behind finished wall

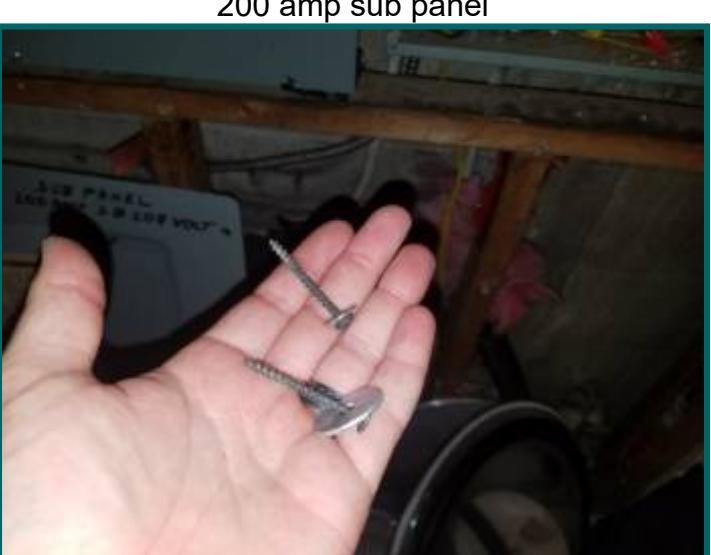
• Sharp-pointed metal screws hold panel cover in place. These are a potential hazard as they may puncture wire insulation and electrify panel box, becoming a shock or electrocution hazard. These screws should be replaced with approved, flat-tipped screws.

Pointed screws

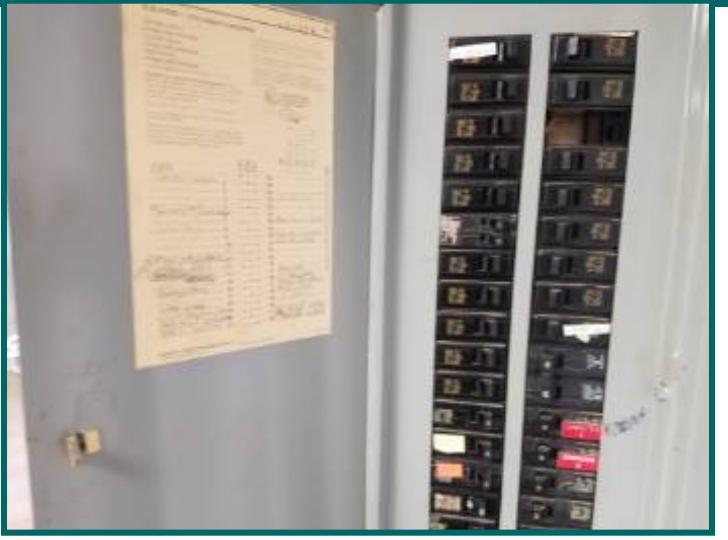
Breakers are not fully labeled

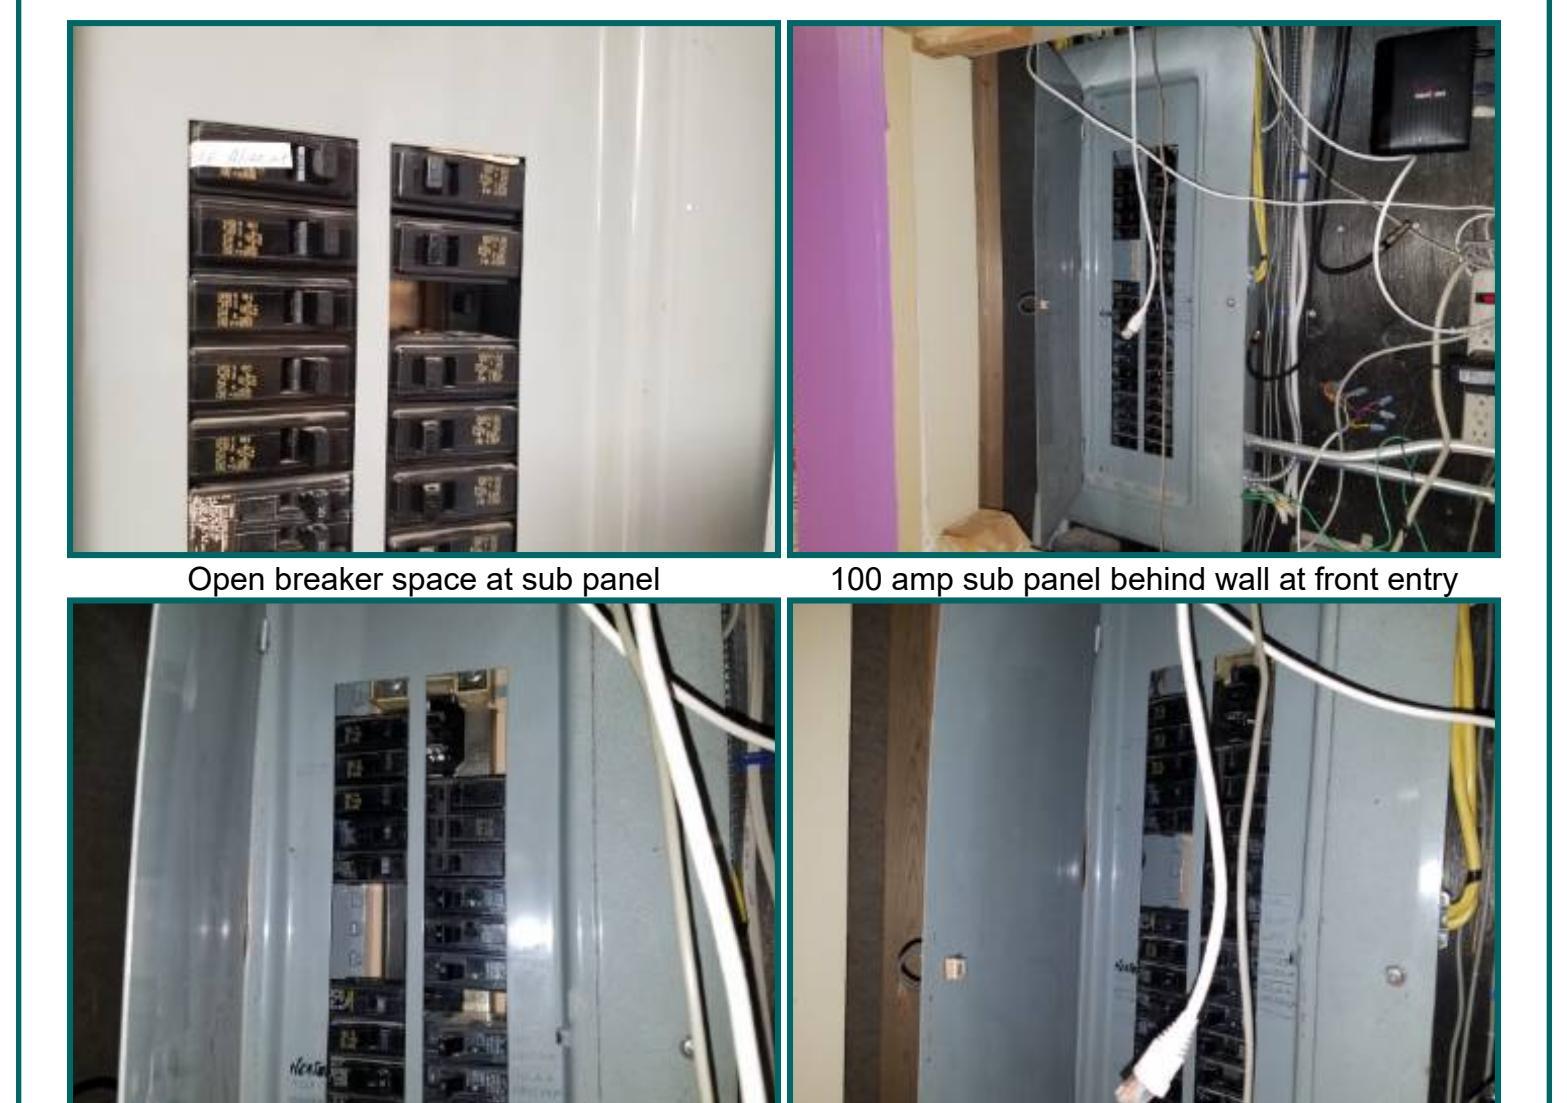
• There is one or more open breaker spaces on service panels this is a safety hazard. The knockouts in the dead front (cover of the main panel) were removed. This is considered a major safety hazard as live components of the electrical system are potentially exposed. Recommend repairs by a qualified electrician to prevent injury/electrical shock.

Open breaker spaces at front entry sub panel

Breakers are not fully labeled

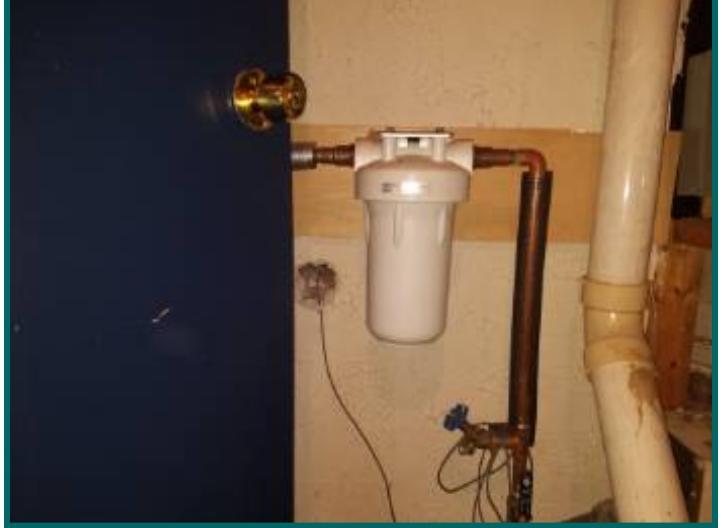
Sediment filter, recommend changing to clear cover to observe when filter needs to be changed

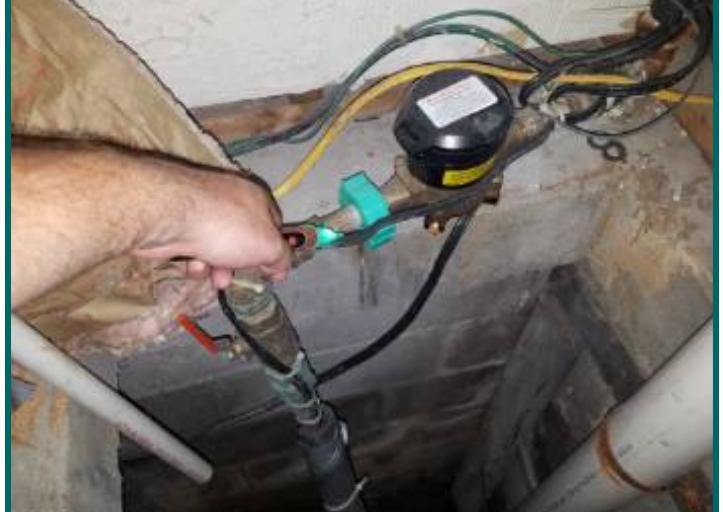
Heat tape on main water line, not energized

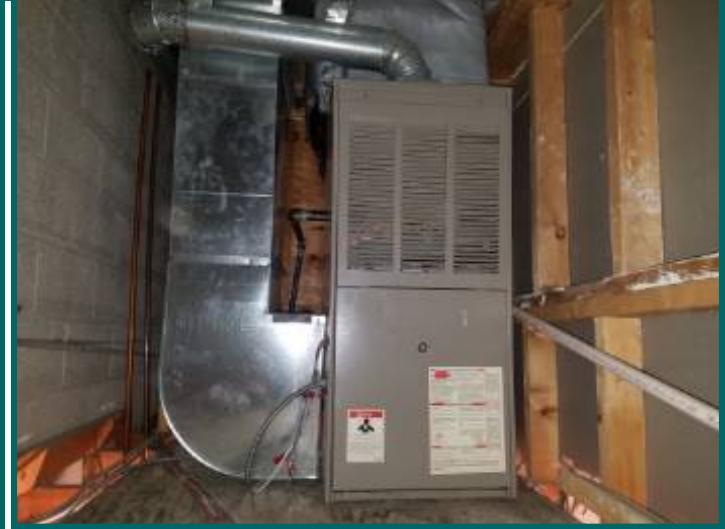
Furnace on upper platform in electrical closet, 20 years old

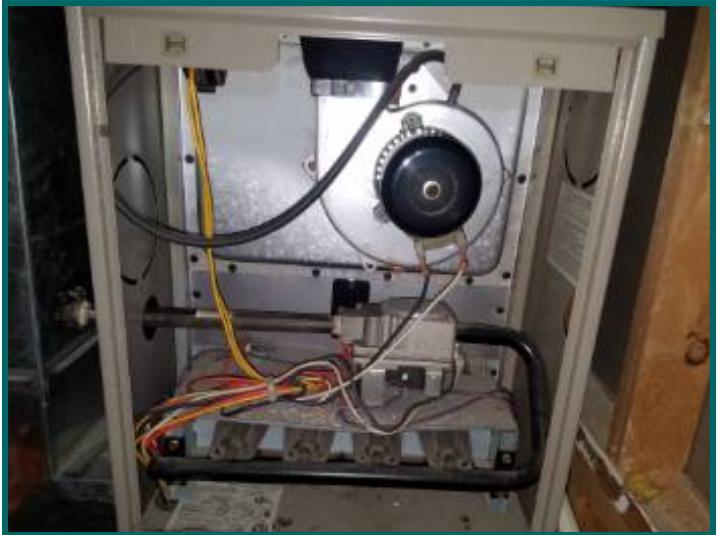
Burner chamber.

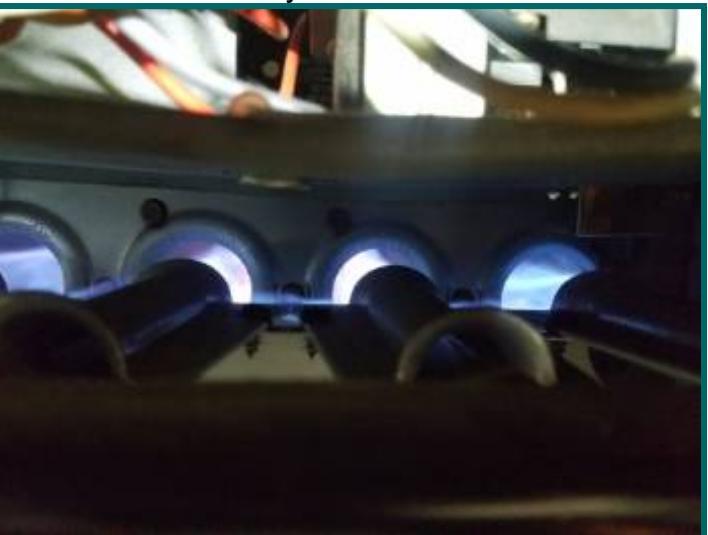
Clean flame pattern

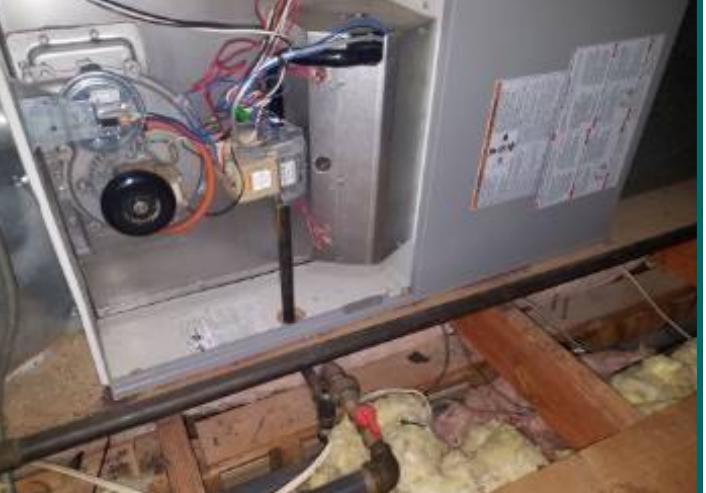
Attic air handler is missing condensate drain pan

1.4. Attic air handlers are missing condensate drain pans, this is a water intrusion hazard, recommend assessment by a qualified HVAC company.

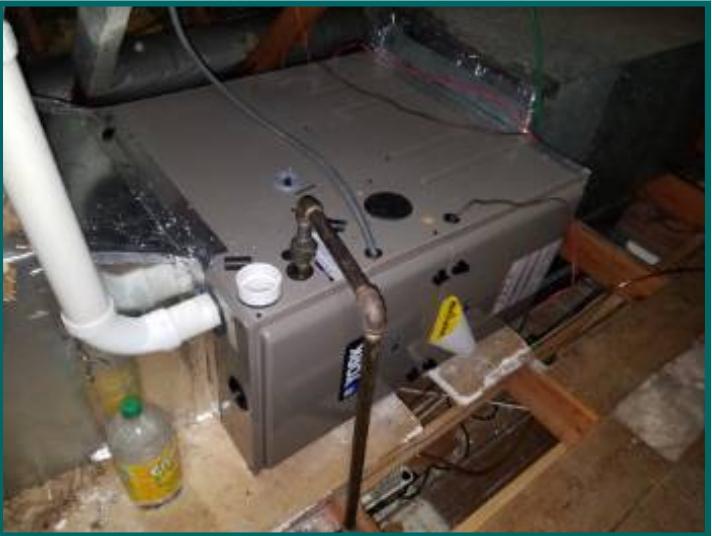
Furnace at front of attic, 3 years old

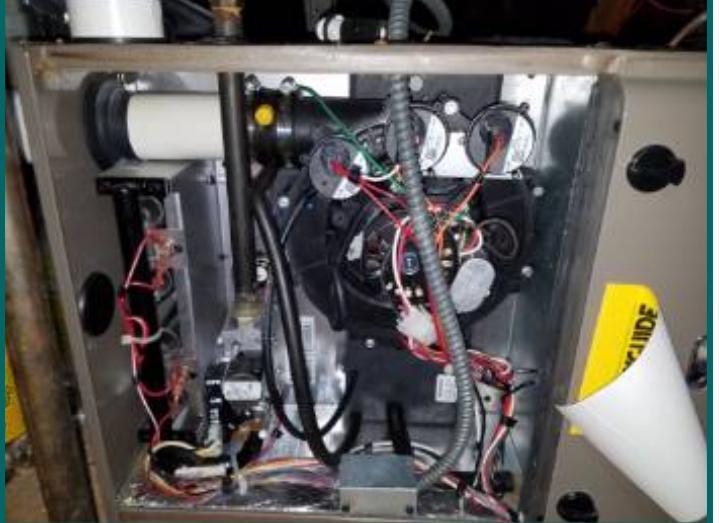
Burner chamber.

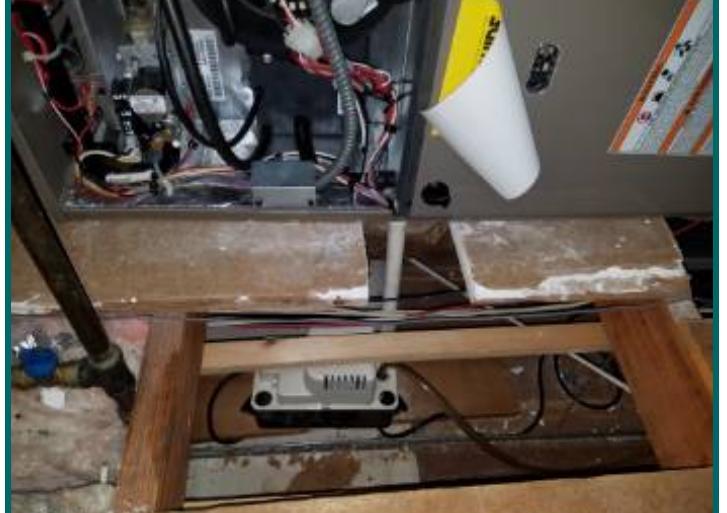
Attic air handler is missing condensate drain pan

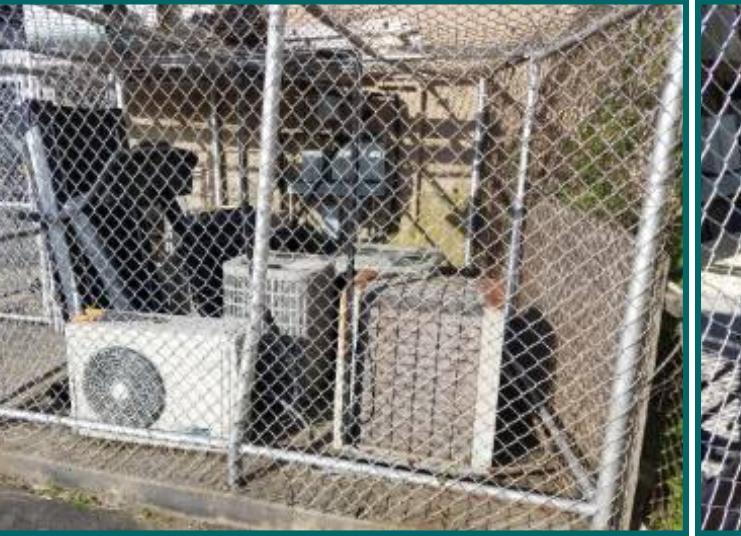
4 AC compressors and 1 ductless mini split at right side

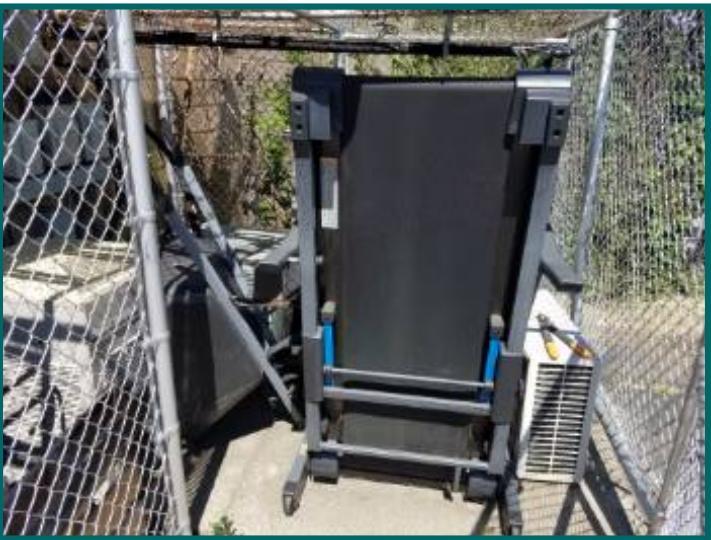
Limited access to AC compressors

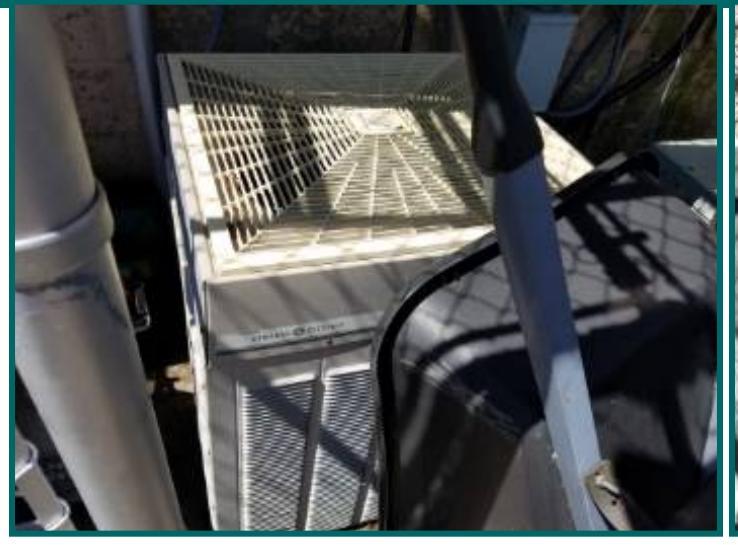
Illegible data plate, appears 20+ years old

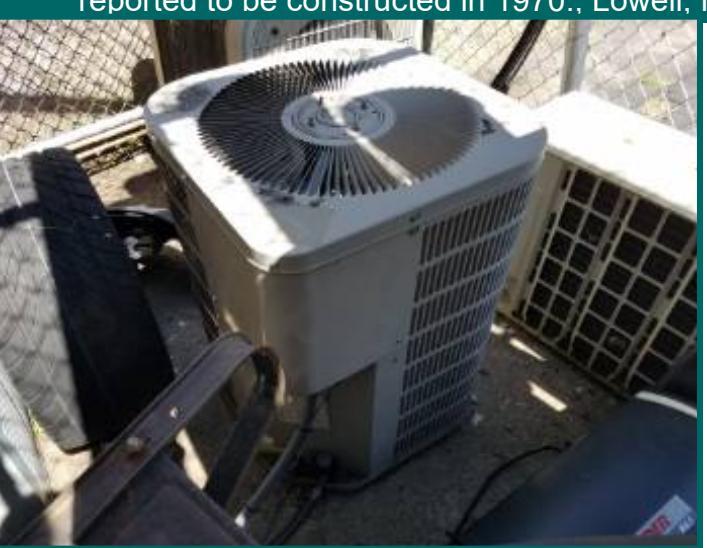
18 years old

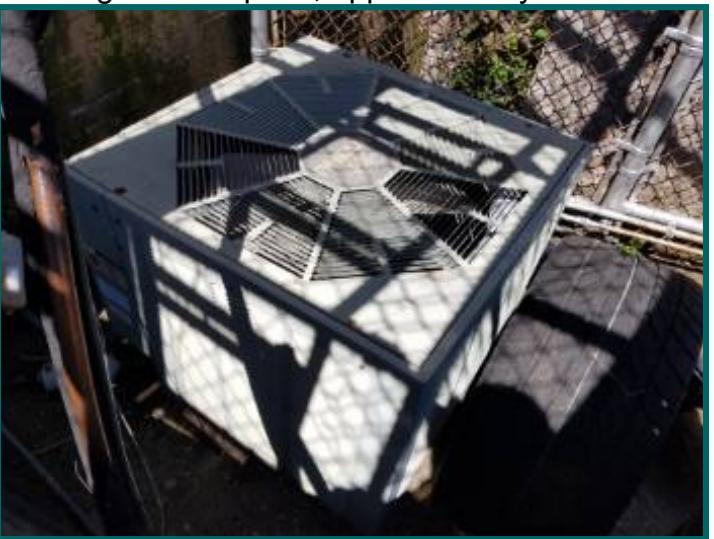
Illegible data plate, 20+ years old

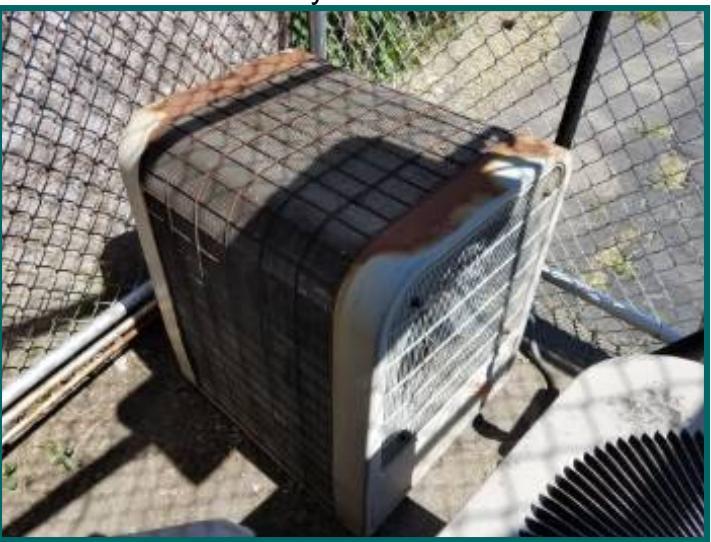
Illegible data plate, 20+ years old

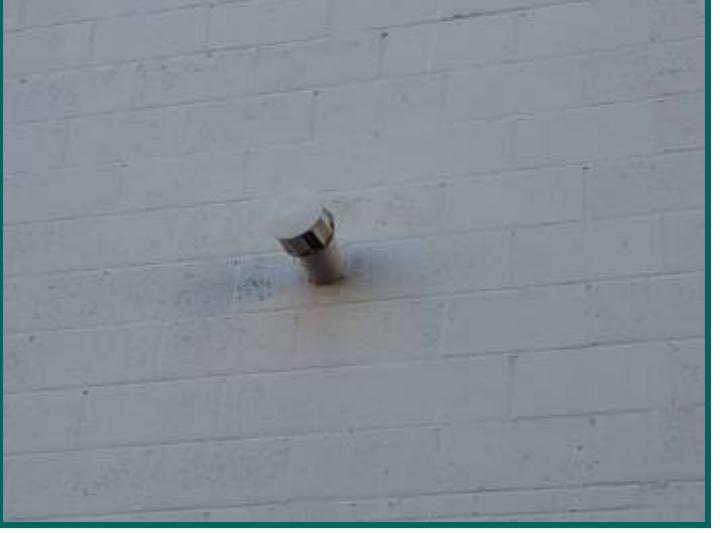
Left side termination is no longer in use

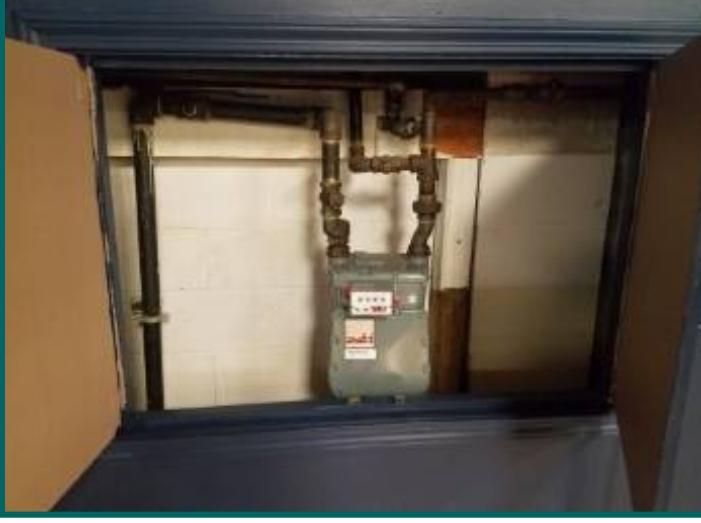
Single gas meter at lower level, rear wall

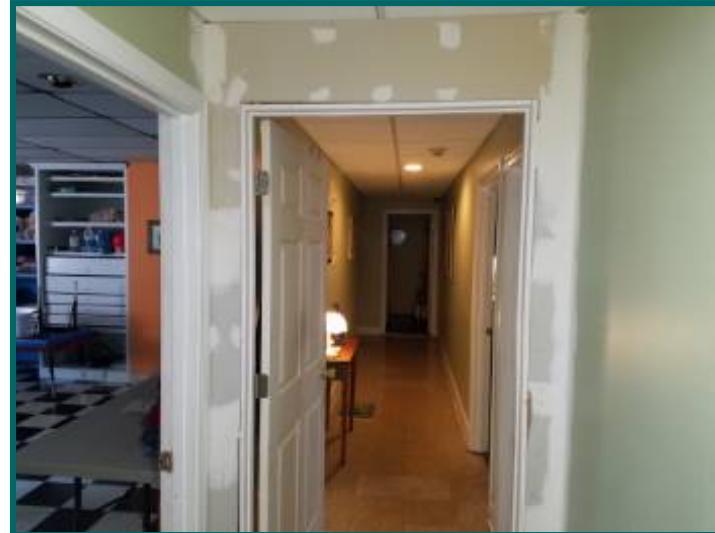
Not tested at second floor rear, thermostat cannot call for heat and AC did not operate

6.3. Distribution could not be tested at one or more area, heat and/or AC could not be operated. Recommend assessment by a qualified heating contractor.

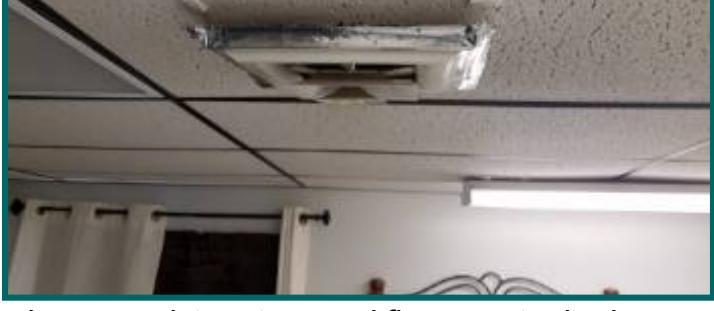
Loose register at second floor master bedroom

6.2. One or more register is loose/damaged at the ceiling, recommend repairs by a qualified heating contractor.

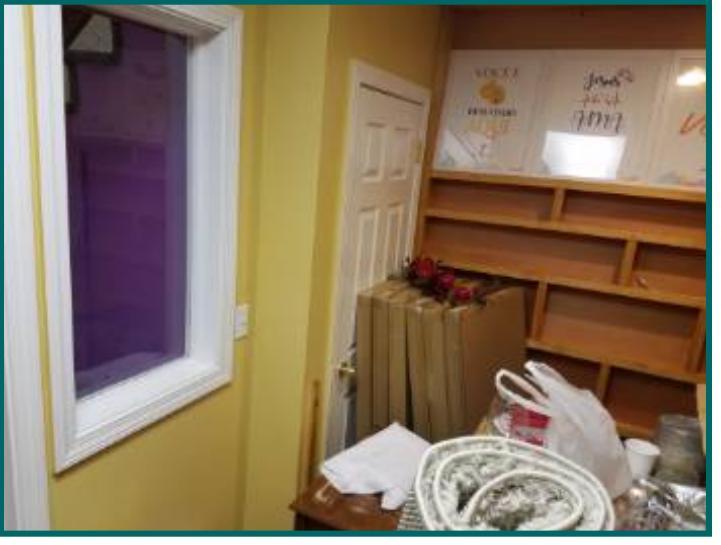
Door was blocked area was not entered at front entry closet

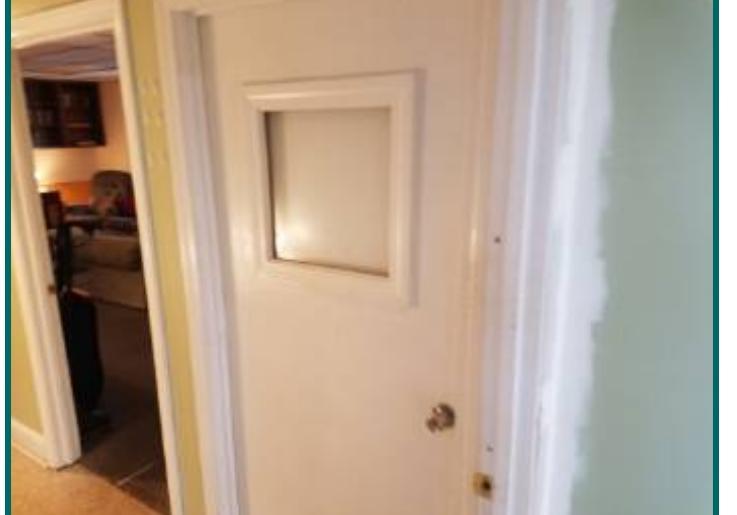
Sellers son sleeping at second floor bedroom, area was not entered

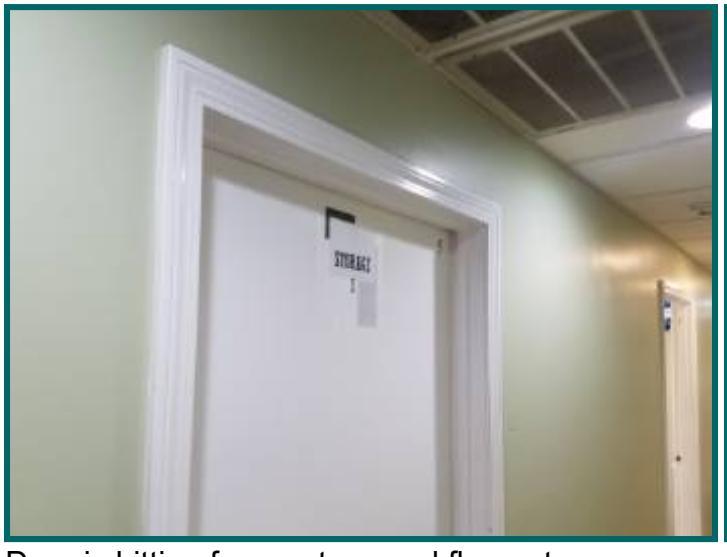
Door is hitting frame at second floor, storage room #5

1.4. Door at one or more location is hitting door frame will not close, recommend repair by a qualified tradesman.

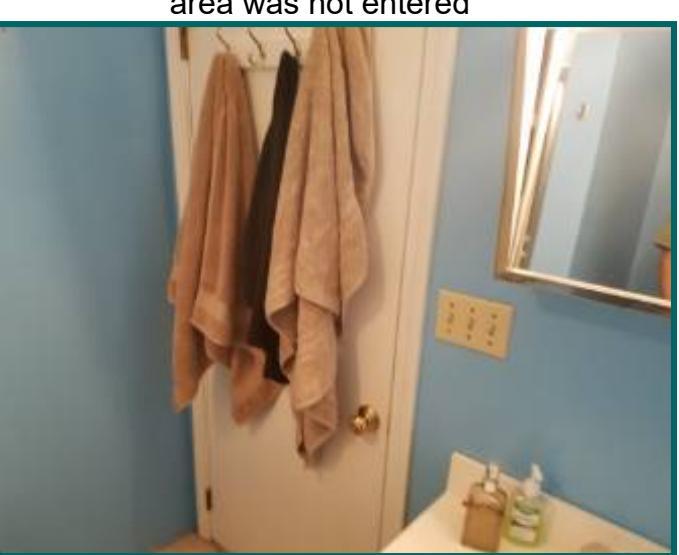
Door does not latch at second floor bathroom

1.5. Door at one or more location does not latch or lock properly. Recommend assessment of doors and repair by a qualified contractor.

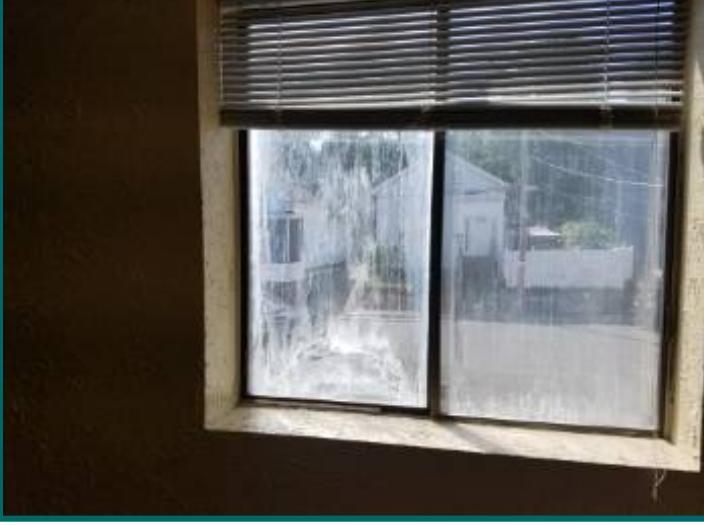
Broken glass and window screwed shut at top of front stairs

2.2. Window has broken pane in one or more area of building. Recommend assessment of windows and repair by a qualified tradesman.

2.3. Window would not open at one or more areas of building. Recommend assessment of windows and repairs by a qualified tradesman.

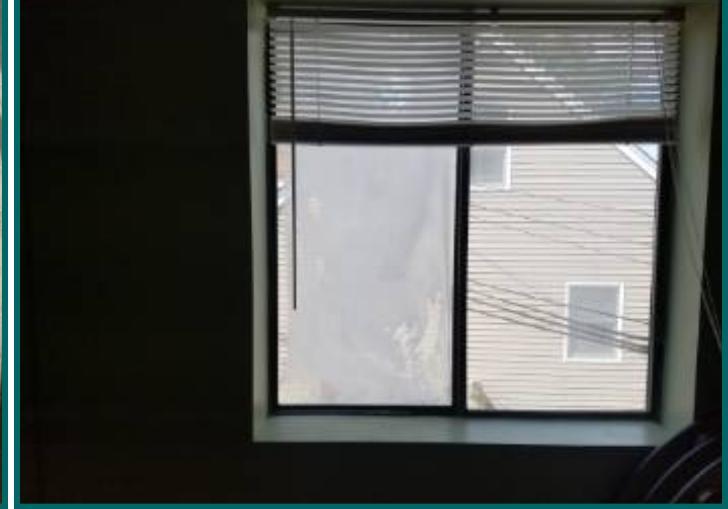
Broken glass at second floor left side

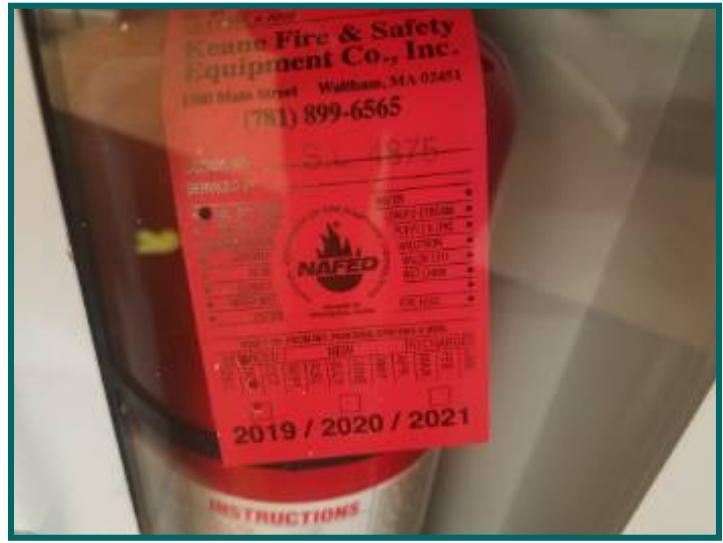
Fire extinguisher tags are current, dated November 2019

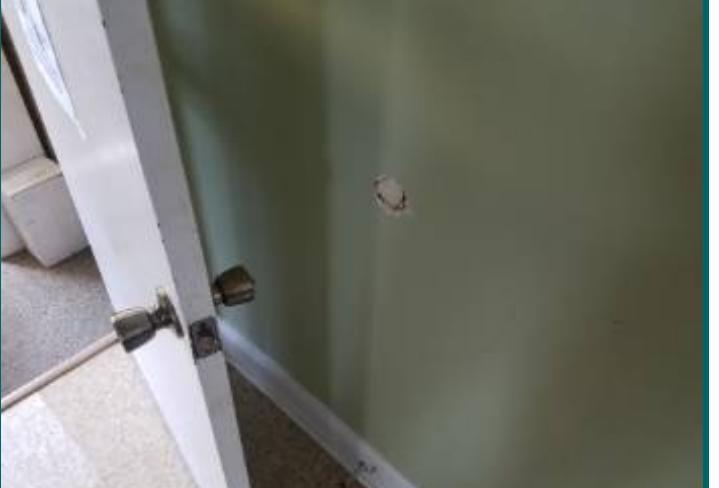
Damage to wall from door at front second floor entry

3.3. Damage to wall surfaces at one or more areas, recommend assessment of wall surfaces and repairs by a qualified tradesman.

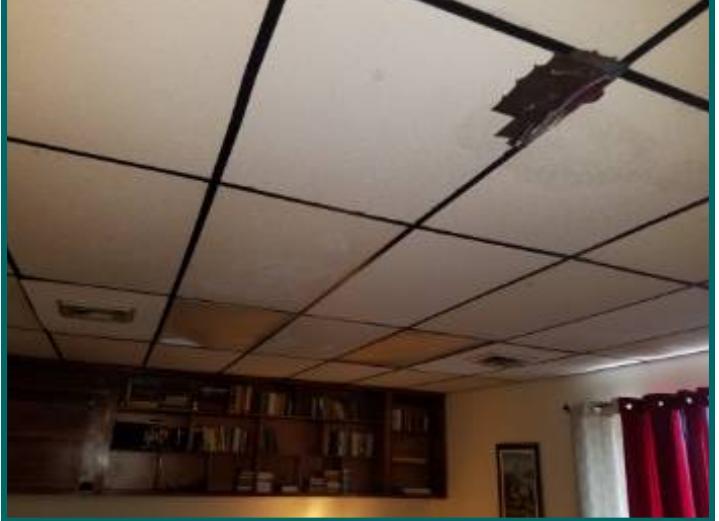
Several stains tested dry at second floor living room

4.2. Stains noted on ceilings in one or more area of building. This is evidence of past or present leaks. They tested dry at the time of the inspection. Recommend asking current building owner for the source and history of any leaks or water intrusion, assessment and repairs by a qualified contractor of any affected areas and monitor for further water staining.
