Alpha Home & Commercial Building Inspections

Property Inspection Report

industrial building 57,000 sf circa 1984 , Peterborough, NH 03458
Inspection prepared for:
Date of Inspection: 9/4/2020 Time: 9:00 AM
Order ID: 11349

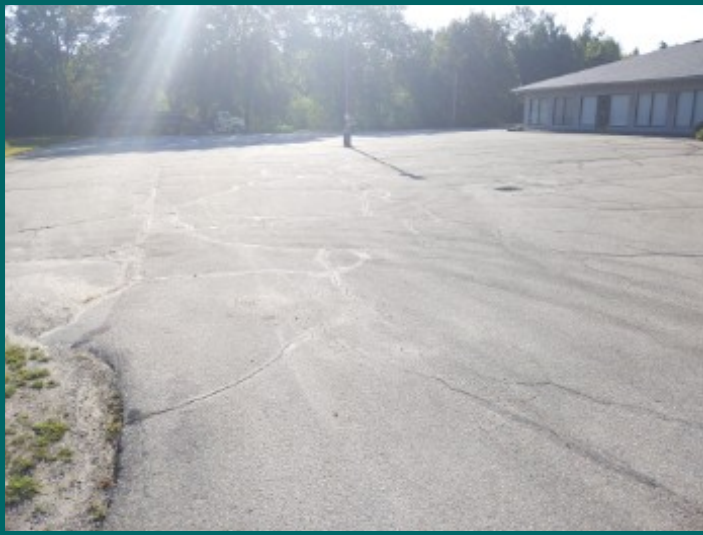
Left side parking

1.2. Excessive deterioration and cracking was observed at the asphalt surfaces. Recommend assessment and repairs by a qualified asphalt contractor.

Damaged asphalt surfaces throughout left side parking.

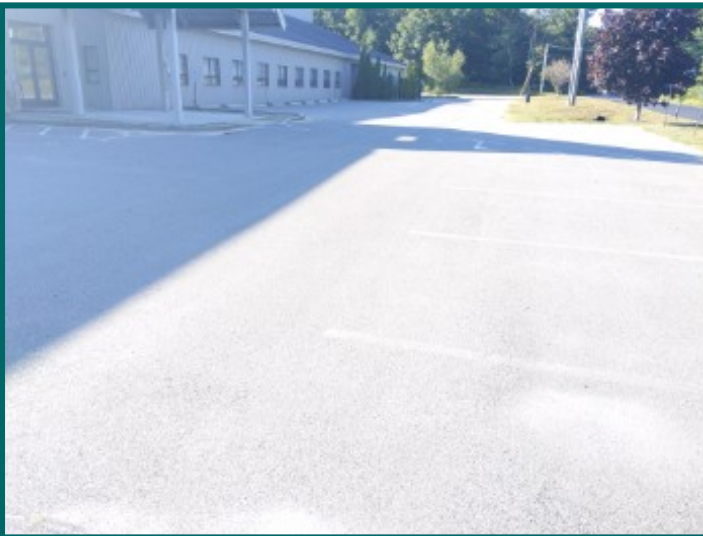
Front parking

Cracks / damaged surface at front and left side of building

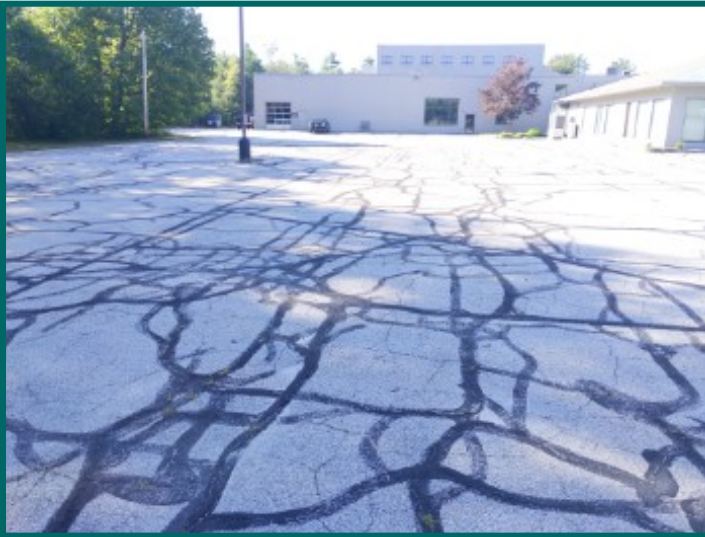
Asphalt surfaces at rear / left side of building
appear to be beyond their design life.

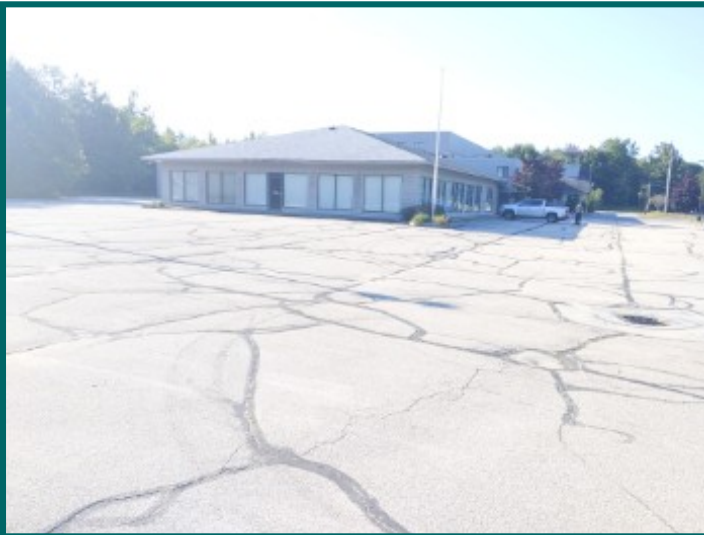
2.2. Grading at one or more area of property has neutral slope, this may be conducive to ponding of water against foundation, recommend monitoring condition and take measures to divert water away from this area as needed.

Neutral grading

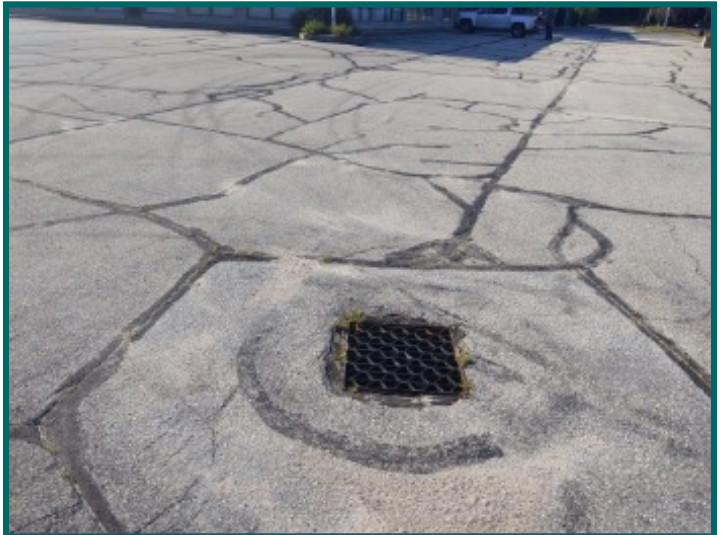
2.3. There is one or more surface drain at exterior of building, recommend monitor for proper drainage, keep clear of snow / ice / debris and have cleaned and serviced as needed.

Surface drains

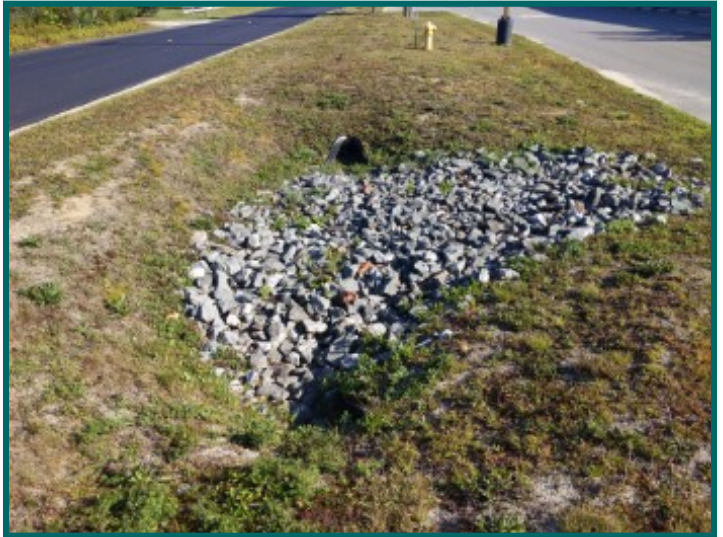
Keep culverts free from debris

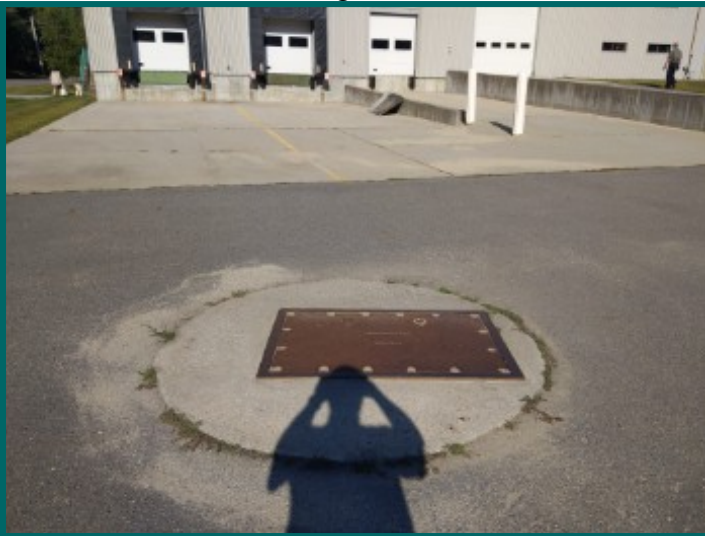
2.5. Undetermined access cover at rear loading dock area, recommend contacting property owner for more information and assessment as needed.

Undetermined access cover at rear loading dock
area

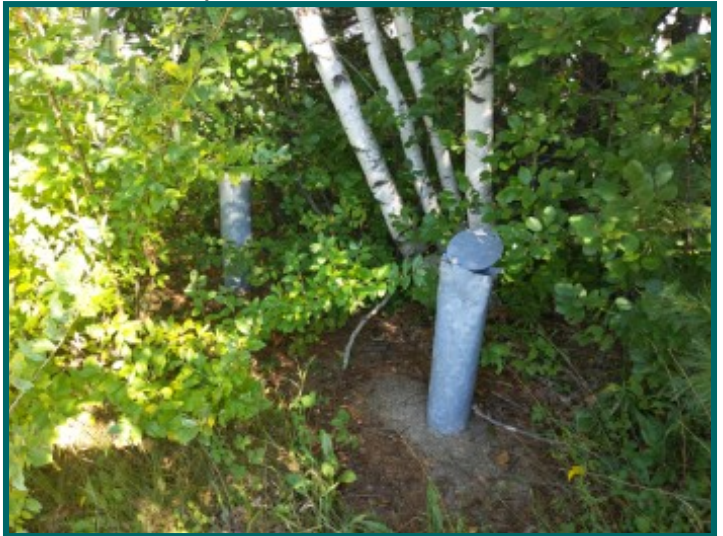
2.4. There are monitoring wells on the property, these are used to observe levels of soil or water contaminates. Recommend contacting property owner for more information and assessment by a qualified environmental testing / engineering firm if needed.

Monitoring wells at rear of building

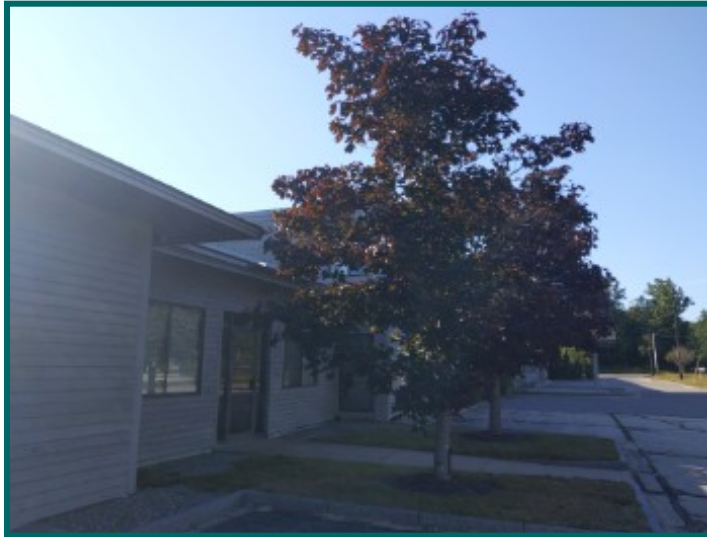
3.1. Vegetation such as trees, shrubs and/or vines are in contact with or less than one foot from the structures exterior. Vegetation can serve as a conduit for wood destroying insects and fungal growth and may retain moisture against the exterior after it rains. Vegetation should be pruned and/or removed as necessary to maintain a one foot clearance between it and the structures exterior.

Vegetation in close proximity to building should be cut back or removed

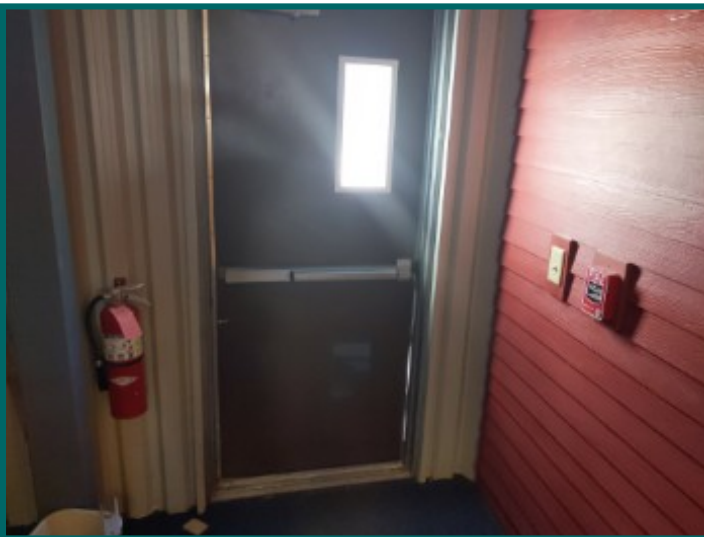
1.3. One or more exterior door does not seal well. This can be an energy drain and allow vermin into building. Recommend repair / adjustment by a qualified contractor.

Rear door does not seal well

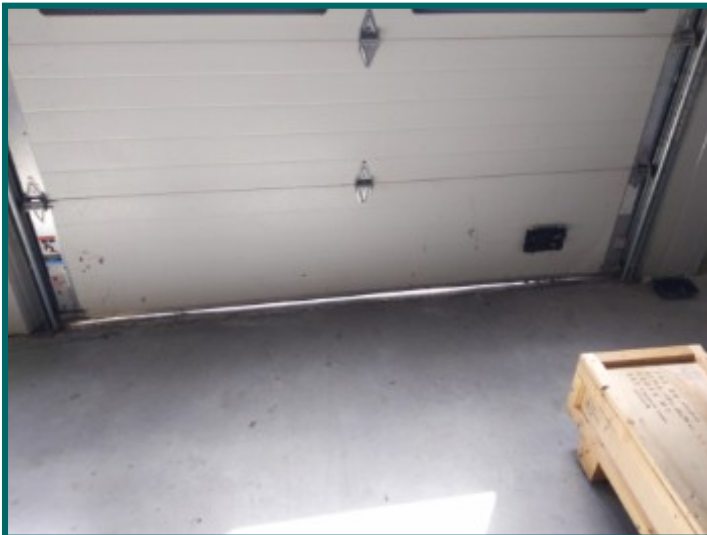
Impact damage at rear overhead door/door does not seal well

1.2. One or more exterior door has damage of door, frame, or trim, recommend full assessment of all doors and repairs by a qualified tradesman as needed.

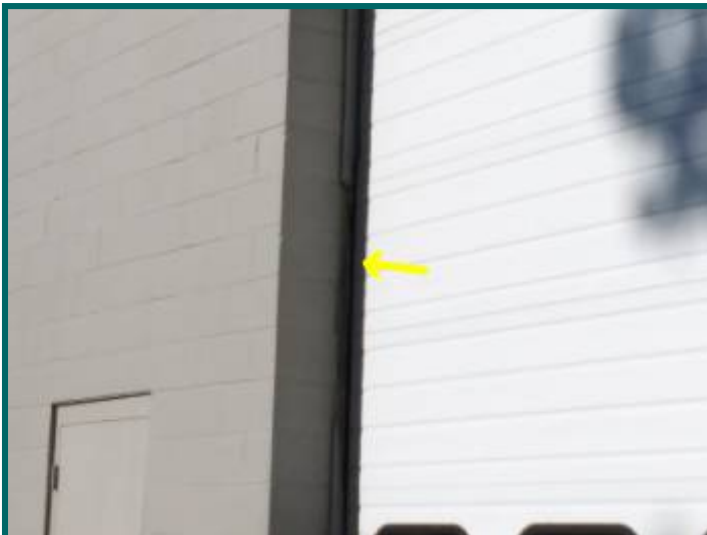
Damage to door and or trim at rear garage

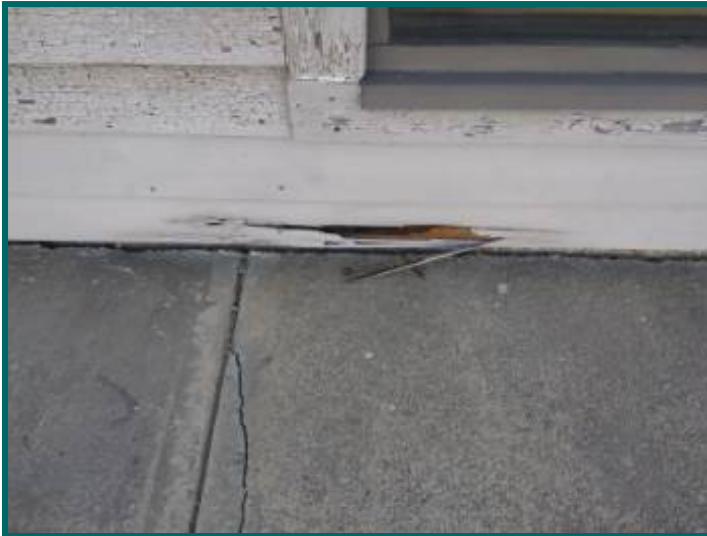
2.2. Siding is in contact with finish grade at one or more area of building, this is conducive to moisture and insect intrusion, recommend monitor area and have repaired as needed by a qualified contractor.

Damage to exterior surfaces in contact with
finished grade at left front.

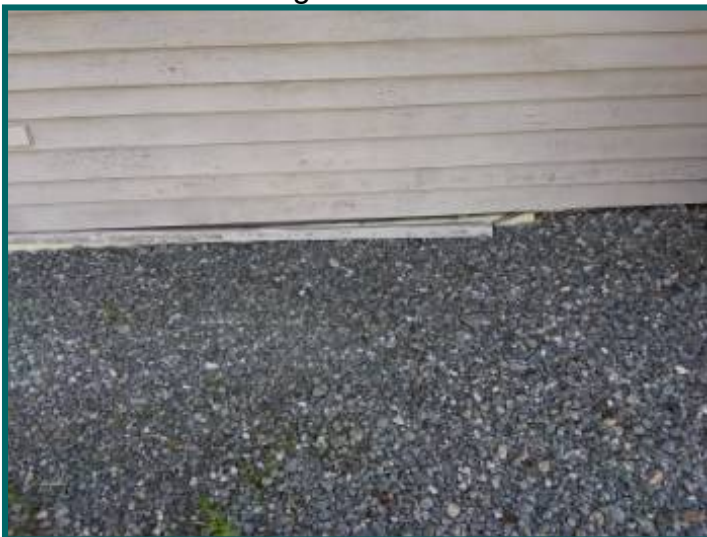
2.3. One or more areas of damage or deterioration to siding. This condition is conducive to water intrusion and further deterioration. There may be damage to structural components of the building that are not visible until further probing by a qualified professional are performed. Recommend further assessment and repair by a qualified tradesman.

Damage to exterior surfaces at front

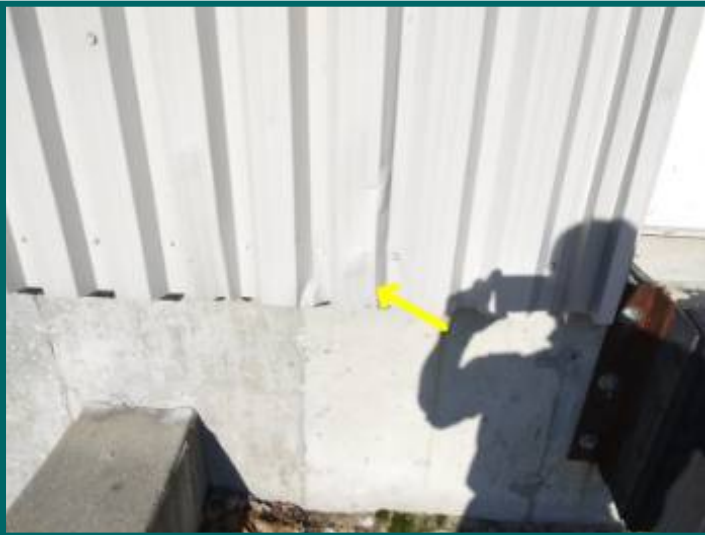
Damage to exterior surfaces at loading dock

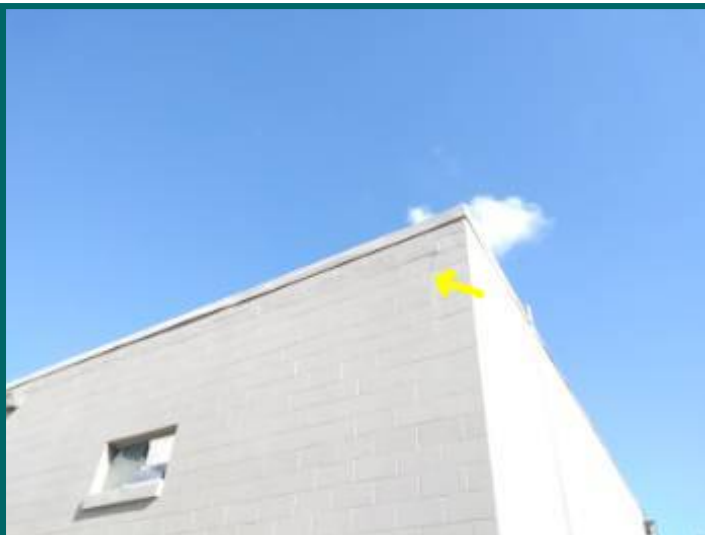
2.4. There is vertical and or step cracking at one or more areas of exterior wall, recommend assessment and repairs by a qualified masonry contractor.

Step cracking at rear

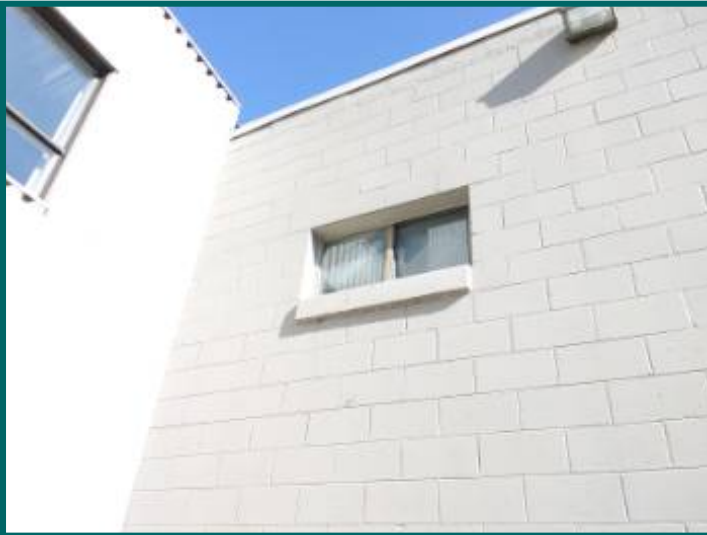
3.4. One or more windows have broken seals (fogged), this condition can diminish the energy efficiency of the window and cause permanent hazing to the glass, recommend repair by a qualified window contractor.

Fogged window at Neatly Done second floor

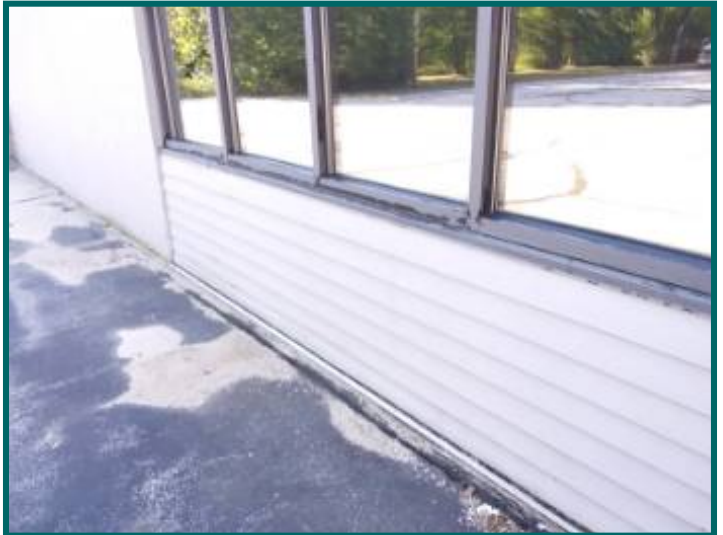
3.2. Peeling paint observed, suggest scraping and painting as necessary.

Peeling paint at left rear

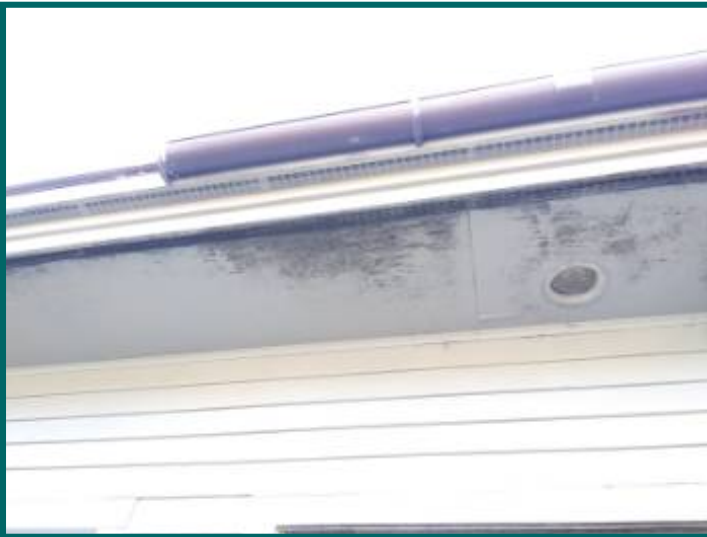
4.2. Trim boards have areas of damage and or deterioration, recommend full assessment of trim boards and repairs by a qualified contractor.

Damage, rot on trim at left front

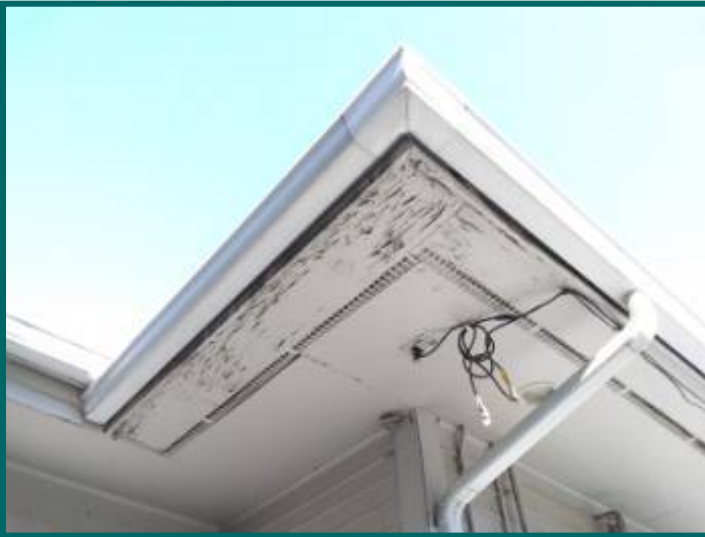
Damage, rot on trim at rear

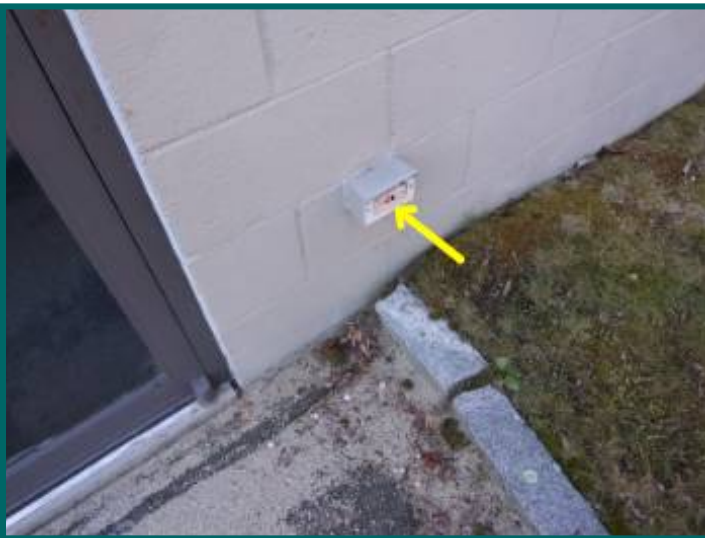
6.1. One or more exterior outlet has damaged or missing weatherproof cover, recommend repairs by a licensed electrician.

Missing weather proof outlet cover at warehouse

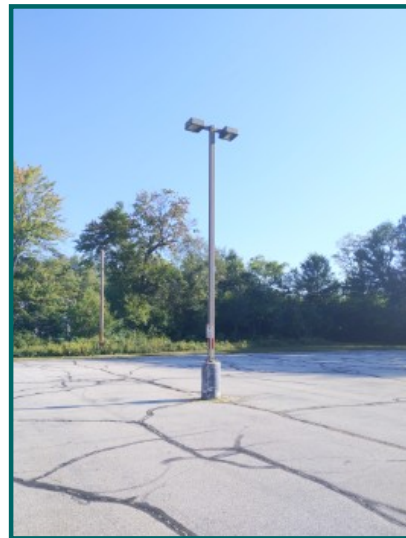
Exterior lighting was not observed illuminated

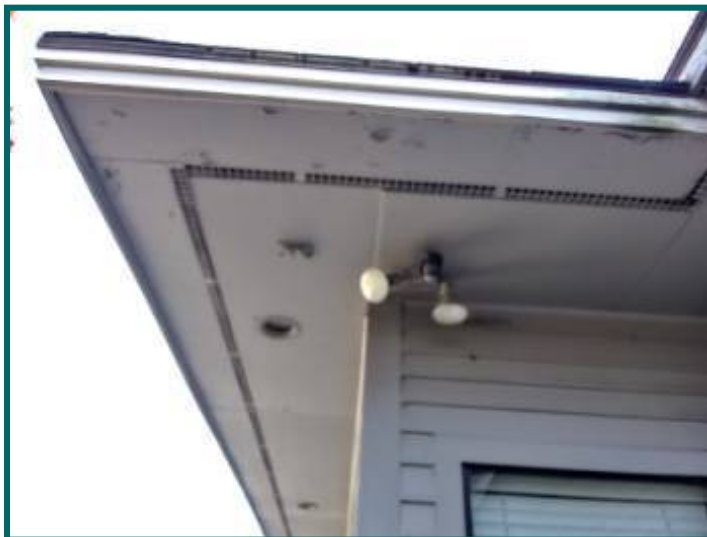
One or more exterior light on photo sensor did not illuminate during inspection.

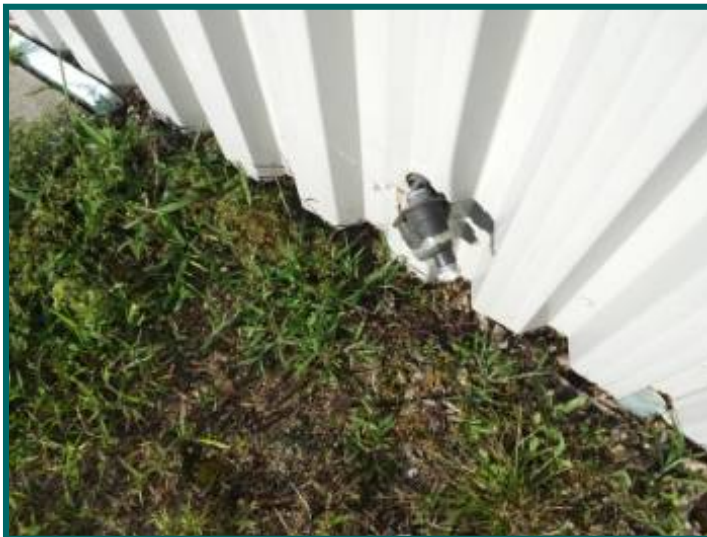
7.2. One or more exterior faucet is damaged and/or loose at wall termination, repairs recommended.

Damaged faucet handle at rear

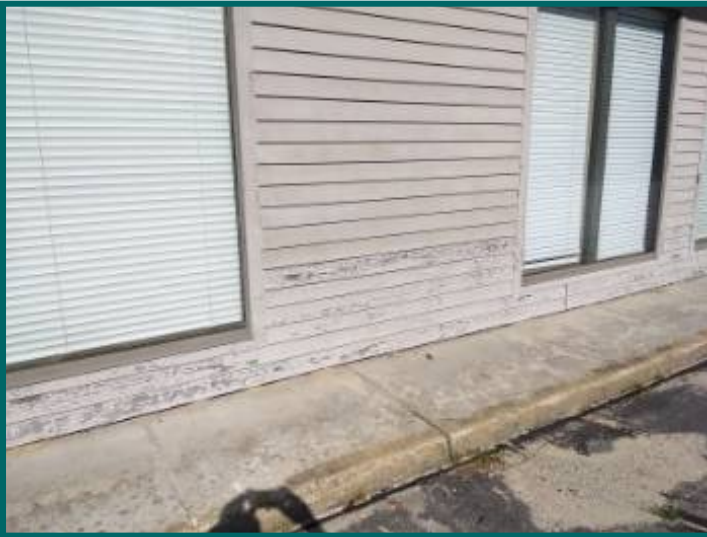
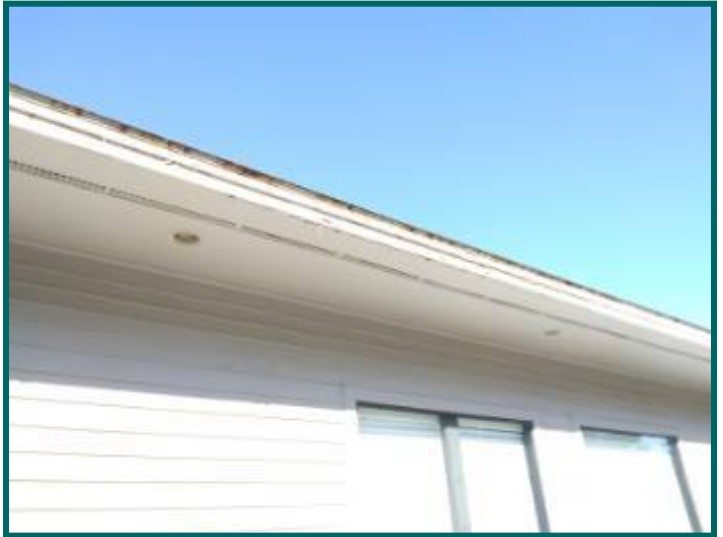
8.1. Peeling paint observed on siding and trim, suggest scraping and painting as necessary.

Peeling paint throughout left building

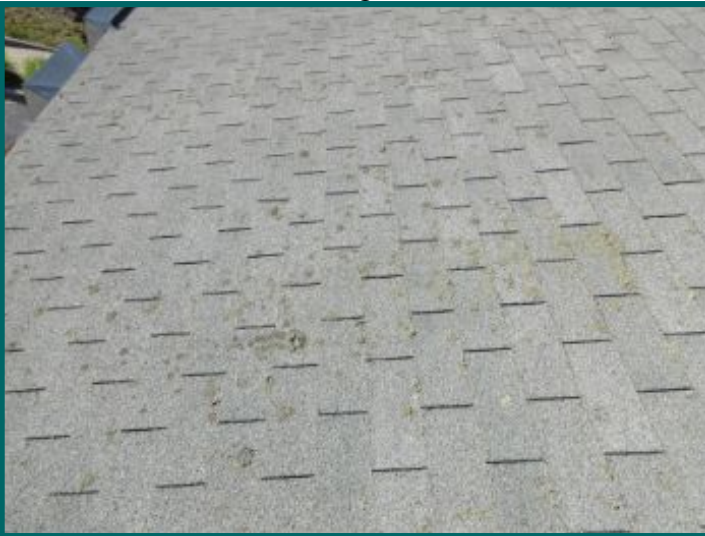
1.4. Staining and fungal growth on surface of roof, recommend cutting back trees and cleaning of roof surfaces by a qualified roofing contractor to help prolong life of roof.

damaged surface / granular loss and fungal growth at left building

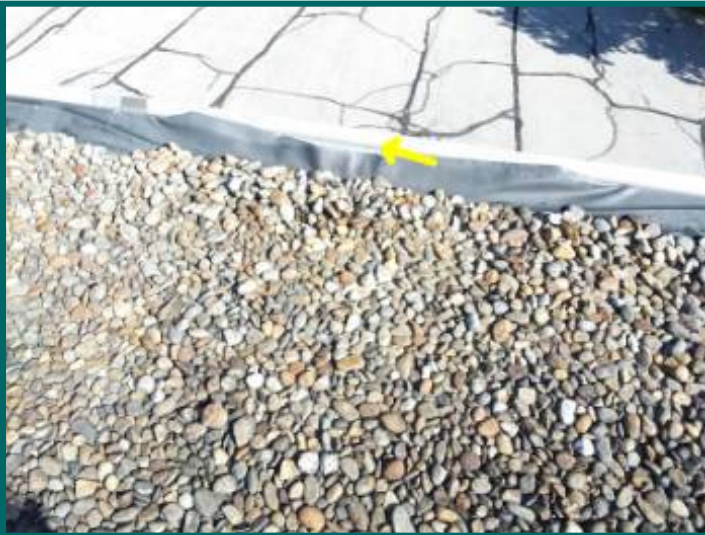
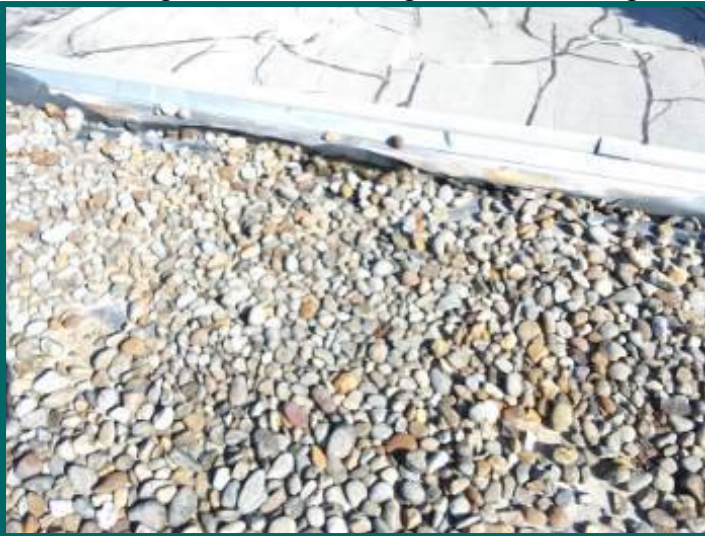
1.7. There area areas of lifting and or damage to roof surfaces, recommend assessment and repairs as needed by a qualified roofing contractor.

Damaged rubber roofing middle building

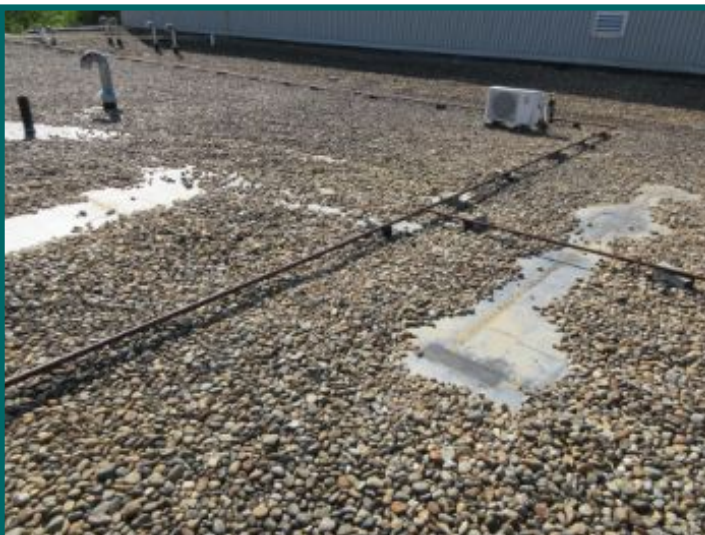
beyond design life / water intrusion at interior

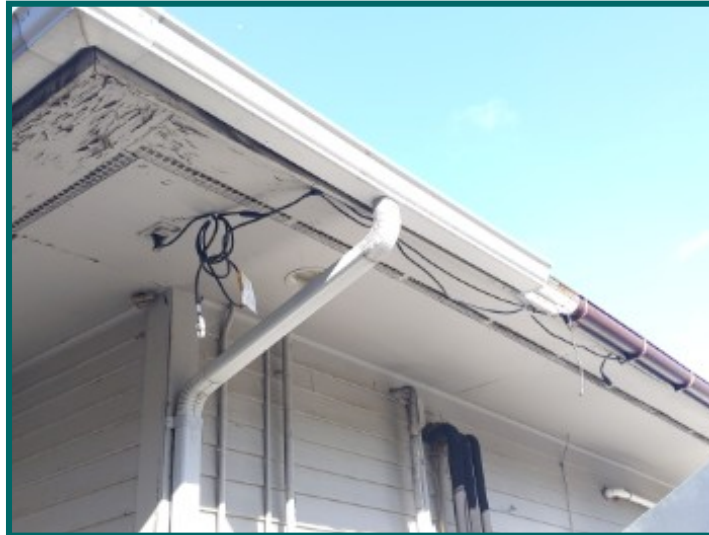
2.1. There is heat tape in gutters and or at edge of roof, the heat tape was not operated or tested during inspection, recommend monitoring for proper operation during icing conditions to prevent ice damming and water intrusion into building. Recommend asking current property owner for information on and history of heat tape use and any leaks or water intrusion issues. Recommend monitoring for water intrusion at roof edge and repairs of any affected areas as needed.

Heat tape at rear left.

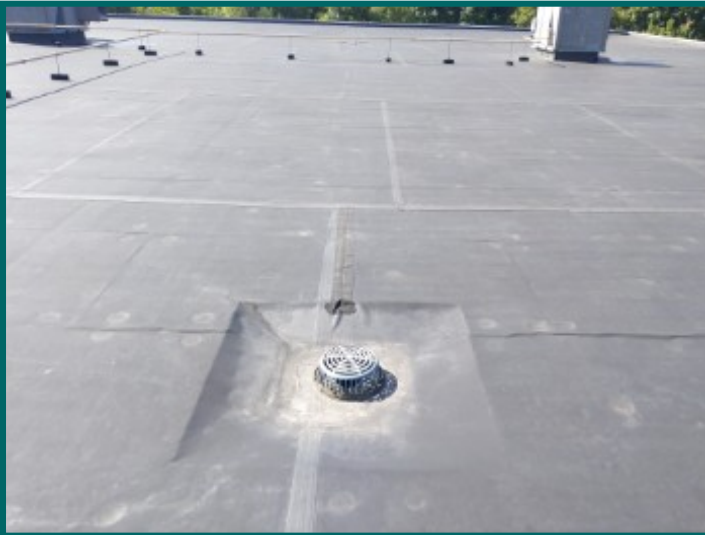
Internal roof drains at right building

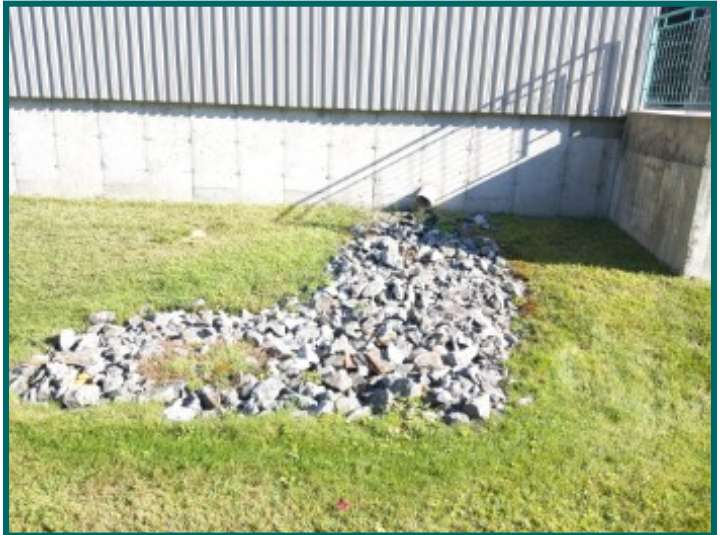
Internal roof drain termination at right side of building.

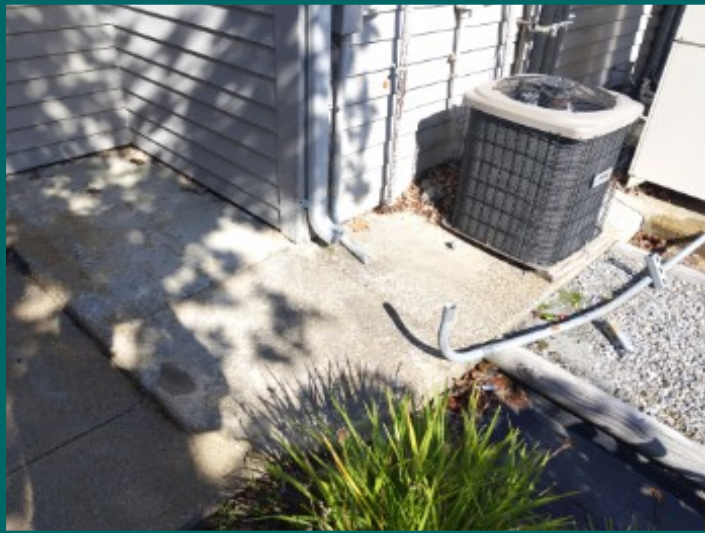
4.3. Downspout drains onto sidewalk / driveway. Recommend exploring ways to divert water away from this area, or at the very least, recognize this as a potential ice hazard; use ice melt products and exercise caution.

Gutter terminates onto walkway at rear of building.

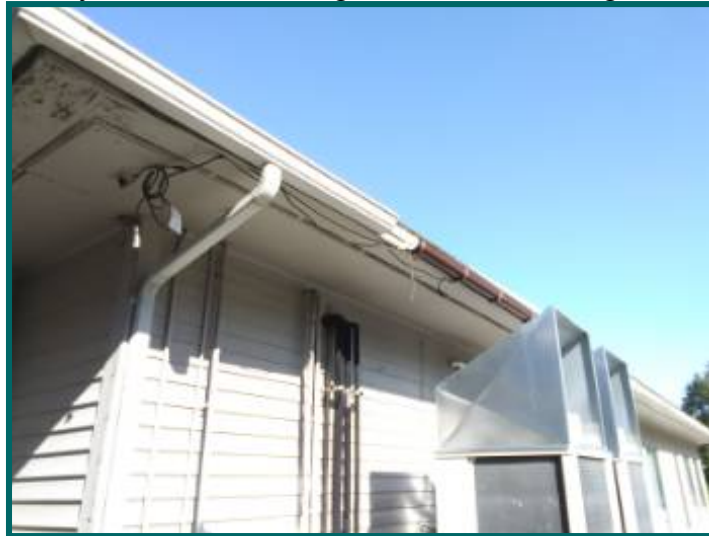
4.2. Gutter and down spouts have areas of damage, this can cause damage to exterior wall surfaces and water intrusion into building. Recommend having repaired as needed by a qualified contractor.

Missing downspout on gutters

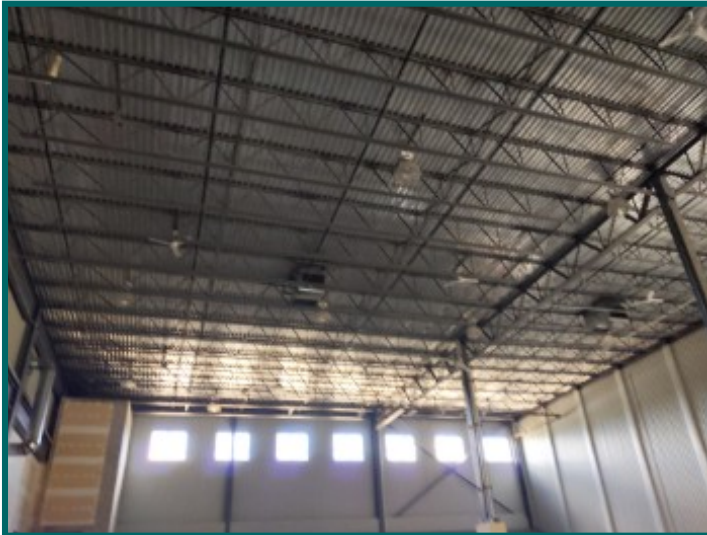
Steel frame at rear right / warehouse

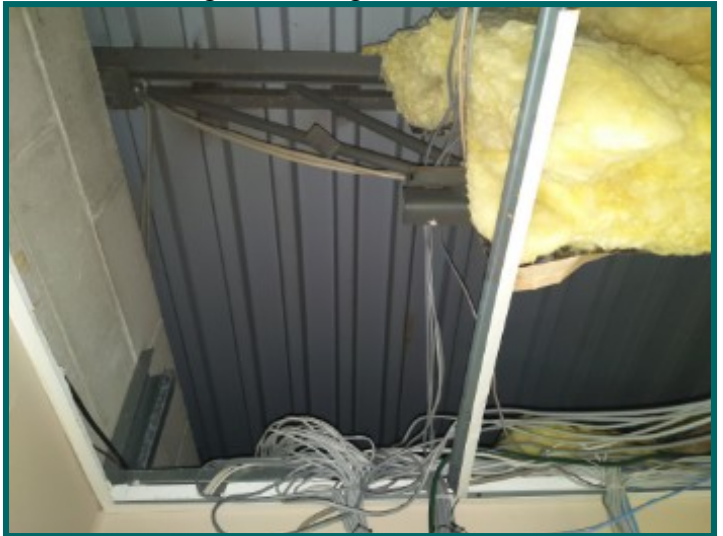
Steel frame on CMU wall at middle building

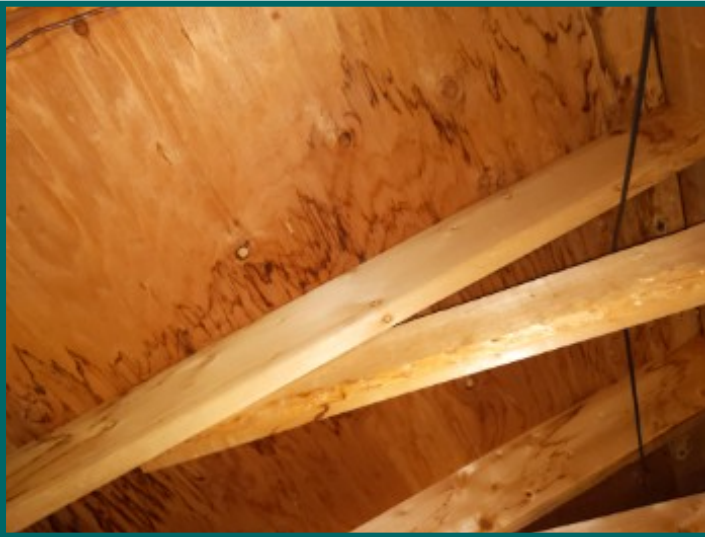
2.5. Stains were found in one or more attic surface areas, no elevated levels of moisture were found. The stain(s) may be due to past or present roof and/or plumbing leaks. Recommend asking the property owner about history of water intrusion and or assessment of any affected areas by a qualified contractor and repairs as necessary.

Stains tested dry

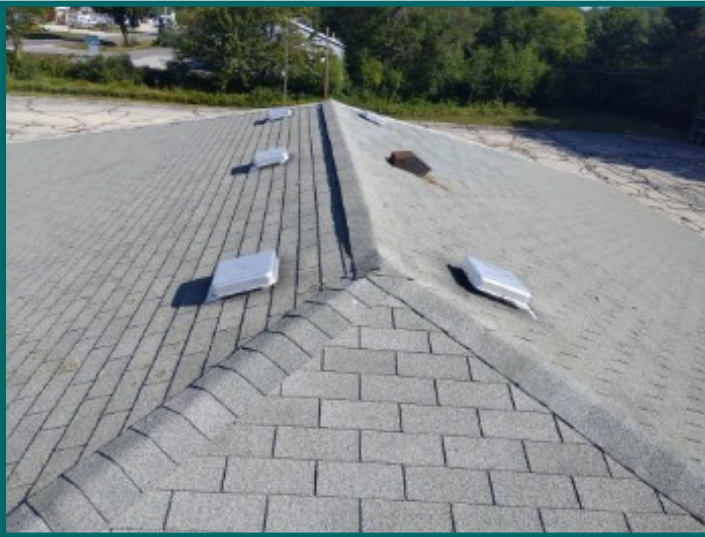
Ridge vent and can vents at left building

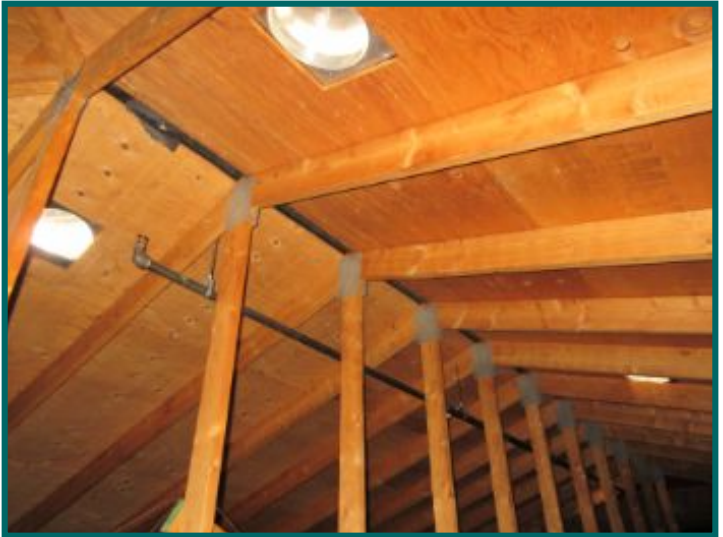
ridge vent and can vents in left building attic

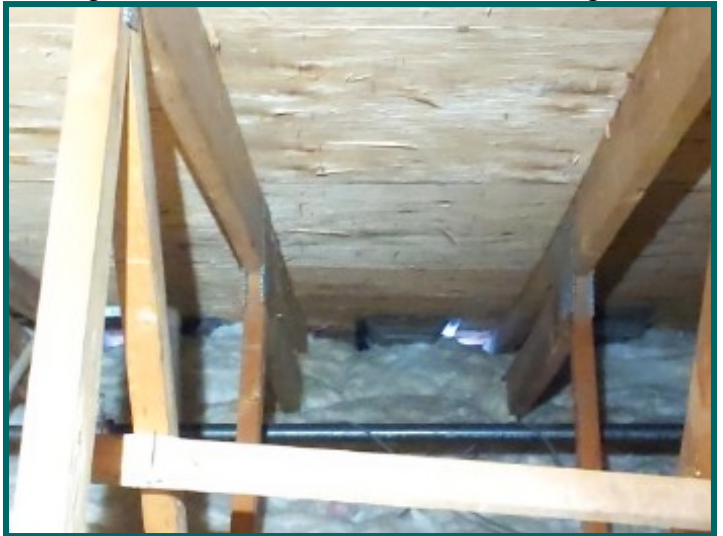
Soffit vents with propa vents at left building

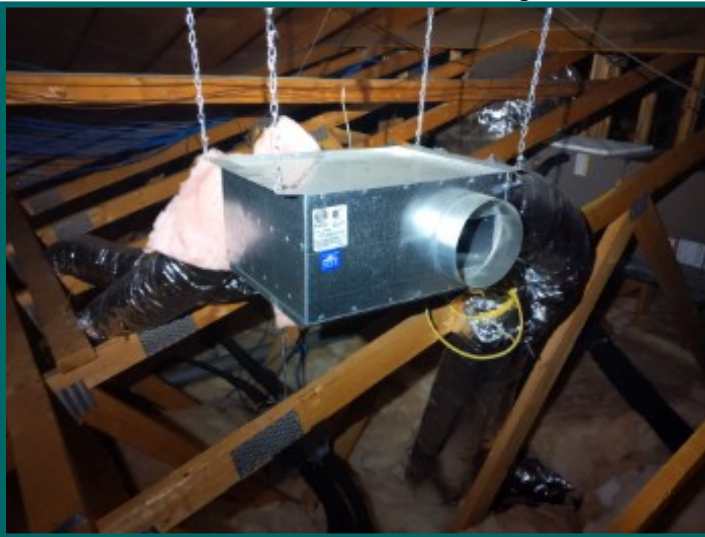
3.4. Bath fans venting directly into attic. This can cause condensation, staining and fungal growth on attic framing as well as be a contributing factor to ice damming. Recommend repair properly terminating bath fans to exterior of building by a qualified contractor.

vent terminating in attic at left building

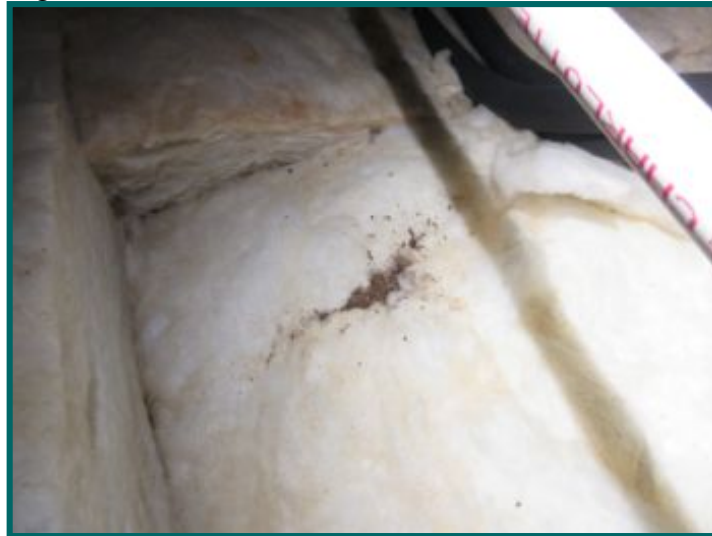
4.1. Rodent activity observed in the attic. Vermin can damage insulation & electrical wiring.
Recommend a professional pest contractor evaluate for treatment.

Rodent activity in left building attic.

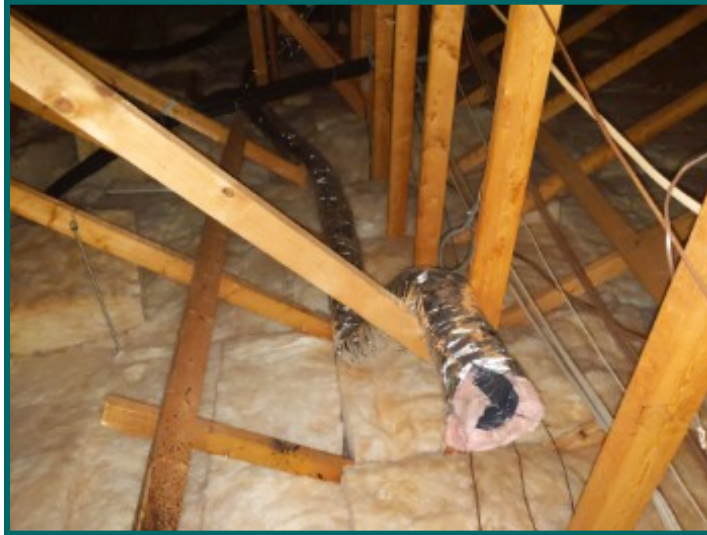
5.1. Ducts are loose or damaged at one or more area, this can contribute to energy loss, ice damming, moisture and mold growth, recommend assessment by a qualified HVAC contractor.

Disconnected ductwork in left building attic

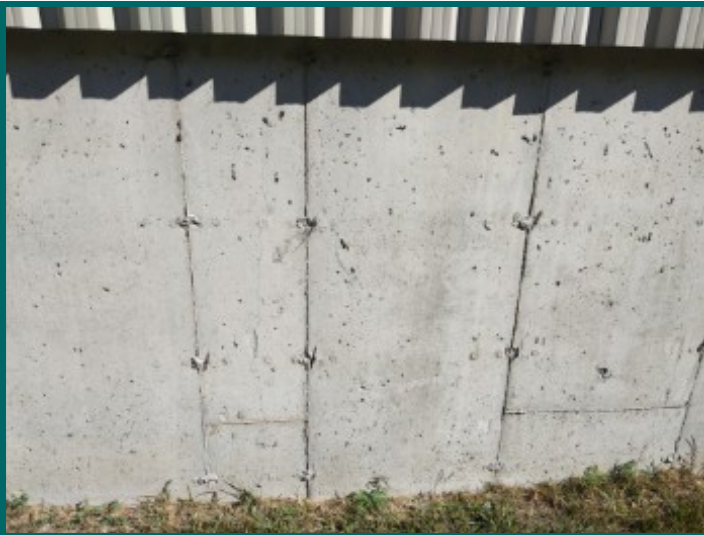
1.2. Vertical cracks noted on foundation wall at one or more location, recommend monitor for further movement and or water intrusion and sealing / repairs as needed.

Vertical cracks at right side wall

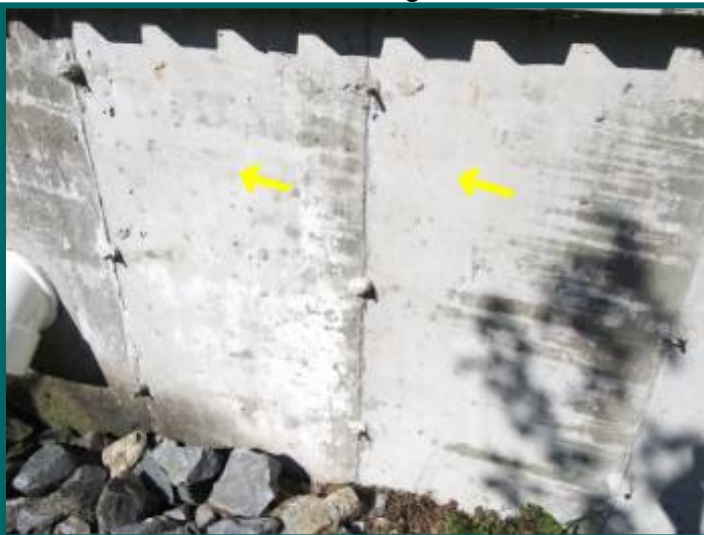
Vertical crack on rear wall

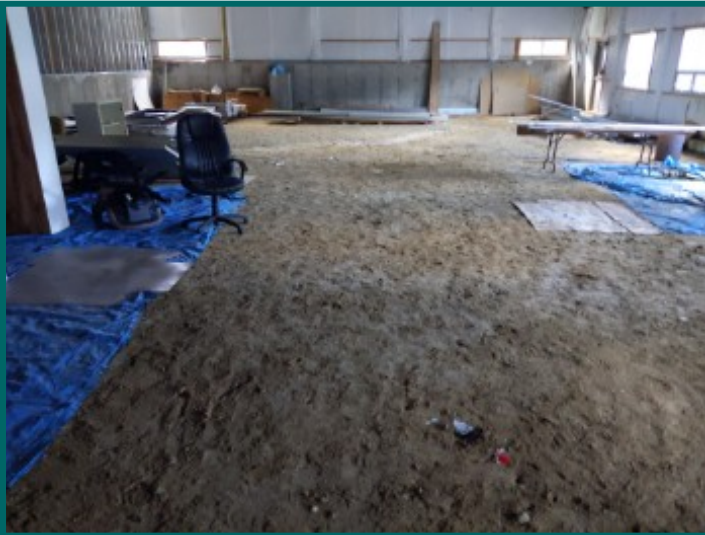
2.5. Dirt floor with no vapor barrier, this is conducive to moisture and insect intrusion. Recommend installation of vapor barrier and ballast, (plastic sheeting and crushed stone) by a qualified tradesman.

Incomplete finish / dirt floor without vapor barrier
at front right.

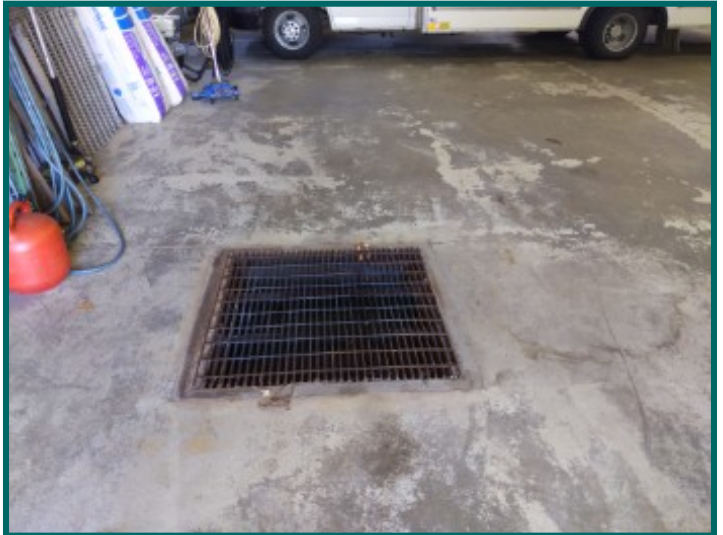
2.4. There are floor drains at slab area, recommend monitor for proper drainage, keep clear of debris and have cleaned and serviced as needed.

Floor drain at neatly done

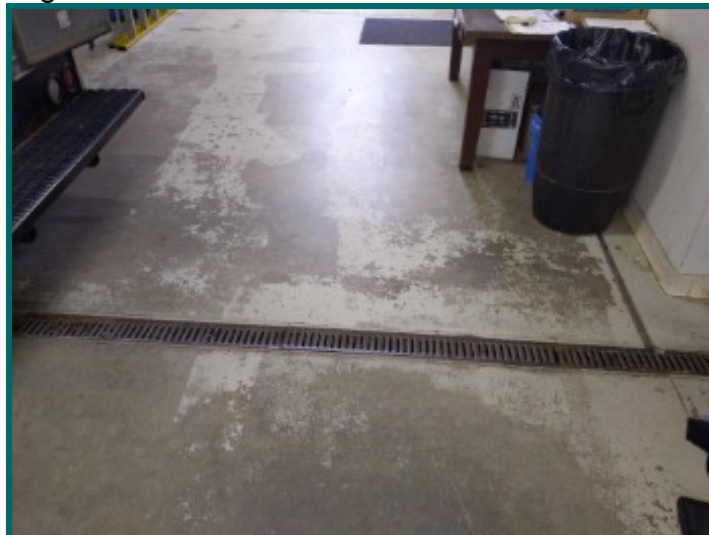
Floor drain at neatly done

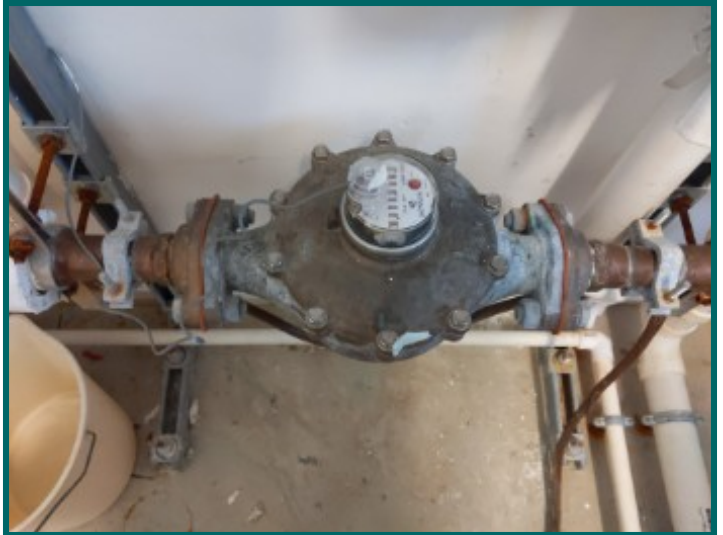
Water meter

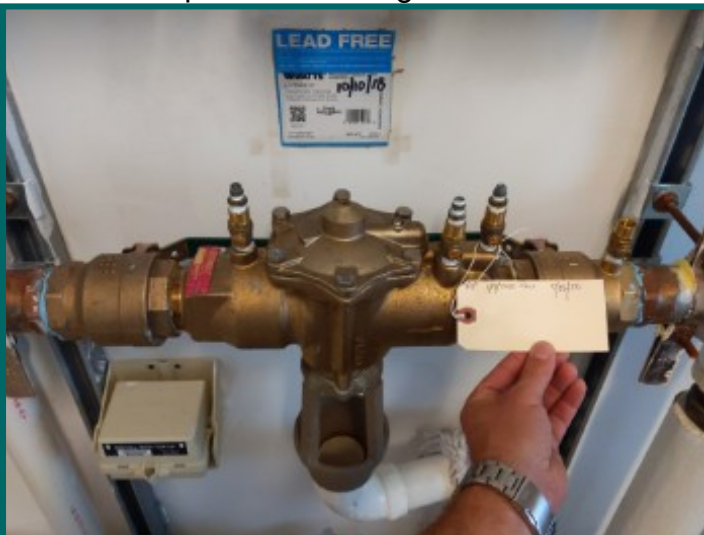
Backflow prevention and most recent service tag

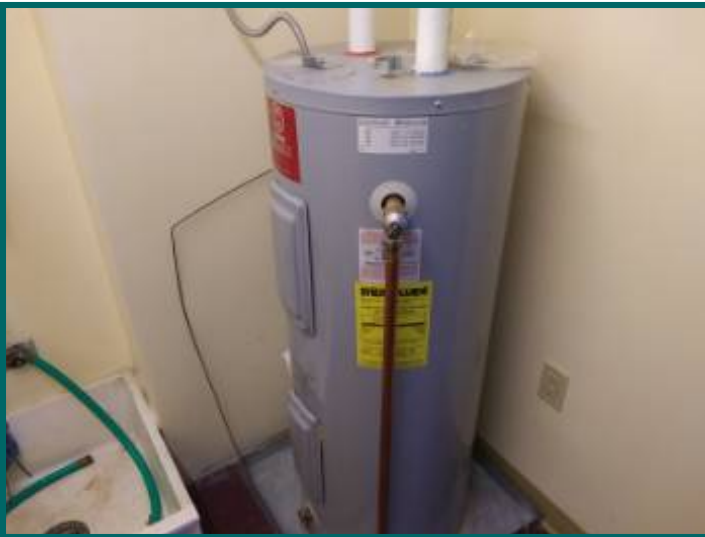
Warehouse water heater 30 gallon 16 years old

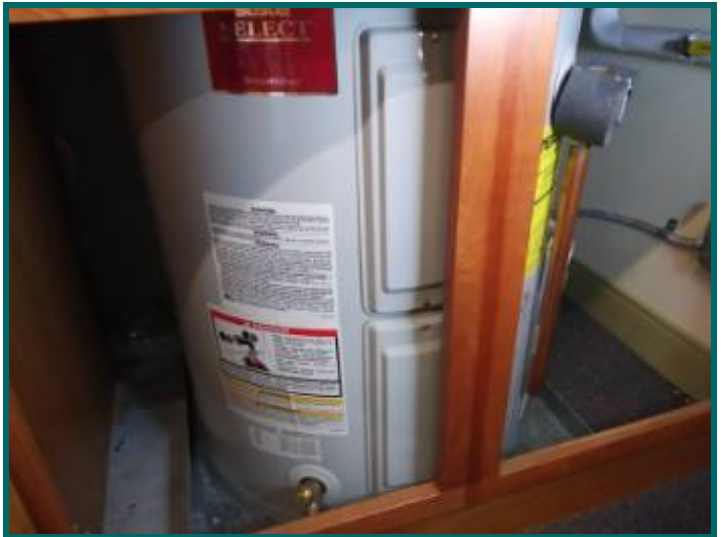
Middle building 30 gallon 15 years old

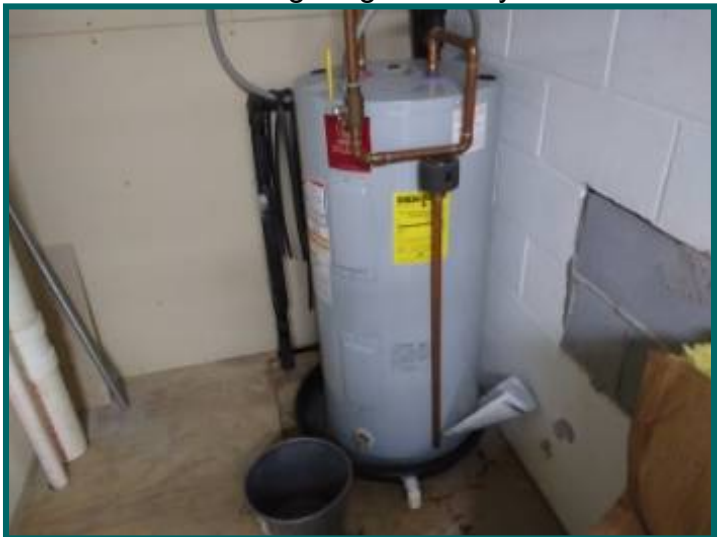
Middle building 30 gallon 14 years old

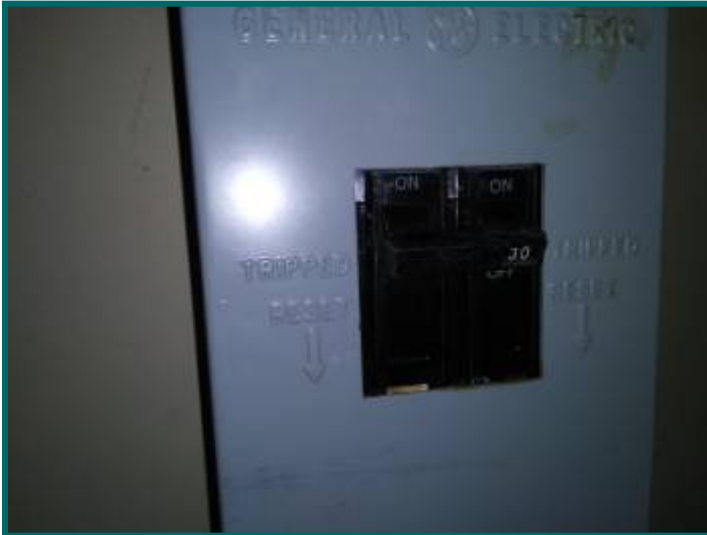
Second floor middle building water heater is off
