Alpha Home & Commercial Building Inspections

Property Inspection Report

industrial building 57,000 sf circa 1984 , Peterborough, NH 03458
Inspection prepared for:
Date of Inspection: 9/4/2020 Time: 9:00 AM
Order ID: 11349

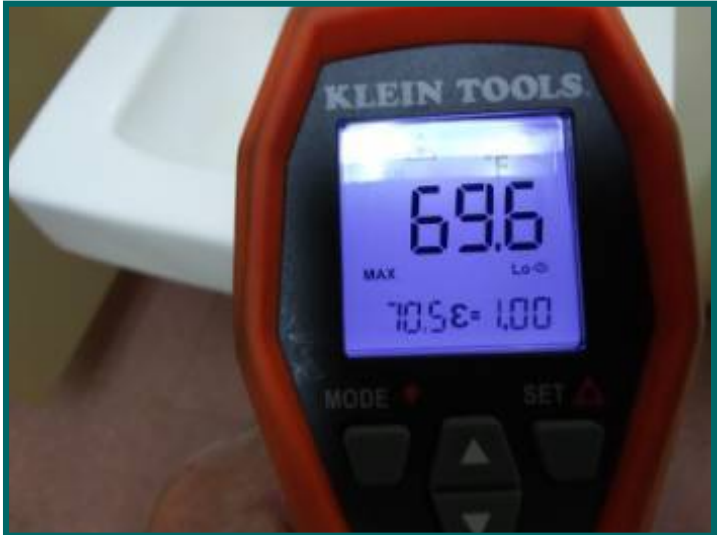
Water temperature left building water heater is off

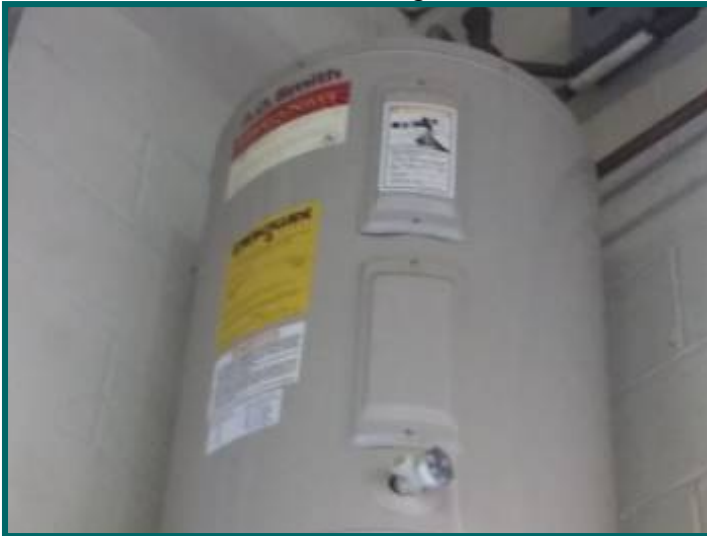
Neatly done 22 years old 30 gallon in shop area

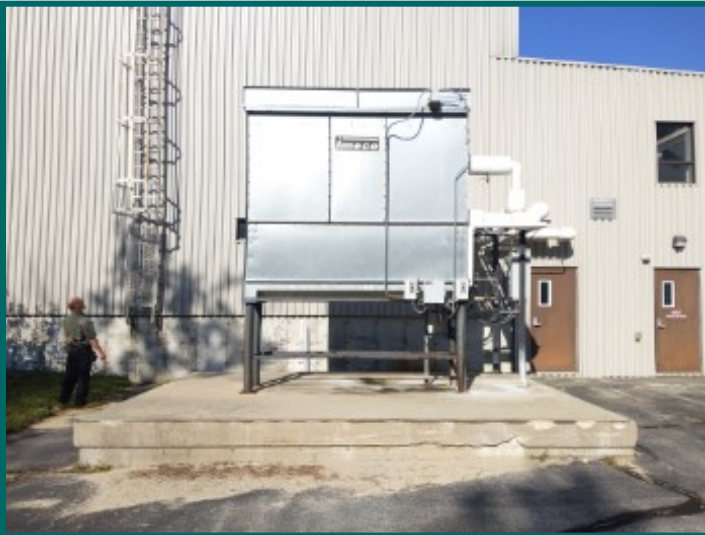
Cooling tower at rear of building, 15 years old

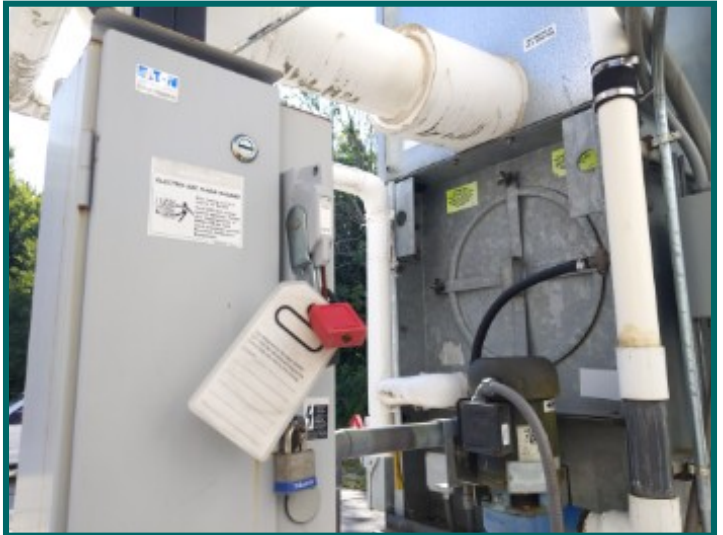
Cooling tower was shut down at the time of inspection.

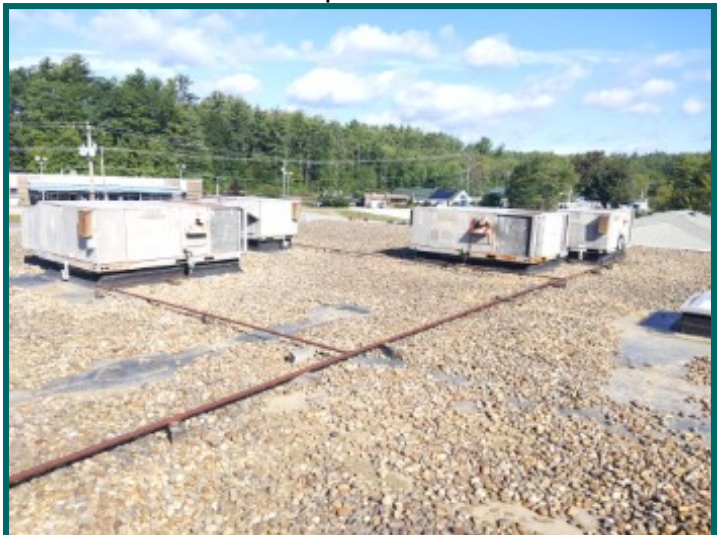
Four rooftop units at front of middle building, all
25+ years old

1.4. One or more system component is approaching or beyond its design life, recommend full inspection and service by a qualified HVAC / heating contractor.

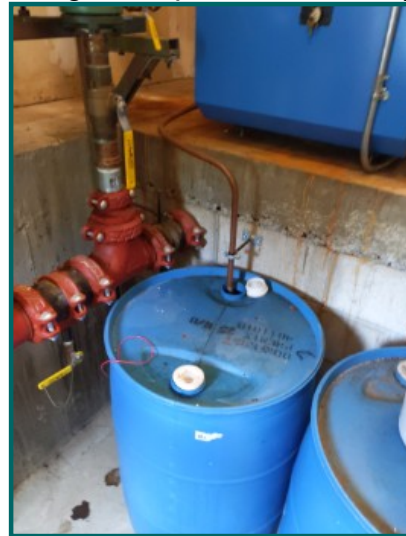
1.5. Temperature & Pressure relief pipe is leaking at one or more boiler, there is corrosion at end of pipe, recommend repair by a qualified plumber.

Boiler TP valve is leaking

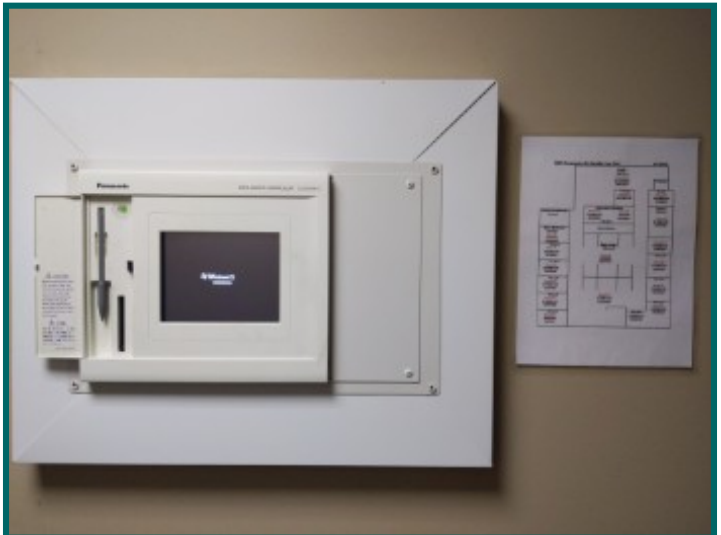
Heat pumps located throughout front office space of right building. Control system was not operating properly, unable to test

1.3. One or more HVAC component was not tested / unable to test during inspection, recommend verifying proper operation prior to closing and inspection and repairs if needed by a qualified HVAC contractor.

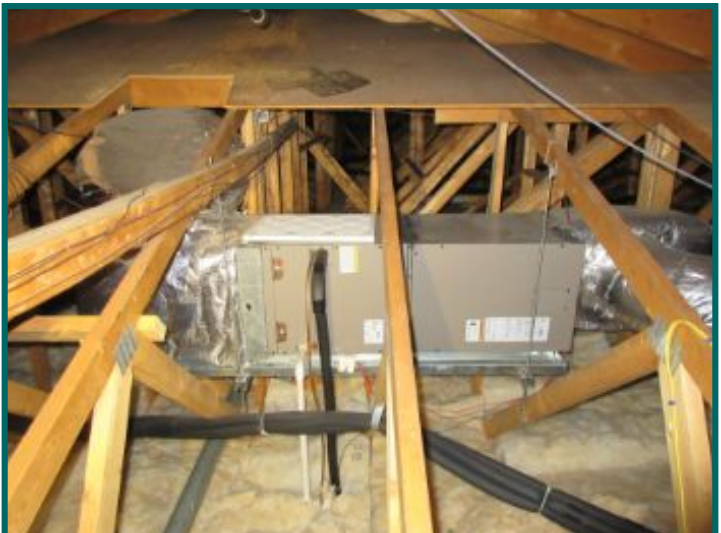
Unable to test left building HVAC, shut down / not operational at the time of inspection. Air handler in attic space above left building, 11 years old

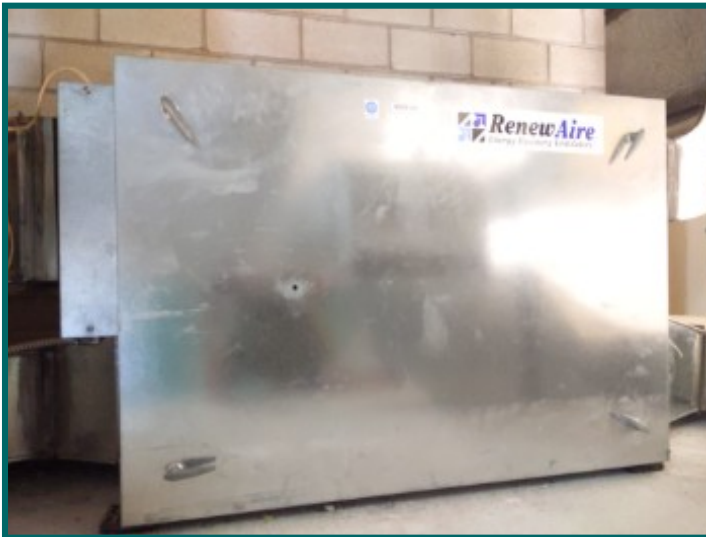
ERV at right building second floor shut down so
it's not inspected

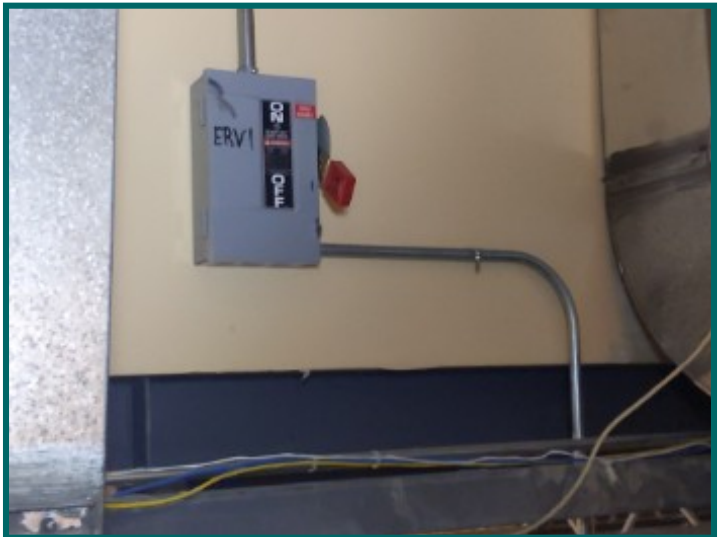
ERV is shut down

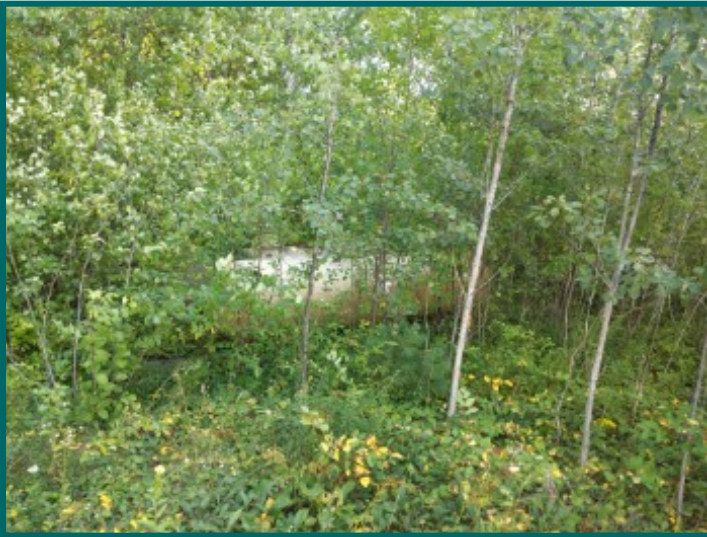
Propane tanks at rear left

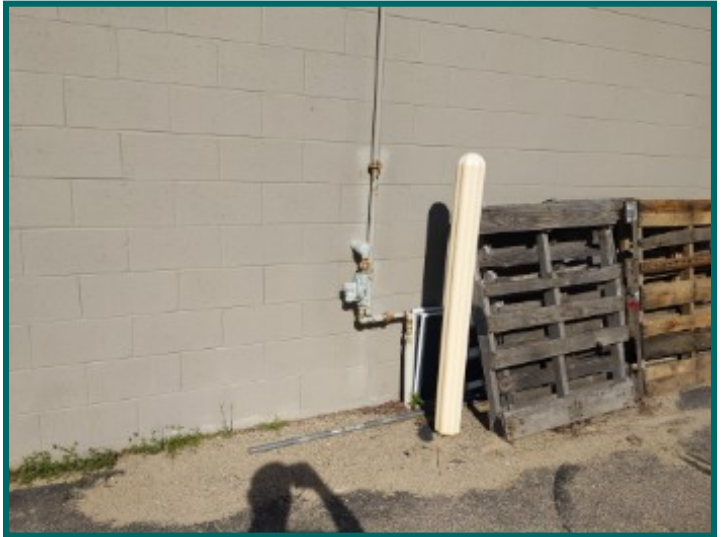
Propane entrance at rear left

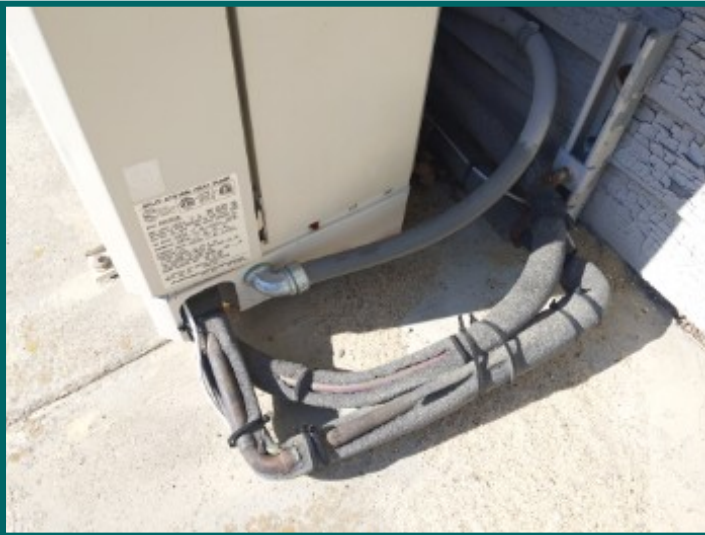
4.1. There are areas of missing insulation on coolant lines. This can diminish efficiency of system and create condensation and water damage to home. Recommend adding insulation as needed and monitor condition closely.

Damaged/missing insulation at rear of building.

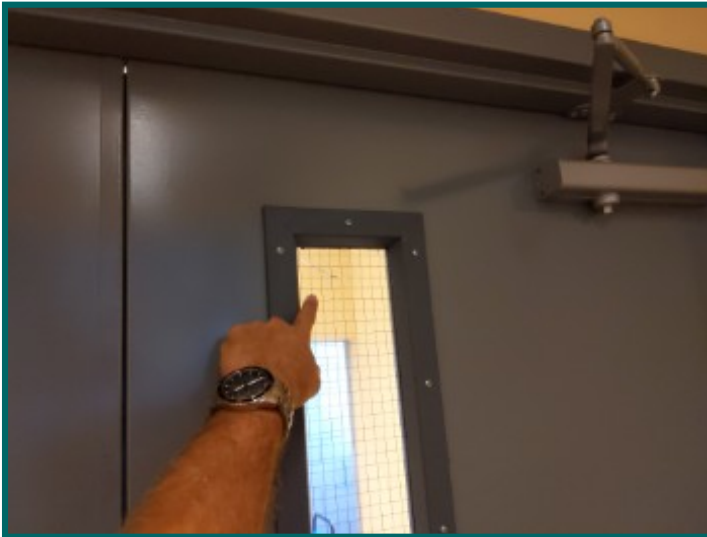
Broken glass at warehouse rear door

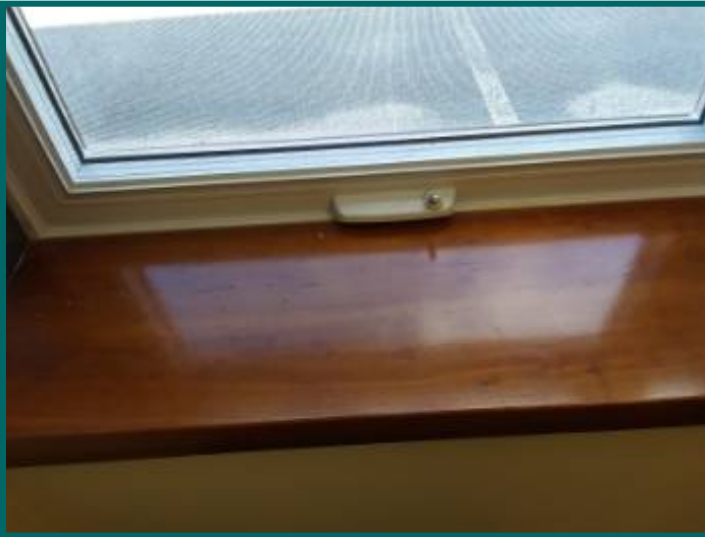
2.2. Casement window crank is broken, will not operate properly at one or more area of the building, recommend assessment of windows and repairs by qualified tradesman.

Damaged window crank at middle front

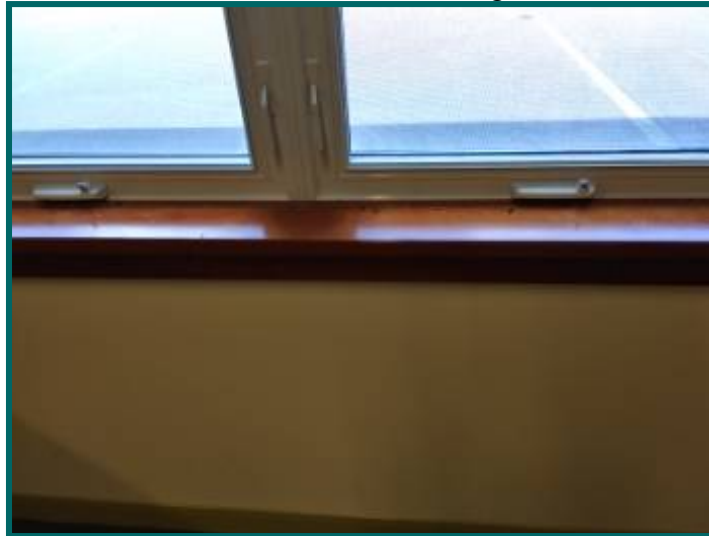
Damaged window crank at middle front office

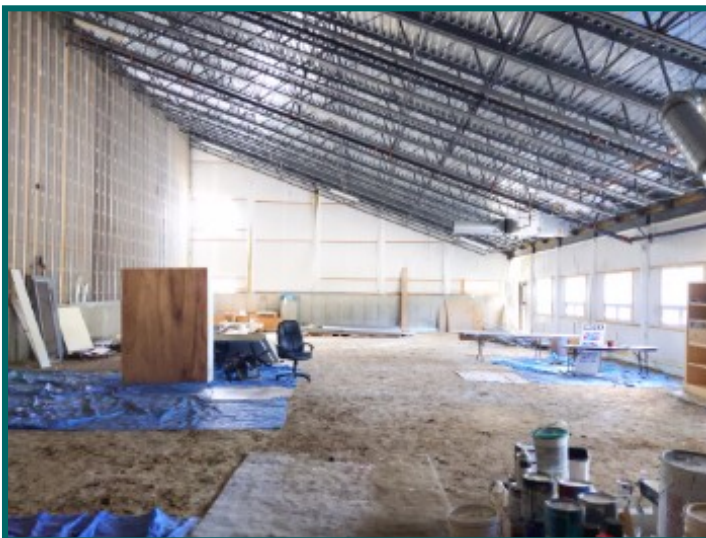
3.7. There are areas of interior finish, trim, electric wiring and or fixtures that are not fully installed at one or more area of the building. Recommend assessment and repairs / completion as needed by a qualified contractor.

Incomplete finish at front right

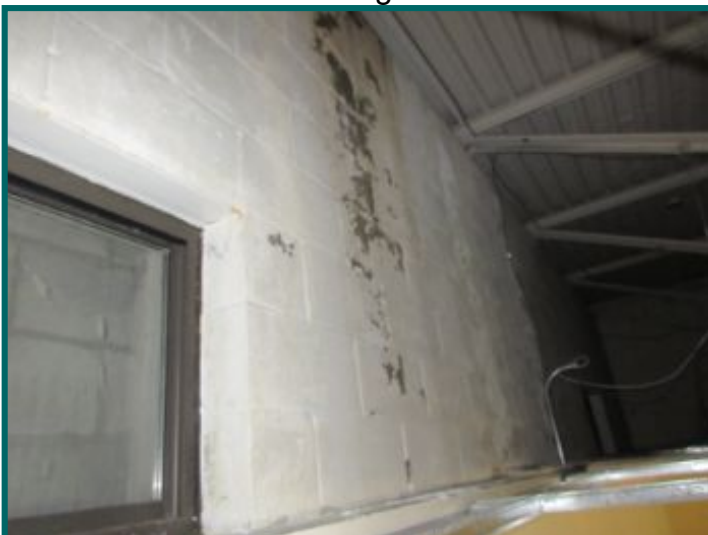
3.5. Efflorescence on exterior walls at one or more area of building, this is evidence of past or present water intrusion. Recommend assessment and repairs by a qualified professional and monitor for further water intrusion or staining.

water staining / efflorescence and wet conditions
at middle building right wall

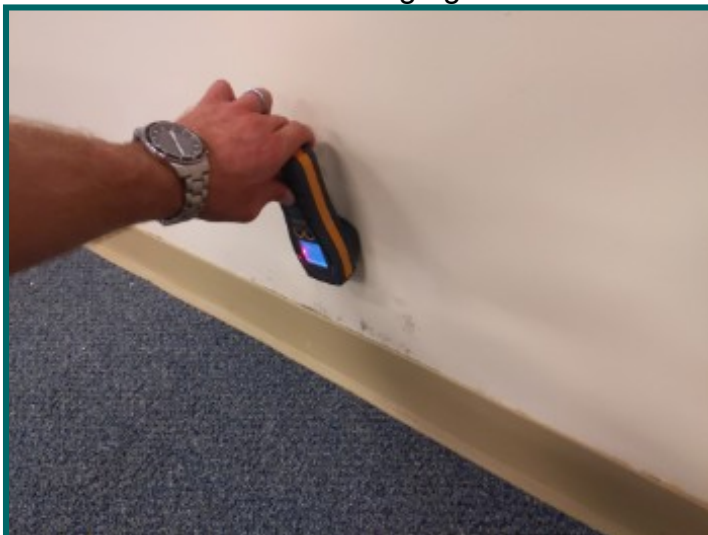
3.4. Although inspection for the presence of mold is specifically excluded in our inspection agreement we do note suspected evidence when observed. There is staining that may be fungal growth on surfaces at one or more area of property. Recommend asking current property owner for the source and history of any leaks or water intrusion, assessment and removal or cleaning / treating affected areas by a qualified contractor and monitor condition for further staining and or elevated moisture levels.

Wet conditions and suspected mold staining at
middle building rear room

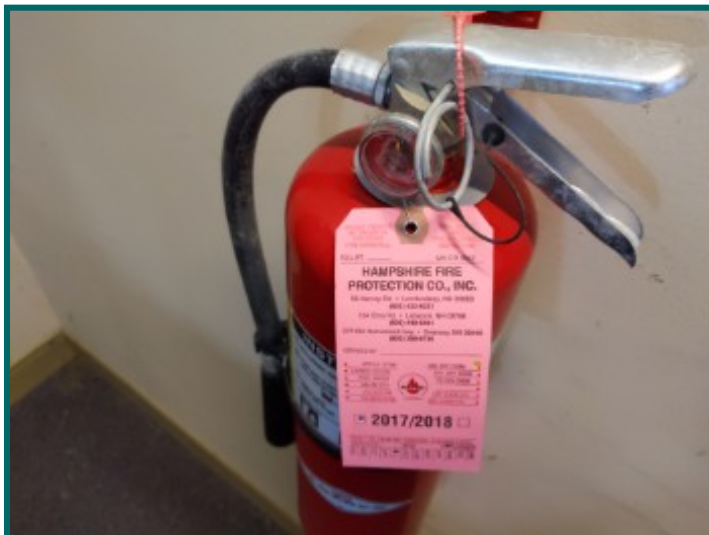
Fire extinguisher tag is expired

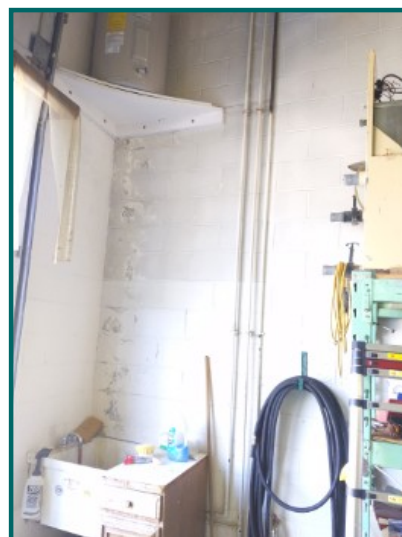
Water staining / efflorescence at neatly done rear wall

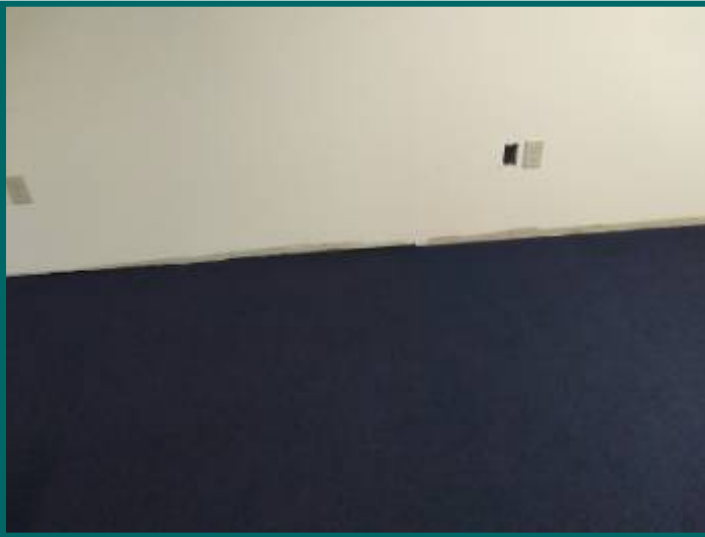
3.6. Damage to wall surfaces at one or more areas, recommend assessment of wall surfaces and repairs by a qualified tradesman.

Damage to wall at Mount Washington room

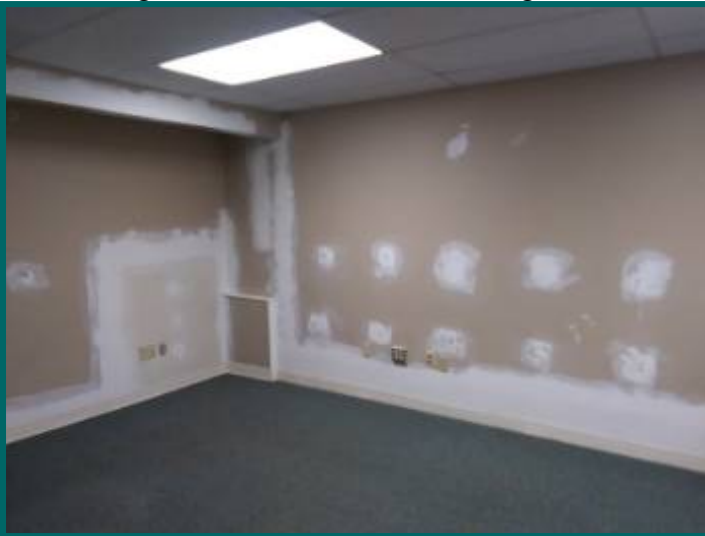
Incomplete finish second floor middle building rear

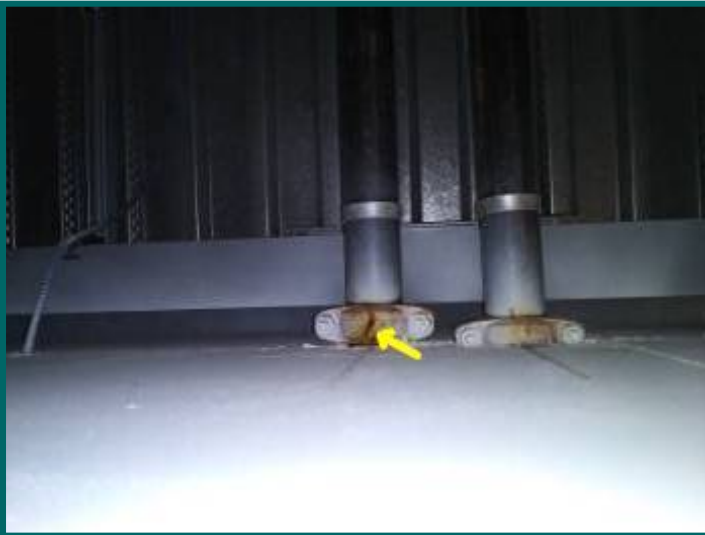
4.4. Stains noted on the ceiling. elevated levels of moisture present in one or more areas of home. Recommend asking current property owner for the source and history of any leaks or water intrusion, further assessment of affected surfaces and repairs by a qualified contractor as needed.

Leak / wet condition at plumbing above right rear office middle building

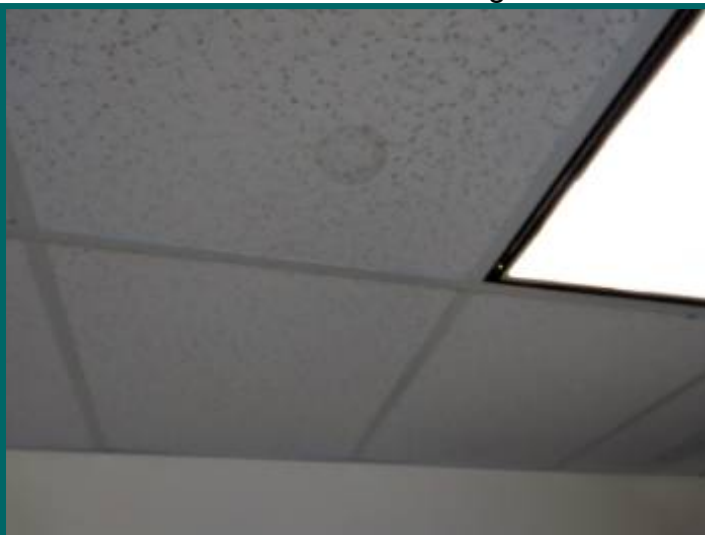
4.3. Stains noted on ceilings in one or more area of building. This is evidence of past or present leaks. They tested dry at the time of the inspection. Recommend asking current building owner for the source and history of any leaks or water intrusion, assessment and repairs by a qualified contractor of any affected areas and monitor for further water staining.

Stains on ceiling tested dry at middle front

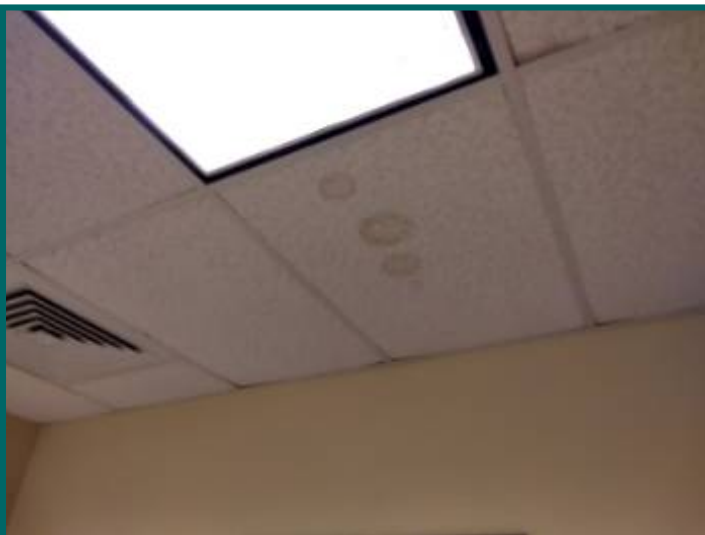
Stains on ceiling tested dry at middle rear

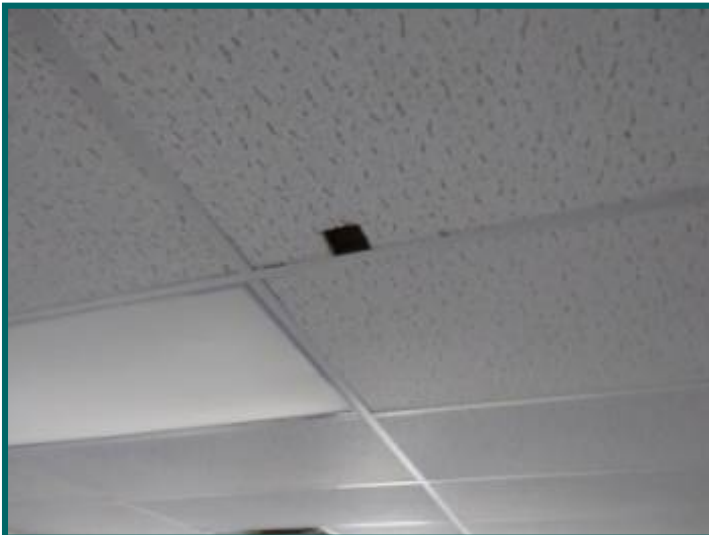
4.2. There are damaged or missing ceiling tiles present in one or more areas, recommend having repaired as needed.

Damaged ceiling tiles at mount Washington room

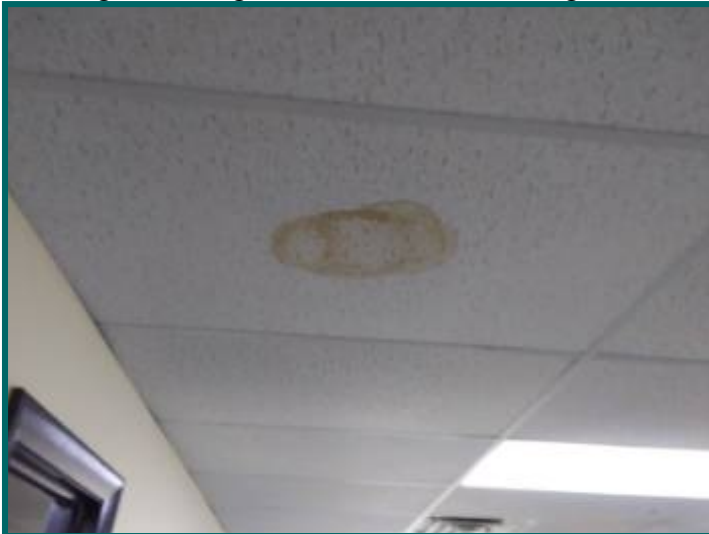
Stains on ceiling tested dry at Mount Monadnock room

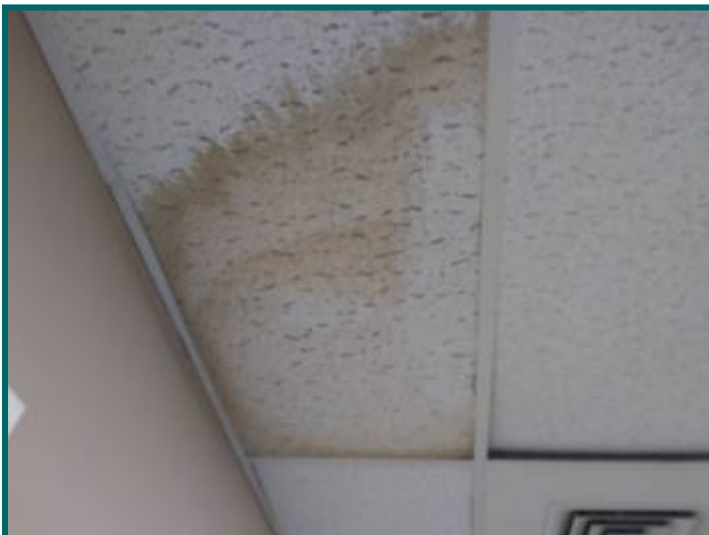
Stains on ceiling tested dry at Mount Monadnock room

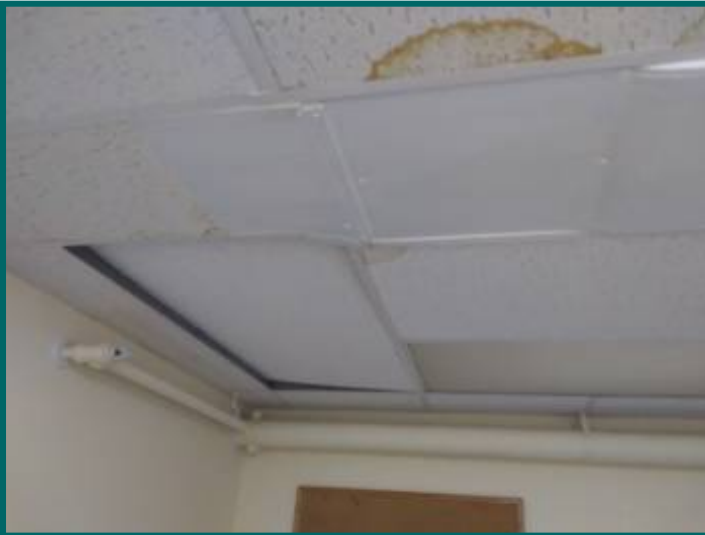
Stains on ceiling tested dry at left building Brad Wuorinen office

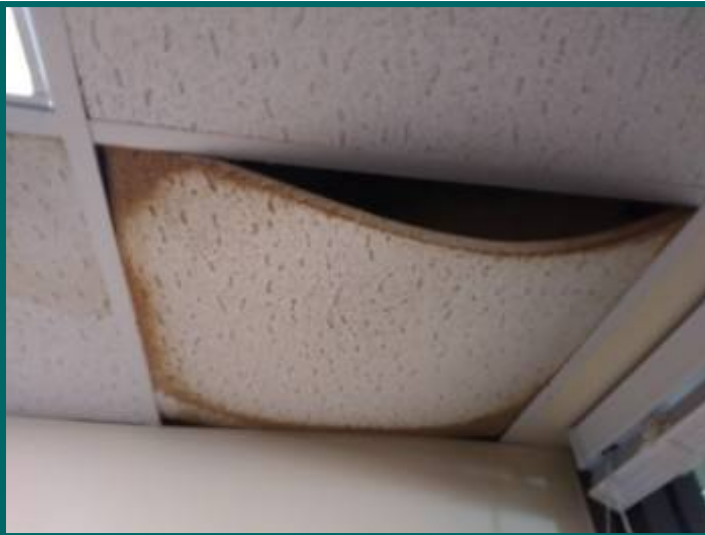
Damage to ceiling at left building middle office

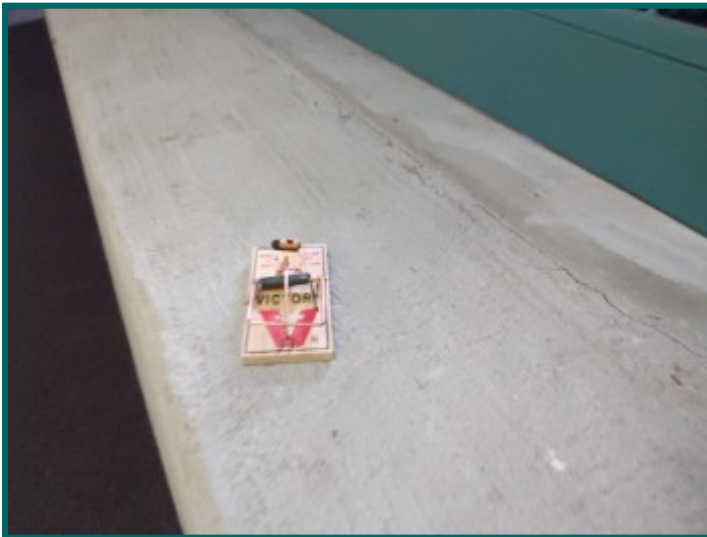
5.2. Rodent bait stations inside building, recommend maintenance of bait stations by a qualified pest control company.

Rodent treatment in warehouse

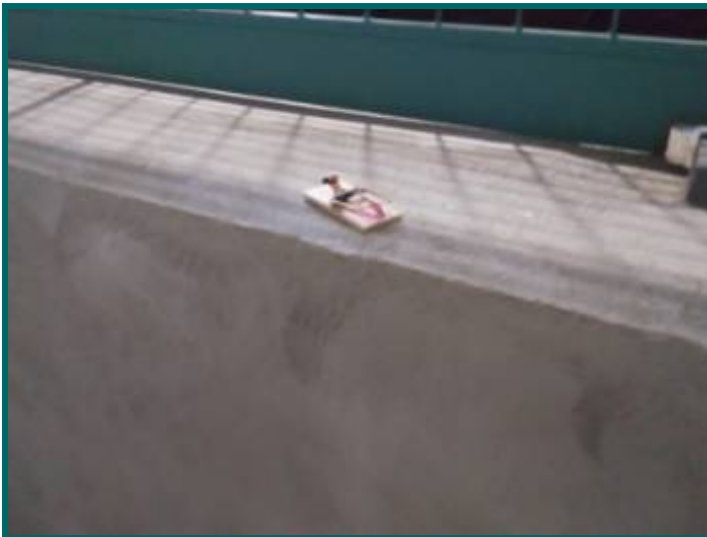
Rodent bait stations

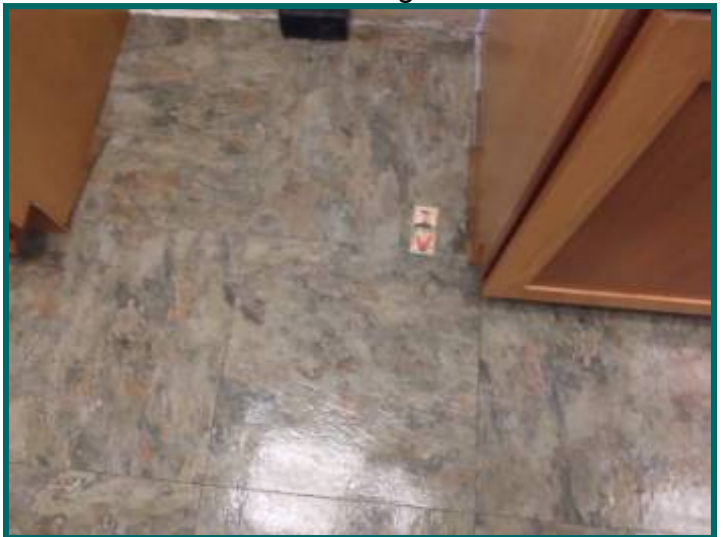
Rodent bait stations

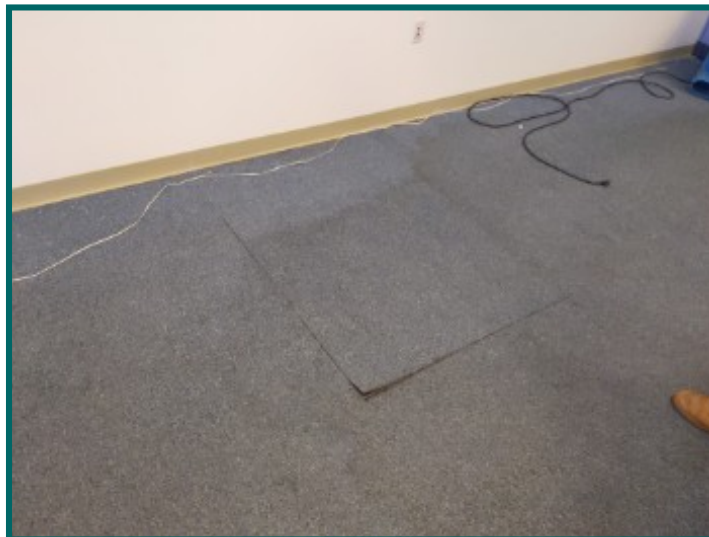
5.3. Unable to open access panel at middle building rear room. Recommend contacting property owner for more information regarding the function of the access panel and assessment as needed by a qualified contractor.

Unable to open access panel at middle building rear room, area not inspected

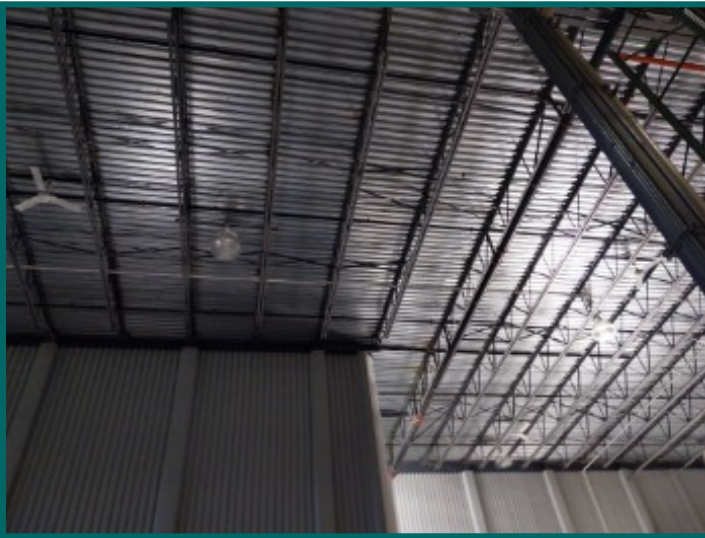
Several warehouse lights did not turn on

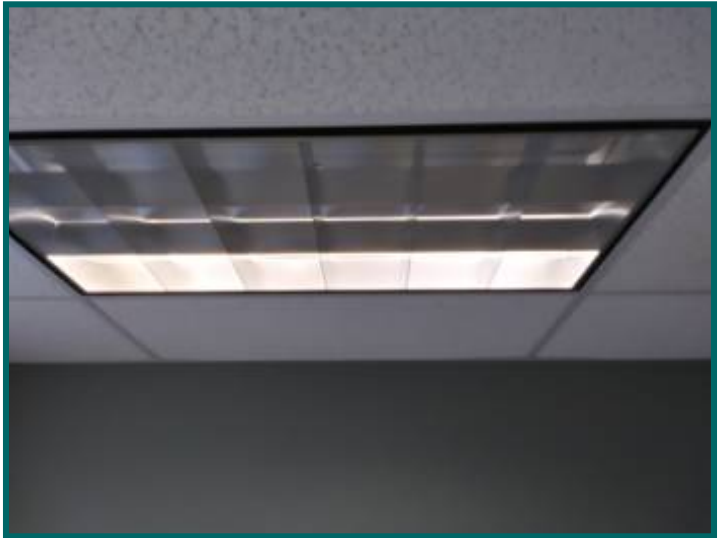
Light is out at middle front office

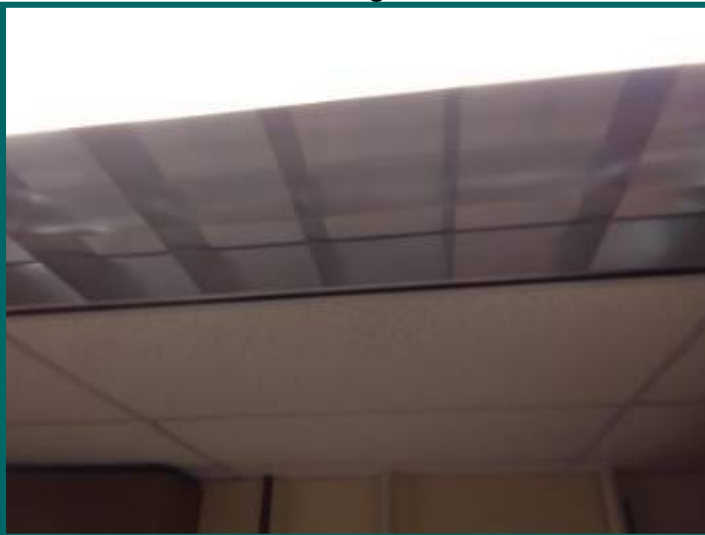
Light is out at utility room middle building

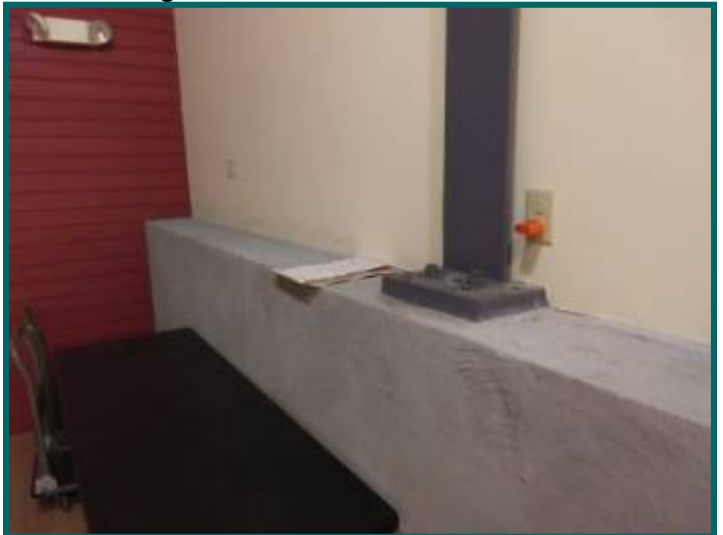
No power to outlet at middle rear hallway

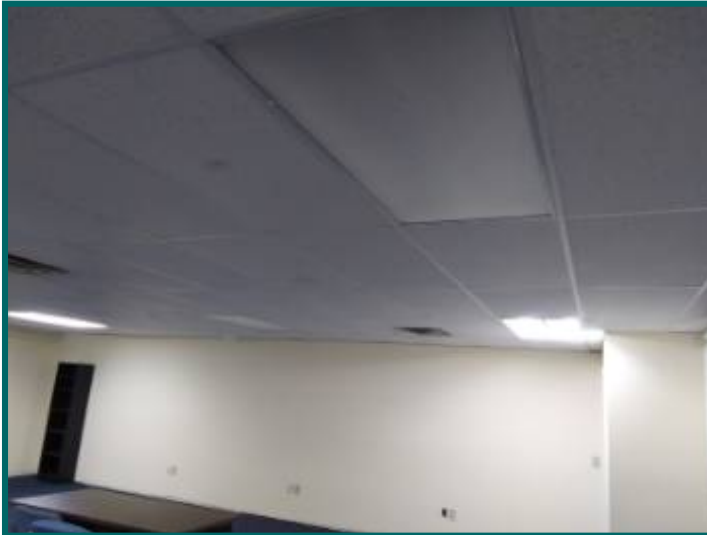
Light is out at Mount Washington room

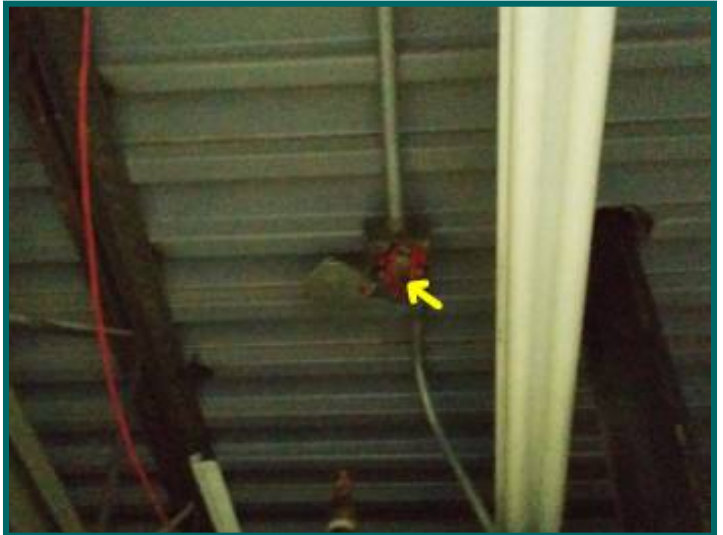
- 6.1. A random sampling of outlets, GFI outlets, switches and light fixtures were observed and tested as well as visual inspection of all accessible / visible interior wiring. All electric components appeared acceptable or operated properly except where noted.
- 6.2. One or more outlet / switch cover plates missing. Recommend repairs for safety.
- 6.3. One or more ceiling light fixtures not working at time of inspection. Recommend changing bulb and repair/ replacement by a qualified electrician as needed.
- 6.4. One or more wall outlets have no power, recommend repairs by a qualified electrician.
- 6.5. Open junction boxes were observed, which is a safety concern. Recommend installing proper covers, as needed, for safety.

Open junctions boxes in Tom Mason room closet

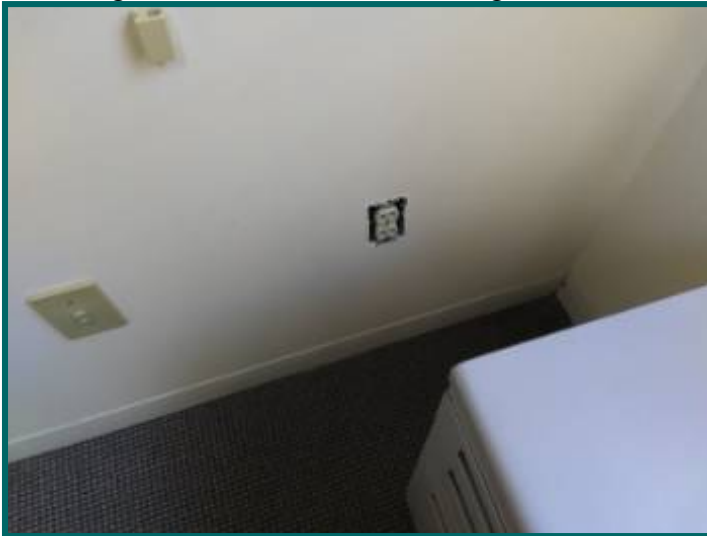
Plate covers missing at left building front office.

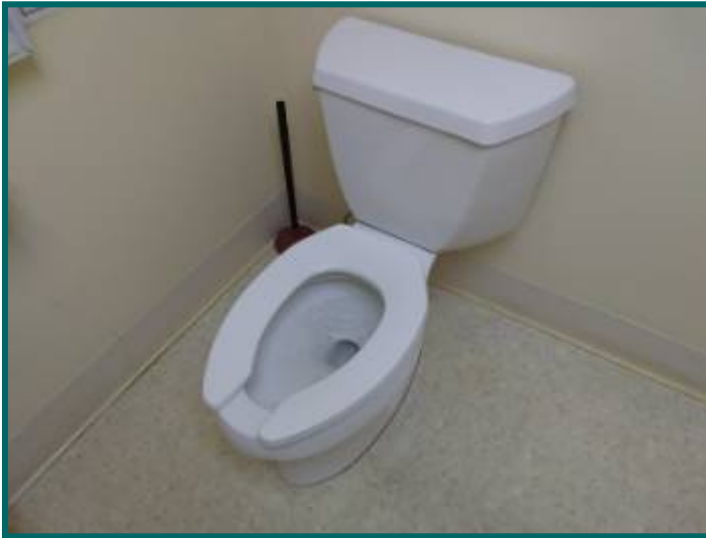
7.2. The toilet bowl at one or more location is loose at floor anchor bolts. The wax ring inside the unit must have a snug, secure fit in order to keep from leaking. Properly resealing and re-securing this unit is suggested to prevent water leakage and damage to the sub-floor area. This type of damage is not always visible or accessible to the inspector at time of inspection.

Loose toilet restroom next to Tom Mason room

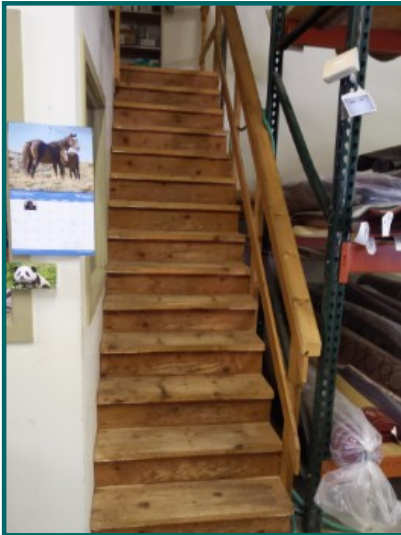
8.2. Hand rails on stairs are non graspable , this is a potential safety hazard. An easily graspable hand rail should be installed by a qualified tradesman.

8.3. Rail opening on stairs is greater than 4 inches, this is a safety hazard for young children. By todays construction and safety standards vertical ballusters should be installed no greater than 4" apart.

Missing graspable handrail and unsafe rail openings at Neatly Done.

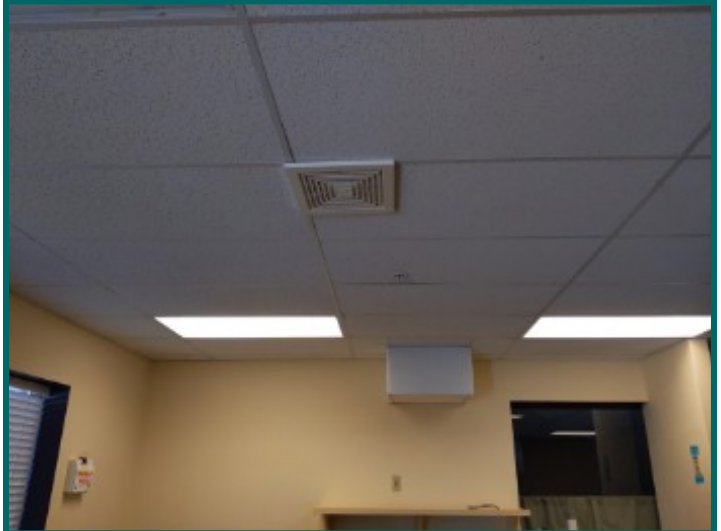
- Kitchen appliances are not operated, visual inspection only.
- One or more vent termination was not located. If kitchen vent hood is not the recirculating type, termination of kitchen venting system should be to the exterior with a proper hood or roof cap equipped with a back draft damper. Recommend assessment by a qualified tradesman.

Kitchen vent fan termination was not located

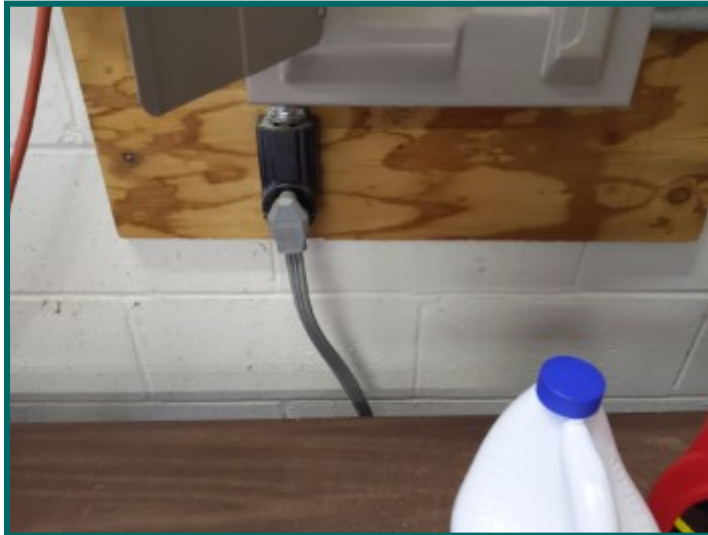
- Electric dryer outlet is three prong, when buying appliances dryer will come with either 3 or 4 prong chord. You can buy three prong chord or upgrade outlet to a four prong receptacle to bring circuit up to current building standards.
- Recommend regular inspection and cleaning of dryer vent to help prevent fire hazard.
- The dryer vent termination at rear wall is located less than 12" from finished grade. The hood opening should point down and exhibit 12 inches of clearance between the bottom of the hood and the ground or other obstruction. This can create venting issues in winter during high snow levels. Recommend assessment and repairs by a qualified tradesman.

3 prong dryer outlet
